## **Phase 1 Land Contamination Risk Assessment**

### **The Erection of Six Dwellings with Vehicular Access and Associated Parking**

**No.38 Hinckley Road, Burbage,  
Hinckley, Leicestershire  
LE10 2AQ**

4292D P1 Hemming – Hinckley, Leicestershire

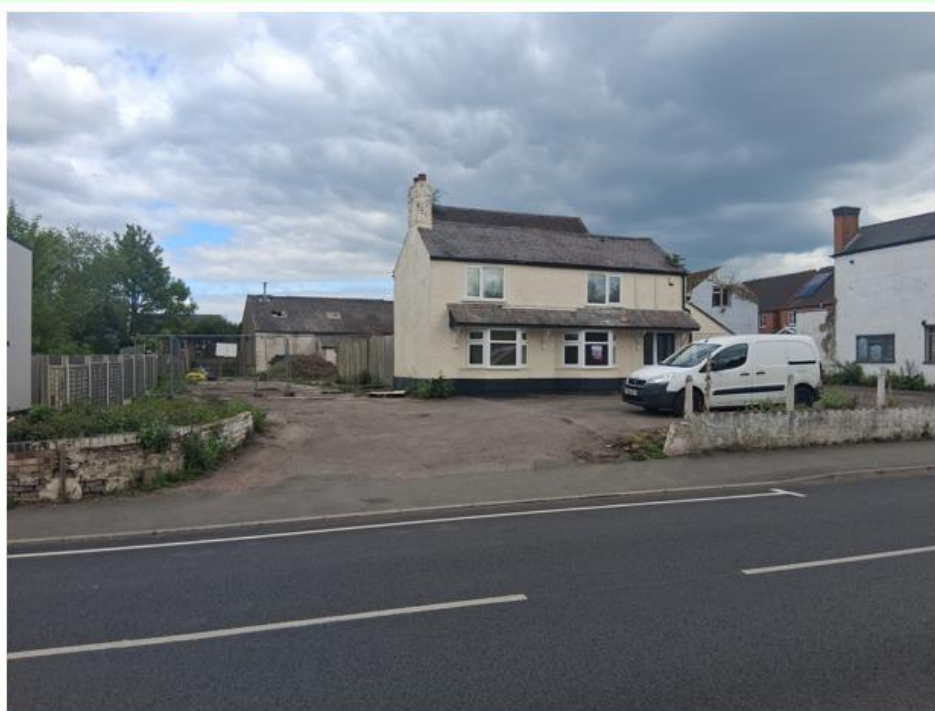
**Photo No.1: Facing east from Hinckley Road (B578) showing the frontage (western) extent of site and yard area**

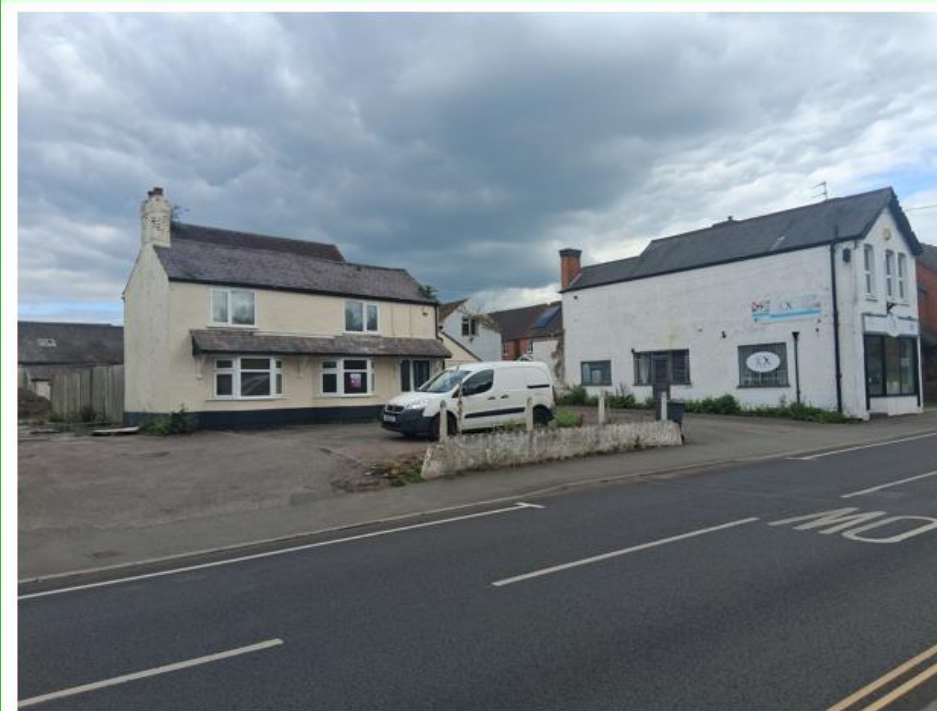
**Photo No.2: Facing slightly SE from the same location**

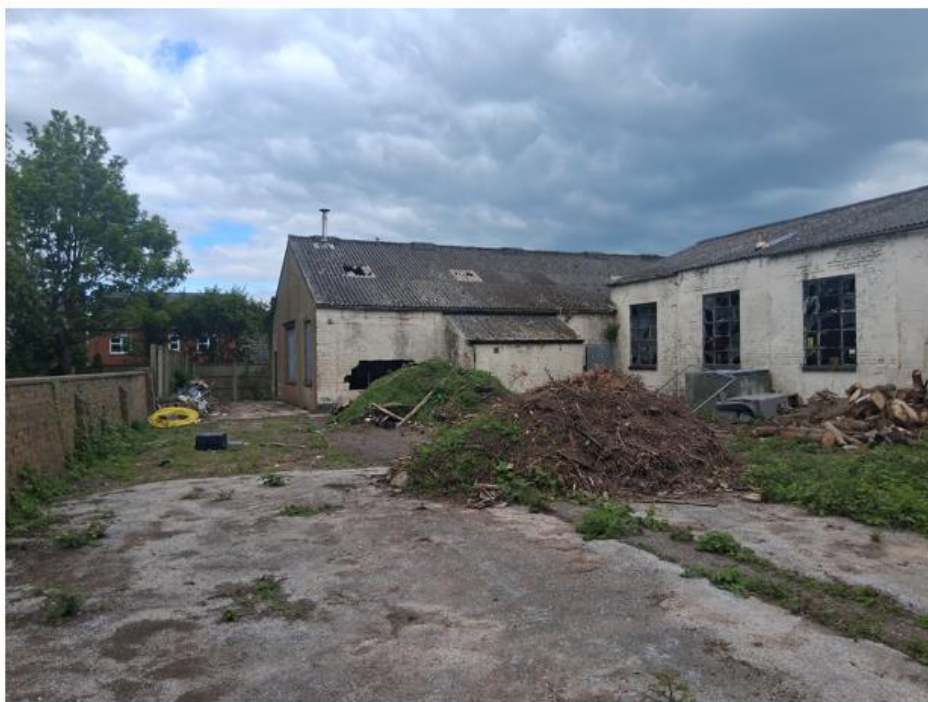
**Photo No.5: Facing east from the NW extent of site showing centrally located dilapidated building & heaps**

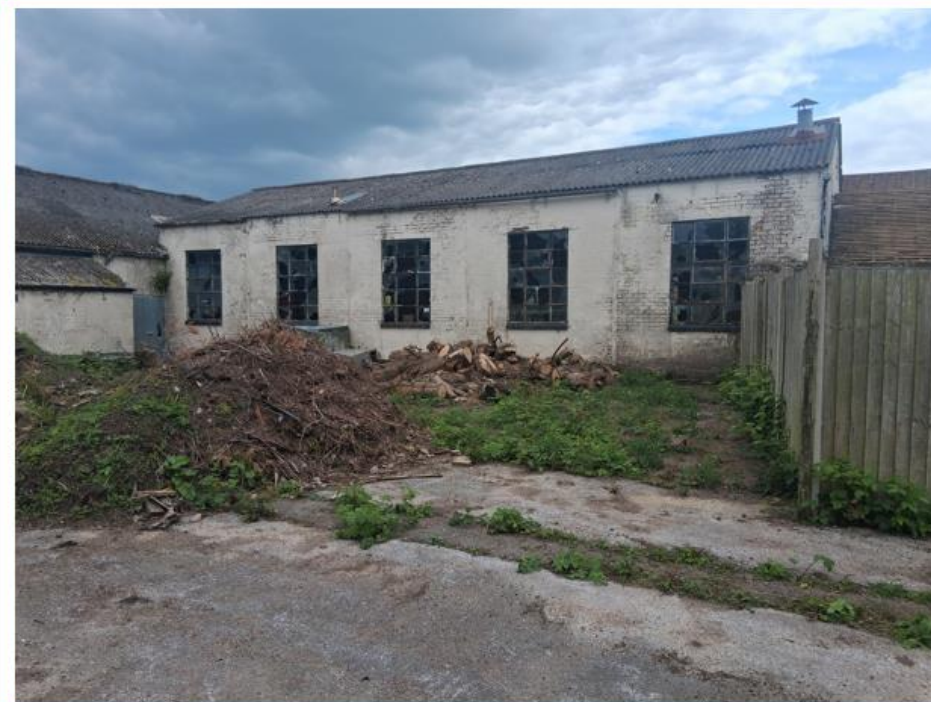
**Photo No.6: Facing south showing heaps in northern yard**

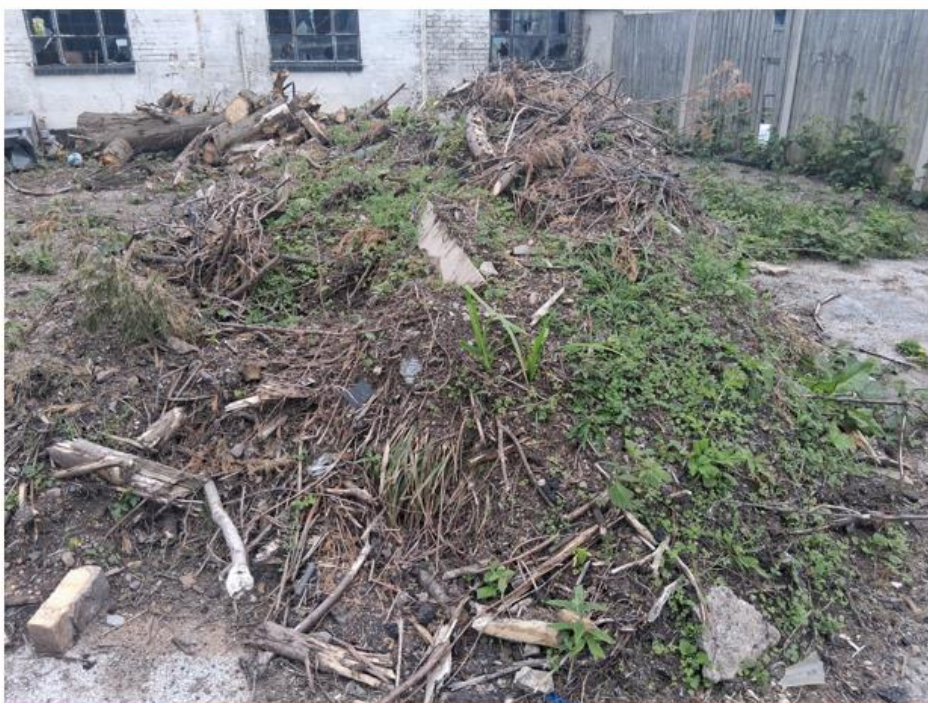
**Photo No.7: Close-up of numerous heaps in northern yard**

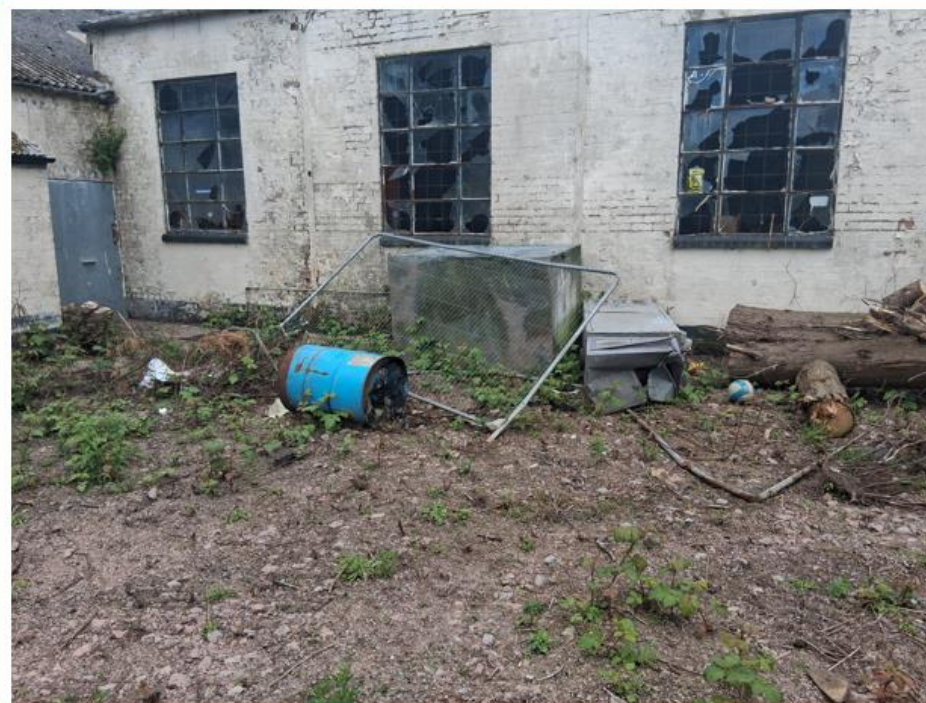
**Photo No.8: Showing the northern face of the centrally located building and scattered wastes, refuse & debris**

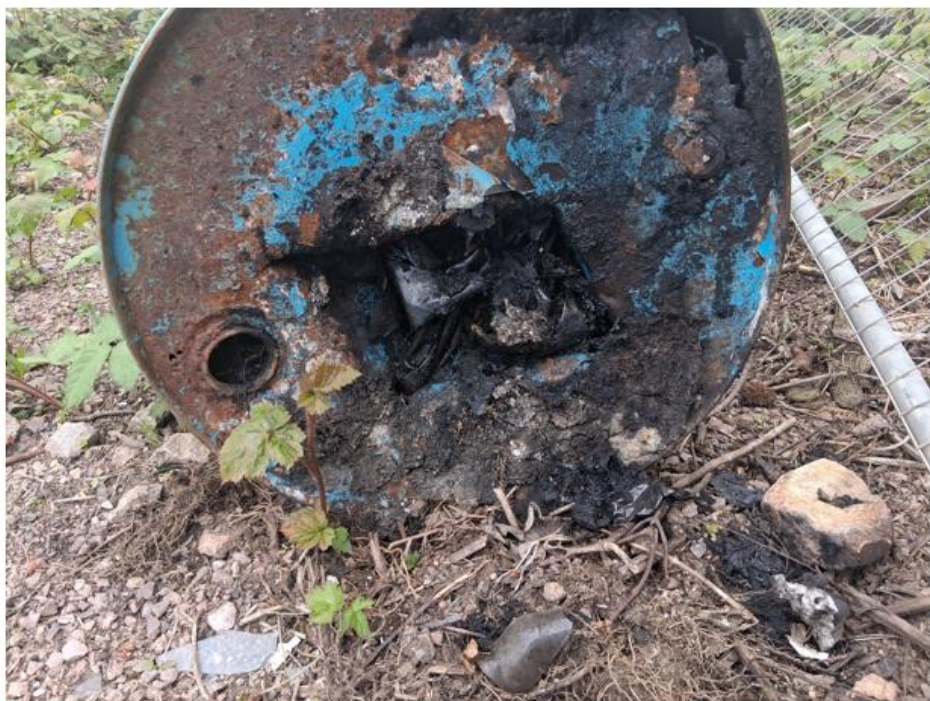
The exterior areas on site then comprise the northern and southern extents of site, being split by the centrally located workshop structure. The northernmost yard area was seen to be formed of hardstanding with limited areas of exposed soils also visible. In this area, a number of heaps of refuse, waste and debris were noted (see Photographs No.5-12 in Appendix D). The heaps appeared to comprise site scrape deposits, consisting of soils, vegetation, timbers and cuttings alongside vehicle wastes, domestic debris and further indiscernible debris. Of note was a number of fragments of what appeared to be potentially asbestos containing materials; and a barrel from which oil appeared to be leaking (with olfactory evidence of such also noted).

**Photo No.9: Leaking oil barrel with strong olfactory evidence of hydrocarbons noted in northern yard area**

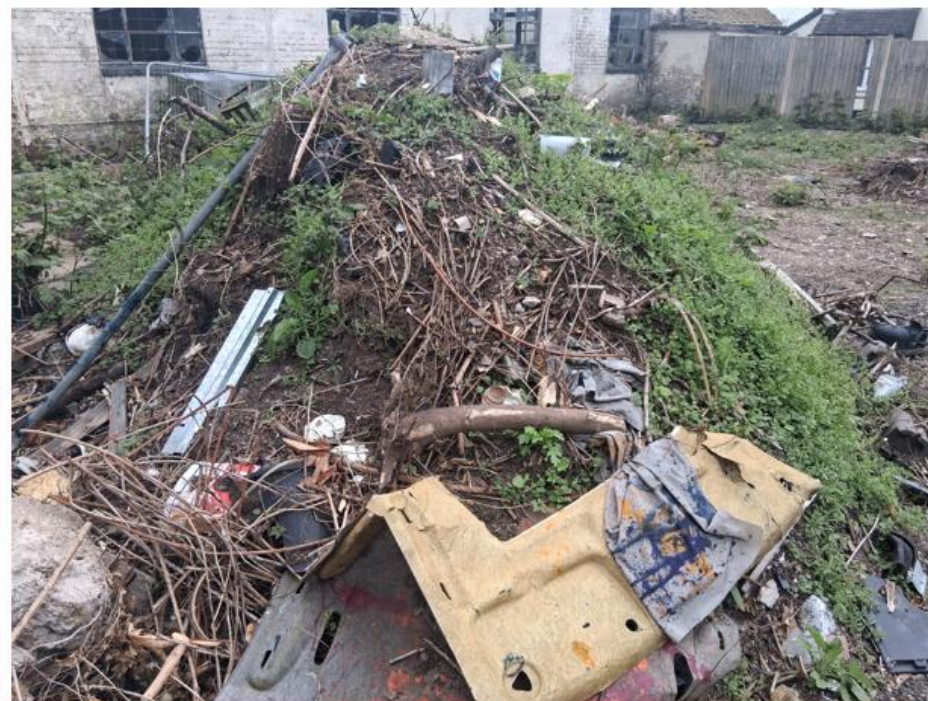
**Photo No.10: Further photograph of waste heaps in the northern yard area on site (various wastes, woods etc)**

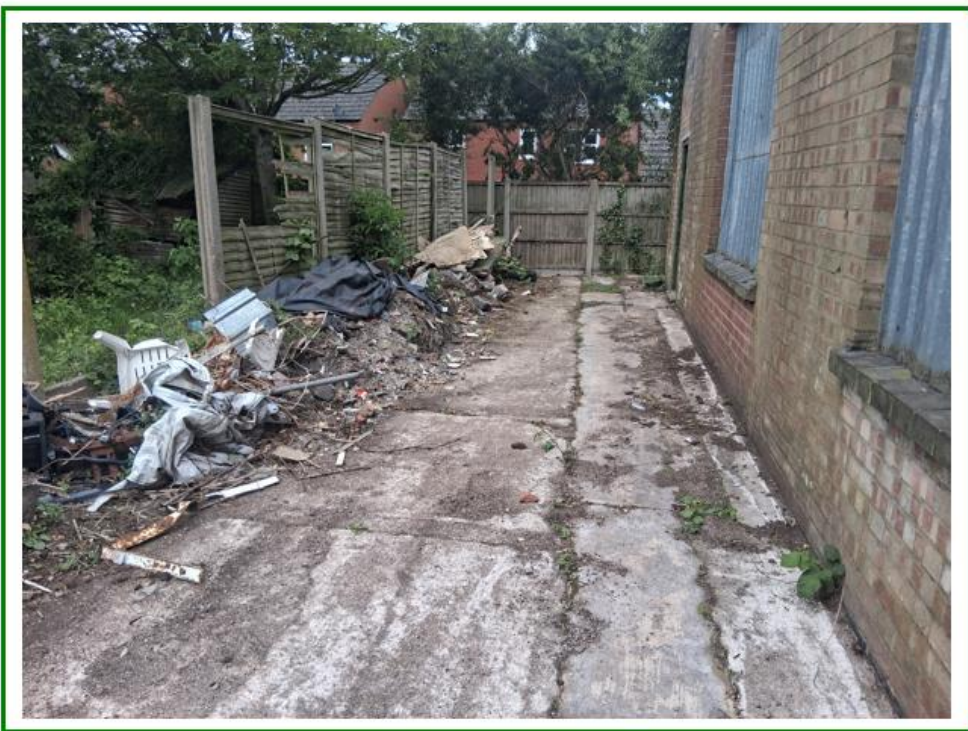
**Photo No.11: Facing slightly NE showing the far NE corner of site and further waste heaps and debris**

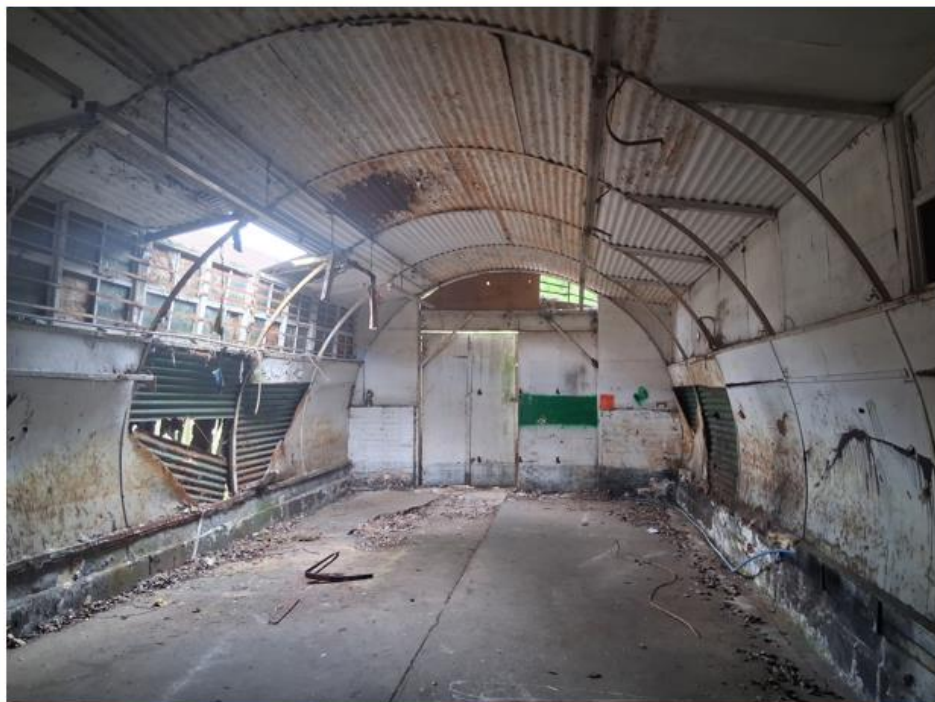
shape). Access to such was provided via a hole in the walling from the northern section, or via the western face of the workshop, through the former vehicle accessway. The east-west orientated structure was seen to be constructed of brick, stone and PACM-roofing with concrete flooring noted through, with the interior being occupied by former vehicle workshop apparatus (i.e. vehicle lift, waste oil burner, associated tools, equipment and containers). The northern section of the east-west structure and the north-south orientated structure adjoined to the eastern face was seen to be similarly constructed and dilapidated, however was largely stripped of interior occupations, fittings and furnishings. Further fragmented PACM were noted throughout the building's interiors. Also of note was an adjoined former Nissen-hut (see Photographs No.17-18) that was also seen to be in a poor state of repair.

**Photo No.17: Dilapidated former Nissen-hut adjoined to onsite structures**

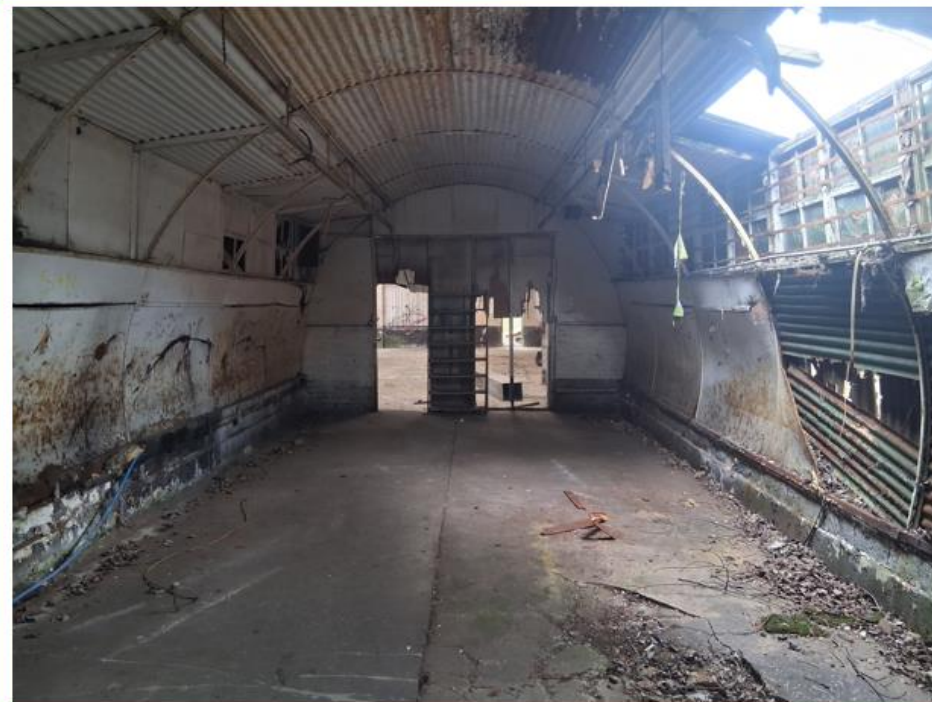
**Photo No.18: Dilapidated former Nissen-hut adjoined to onsite structures**

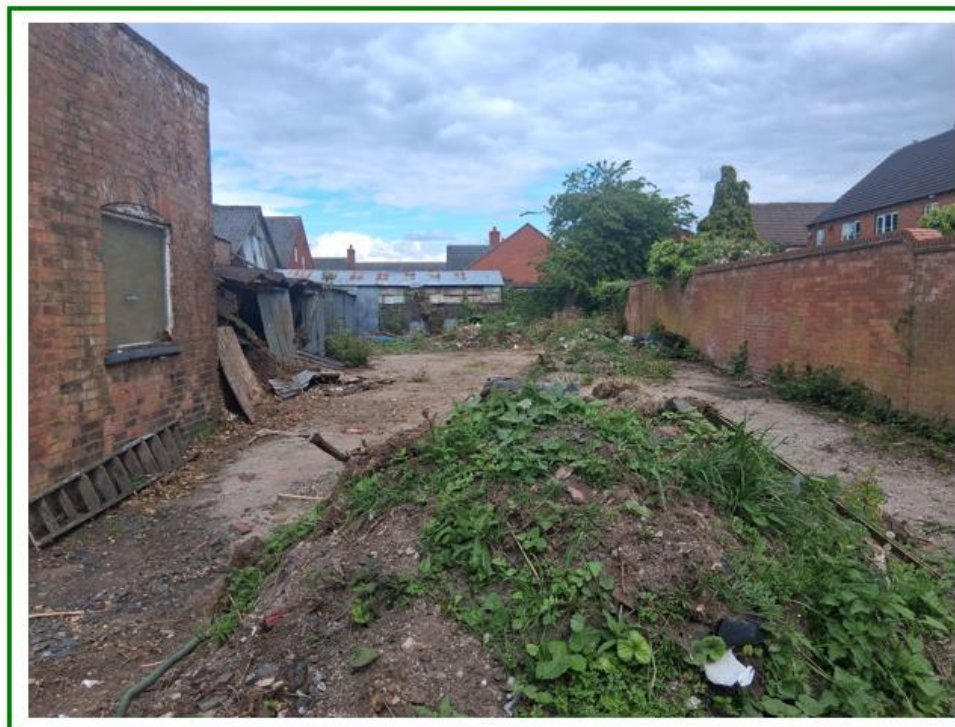
The southernmost exterior area was seen to be similar to that in the north, being comprised of a mixture of hardstanding and exposed soils and with numerous further heaps of wastes and debris noted. Such wastes included further site scrape deposits, such as soils and vegetation cuttings; however, alongside this was further PACM, vehicle debris, demolition debris (i.e. tiling and ceramics) and chemical and hydrocarbon containers (see Photographs No.26-32 in Appendix D).

**Photo No.26: Facing east showing the remaining southern exterior area on site (workshop to left) & further heaps**

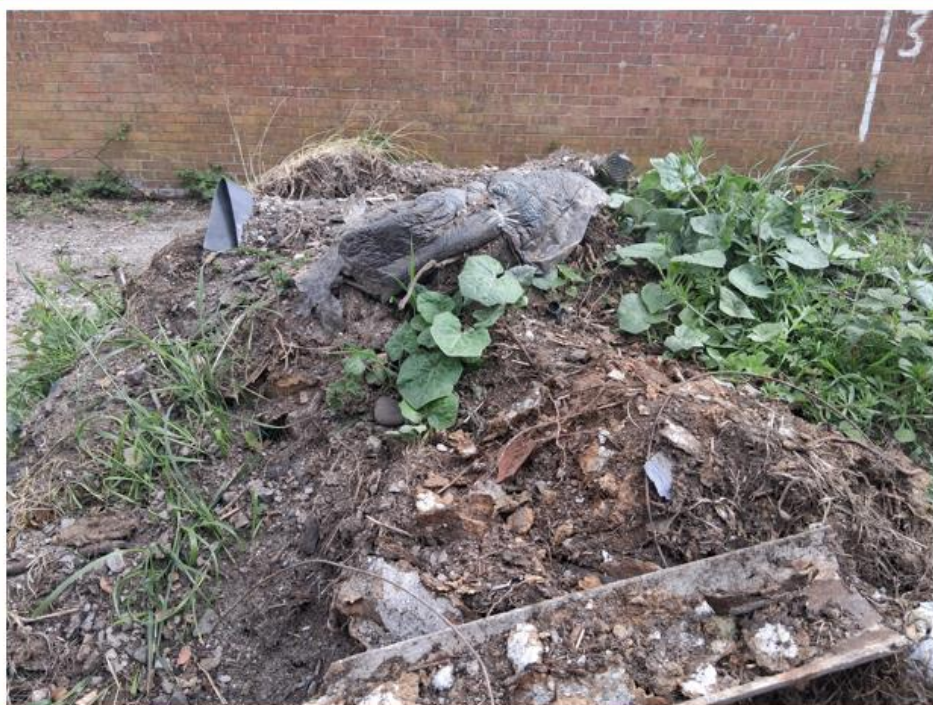
**Photo No.27: Close-up of heaps in the southern extent of site with visible, fragmented PACM piping (bottom of photo)**

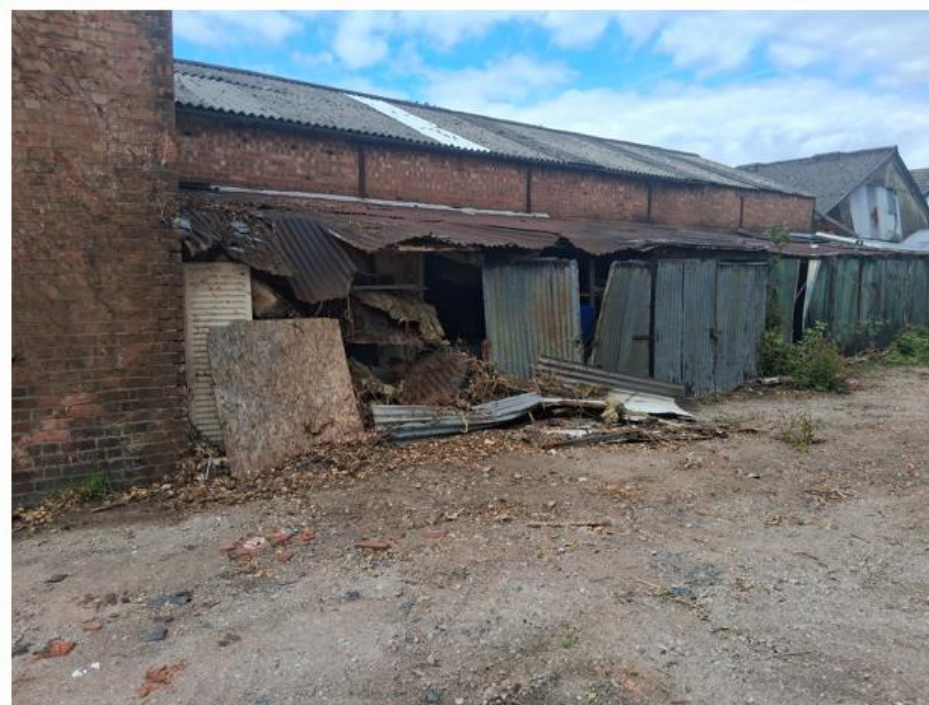
**Photo No.28: Facing north showing the southern face of the dilapidated, centrally located workshop structures**

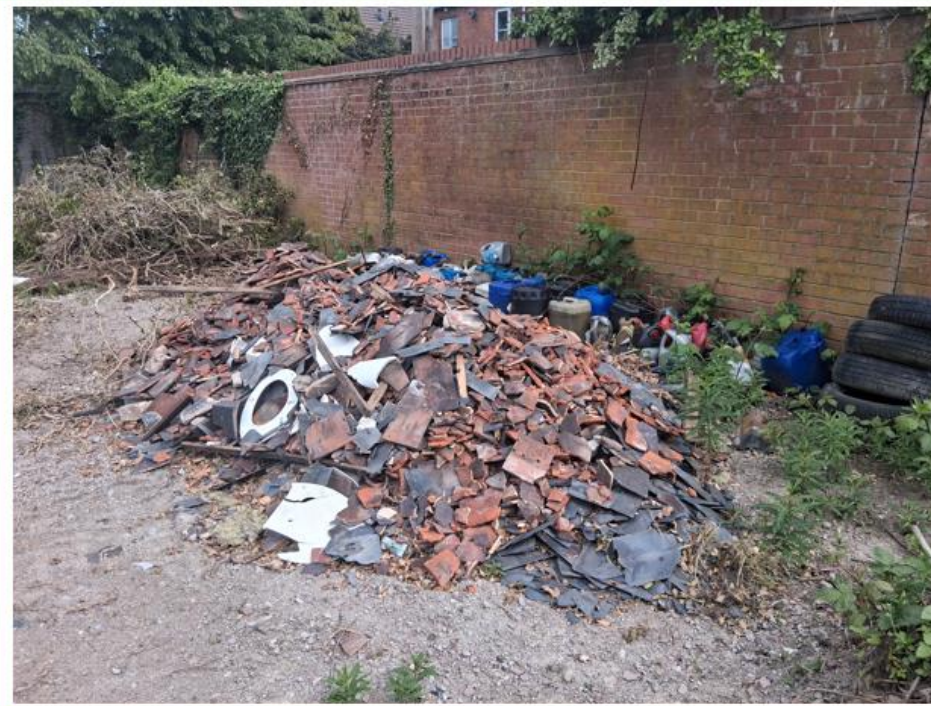
**Photo No.30: Further heaps of refuse and waste noted in southern exterior area on site (ceramics, tiling, tyres, containers)**

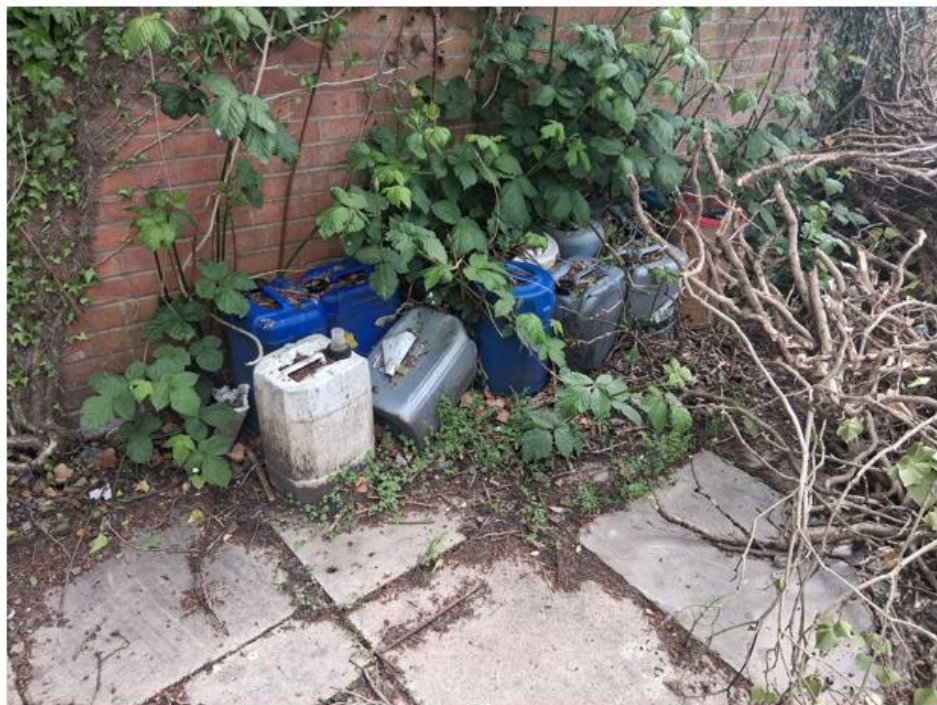
**Photo No.31: Chemical & hydrocarbon containers noted on and inside the southern boundary of site**

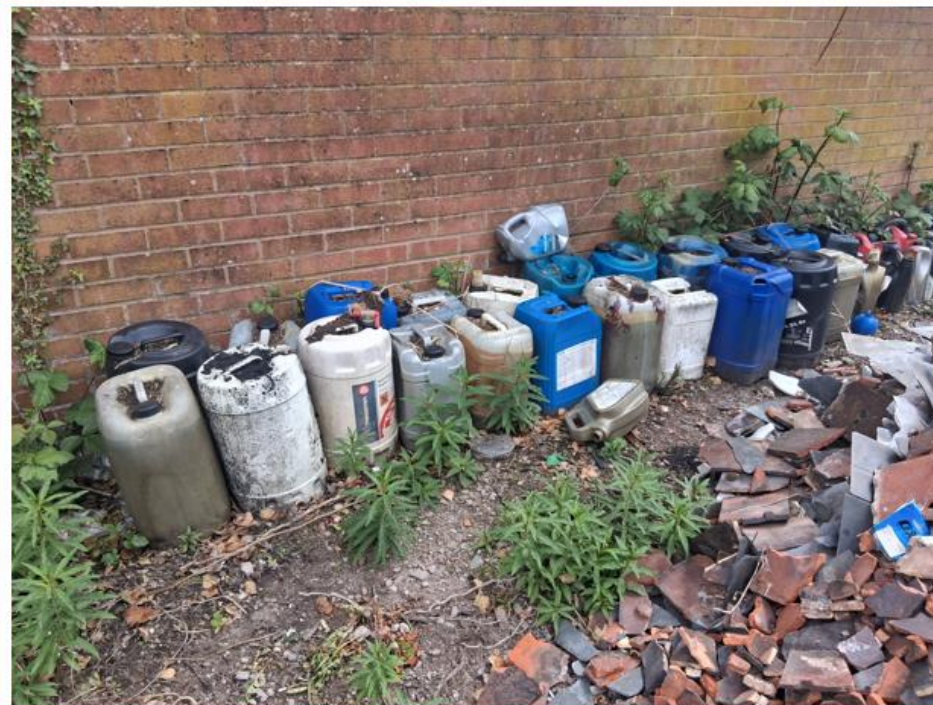
**Photo No.32: Further chemical & hydrocarbon containers noted on and inside the southern boundary of site**

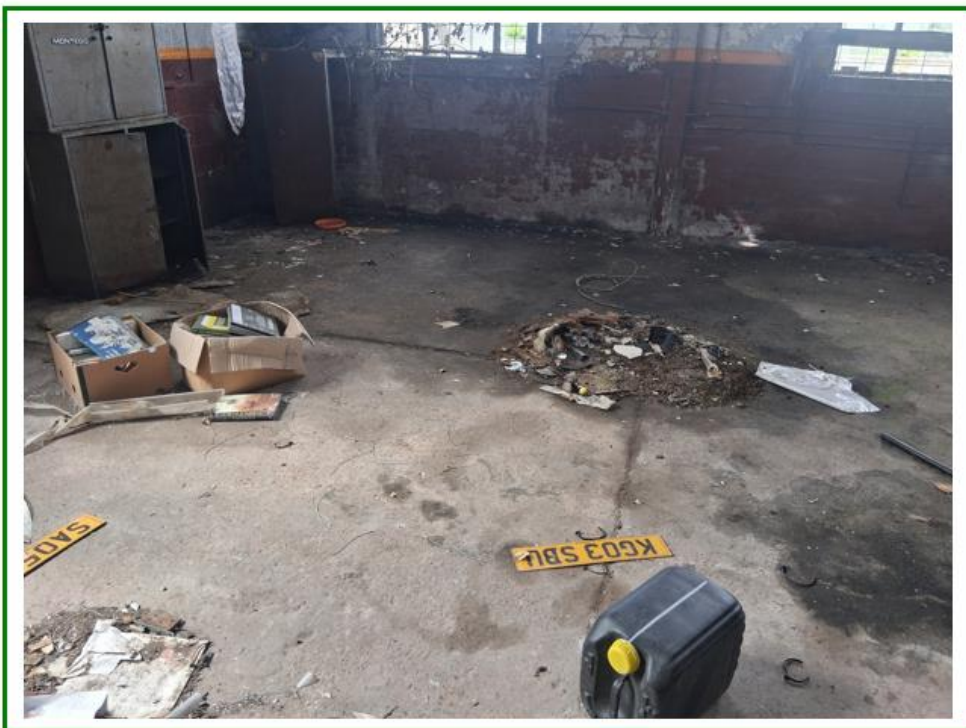
**Photo No.35: Example shot of concrete flooring throughout the workshop with some staining noted, further debris**

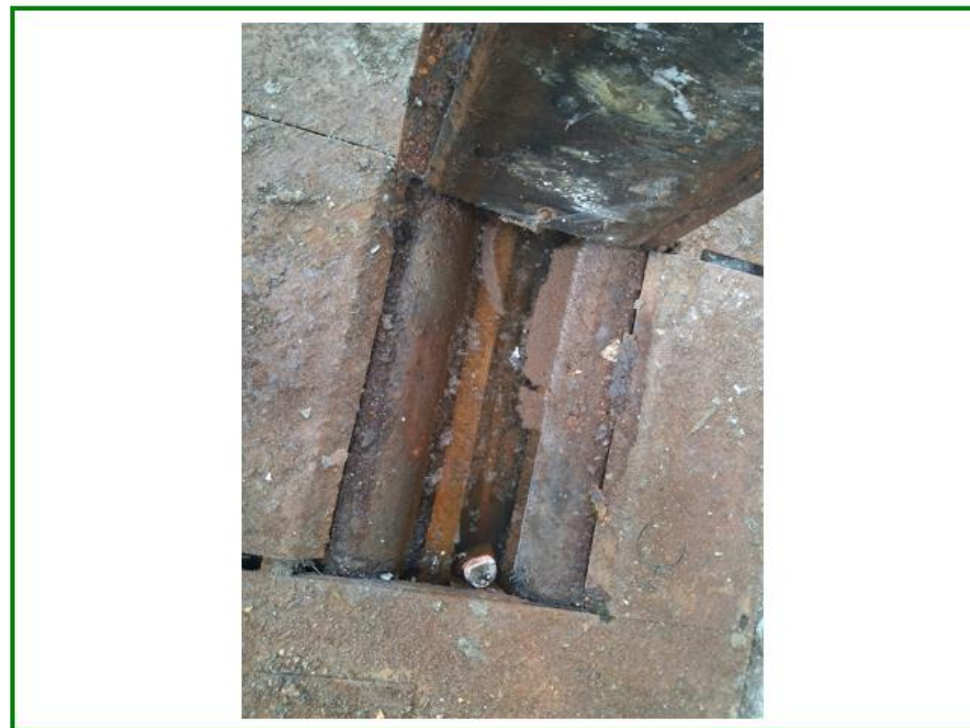
**Photo No.36: Vehicle rolling-road apparatus noted underfoot in workshop seen to be retaining iridescent water**

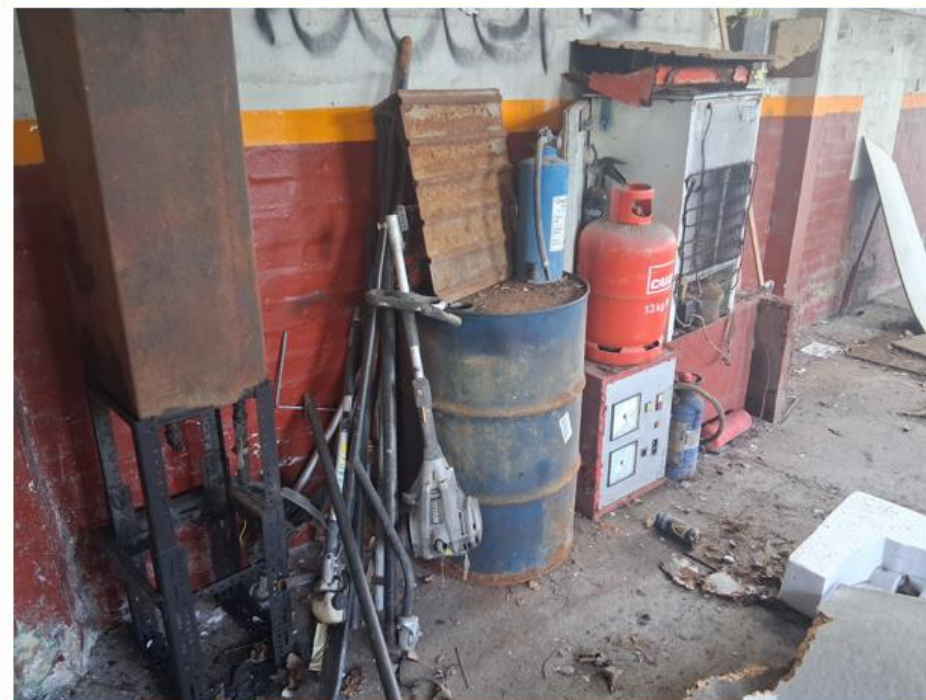
**Photo No.38: Waste oil burner, barrel and equipment storage noted in the former vehicle workshop**
