## CCTV REPORT

| <b>CLIENT</b> | MJM CONSULTING ENGINEERS |
| <b>LOCATION</b> | HAMMONDS WAY<br>HINCKLEY<br>LEICESTERSHIRE<br>LE10 3EG |
| <b>REF</b> | 071676 |

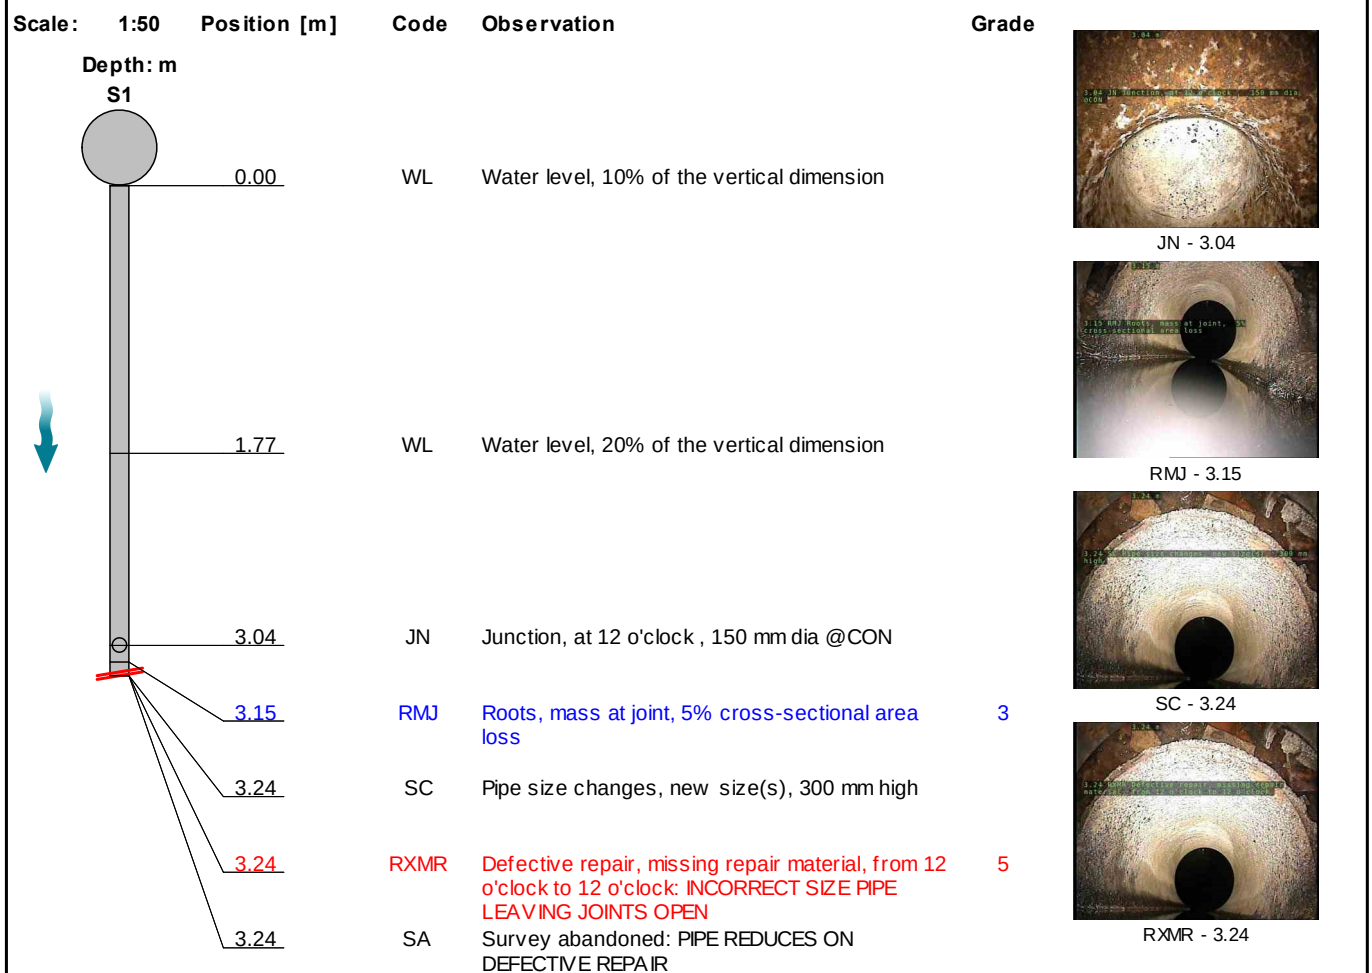
| Item No. | PLR | Grade | Description |
|---|---|---|---|
| 2 | S1X | 5 | Defective repair, missing repair material, from 12 o'clock to 12 o'clock |

| Item No. | PLR | Grade | Description |
|---|---|---|---|
| 2 | S1X | 3 | Roots, mass at joint, 5% cross-sectional area loss |

| No. | m + | Code | Observation |
|---|---|---|---|
| 4 | 3.15 | RMJ | Roots, mass at joint, 5% cross-sectional area loss |
| 6 | 3.24 | RXMR | Defective repair, missing repair material, from 12 o'clock to 12 o'clock |

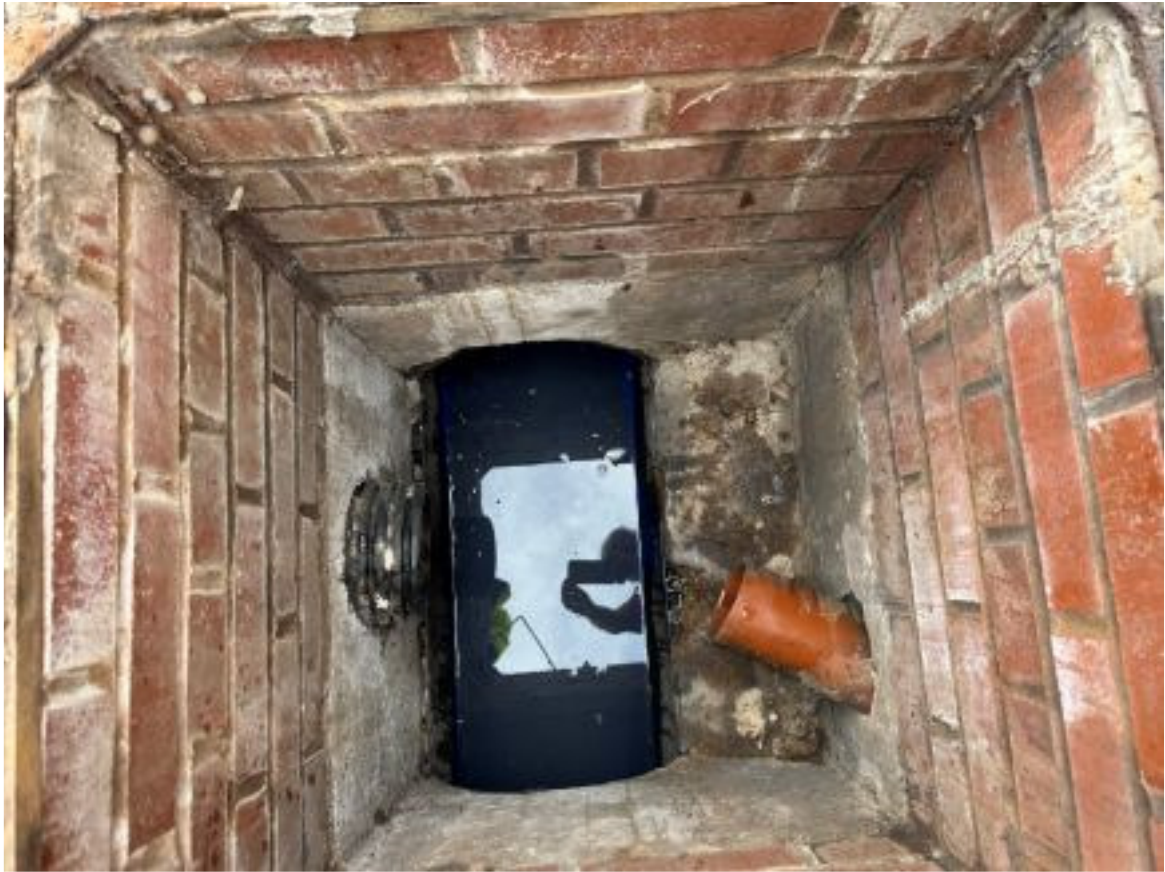
MH S1

MH No. S1  
DEPTH. 1.16  
COVER. SM  
CONSTRUCTION. Br  
REMARKS.

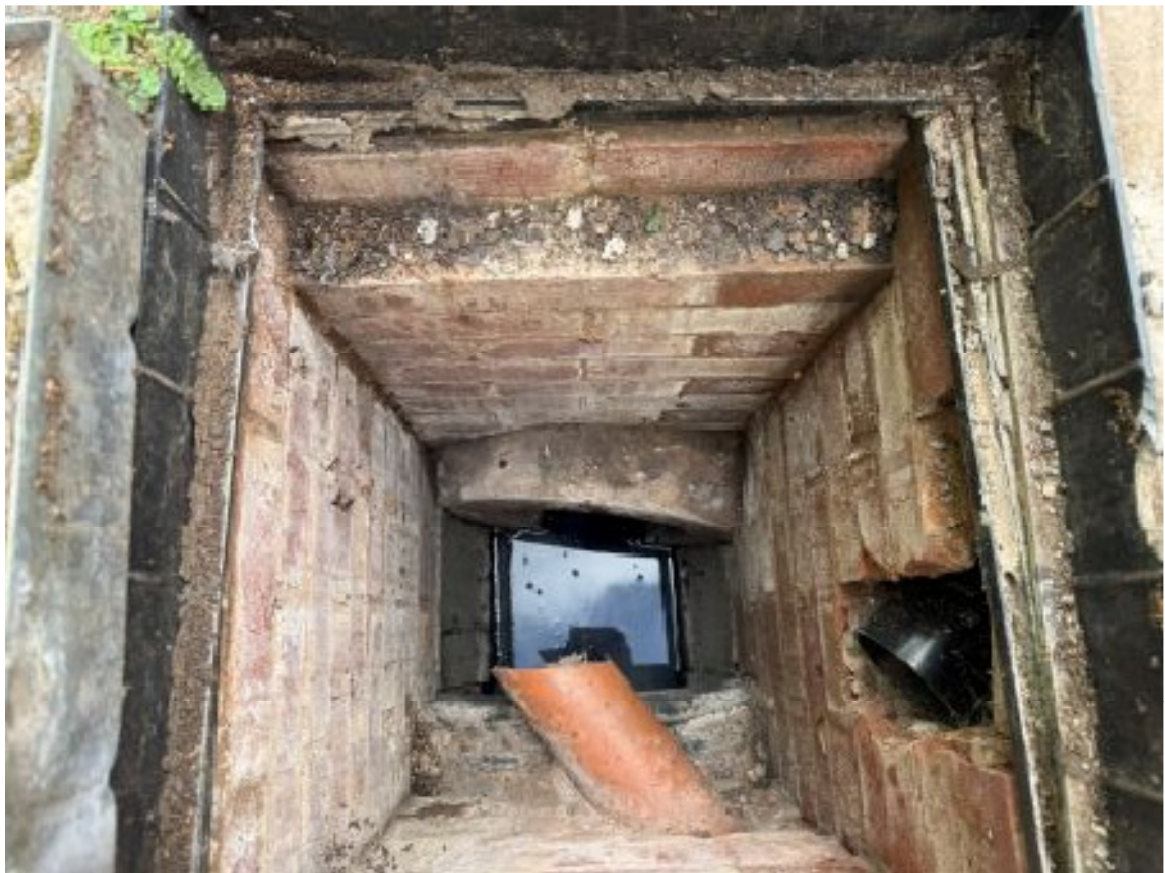
MH S2

MH No. S2  
DEPTH. 1.10  
COVER. RM  
CONSTRUCTION. Br  
REMARKS.
