# ASTON FLAMVILLE SOLAR FARM

## Condition 21 – Pre-Commencement Highway Condition Survey

794-PLN-WWP-TRP-00230-02b  
Highway Condition Survey (HBBC)  
Version 02b  
30 October 2024

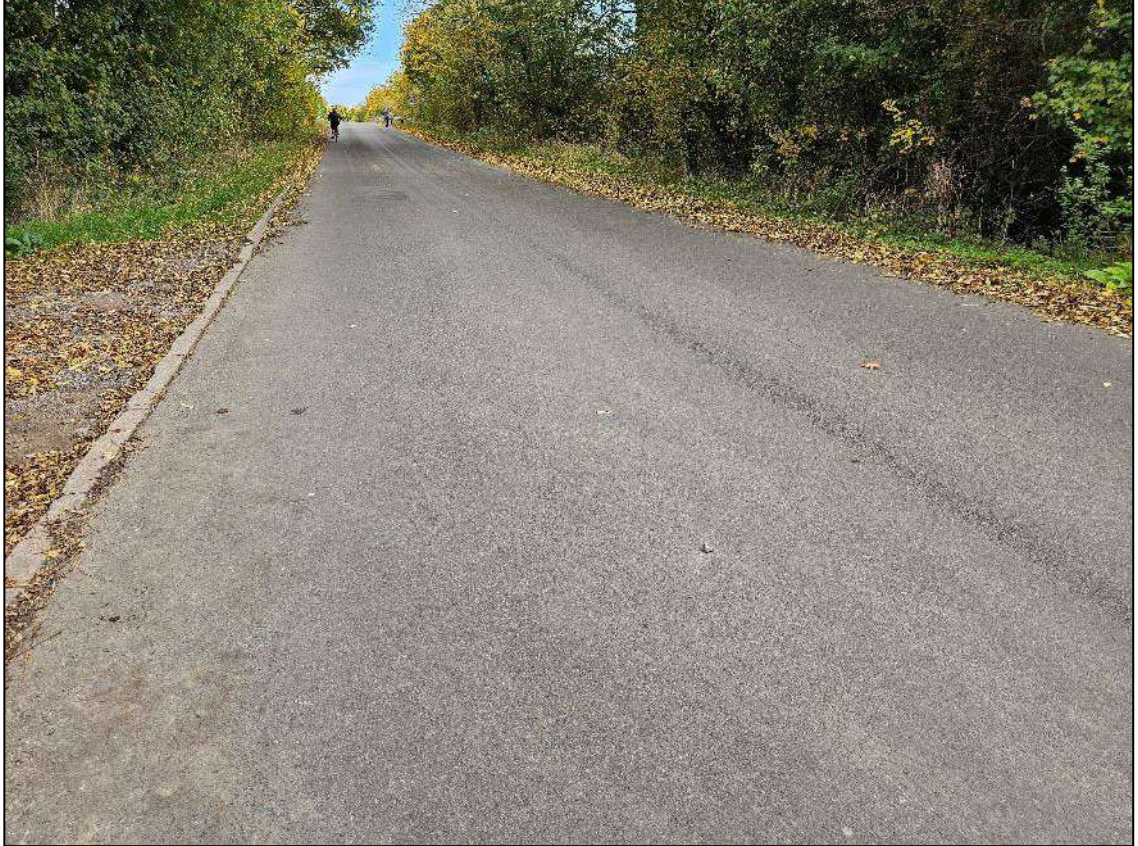
**Figure 5: Eastbound View of Lychgate Lane from the Parcel A Access**

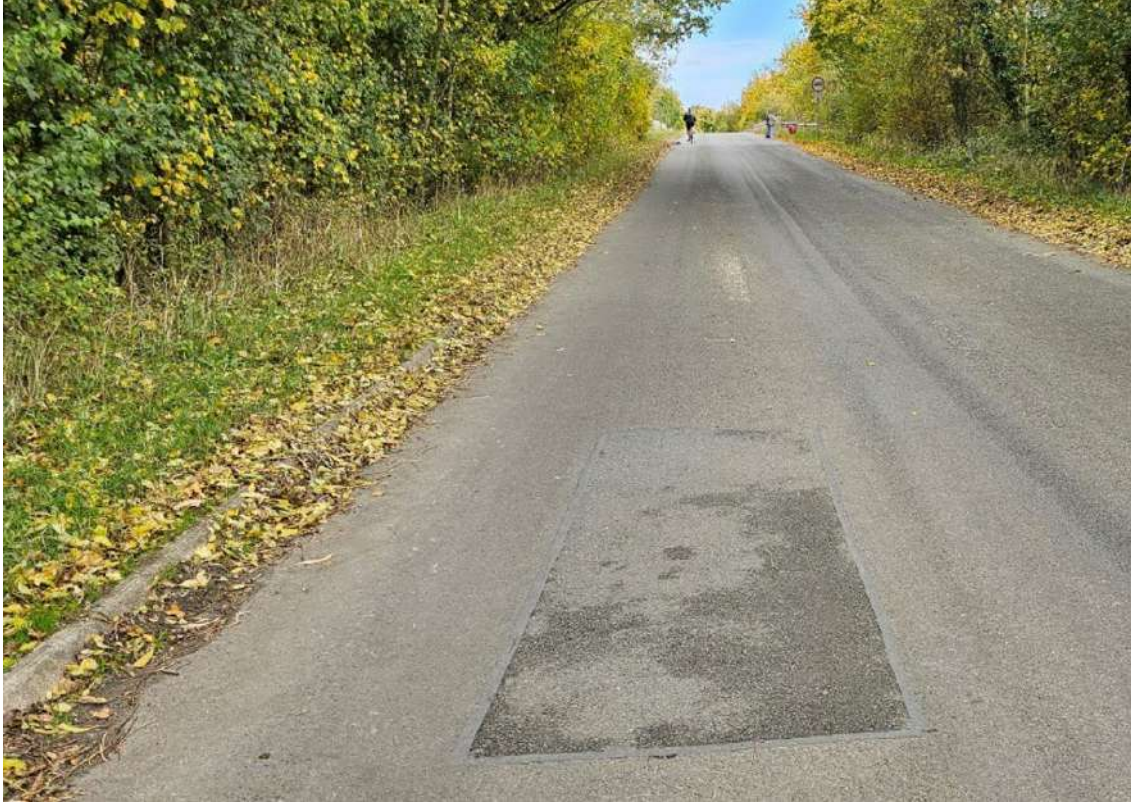
2.9 **Figure 6** shows an area of carriageway patching, and sediment / leaf litter build up adjacent to the kerbing, within the extent of the carriageway tarmac.

**Figure 6: Eastbound View of Lychgate Lane, approximately 10m east of the Parcel A Access**

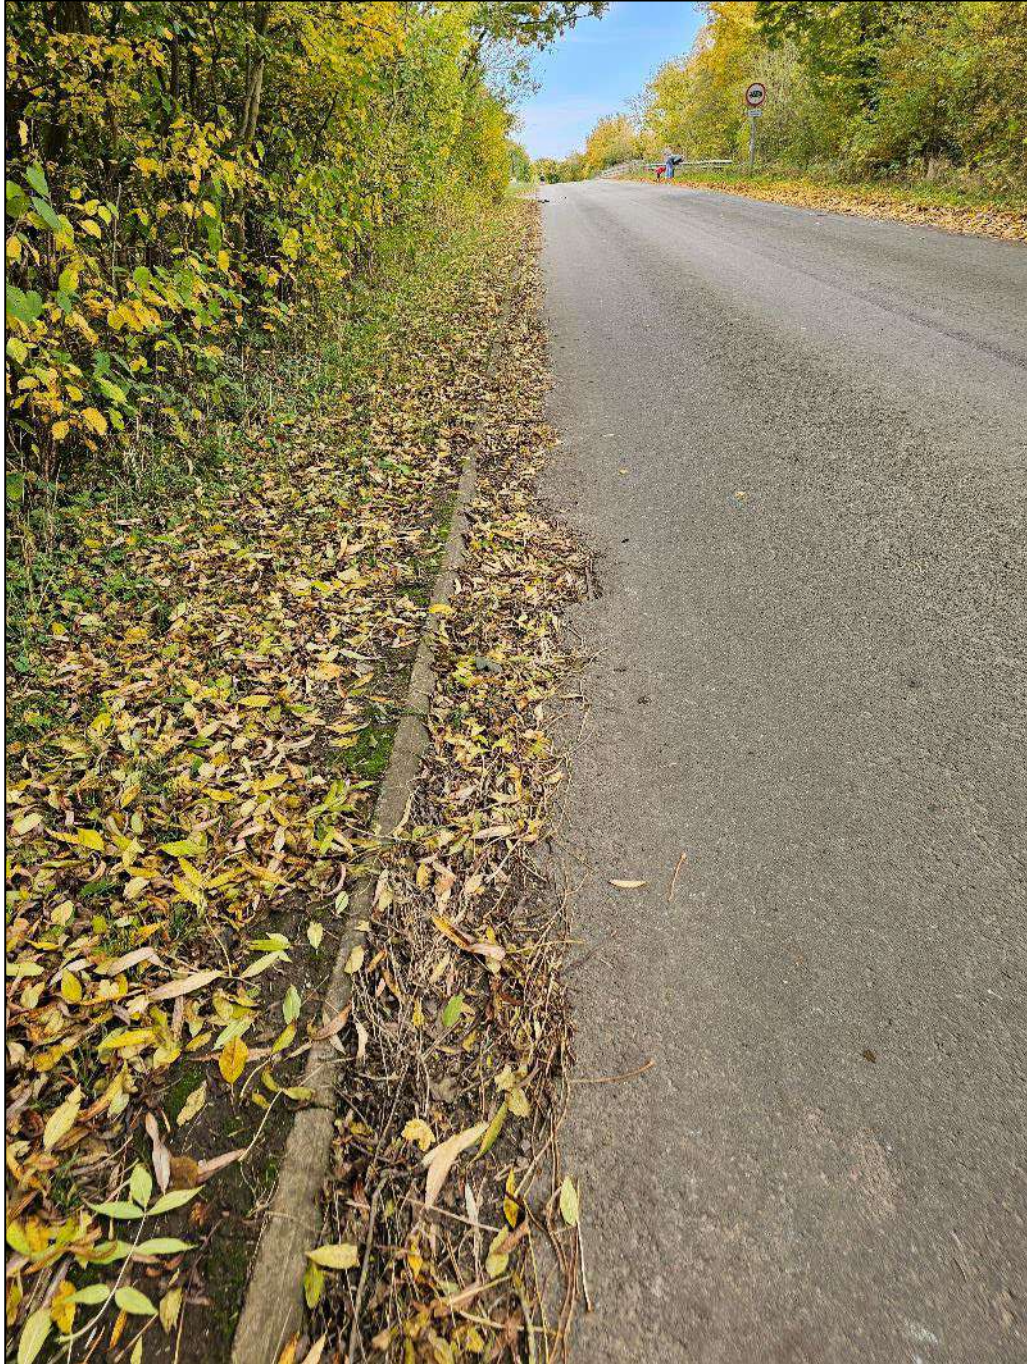
2.10 **Figure 7** also shows the extent of sediment / leaf litter build up adjacent to the kerbing, within the extent of the carriageway tarmac. This is consistent within the vicinity of trees within the grass verge, between the Parcel A access and the M69 motorway bridge.

**Figure 7: Eastbound View of Lychgate Lane, approximately 20m east of the Parcel A Access**

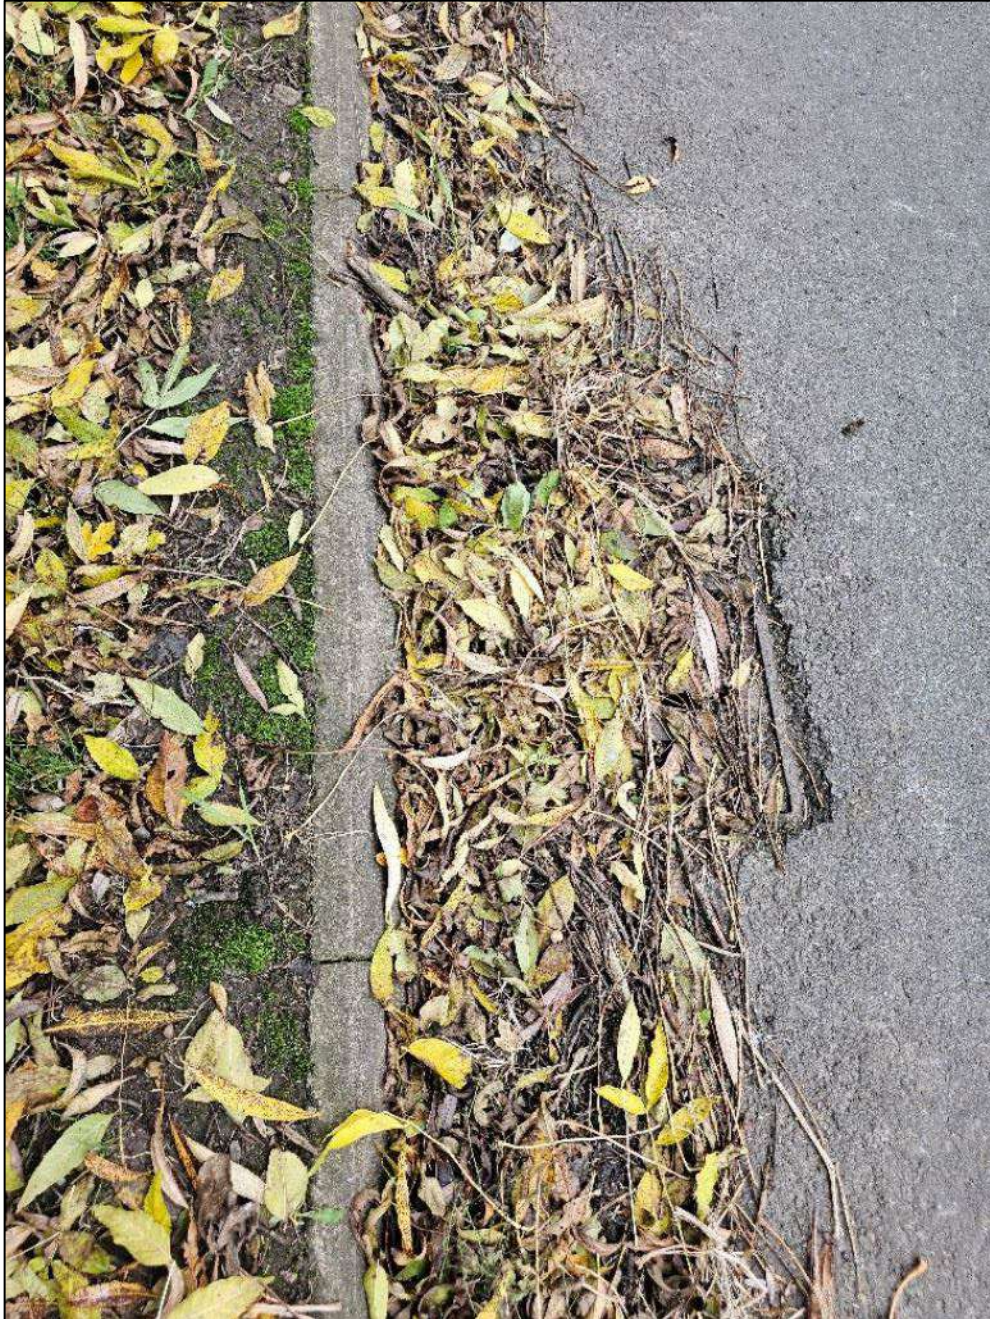
**Figure 8: Drain Obstructed by Debris 40m East of the Parcel A Access**

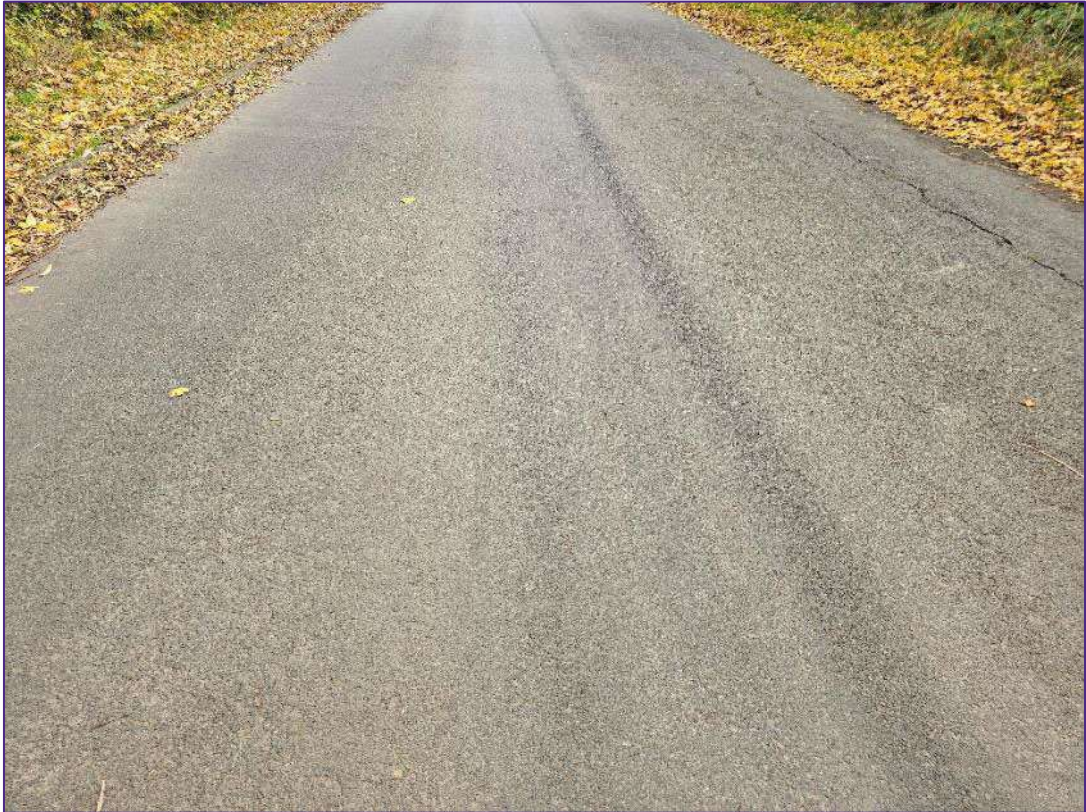
**Figure 9: General Carriageway Condition 40m East of the Parcel A Access**

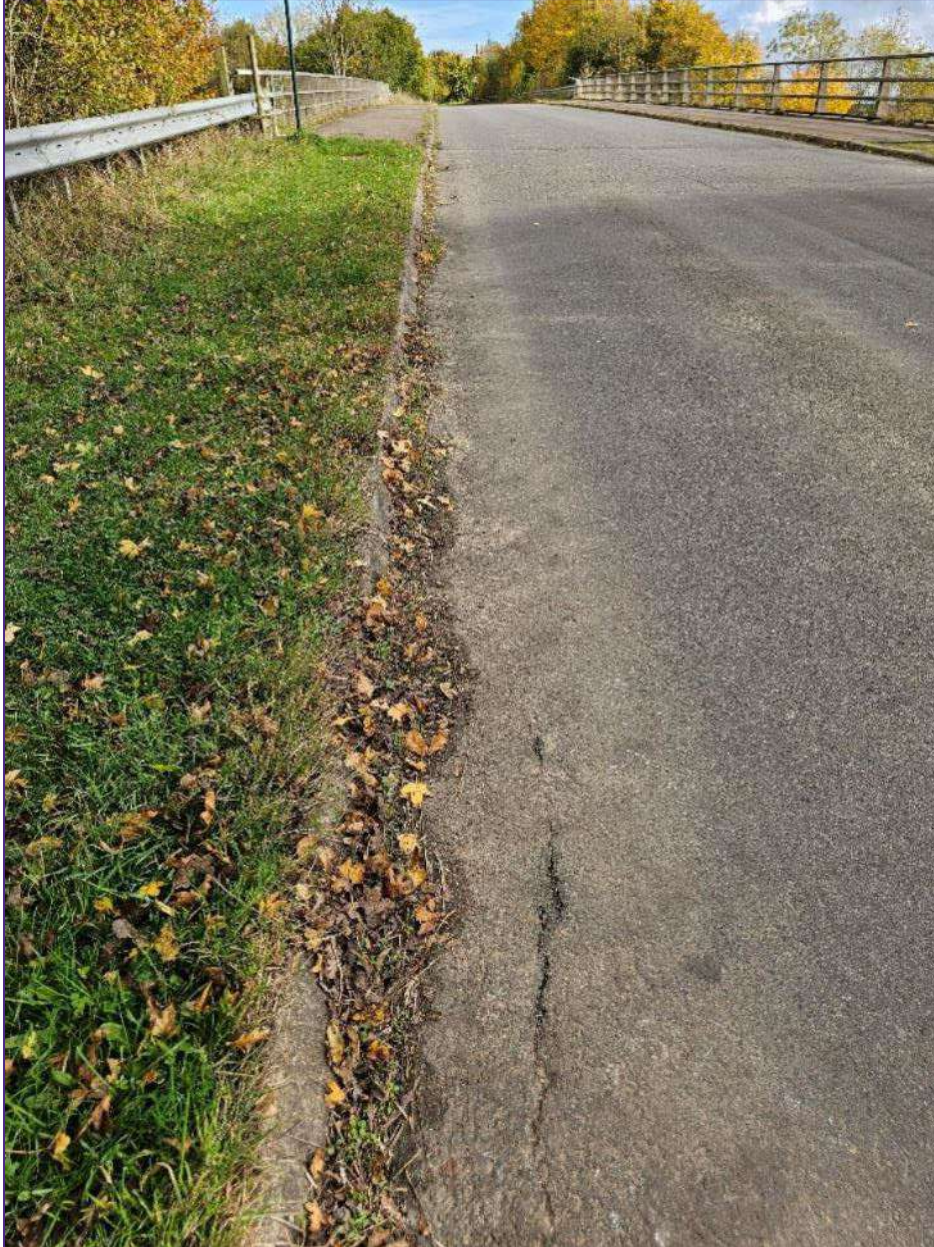
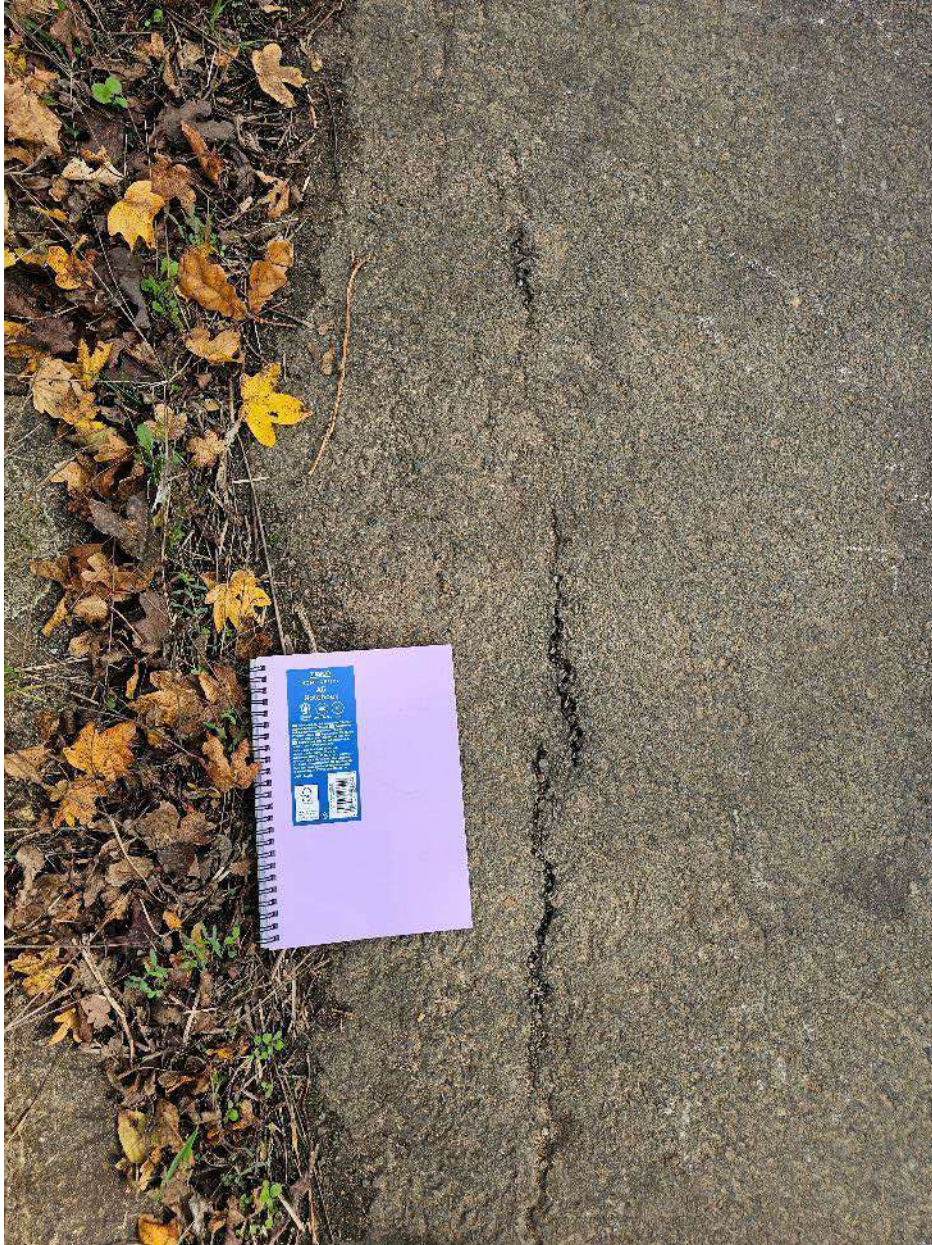
**Figure 10: Defect in Carriageway 110m east of the Parcel A Access**

- 2.11 **Figures 10 and 11** show a surface defect within the tarmac which runs parallel to the edge of carriageway. It should be noted that the notebook within **Figure 11** is an A5 notebook which has been placed for scale.

**Figure 11: Defect in Carriageway 110m east of the Parcel A Access**

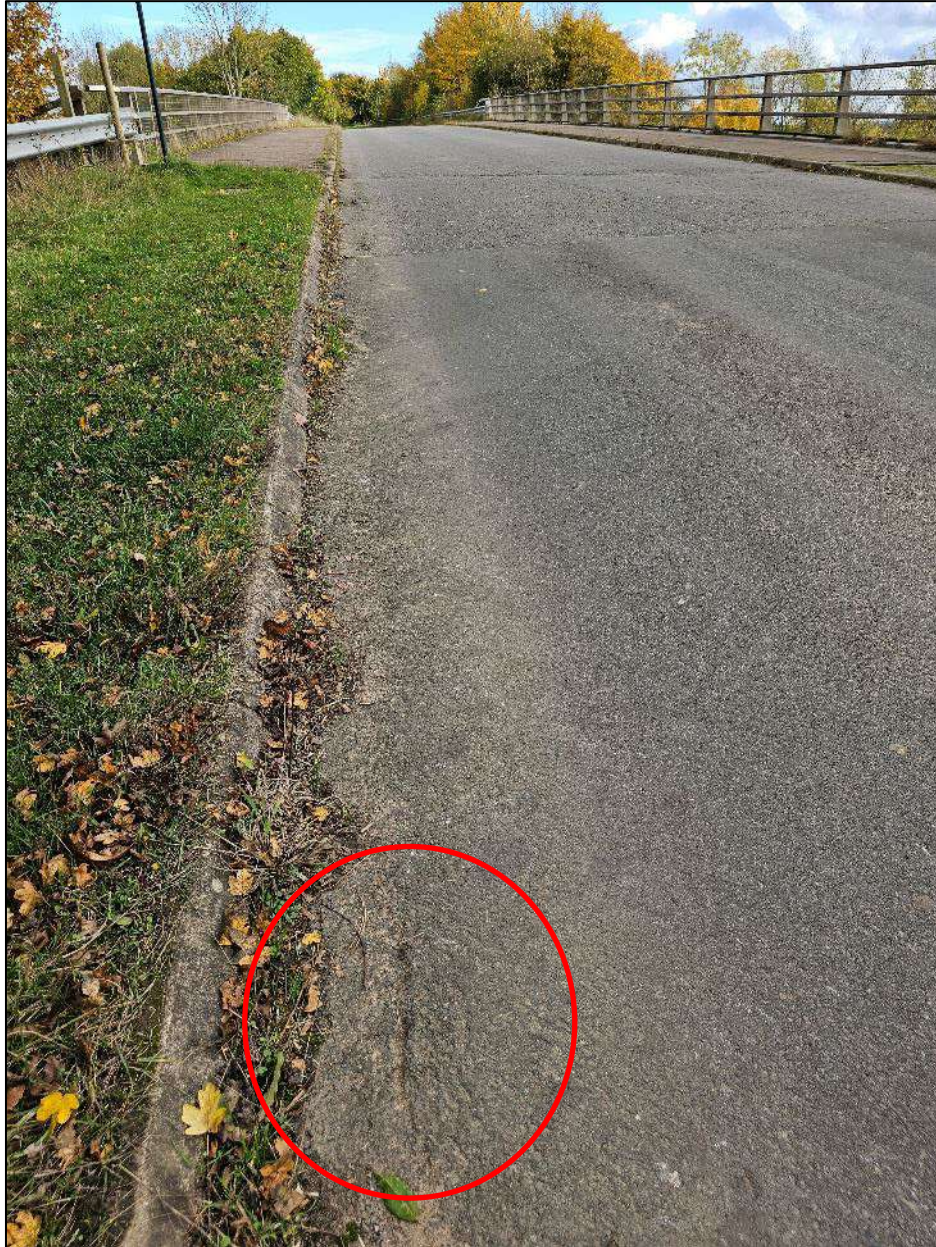
**Figure 12: Defect in Carriageway 115m east of the Parcel A Access**

- 2.12 **Figures 12 and 13** shows carriageway patching and the general carriageway condition of Lychgate Lane to the west of the M69 motorway bridge.
- 2.13 The Lychgate Lane / M69 motorway bridge has shallow cracks within its surface, both transverse and parallel to the kerb line. These defects are shown below.

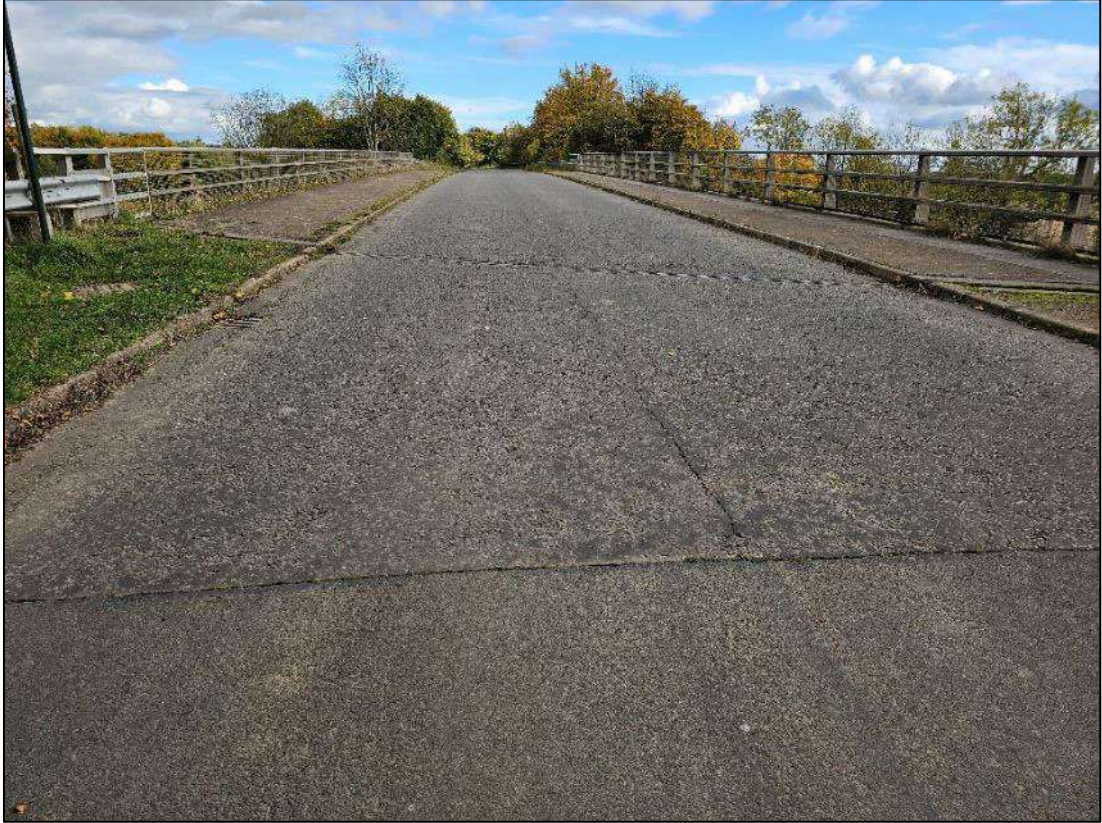
**Figure 13: General Carriageway Condition 120m East of the Parcel A Access**

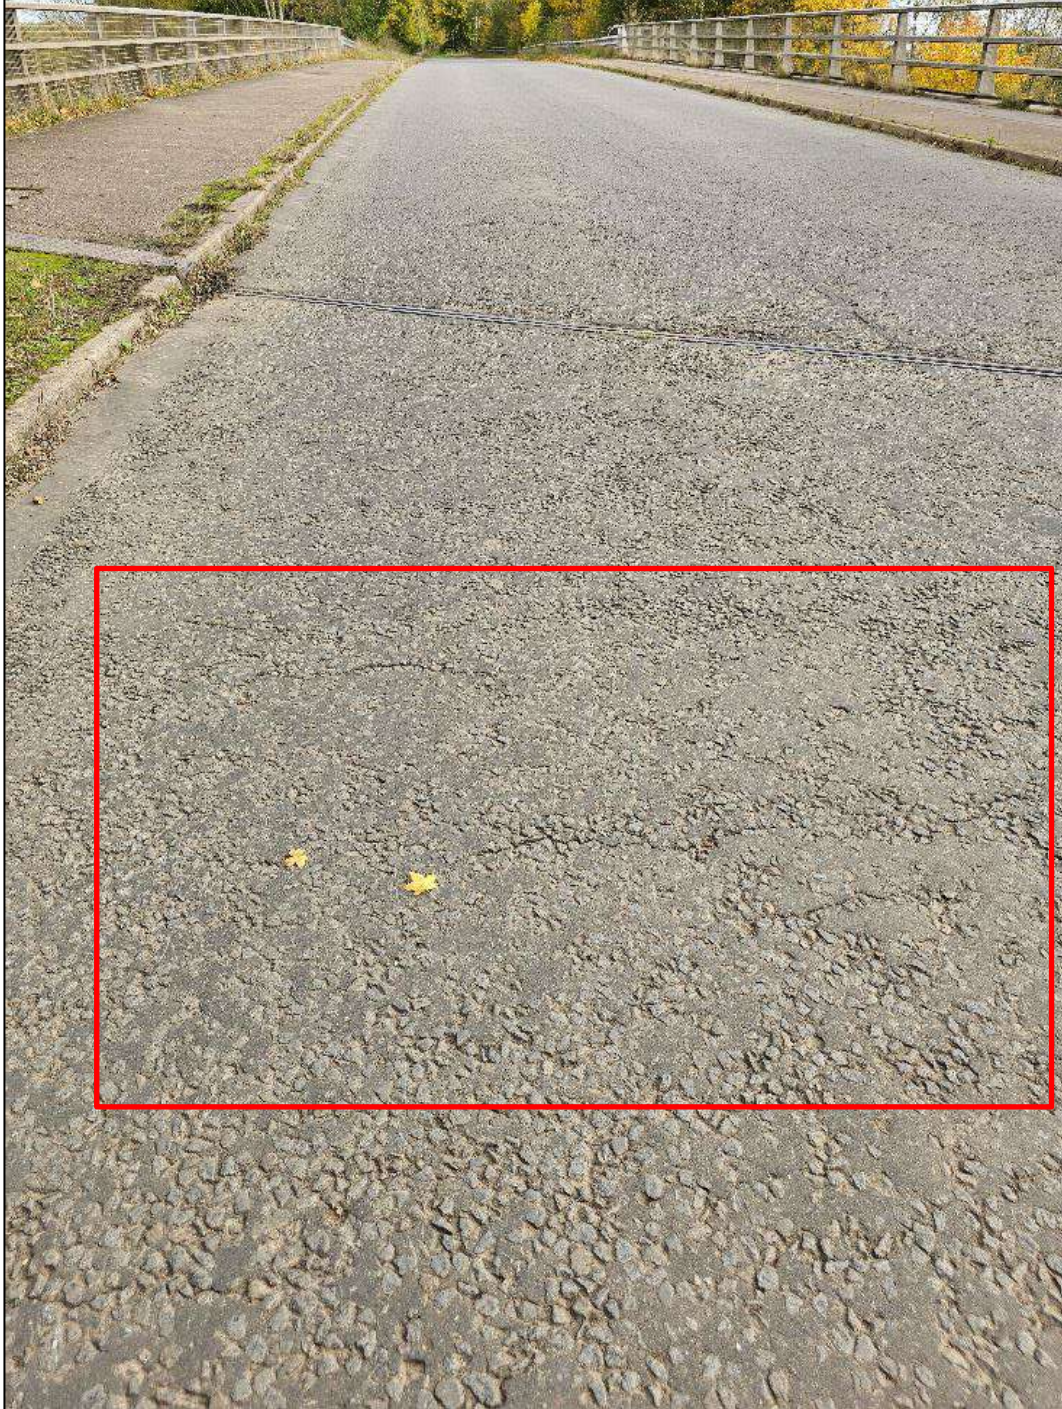
**Figure 14: General Carriageway Condition 125m East of the Parcel A Access**

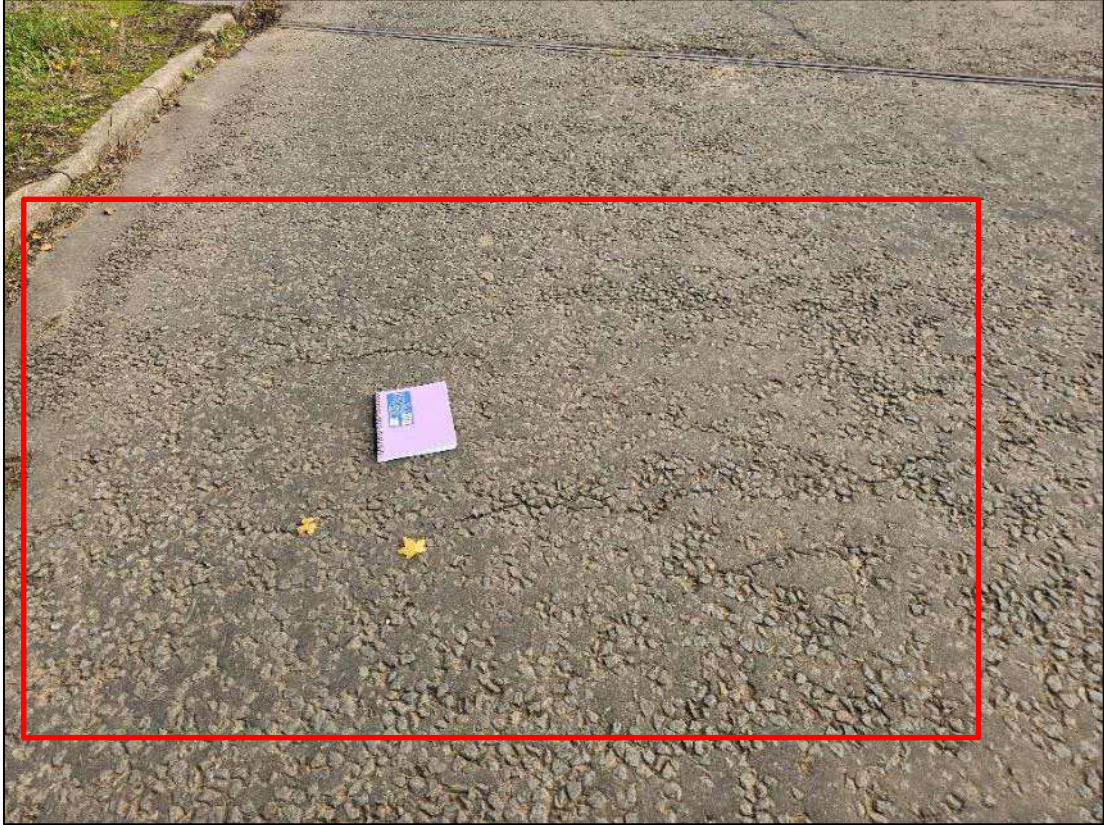
**Figure 15: Shallow Transverse Cracks 125m East of the Parcel A Access**

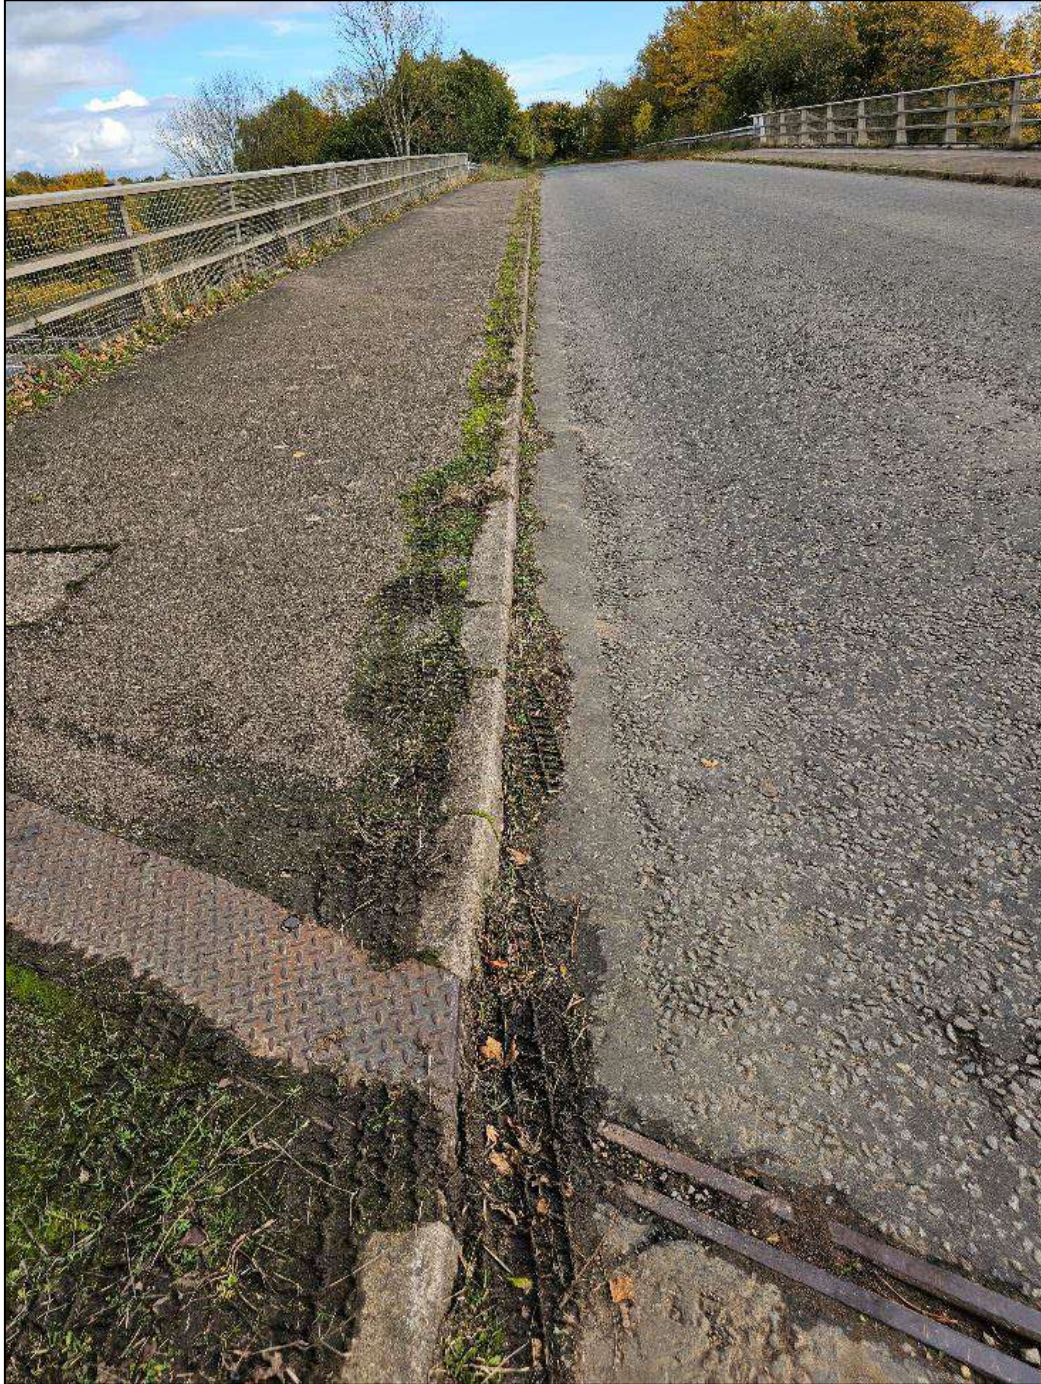
**Figure 16: General Carriageway Condition 130m East of the Parcel A Access**

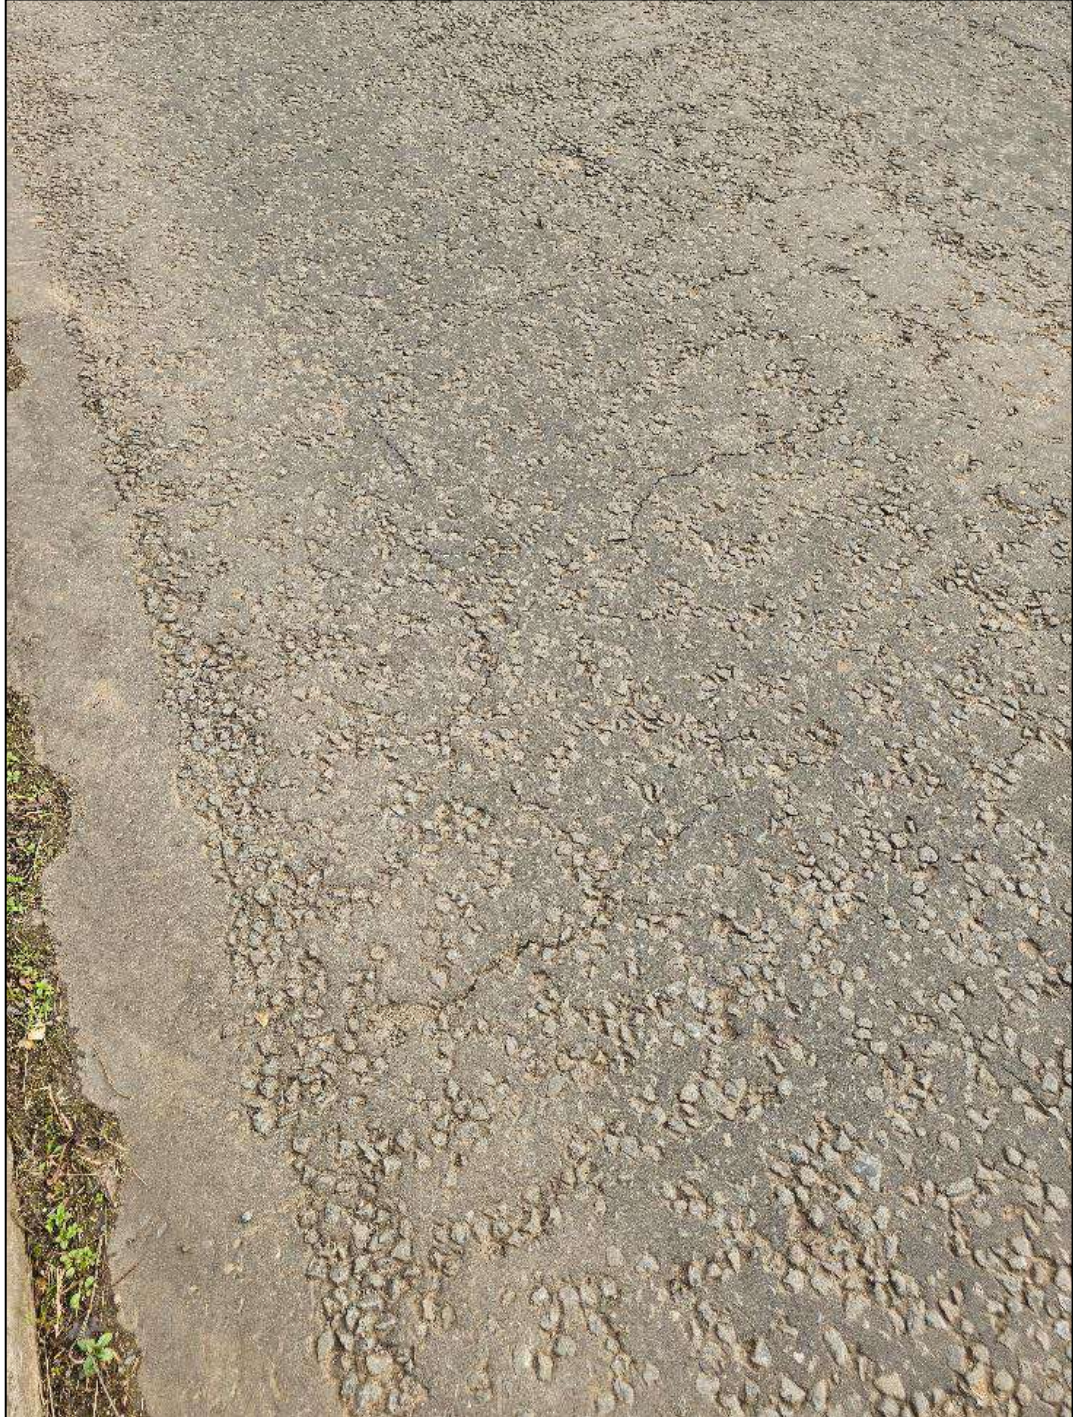
**Figure 17: Surface Tarmac Shallow Cracks 130m East of the Parcel A Access**

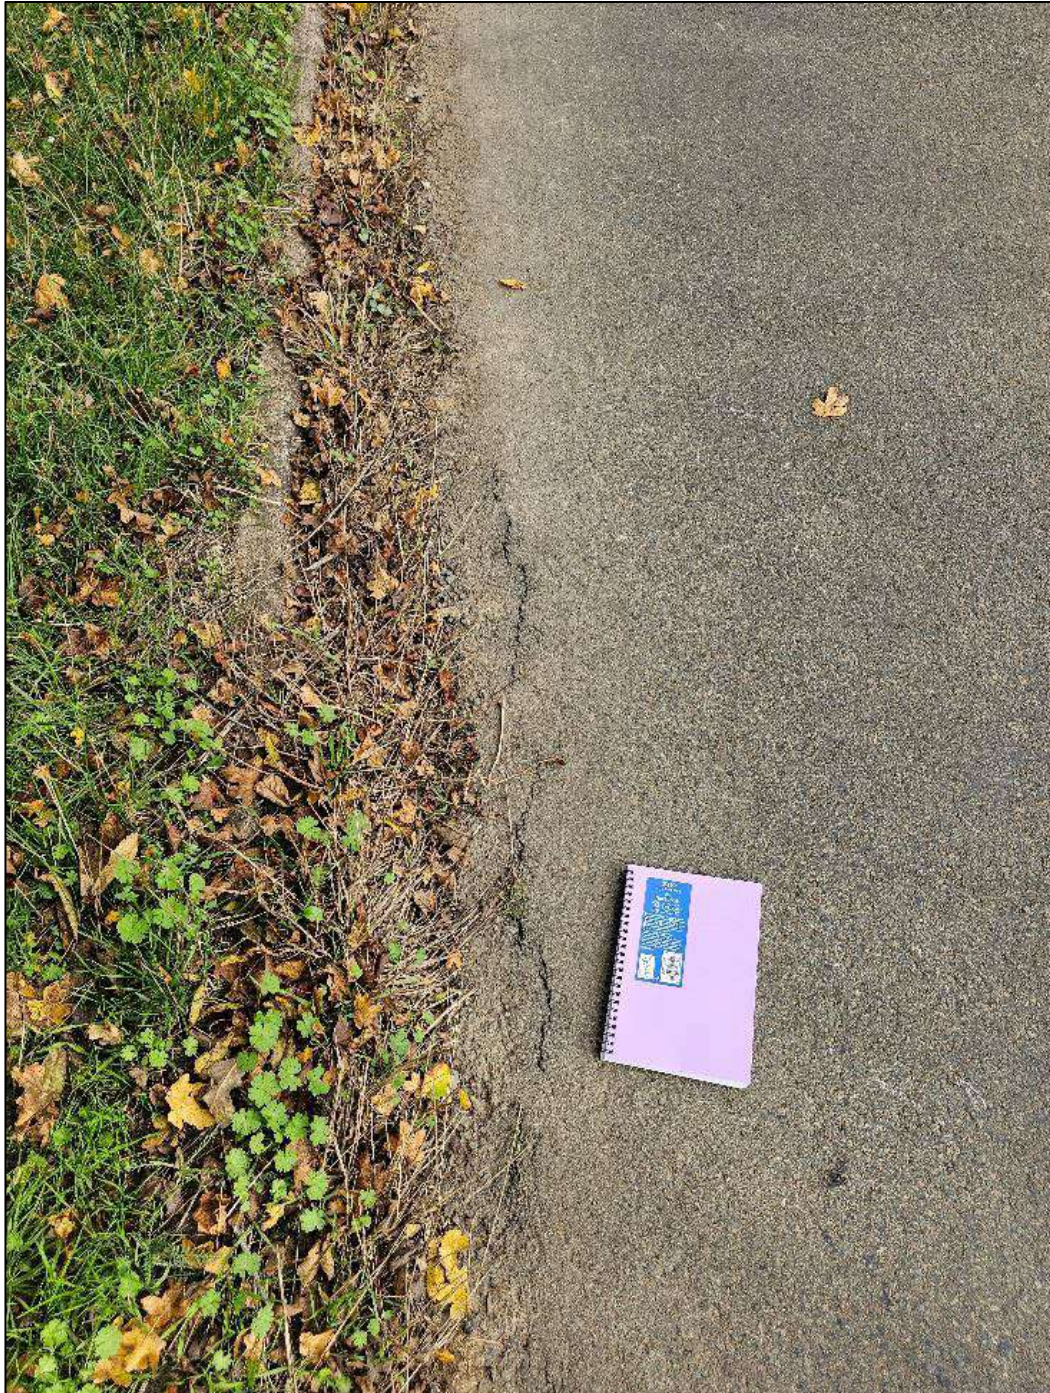
**Figure 18: Cracks in Tarmac Running Parallel to Kerbing, 210m East of the Parcel A Access**

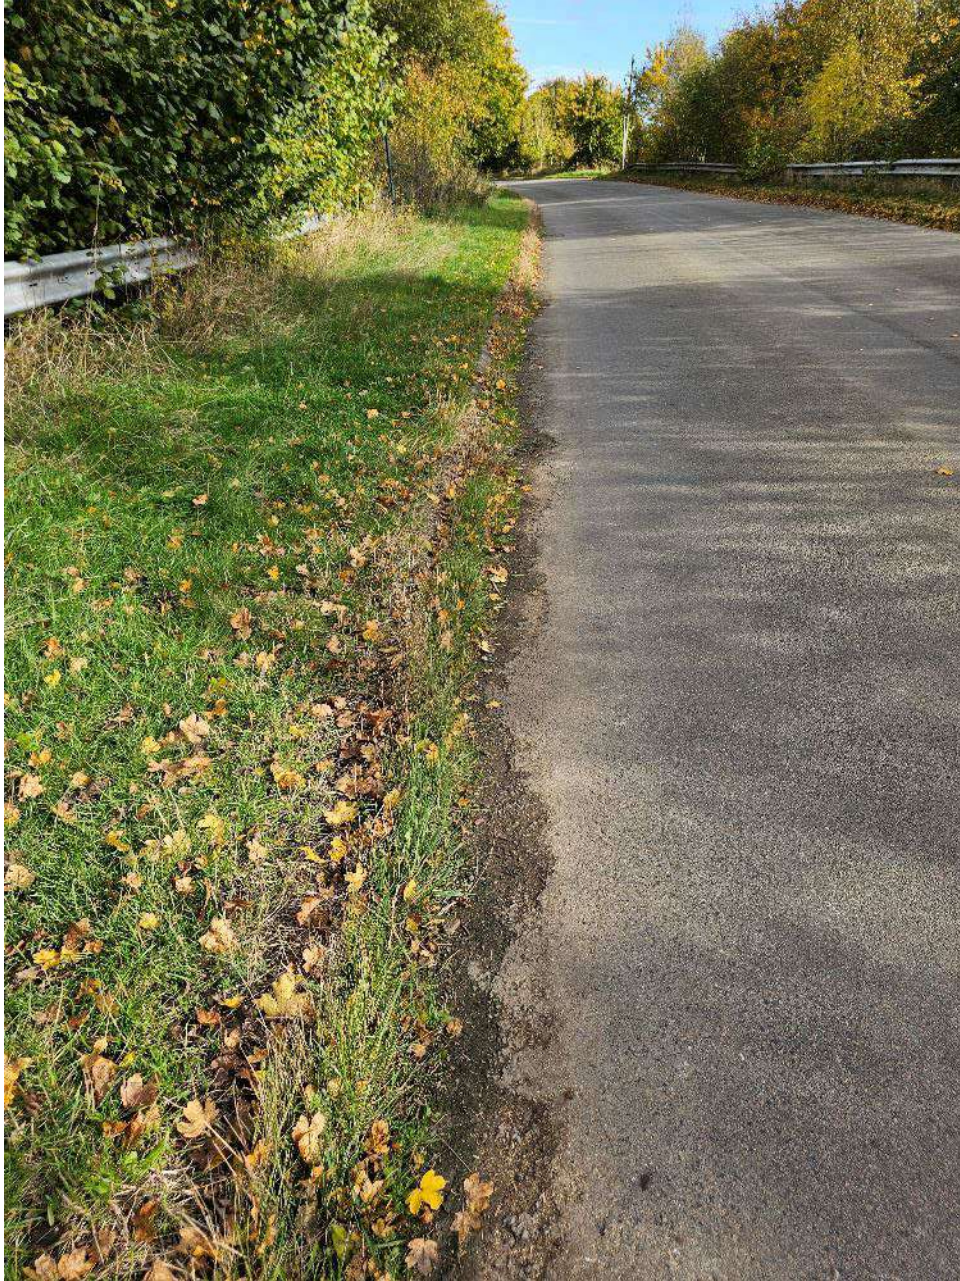
**Figure 19: Kerblines and Tarmac Condition 200m East of the Parcel A Access**

- 2.14 **Figure 19** shows that there is consistent vegetation and debris along the kerblines. This is consistent along Lychgate Lane within the vicinity of hedgerow and trees located within the grass verge. Obscured by the leaf litter and debris is a surface crack which runs parallel to the edge of carriageway; however, the remainder of the carriageway condition within the vicinity of this defect remains reasonable.

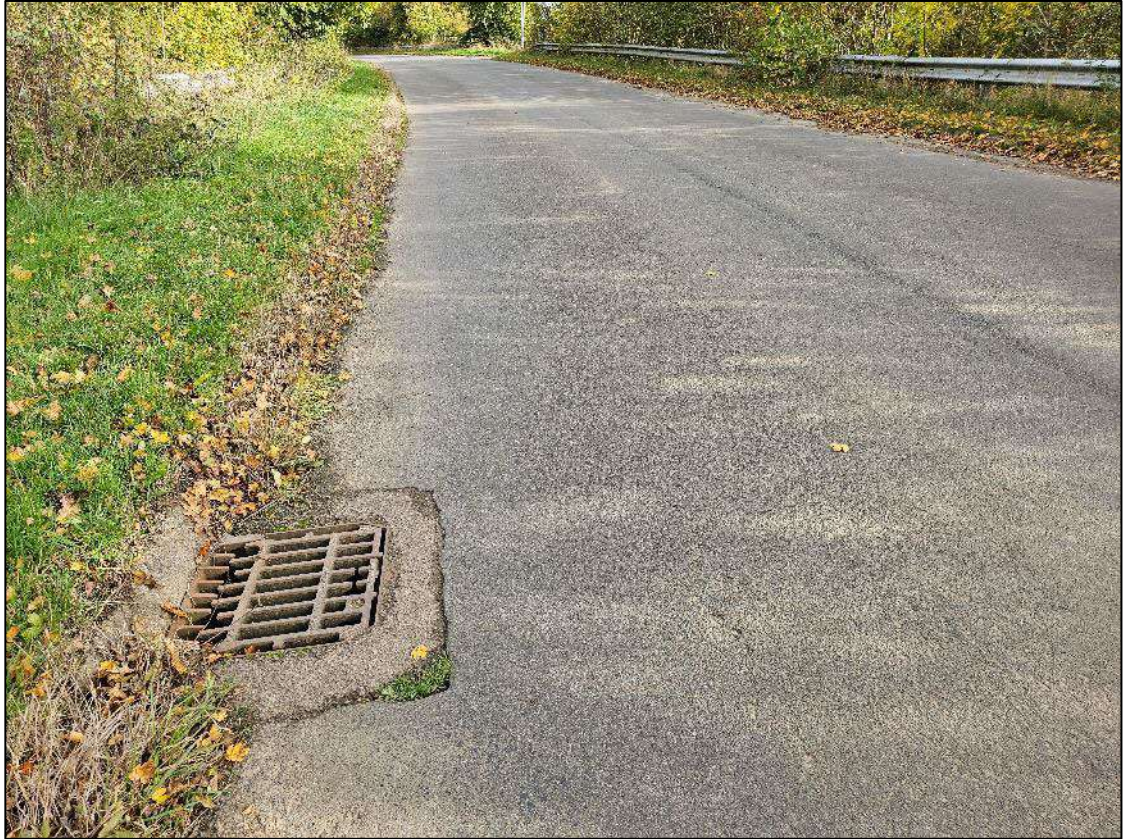
**Figure 20: Drain and Carriageway Condition 220m East of the Parcel A Access**

- 2.15      Drains within the vicinity of the M69 bridge on Lychgate Lane have similar patterns of repair, with patching around the grate.

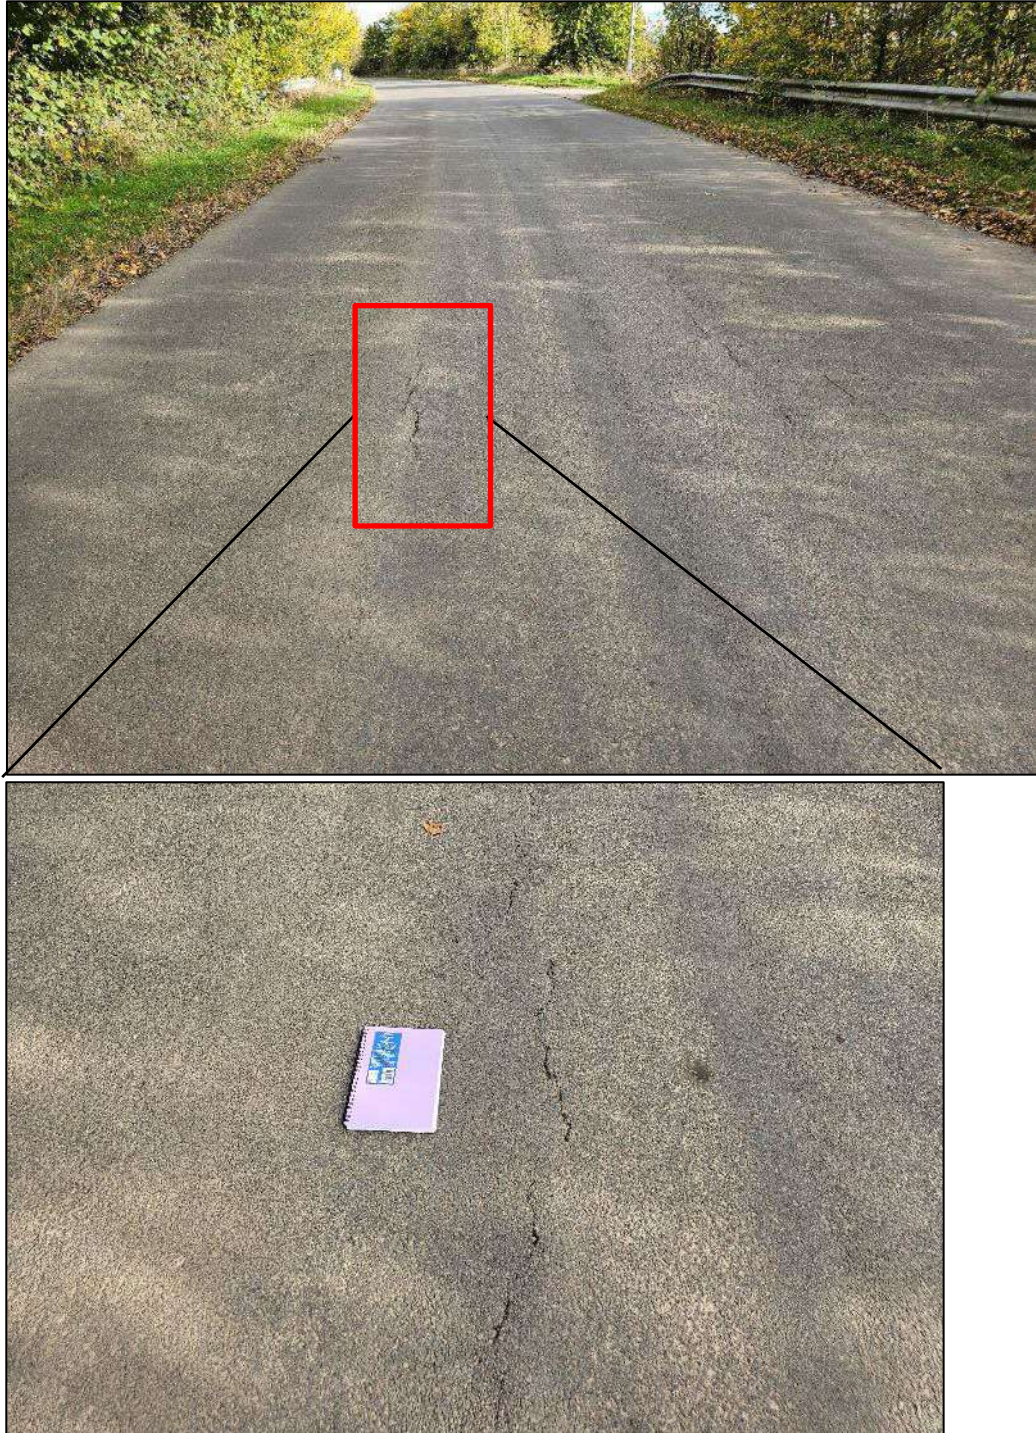
**Figure 21: Tarmac Cracks 220m East of the Parcel A Access**

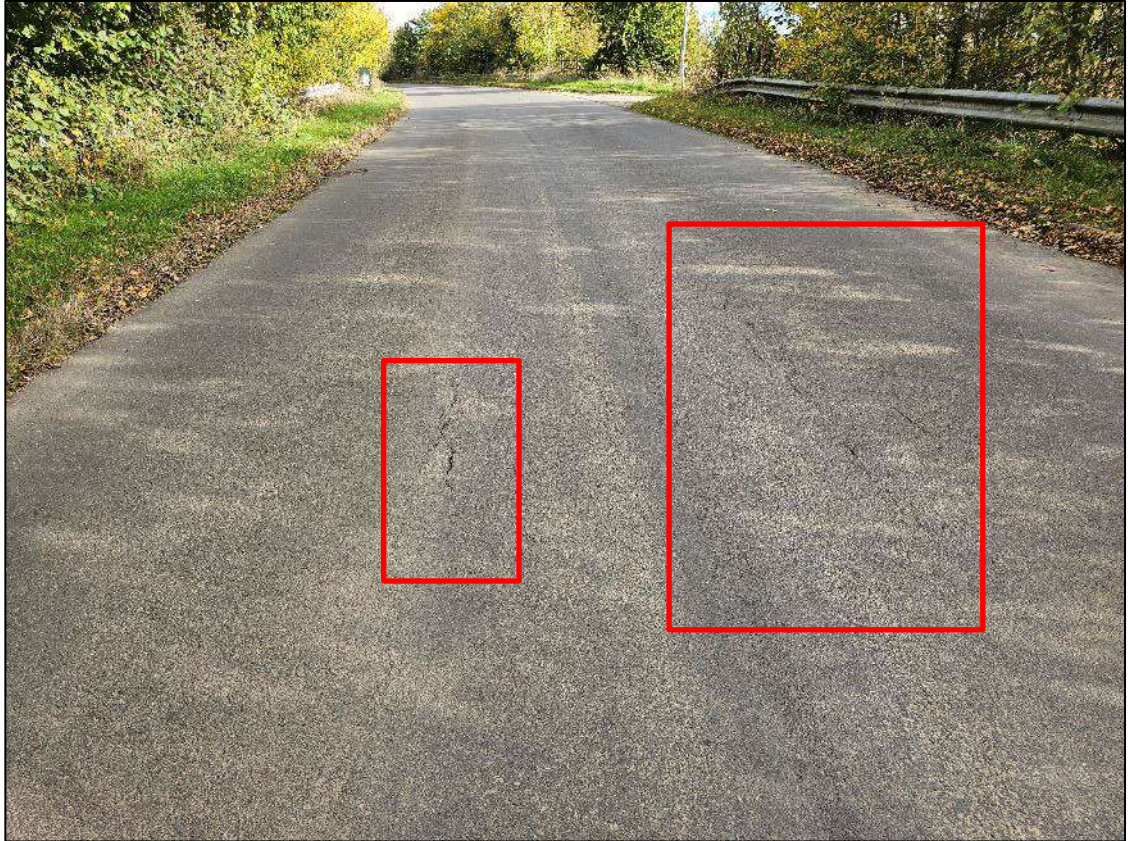
**Figure 22: Tarmac Cracks 225m East of the Parcel A Access**
