# ASTON FLAMVILLE SOLAR FARM

## Condition 21 – Pre-Commencement Highway Condition Survey

794-PLN-WWP-TRP-00230-02b  
Highway Condition Survey (HBBC)  
Version 02b  
30 October 2024

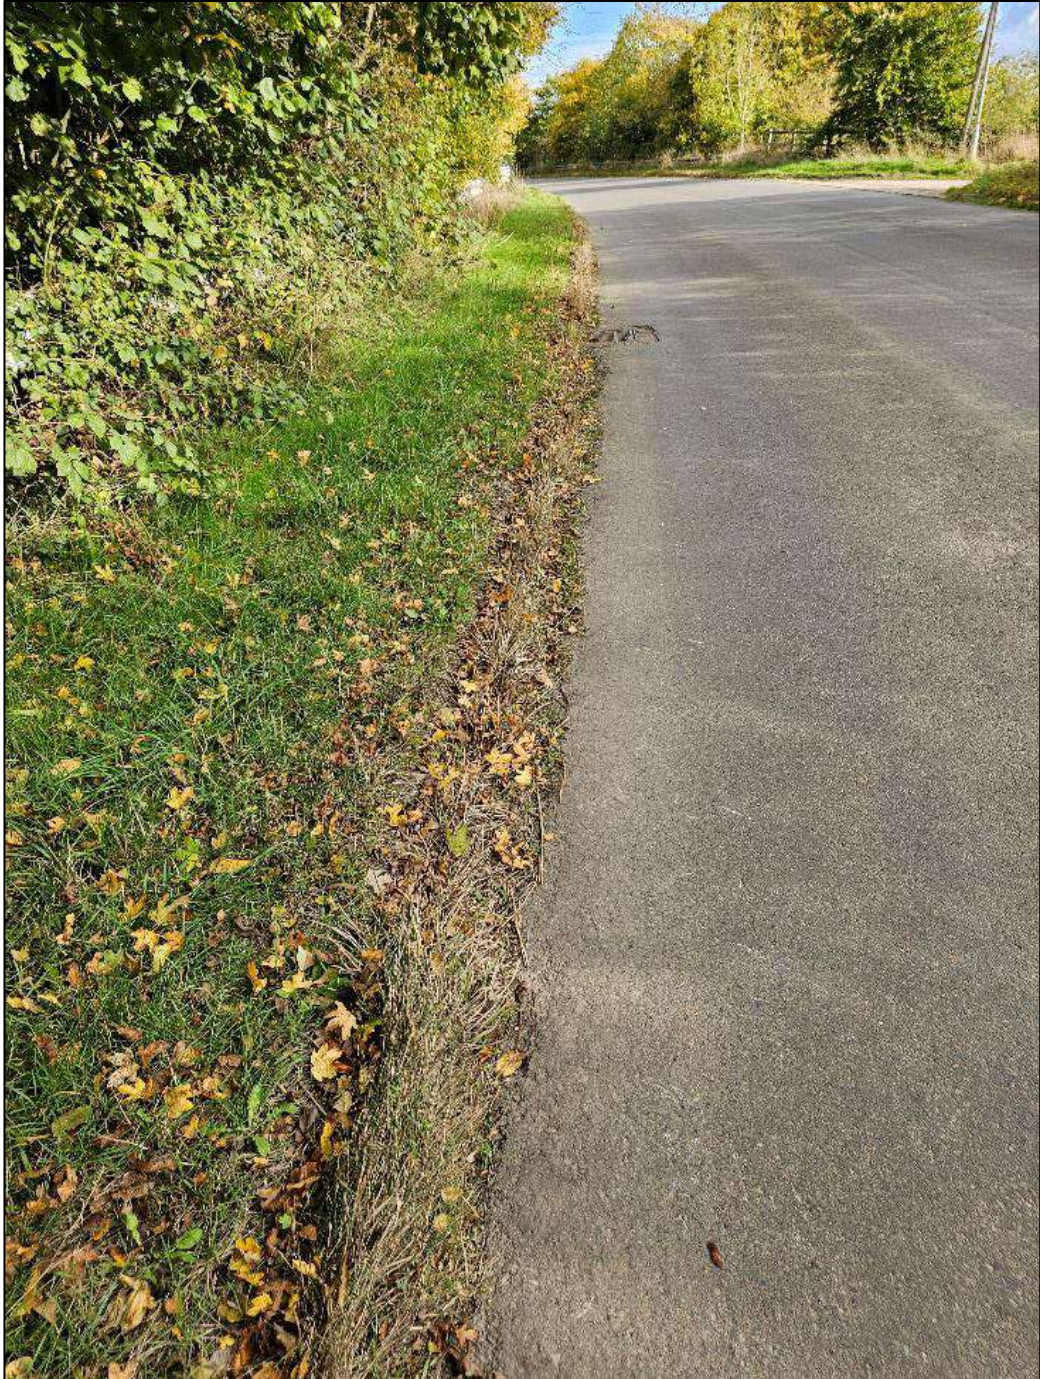
**Figure 23: Kerblines and Tarmac Condition 225-230m East of the Parcel A Access**

- 2.16 **Figure 23** shows that, obscured by the leaf litter and debris is a surface crack which runs parallel to the edge of carriageway; however, the remainder of the carriageway condition within the vicinity of this defect remains good.

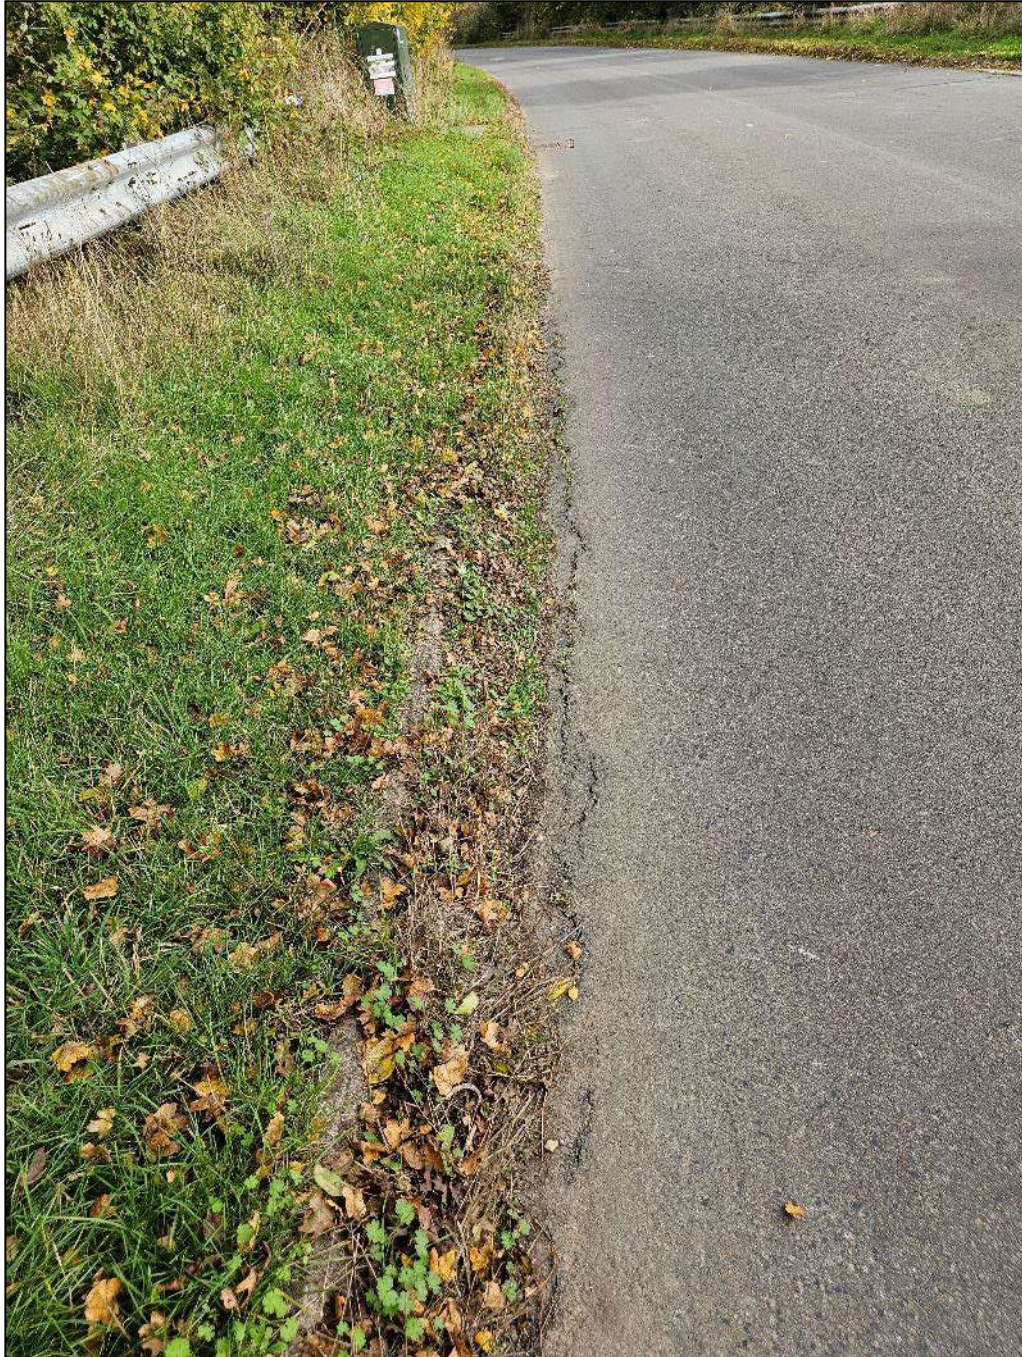
**Figure 24: Kerbline and Tarmac Condition 250m East of the Parcel A Access.  
Surface Defects Run Parallel to Kerbline**

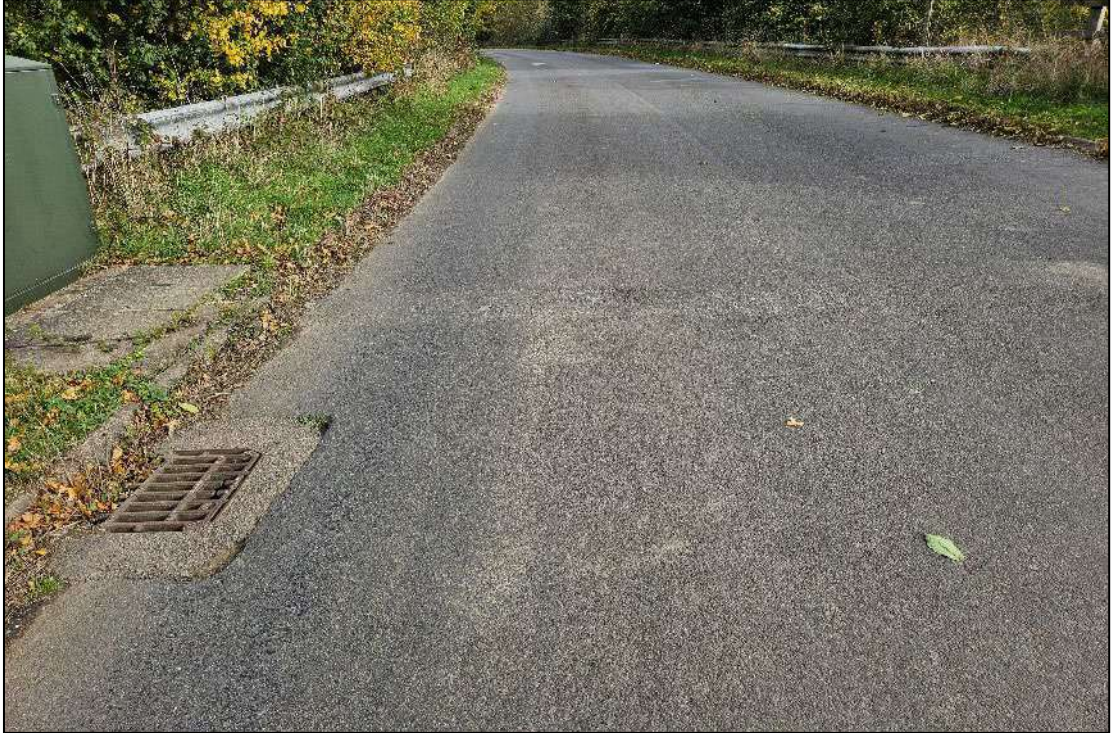
**Figure 25: General Carriageway Condition 250m east of Parcel A Access**

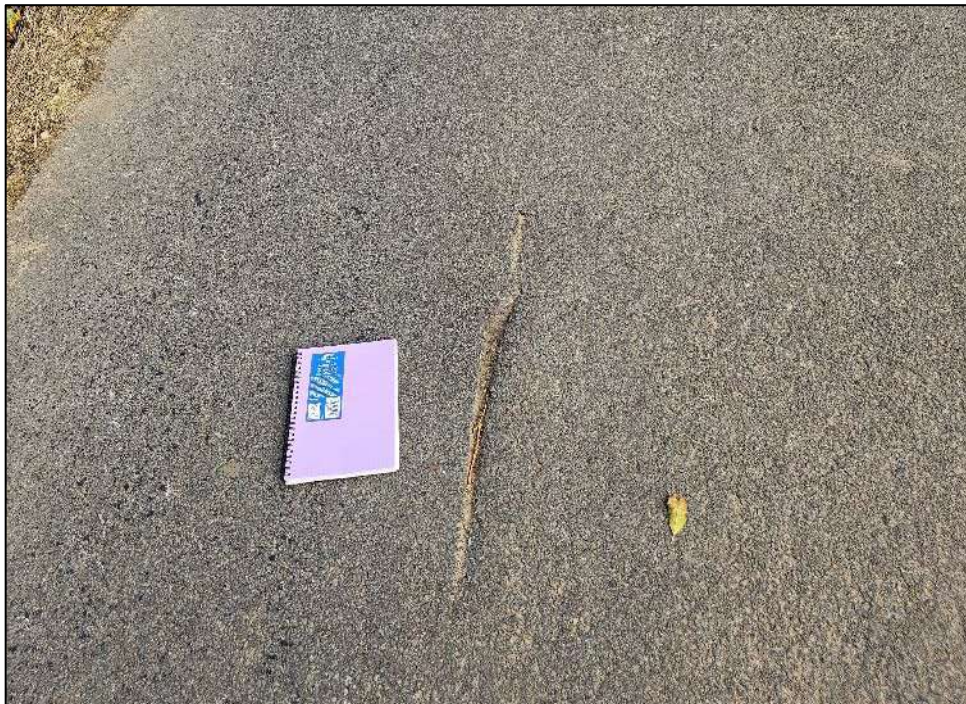
**Figure 26: Defect 260m East of the Parcel A Access**

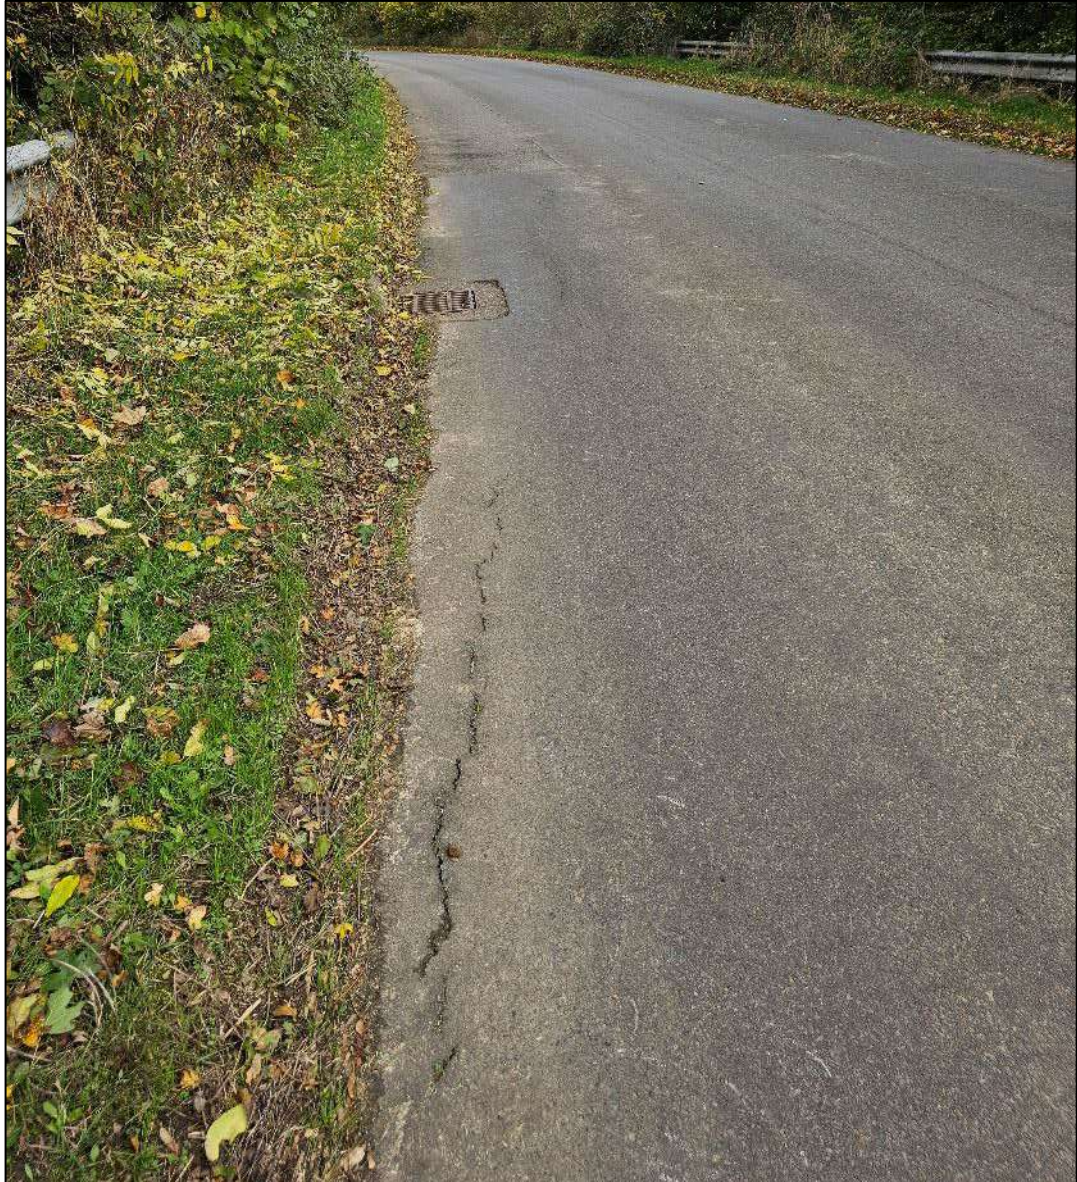
**Figure 27: Kerbline and Tarmac Condition 280m East of the Parcel A Access.  
Surface Defects Run Parallel to Kerbline**

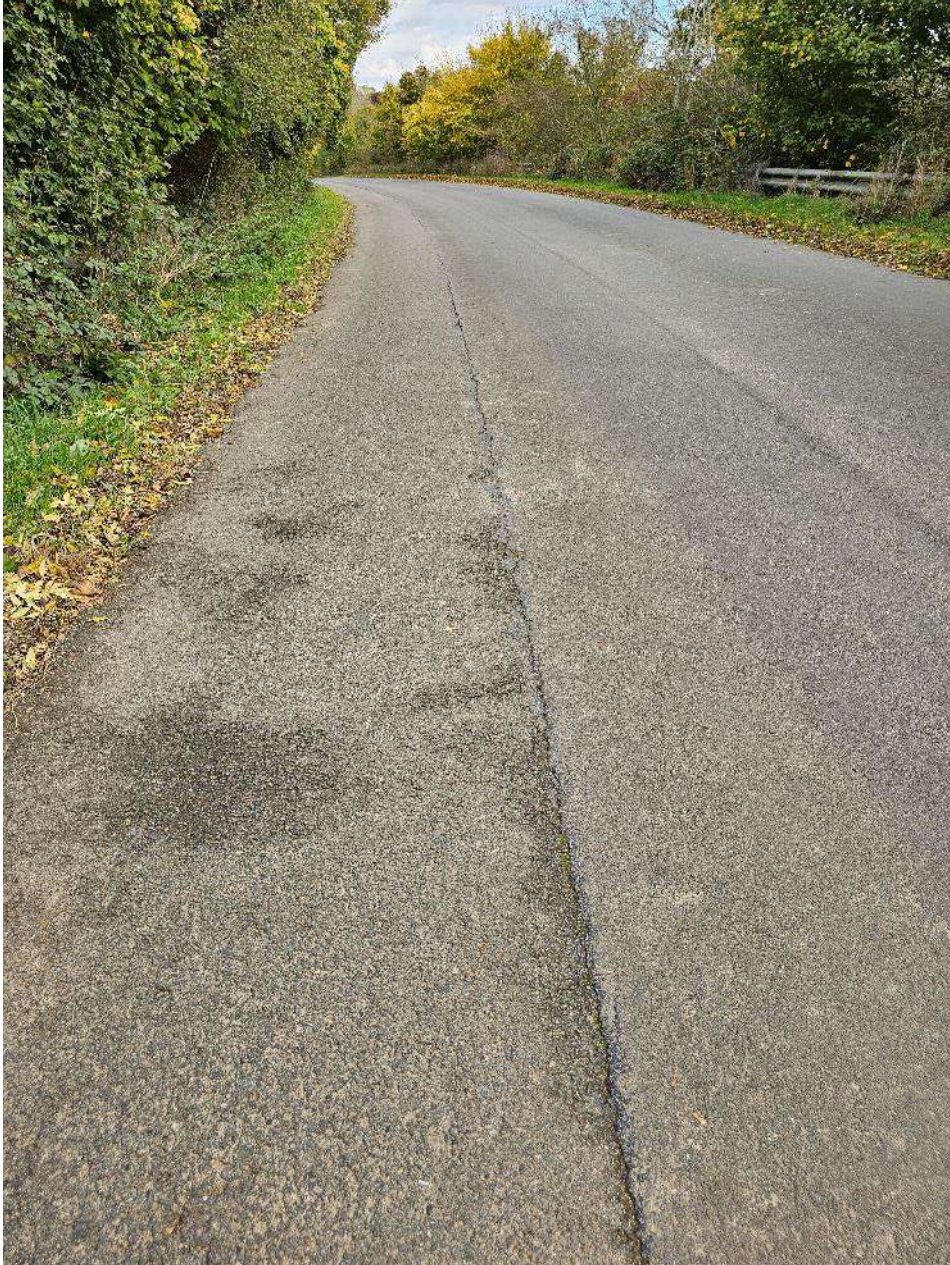
**Figure 28: Kerbline and Tarmac Condition 280-290m East of the Parcel A Access. Surface Defects Run Parallel to Kerbline**

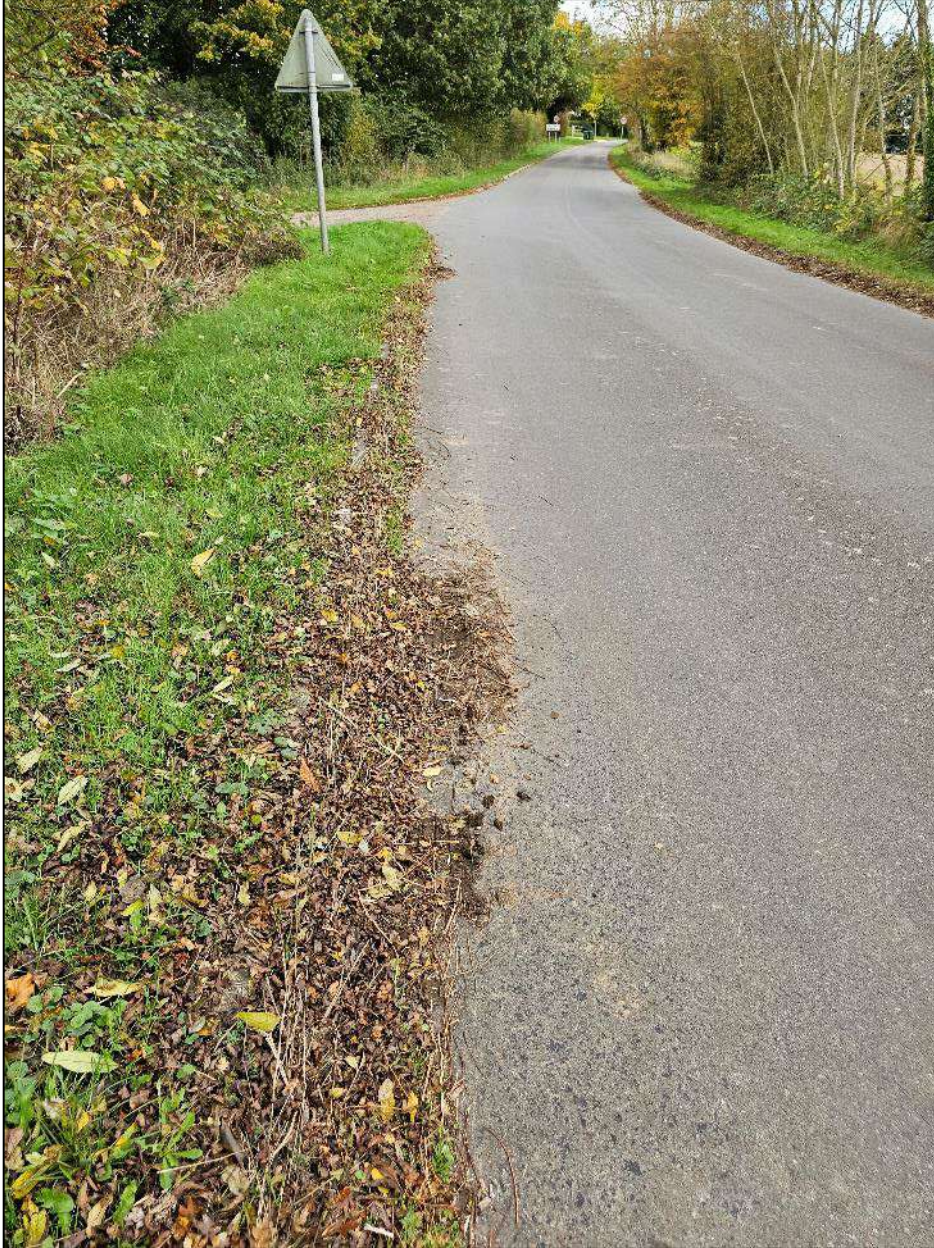
**Figure 29: Kerbline and Tarmac Condition 450m East of the Parcel A Access.  
Debris Adjacent to Kerbline**

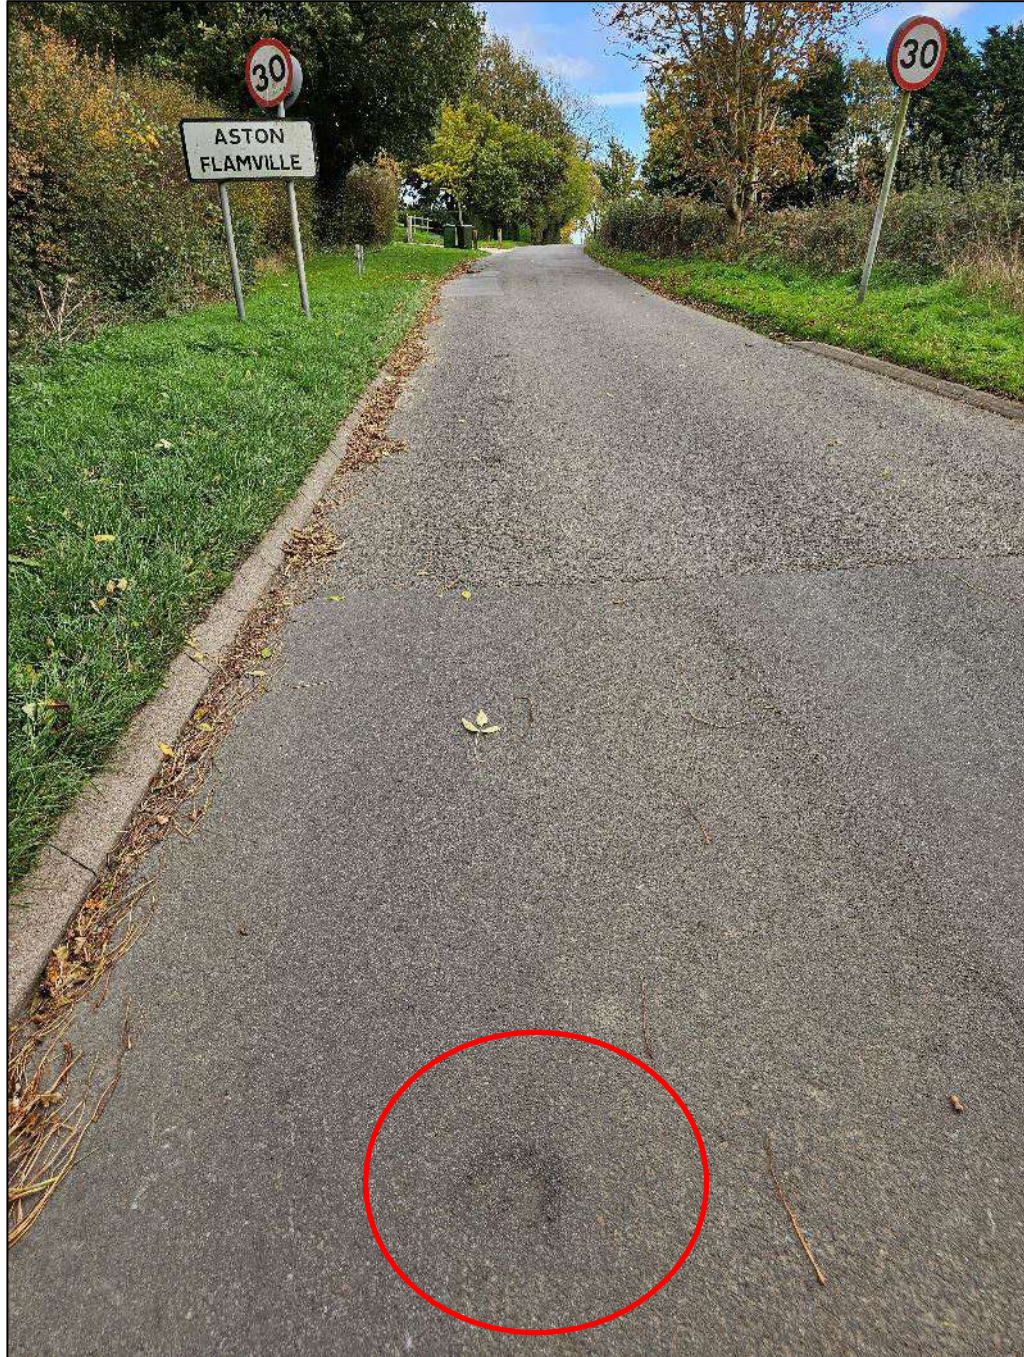
**Figure 30: Kerbline and Tarmac Condition Approximately 520m East of the Parcel A Access.**

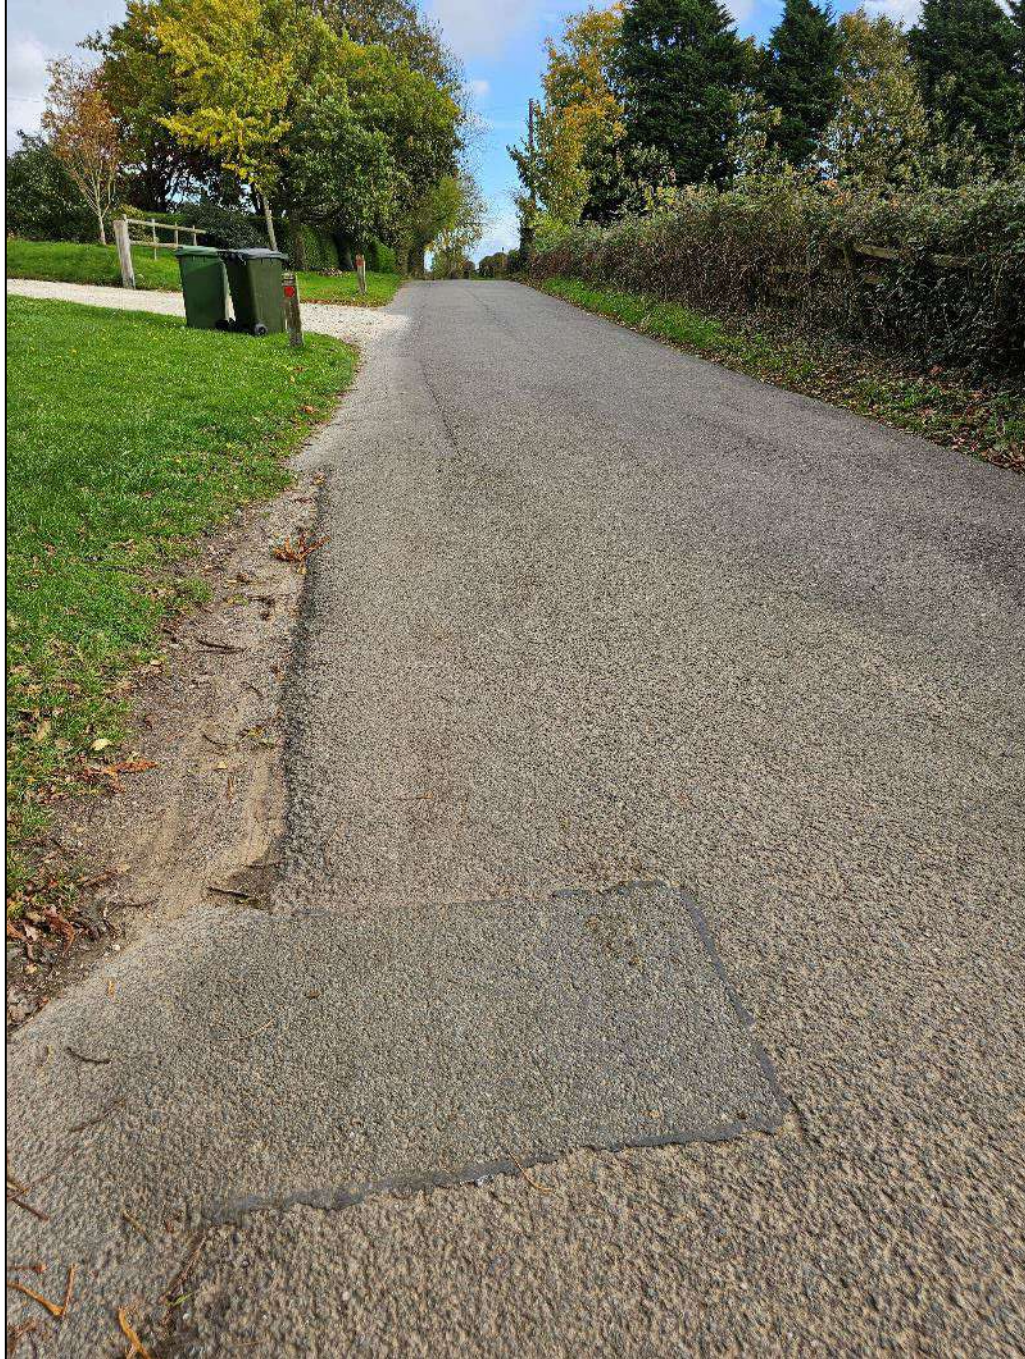
**Figure 31: Carriageway Patching and General Carriageway Condition  
Approximately 600m East of the Parcel A Access.**

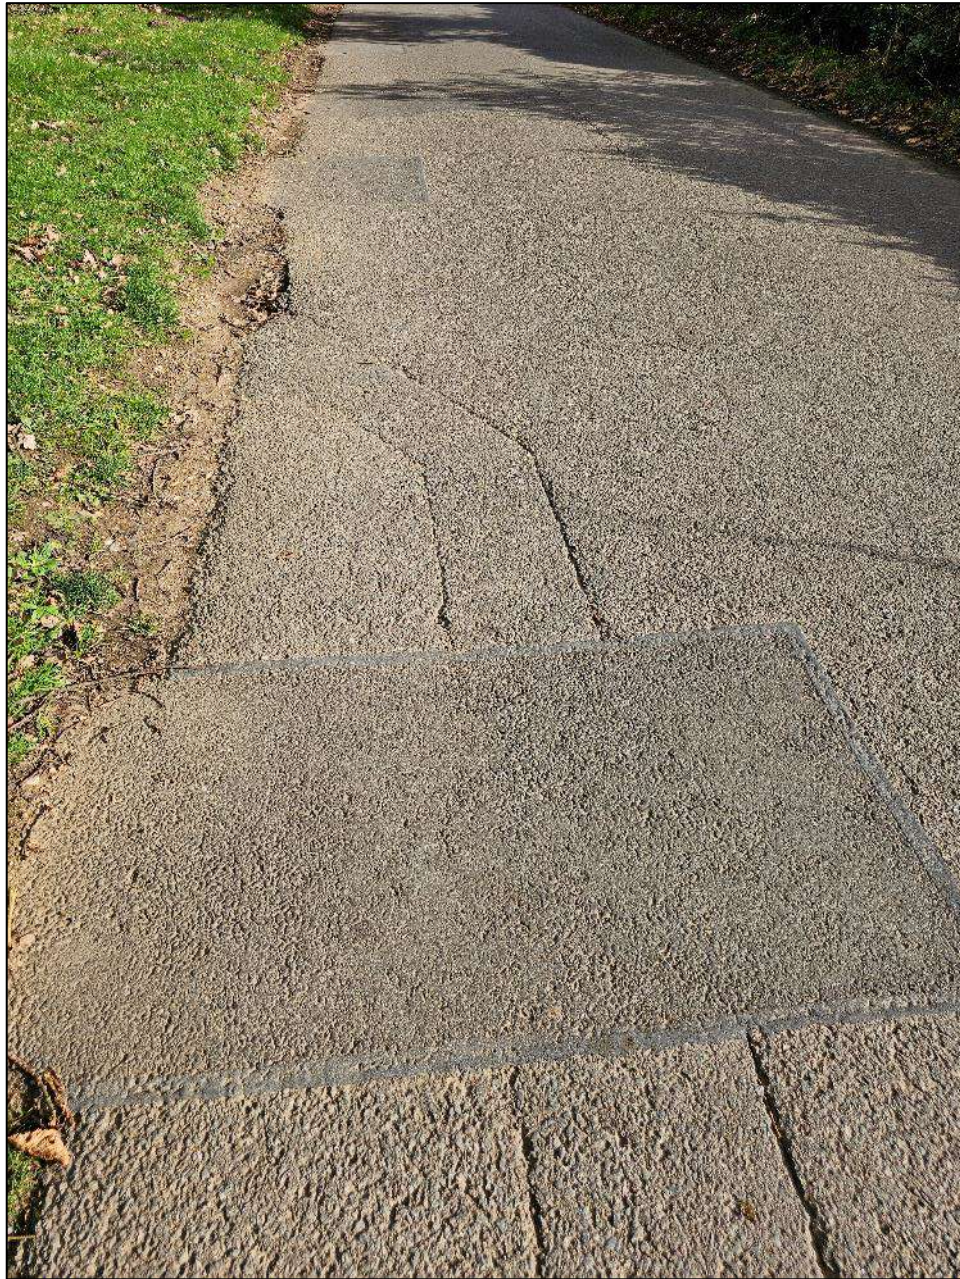
**Figure 32: Carriageway Patching and General Carriageway Condition Approximately 630m East of the Parcel A Access.**

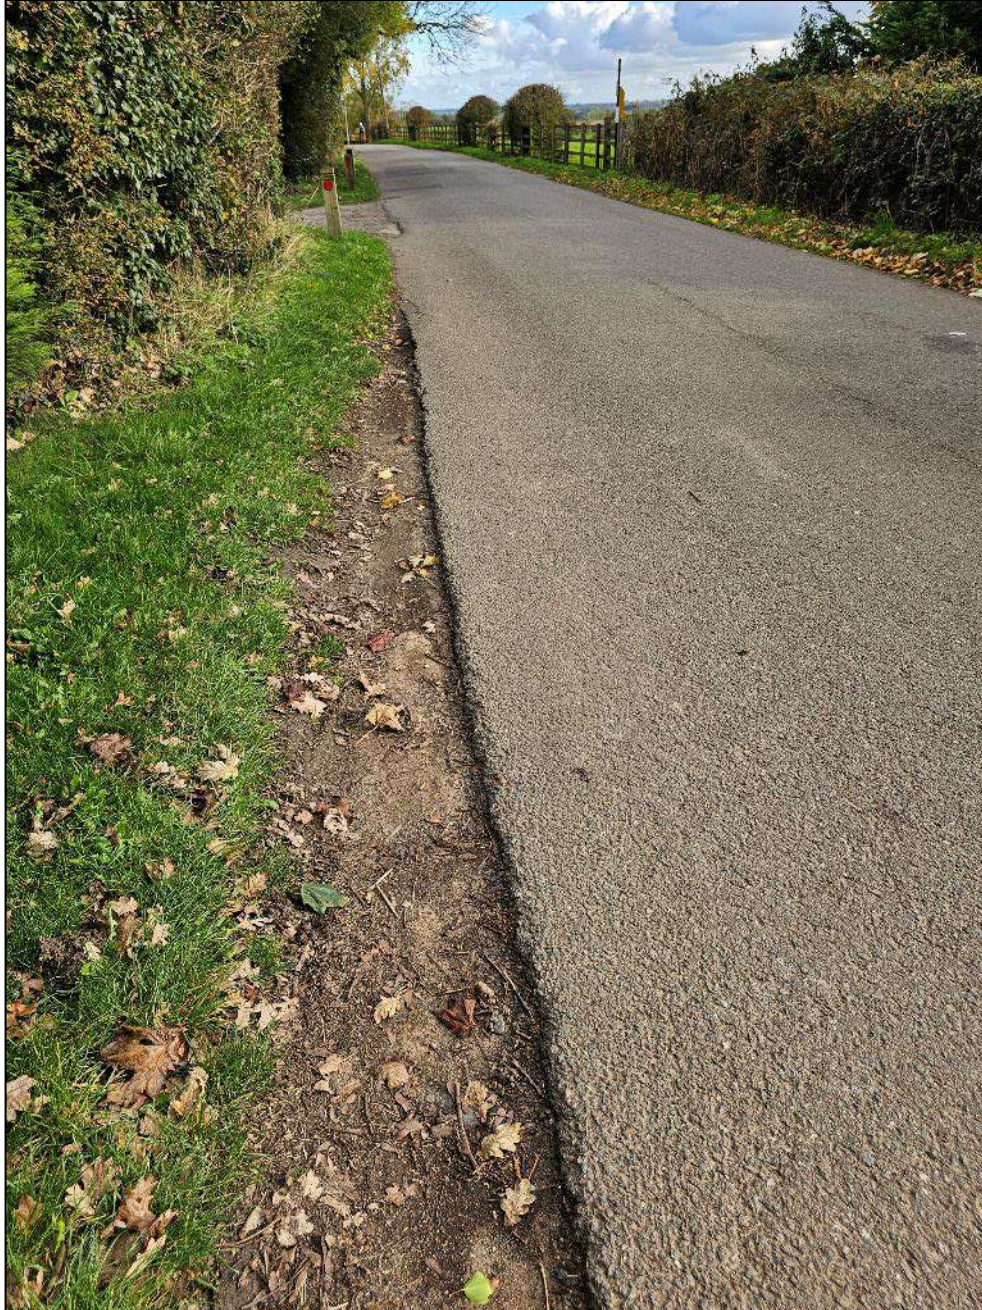
**Figure 33: Grass Verge Degradation 650m East of the Parcel A Access**

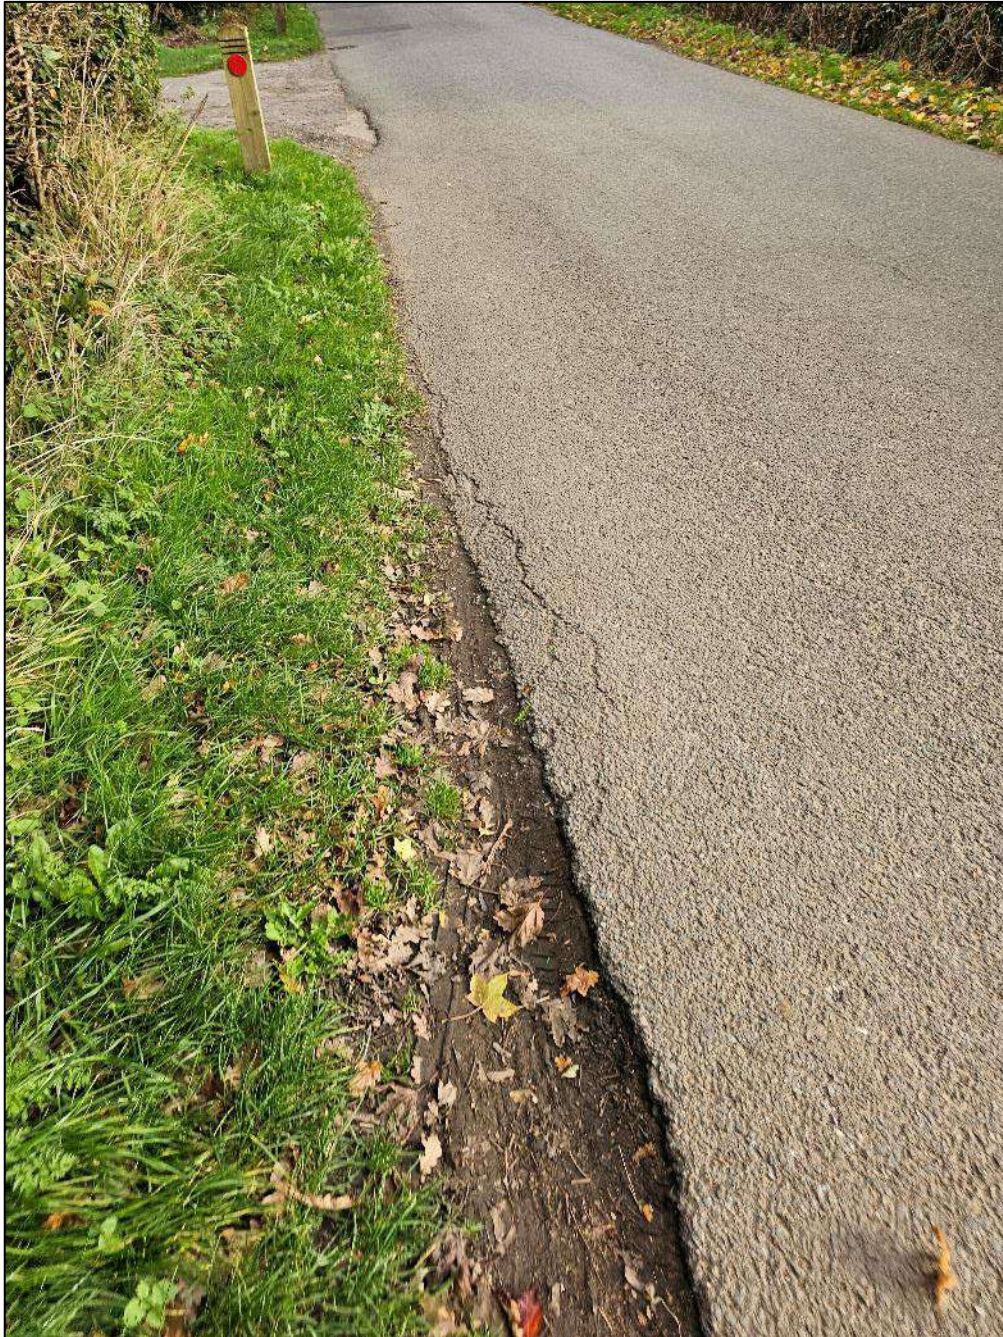
**Figure 34: Grass Verge Degradation and Tarmac Defect 670-680m East of the Parcel A Access**

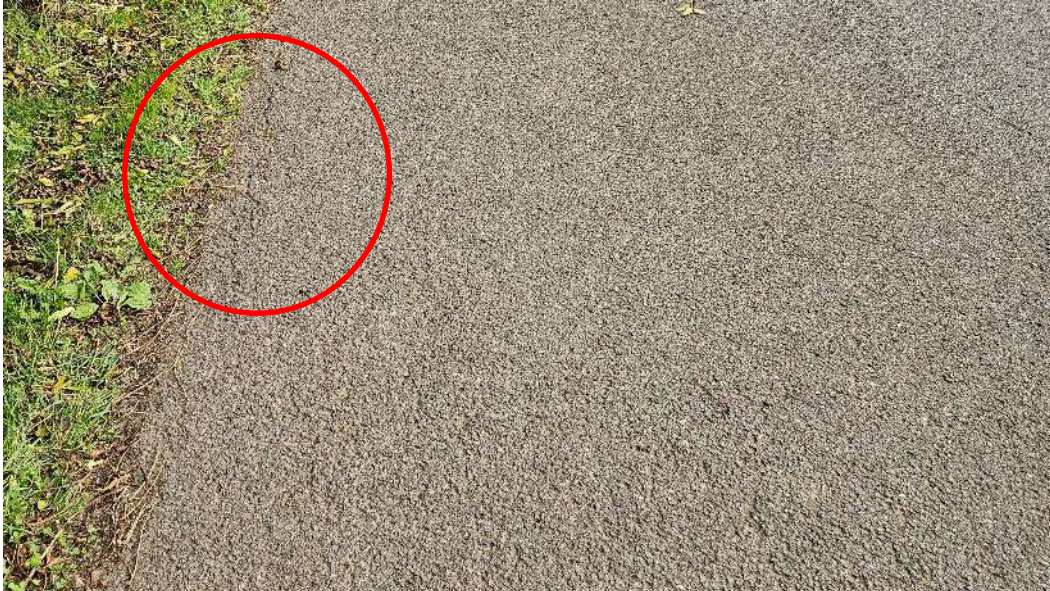
**Figure 35: Shallow Tarmac Defect Approximately 700m East of the Parcel A Access**

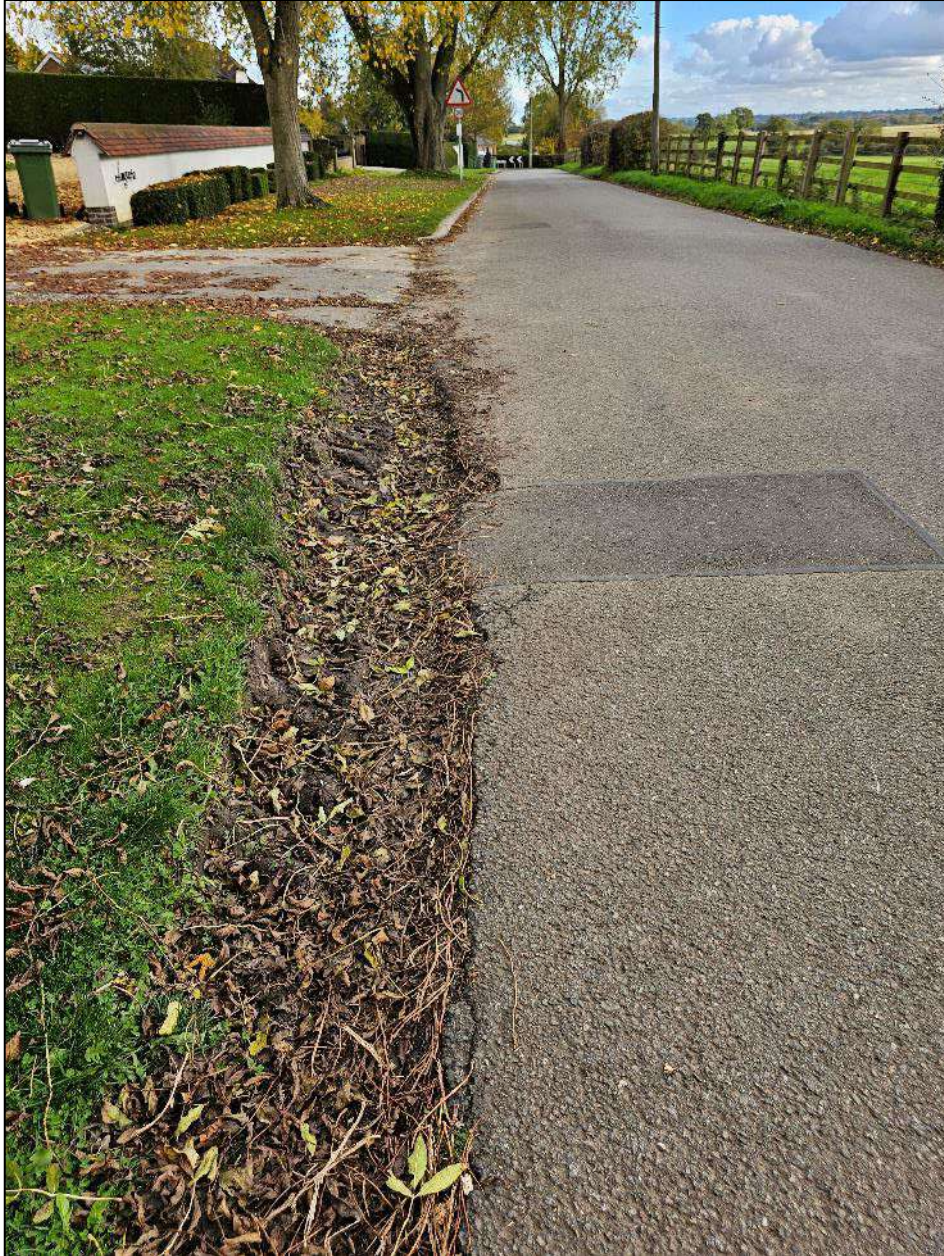
**Figure 36: Grass Verge Damage Approximately 740m East of the Parcel A Access**

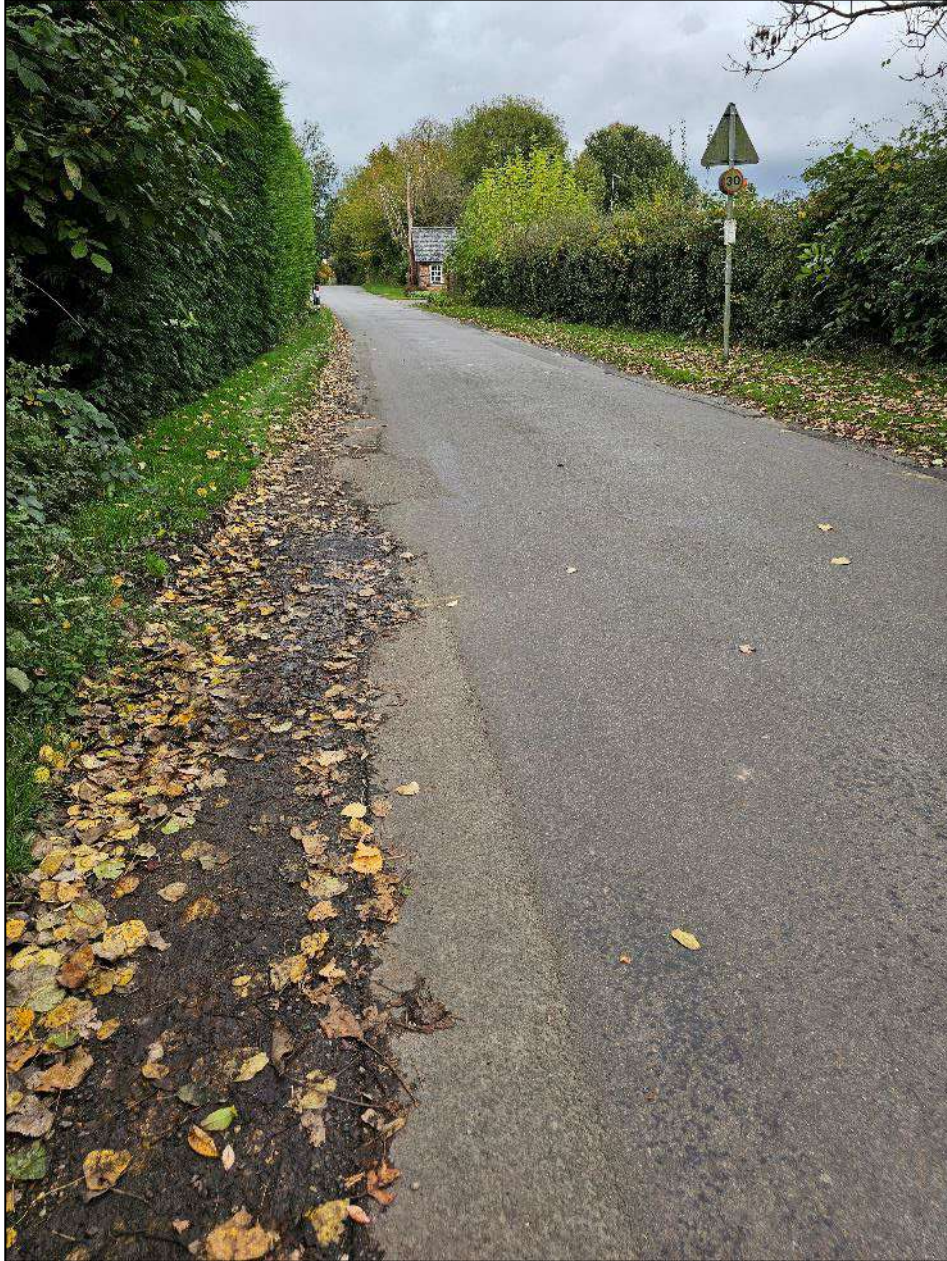
**Figure 37: General Carriageway Condition Approximately 850m East of the Parcel A Access**

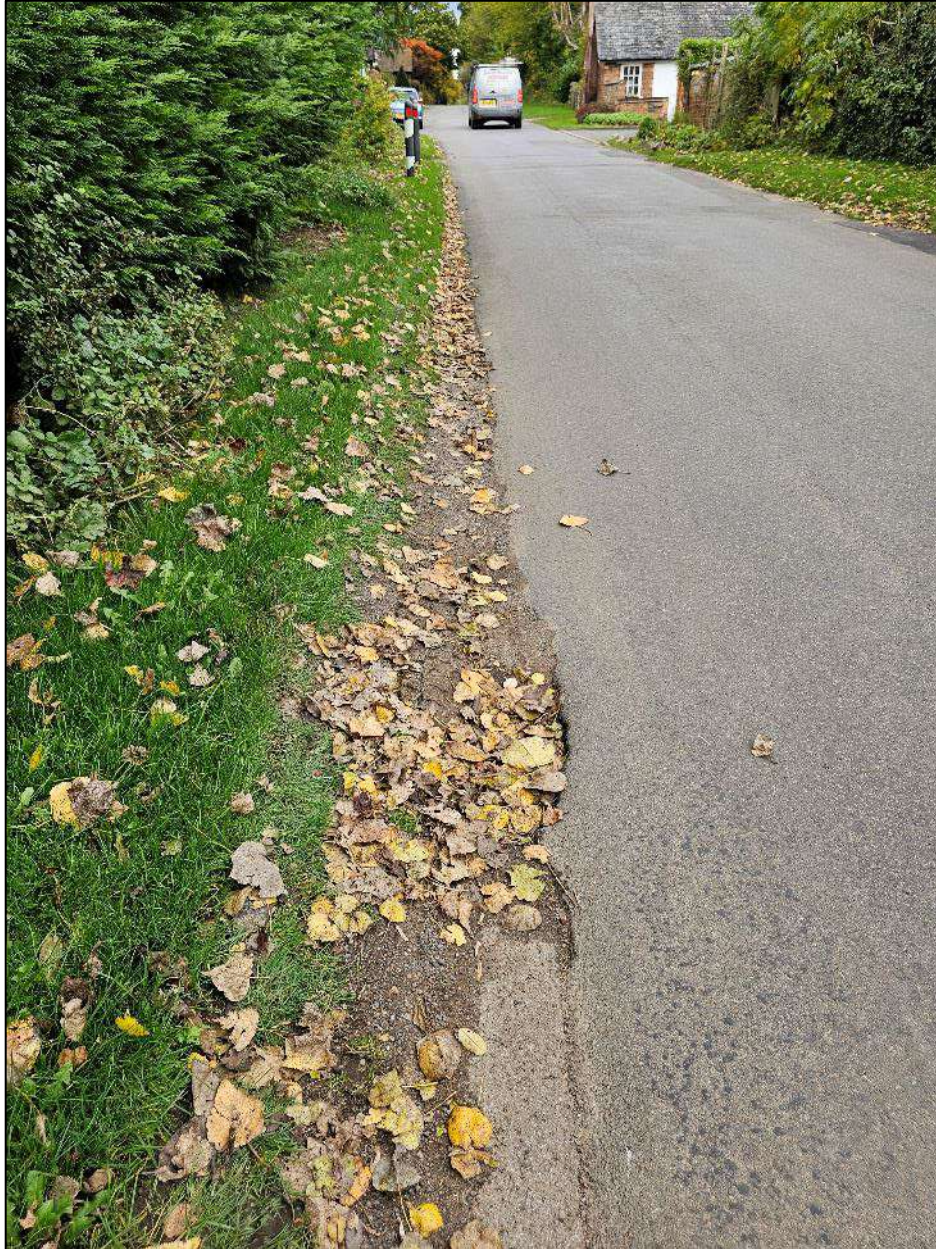
**Figure 38: Defects on Edge of Carriageway Approximately 900m East of the Parcel A Access**

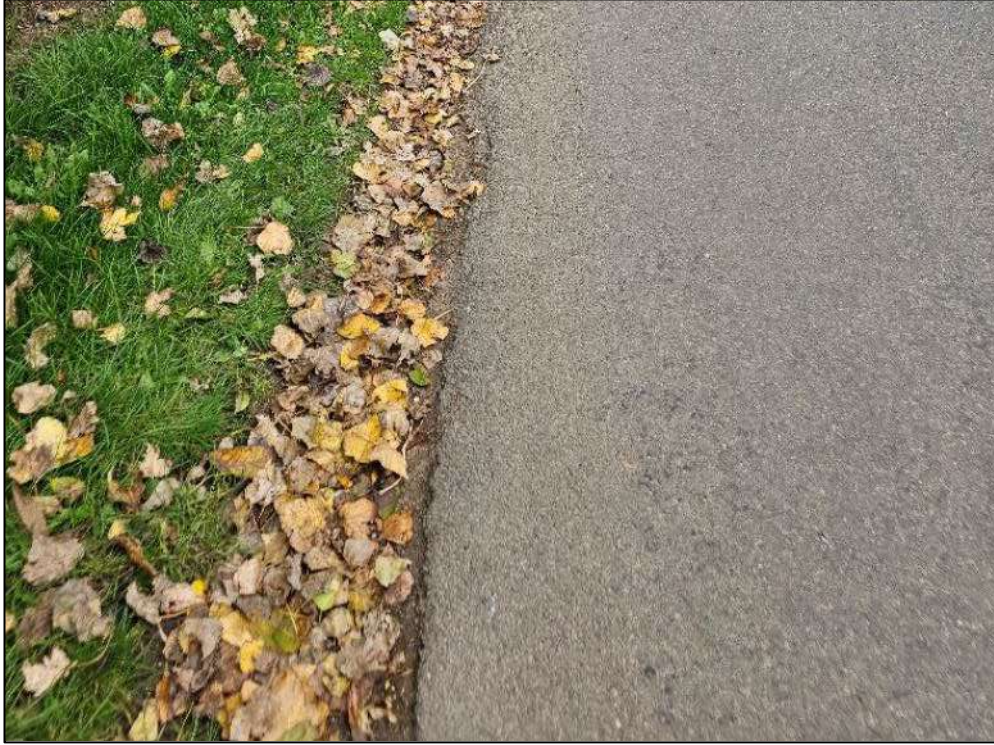
**Figure 39: Defects on Edge of Carriageway Approximately 900m East of the Parcel A Access**

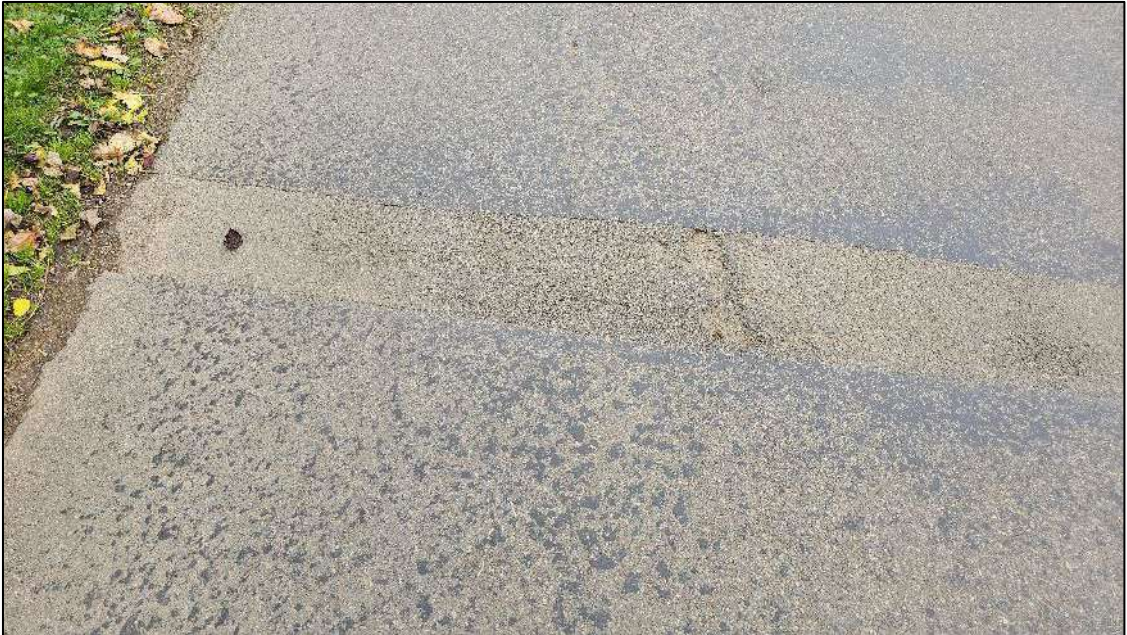
**Figure 40: Carriageway Patching Approximately 930-940m East of the Parcel A Access**

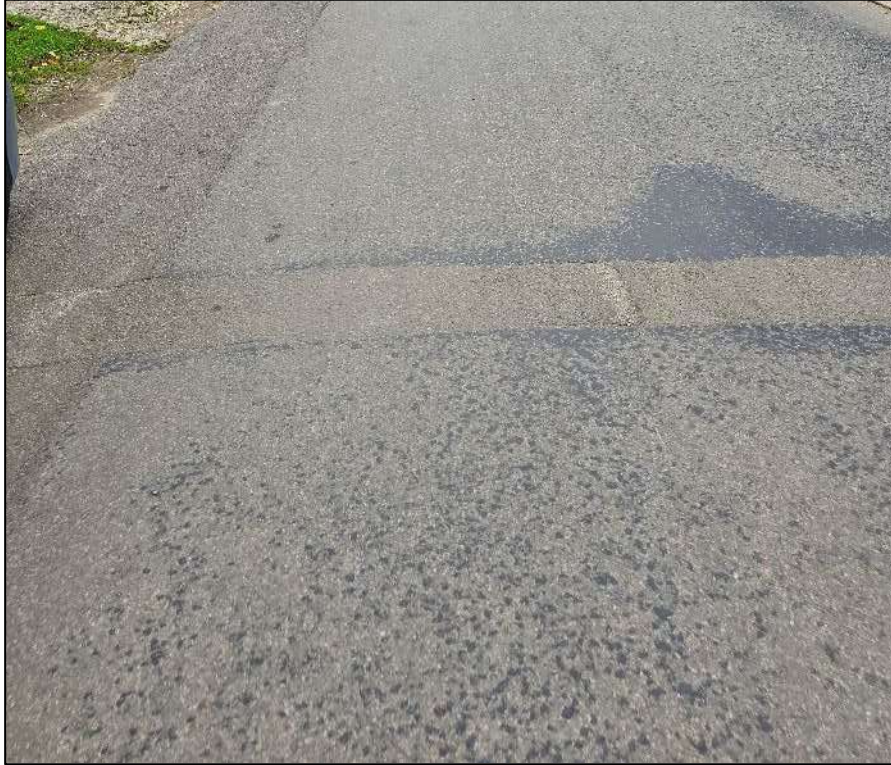
**Figure 41: Carriageway Patching Approximately 950m East of the Parcel A Access**

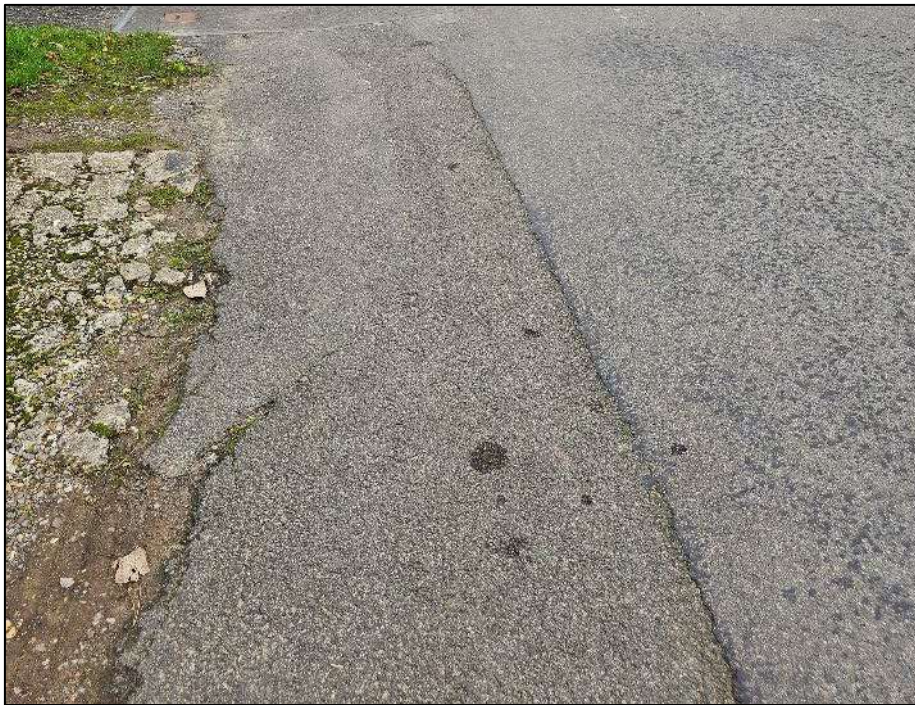
**Figure 42: Carriageway Patching Approximately 950m East of the Parcel A Access**

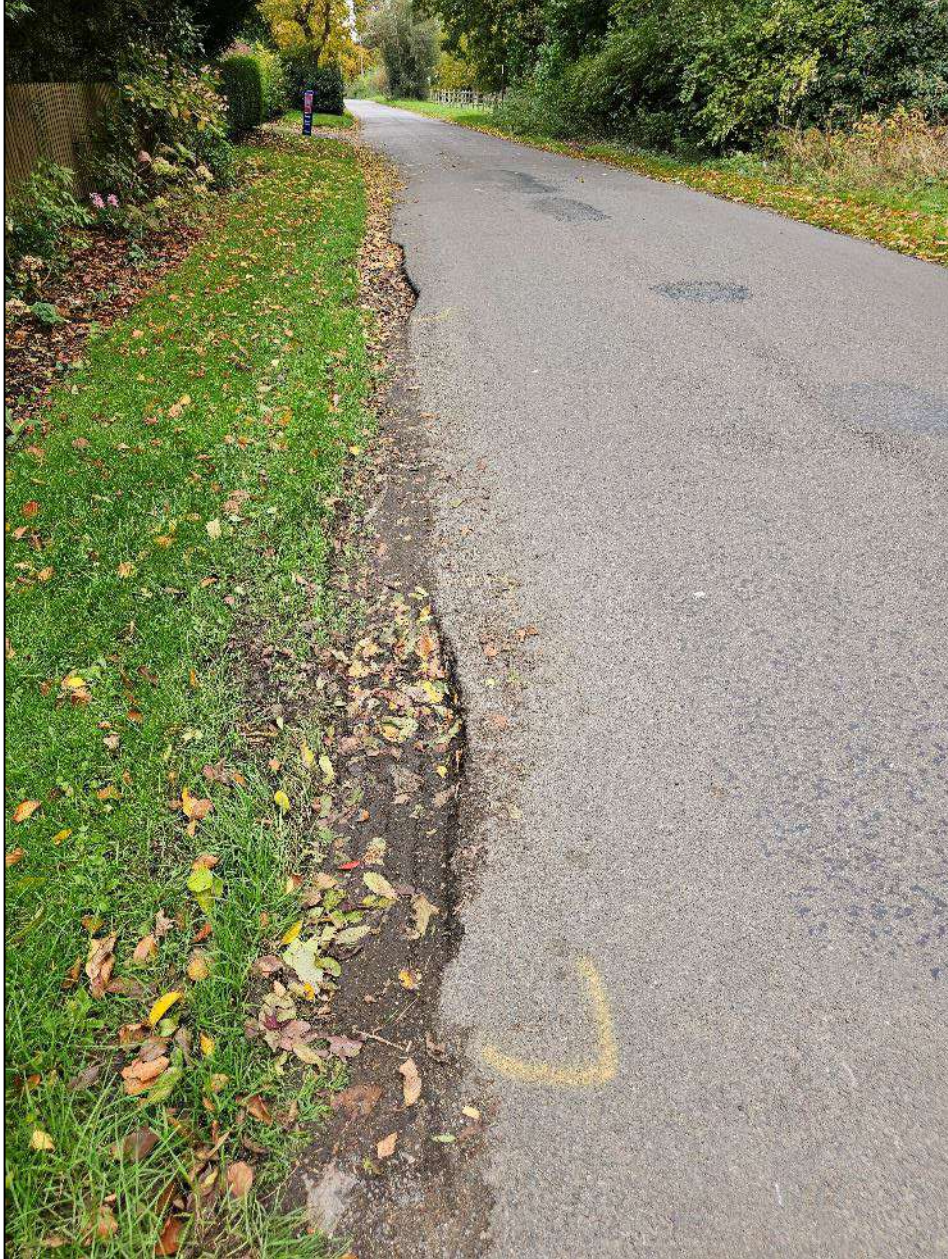
**Figure 43: Breakup of Tarmac Surfacing at Edge of Carriageway Approximately 1000m East of the Parcel A Access**
