# ASTON FLAMVILLE SOLAR FARM

## Condition 21 – Pre-Commencement Highway Condition Survey

794-PLN-WWP-TRP-00230-02b  
Highway Condition Survey (HBBC)  
Version 02b  
30 October 2024

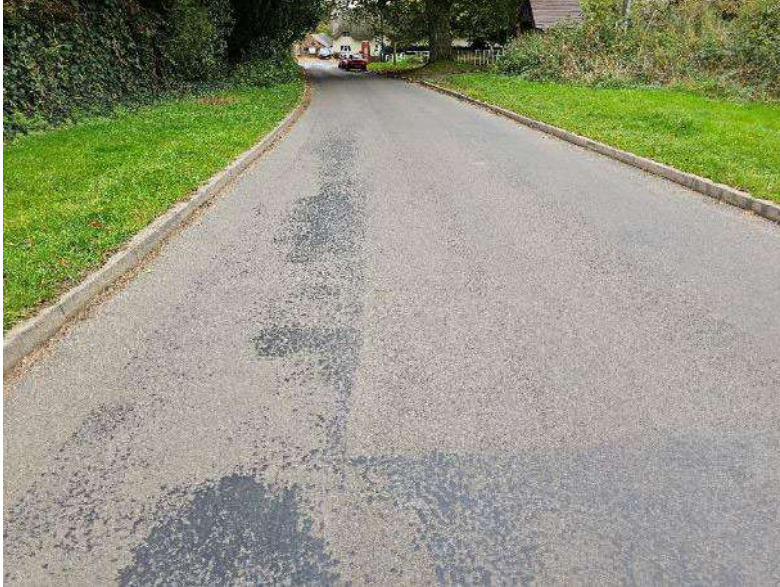
**Figure 44: General Carriageway Condition Approximately 1km East of the Parcel A Access**

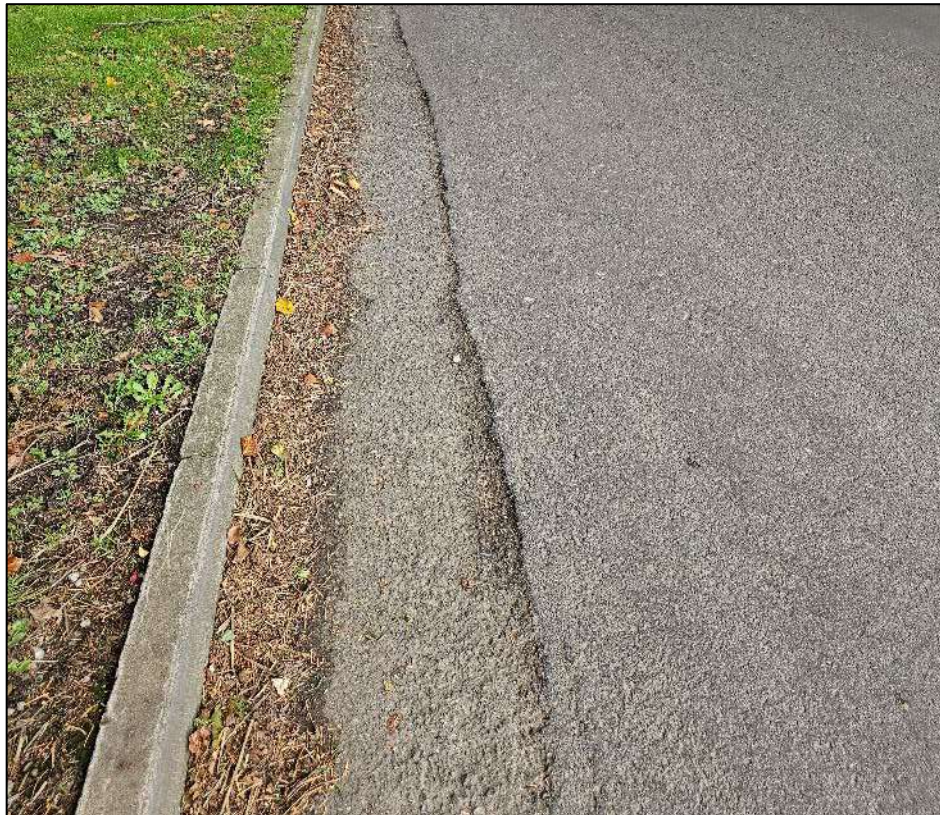
**Figure 45: Defects within Carriageway Approximately 1.2km East of the Parcel A Access**

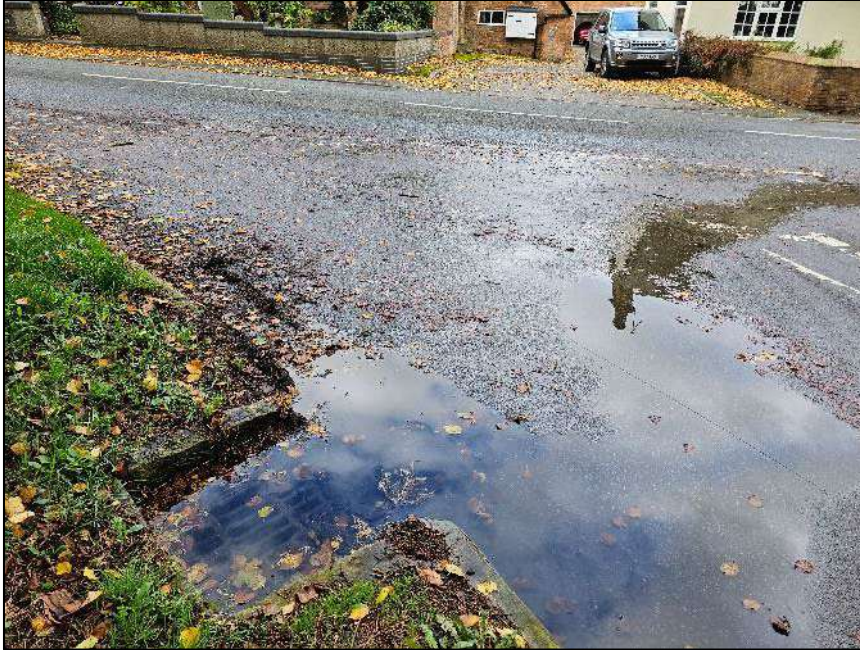
- 2.17 It should be noted that on the day of the survey, debris was blocking a drain at the Lychgate Lane / Hinckley Road junction. This is shown on Figures 46 and 47.

**Figure 46: Blocked Drain at the Lychgate Lane / Sharnford Road Junction**

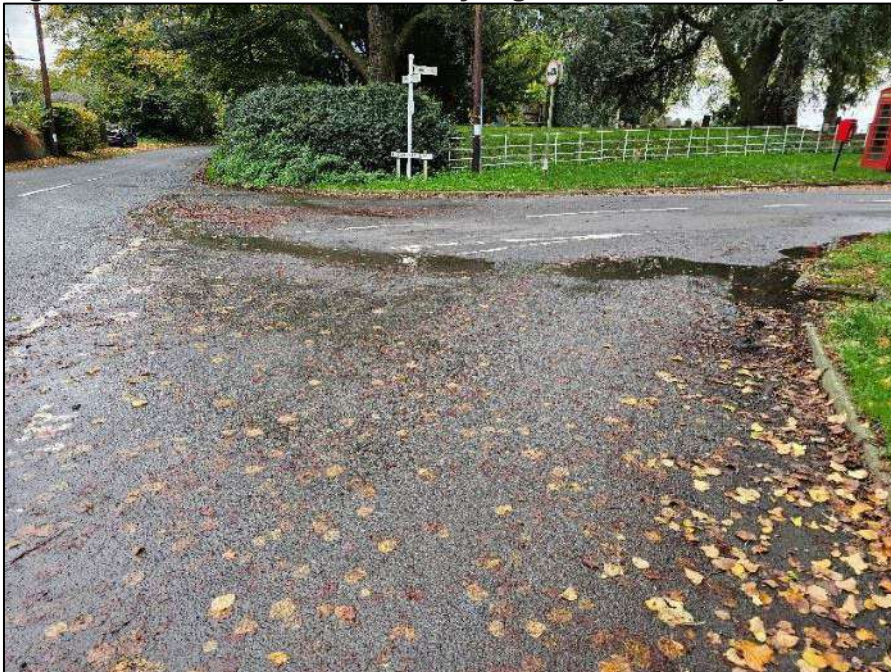
**Figure 47: Blocked Drain at the Lychgate Lane / Hinckley Road Junction**
