## Westbound Carriageway Condition

## Section 2: Sharnford Road and Aston Lane

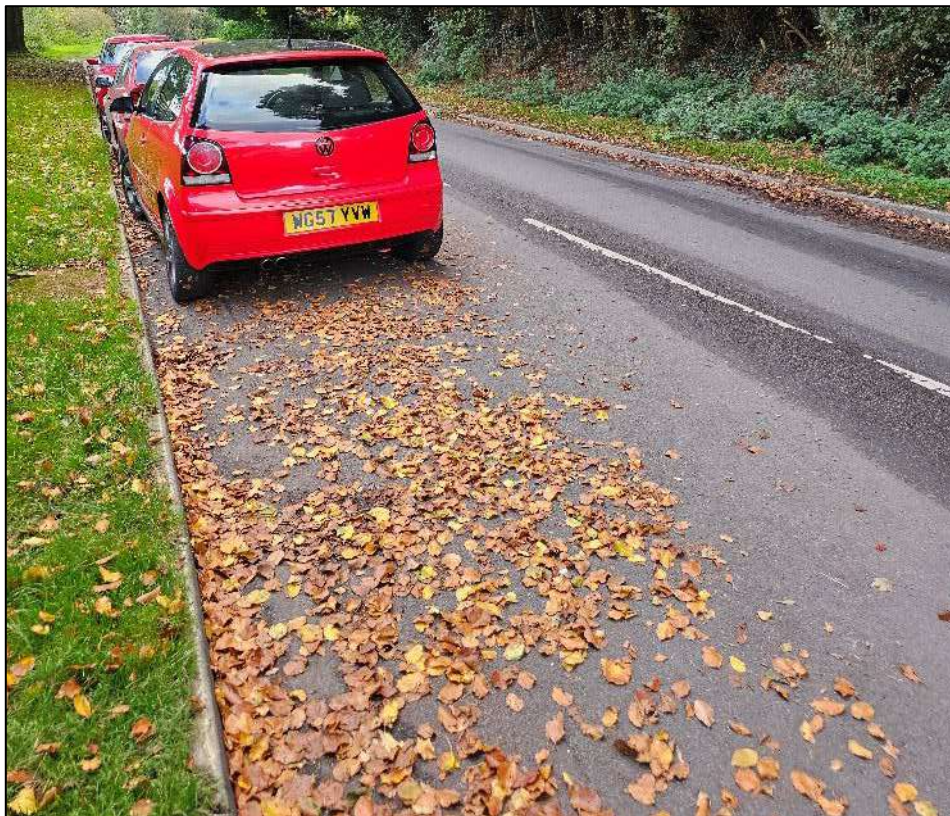
**Figure 48: Onstreet Parking Adjacent to St Peters Church**

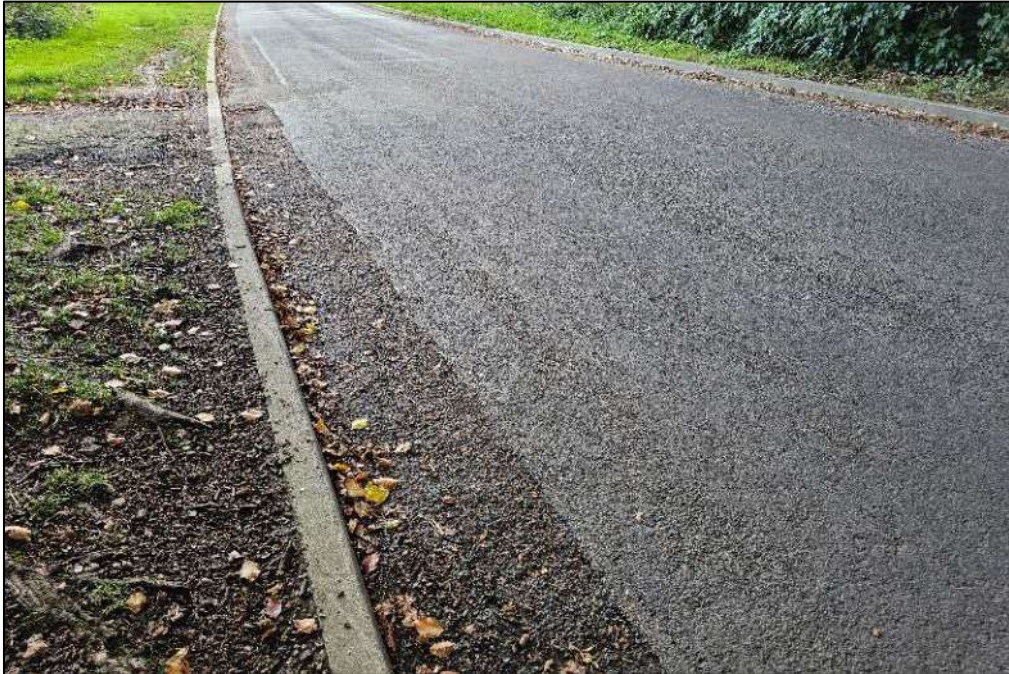
**Figure 49: Carriageway Adjacent to St Peters Church**

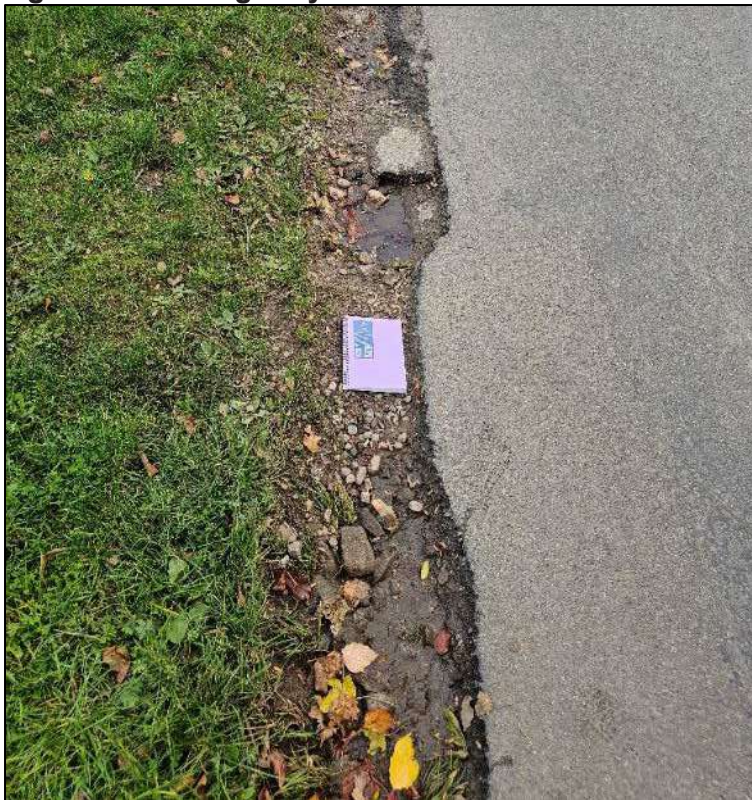
**Figure 50: Carriageway 1.15km East of the Parcel A Access**

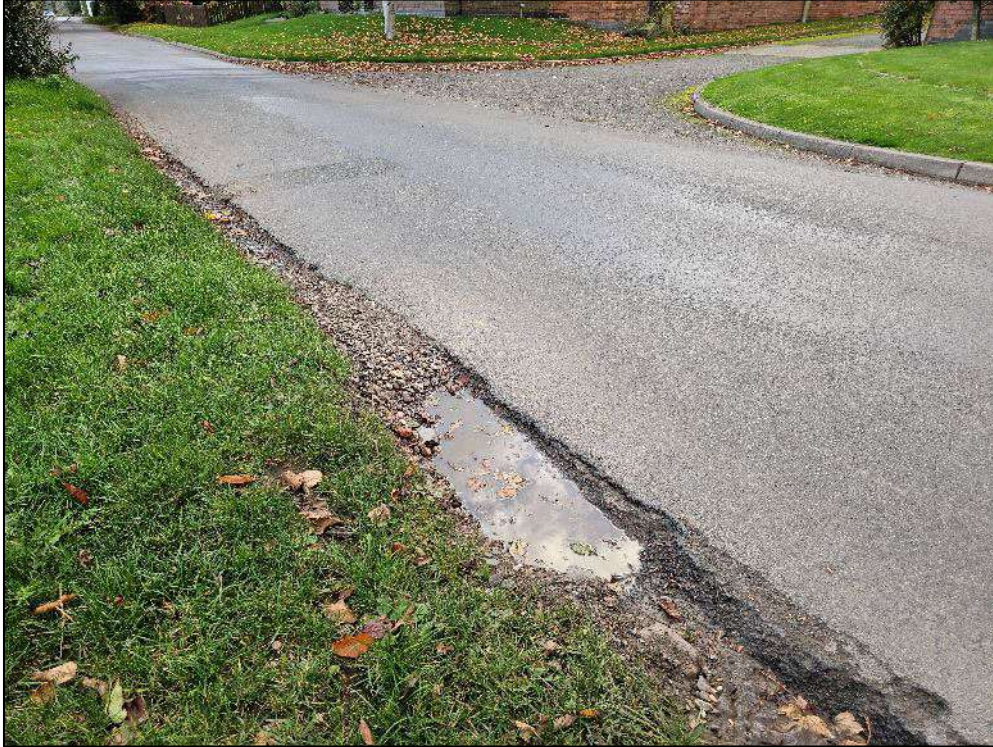
**Figure 51: Carriageway 1.1km East of the Parcel A Access**

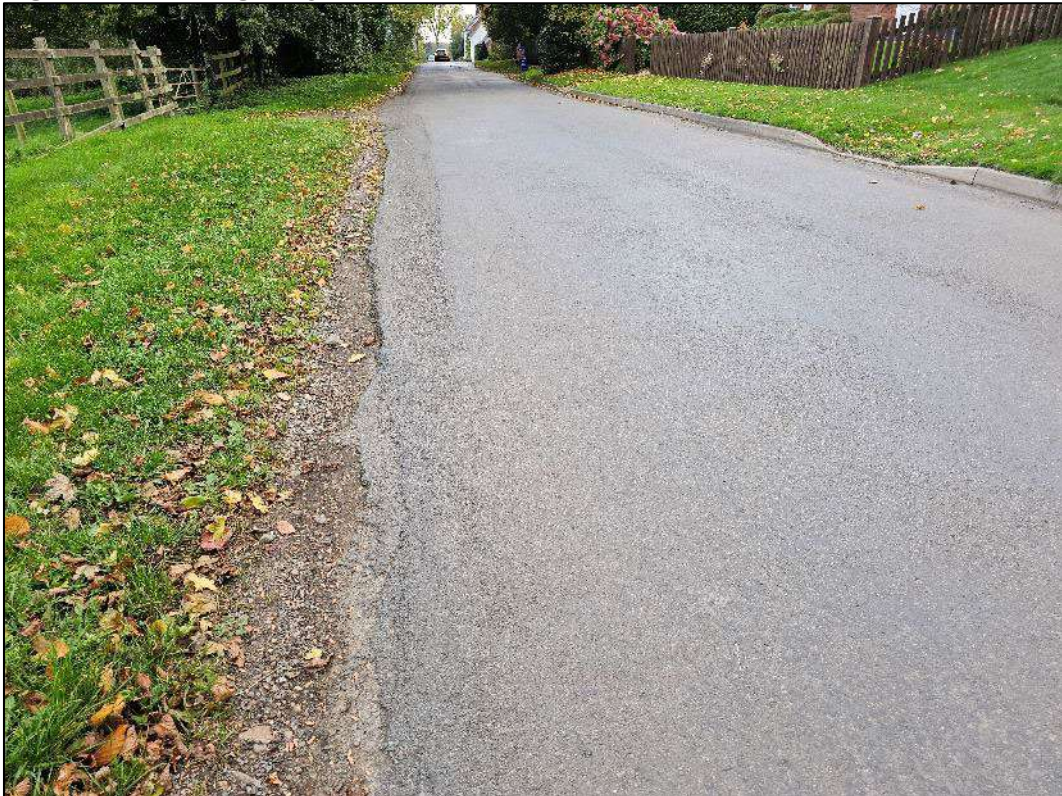
**Figure 52: Carriageway 1.05km East of the Parcel A Access**

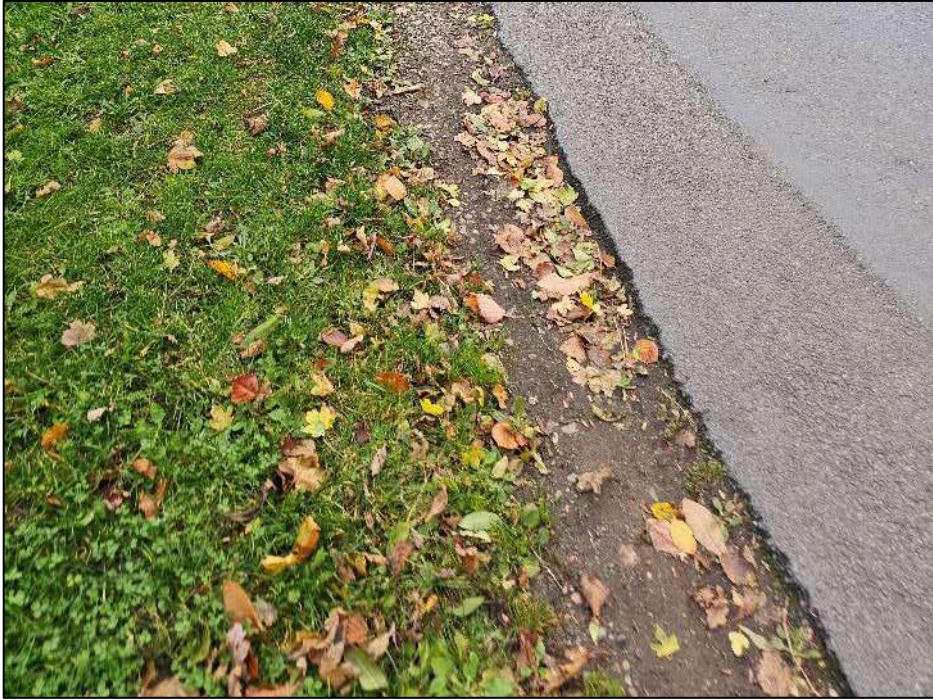
**Figure 53: Carriageway 1km East of the Parcel A Access**

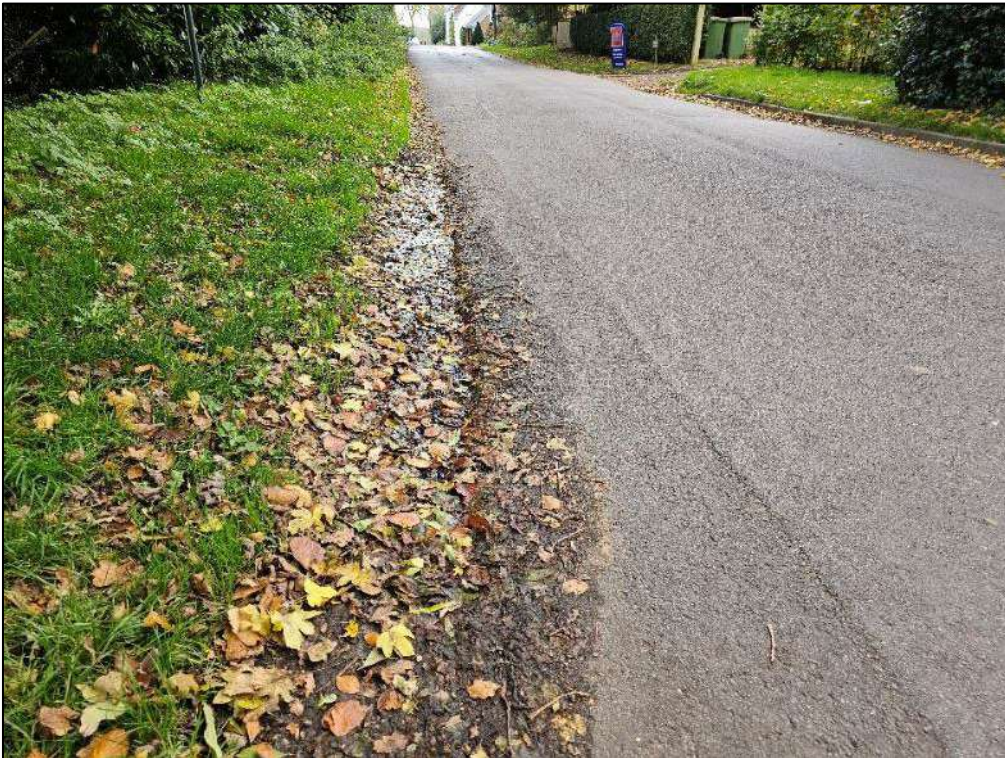
**Figure 54: Damage to Grass Verge Approximately 1km East of the Parcel A Access**

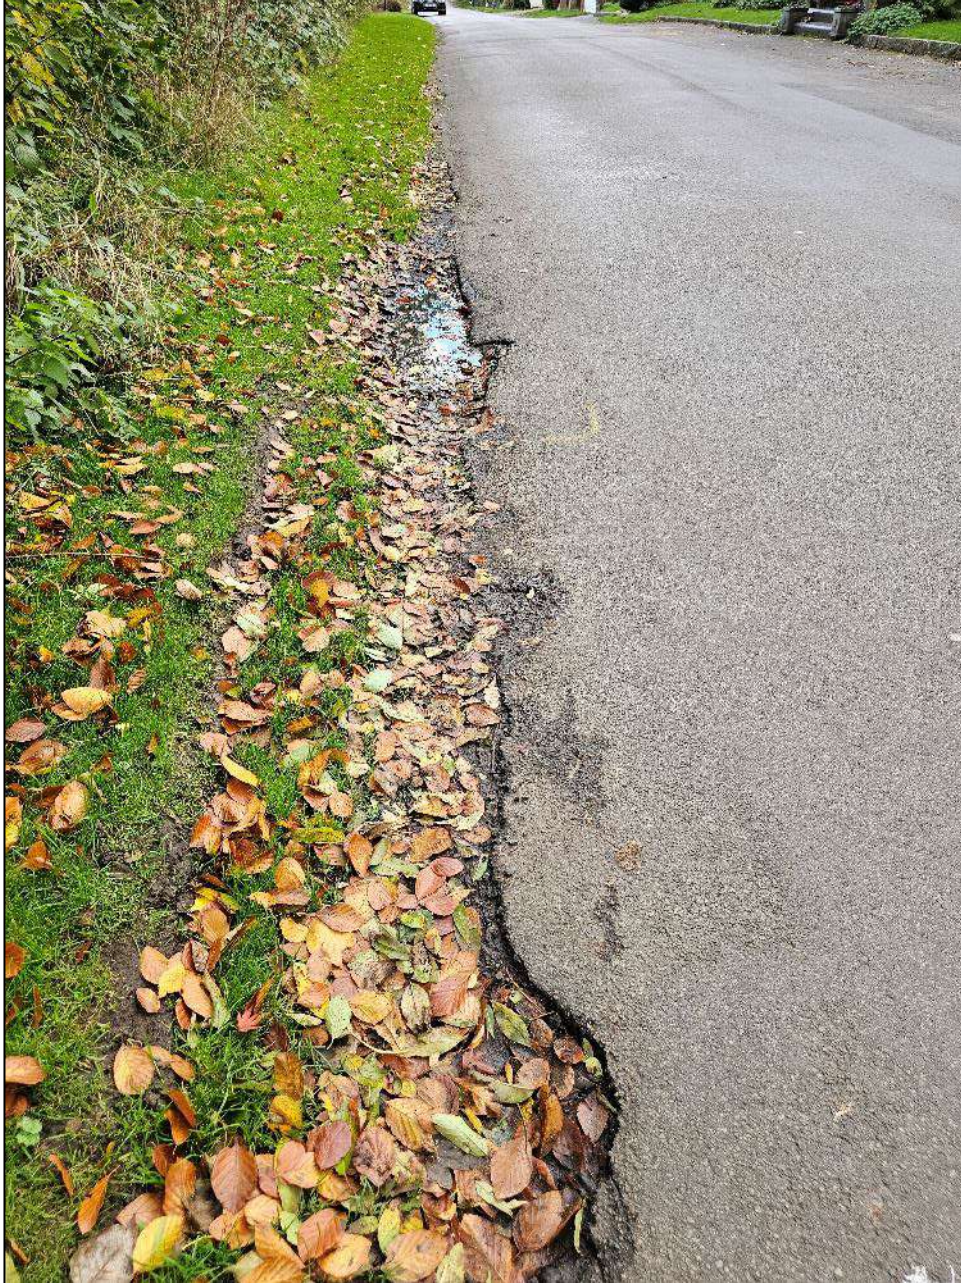
**Figure 55: Damage to Edge of Carriageway Approximately 950m East of the Parcel A Access**

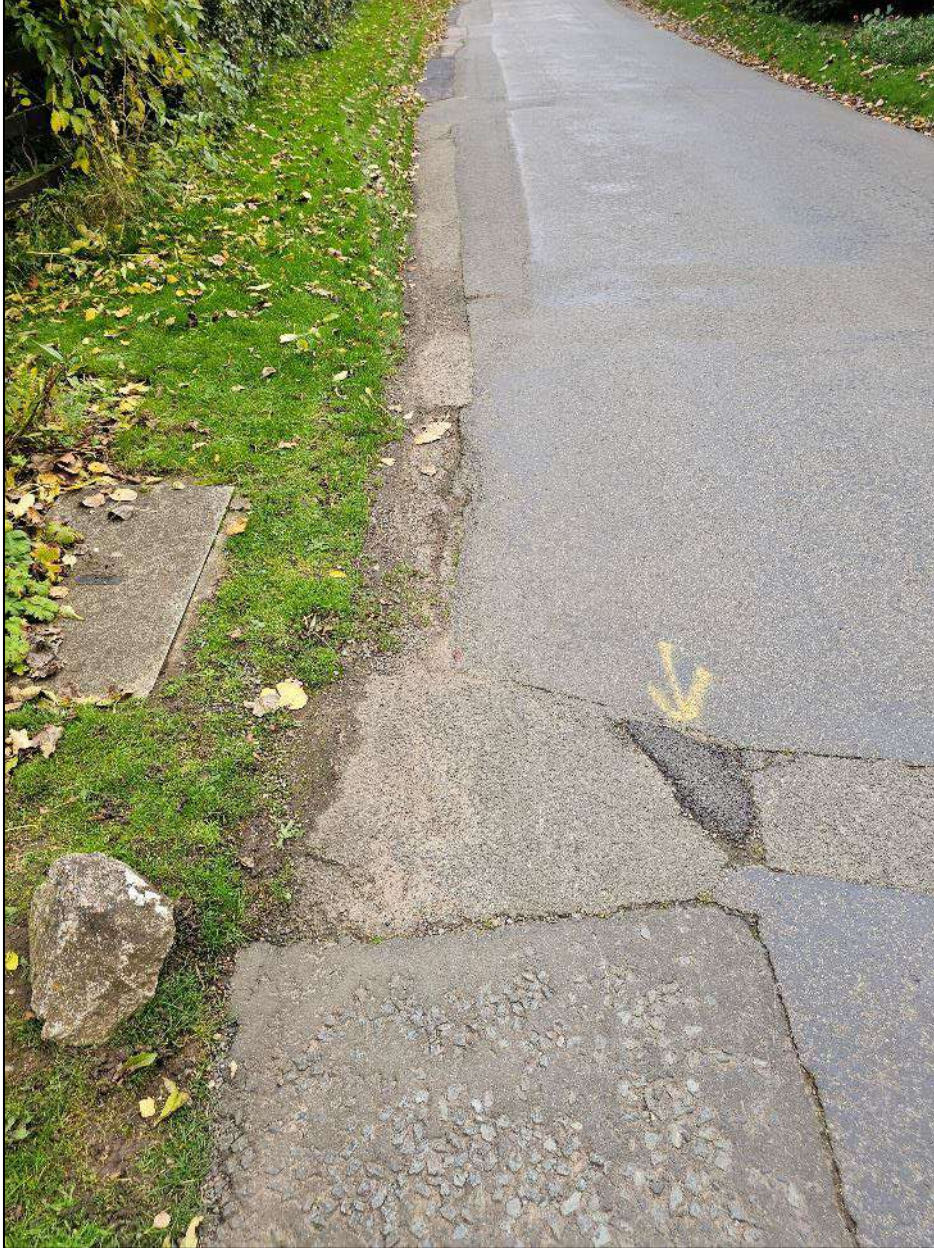
**Figure 56: Carriageway Patching on Lychgate Lane, Approximately 900m East of the Parcel A Access**

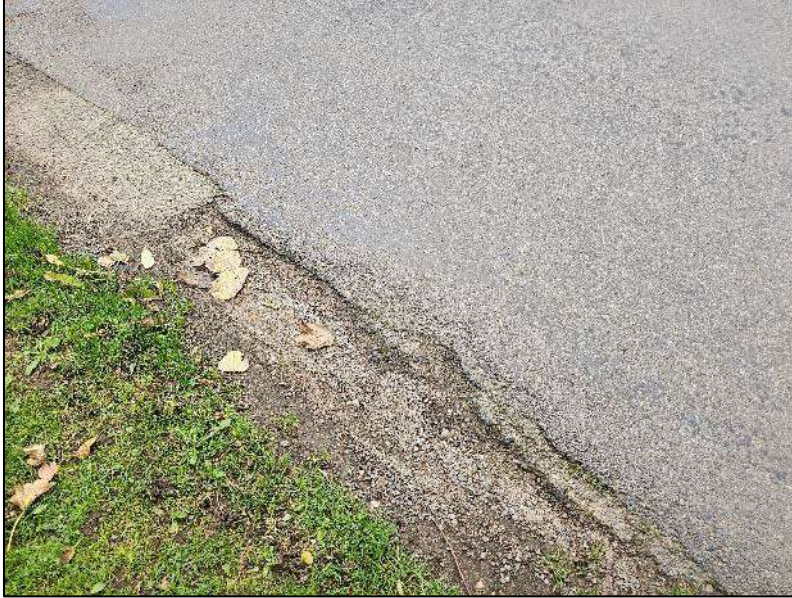
**Figure 57: Damage to Edge of Carriageway Approximately 85m East of the Parcel A Access**

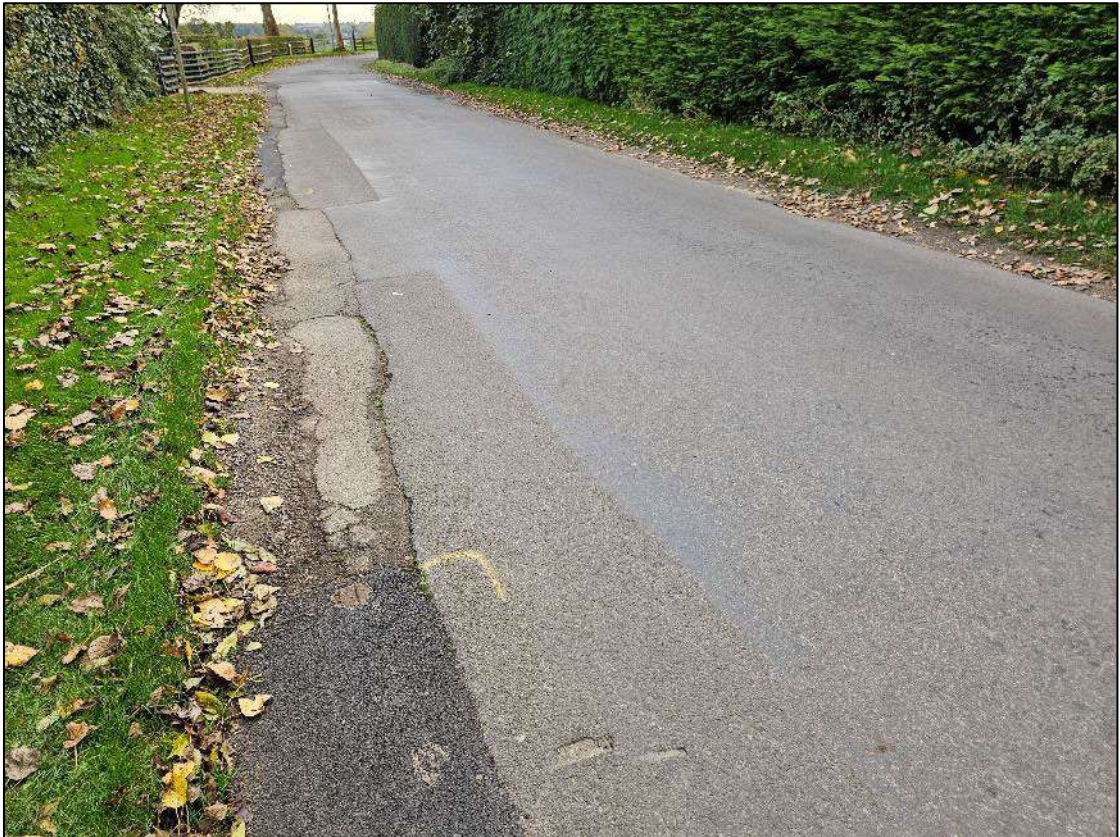
**Figure 58: Damage to Edge of Carriageway Approximately 85m East of the Parcel A Access**

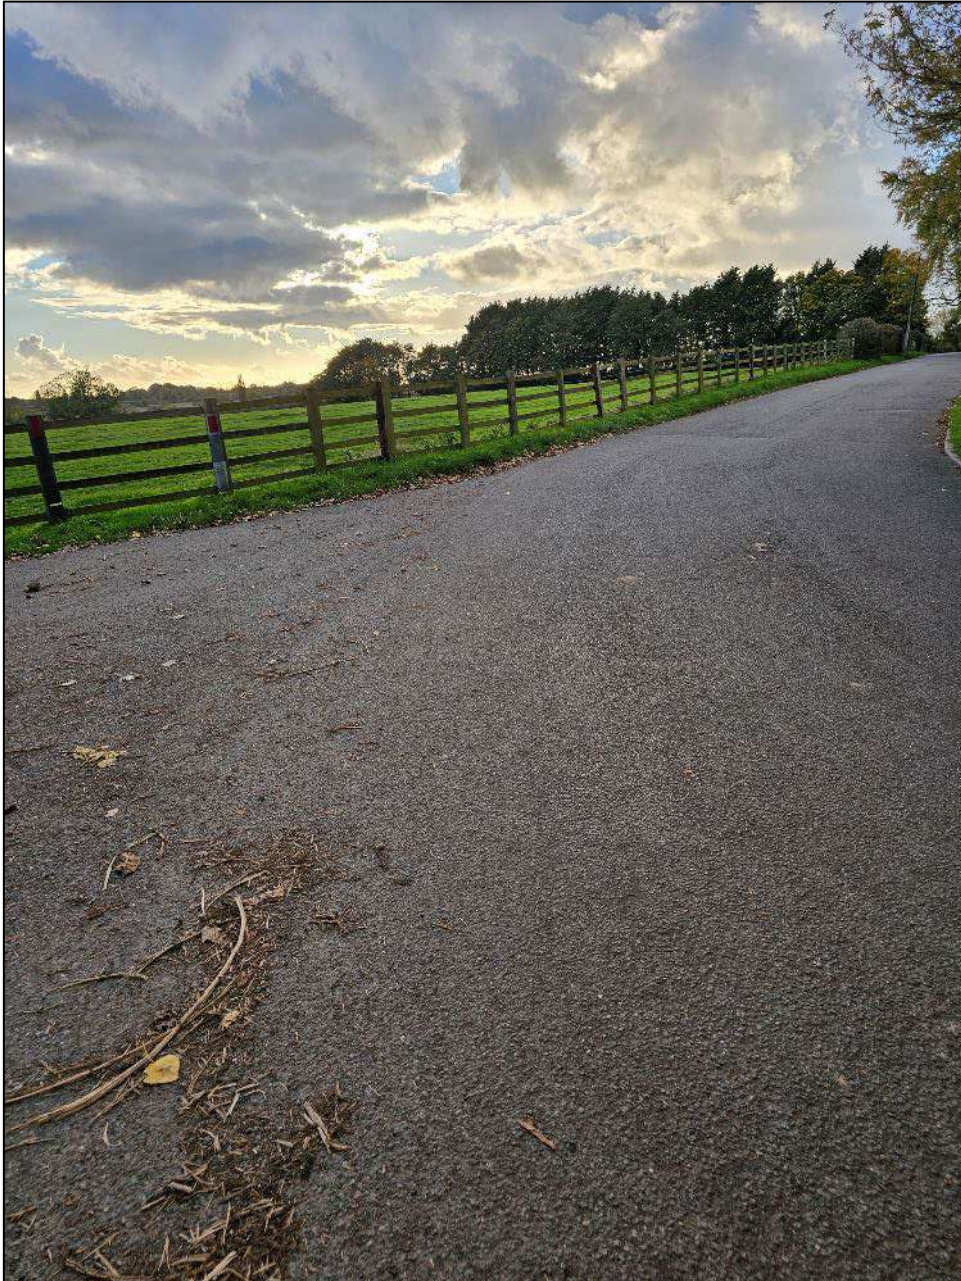
**Figure 59: General Carriageway Condition at Lychgate Lane Bend**

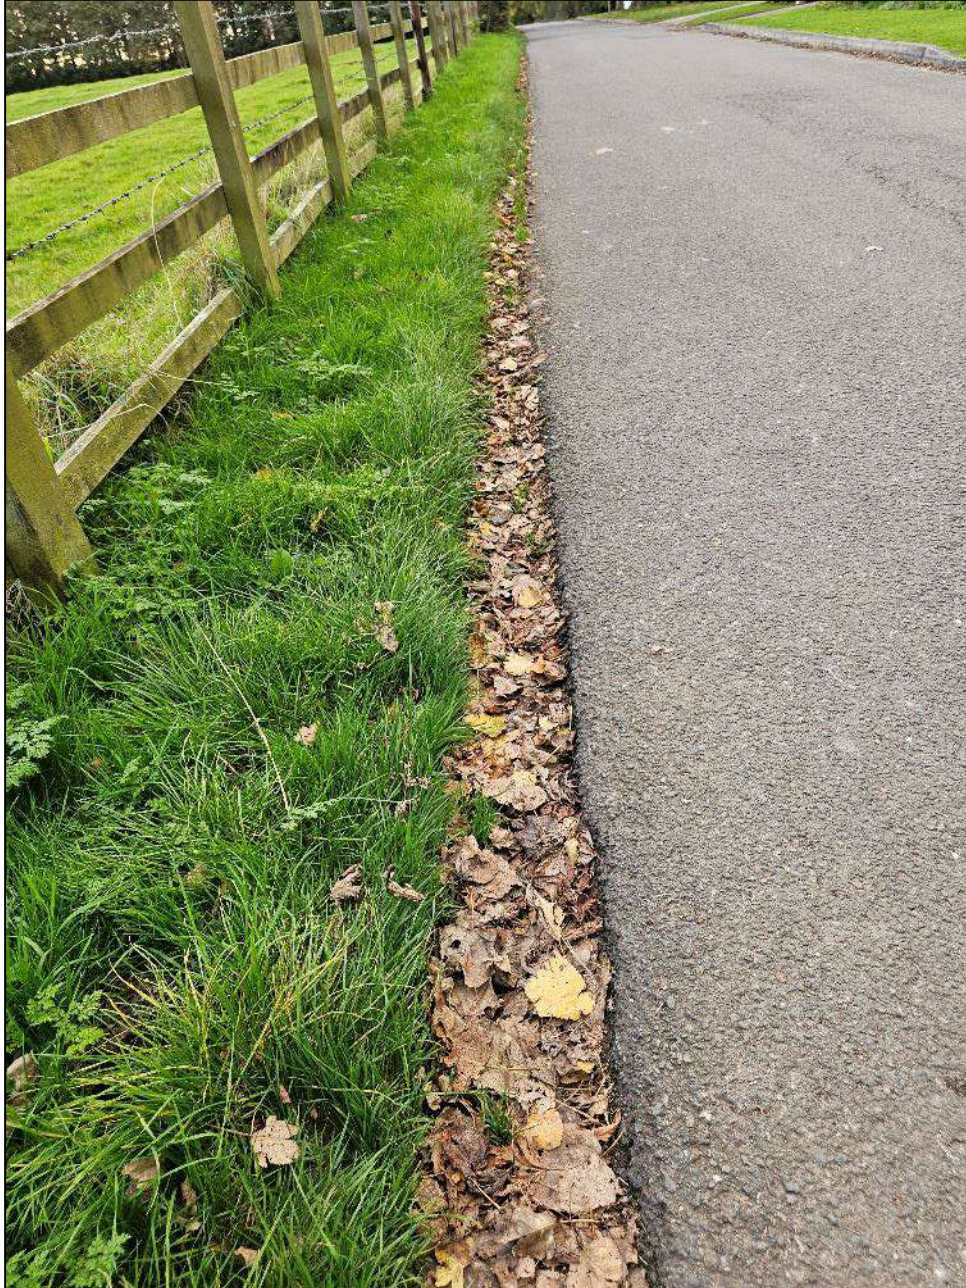
**Figure 60: Damage to Grass Verge Approximately 750m East of the Parcel A Access**

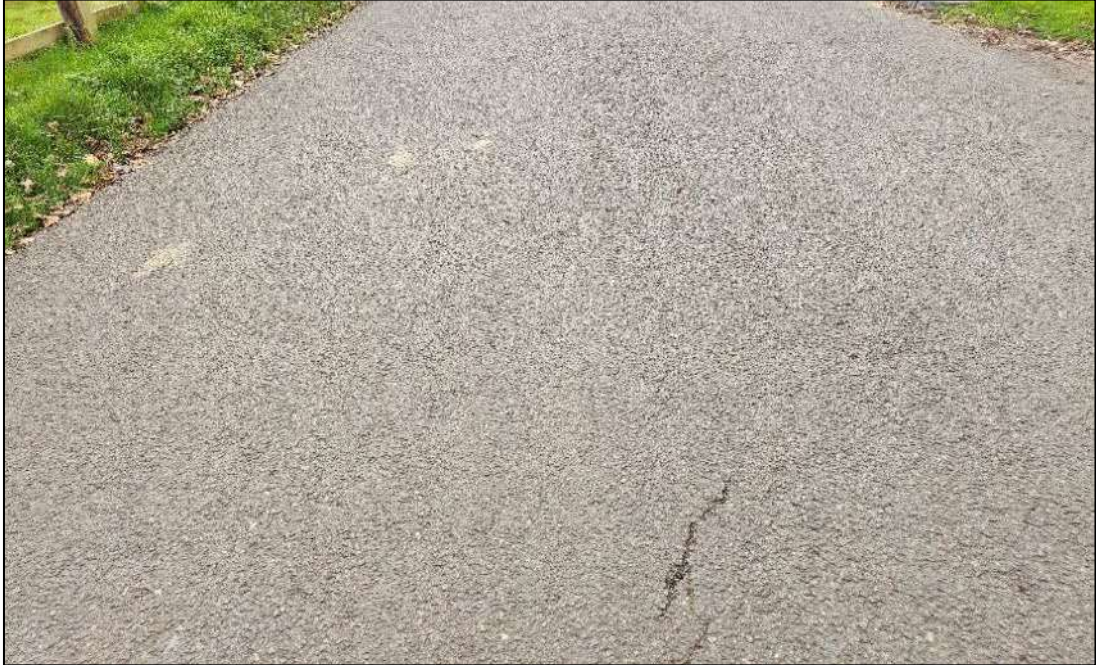
**Figure 61: Tarmac Crack Approximately 750m East of the Parcel A Access**

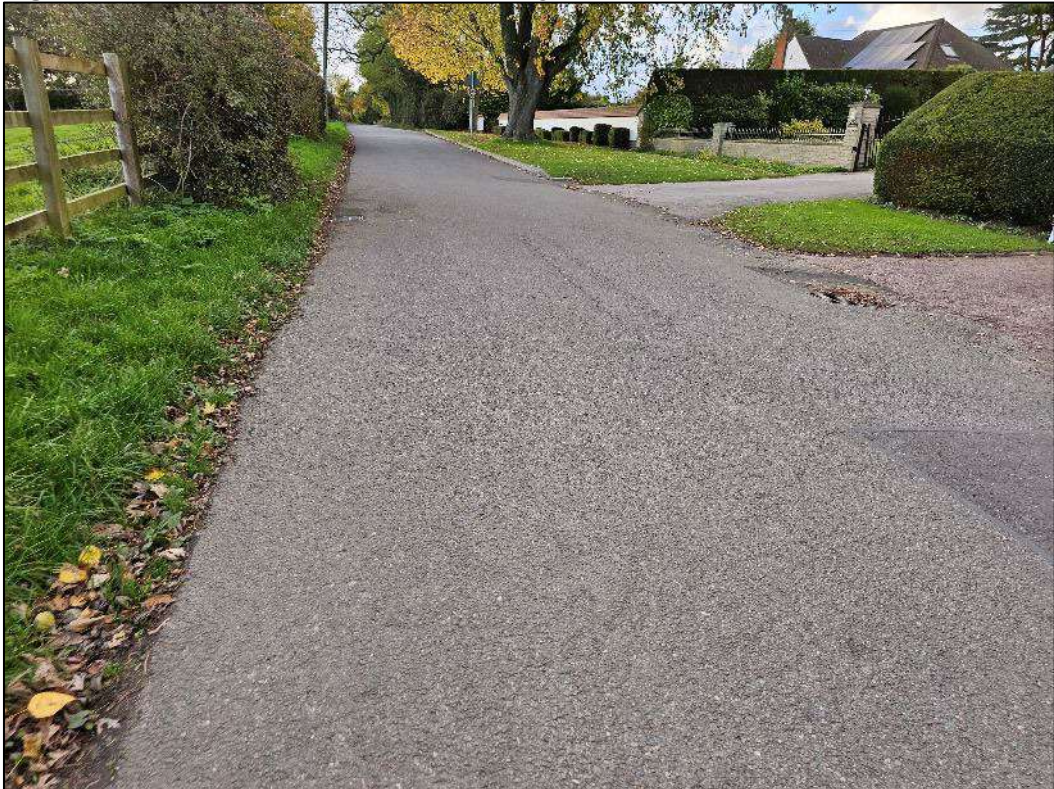
**Figure 62: Tarmac Crack Approximately 750m East of the Parcel A Access**

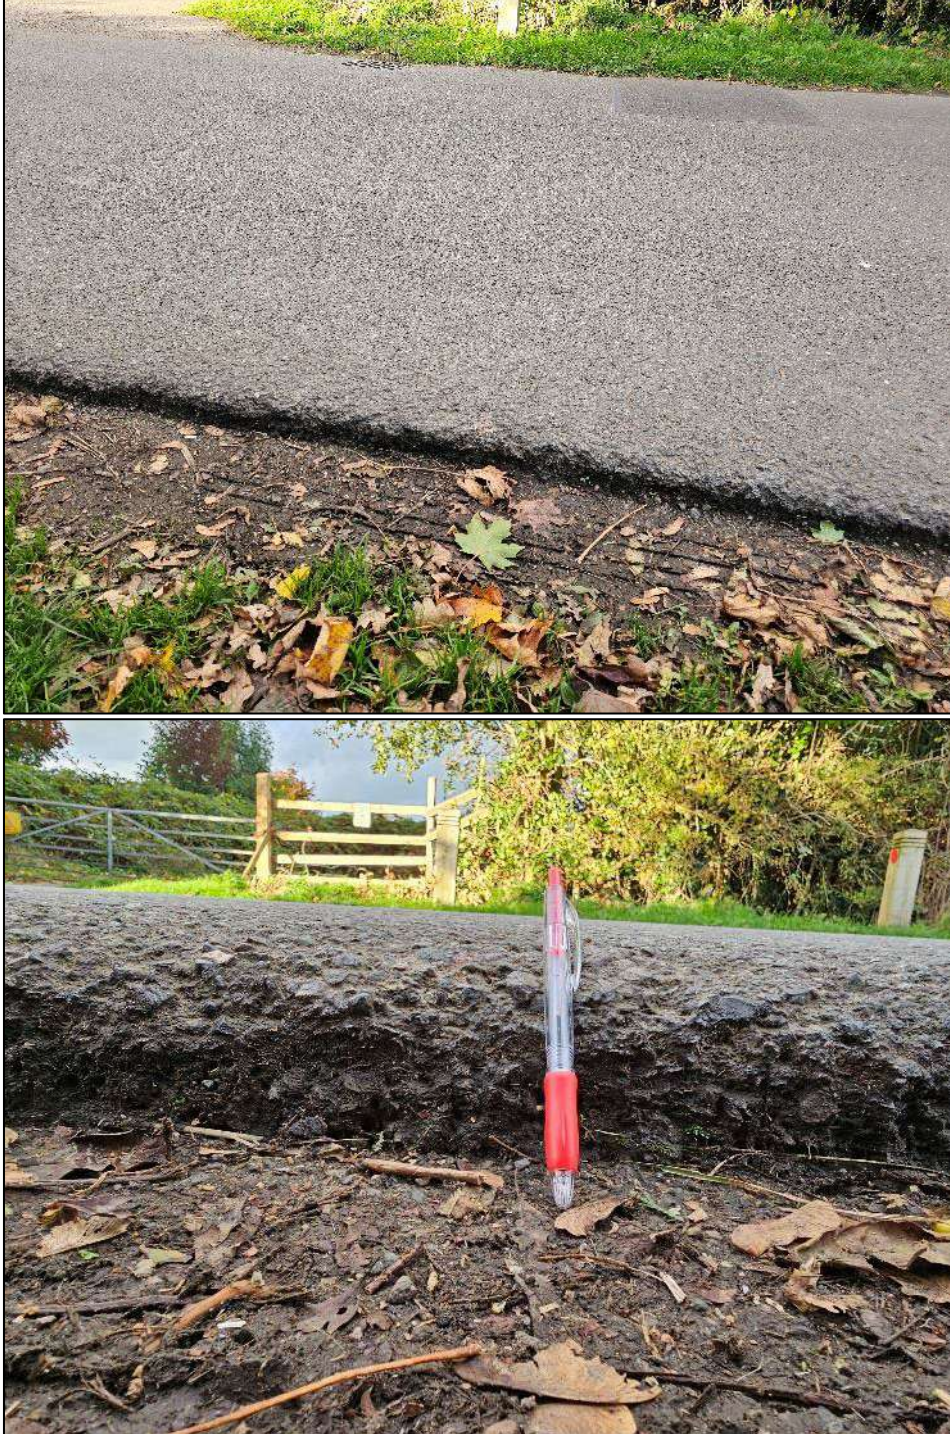
**Figure 63: Grass Verge Damage Approximately 700m East of the Parcel A Access**

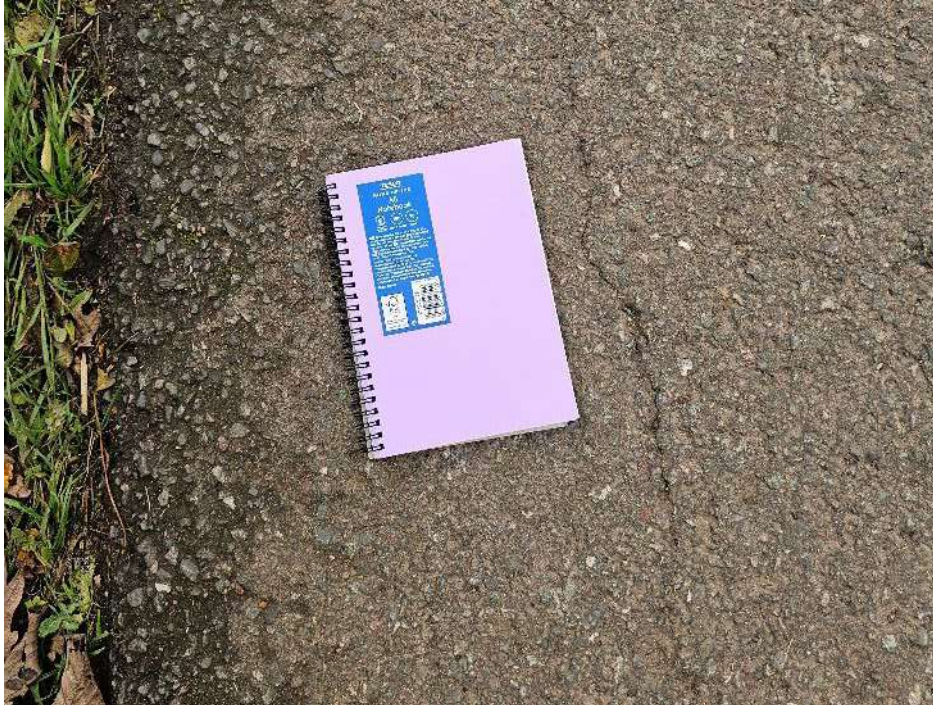
**Figure 64: Tarmac Defect Approximately 650m East of the Parcel A Access**

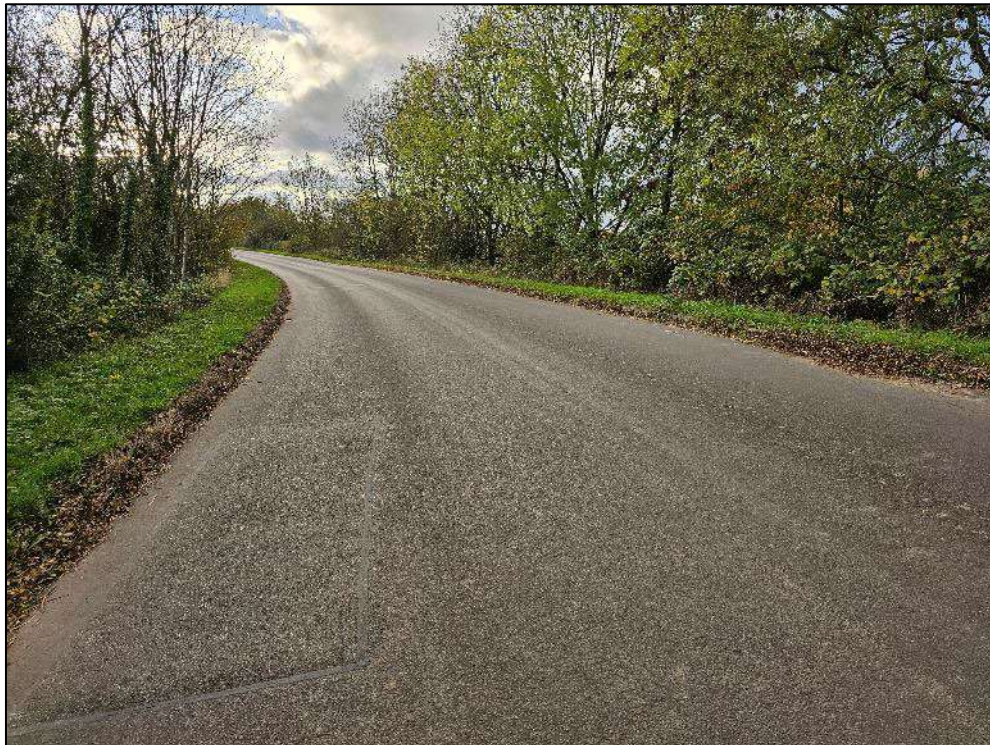
**Figure 65: Carriageway Patching Approximately 500m east of the Parcel A Access**

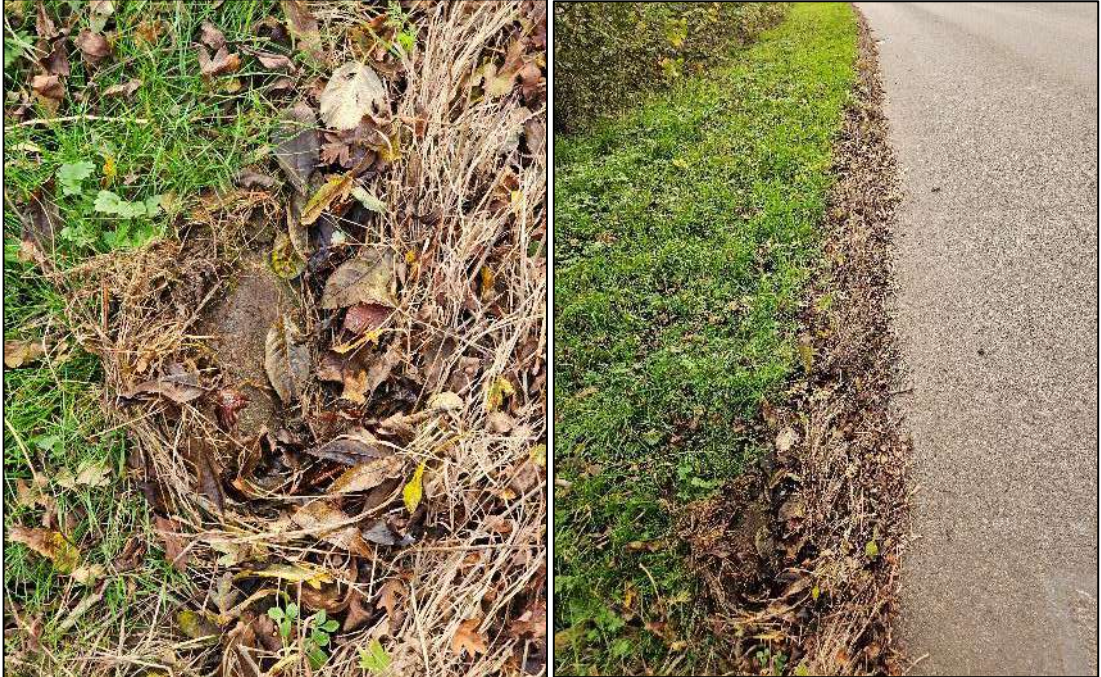
**Figure 66: Kerbing Obscured by Vegetation Approximately 500m east of the Parcel A Access**

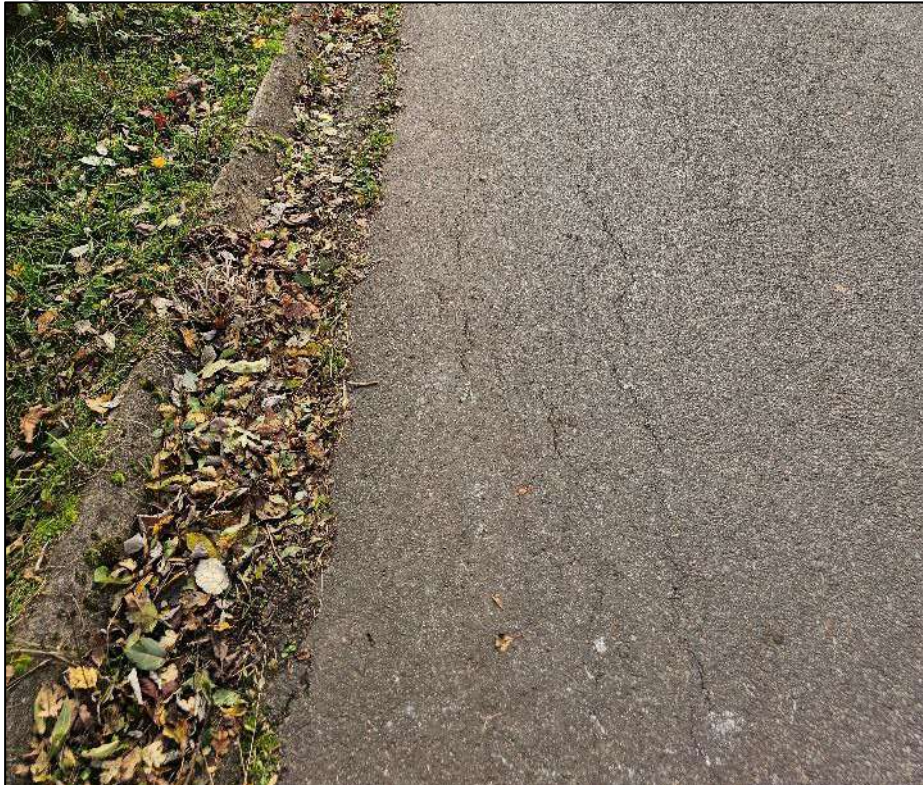
**Figure 67: Tarmac Cracks 450m East of the Parcel A Access**

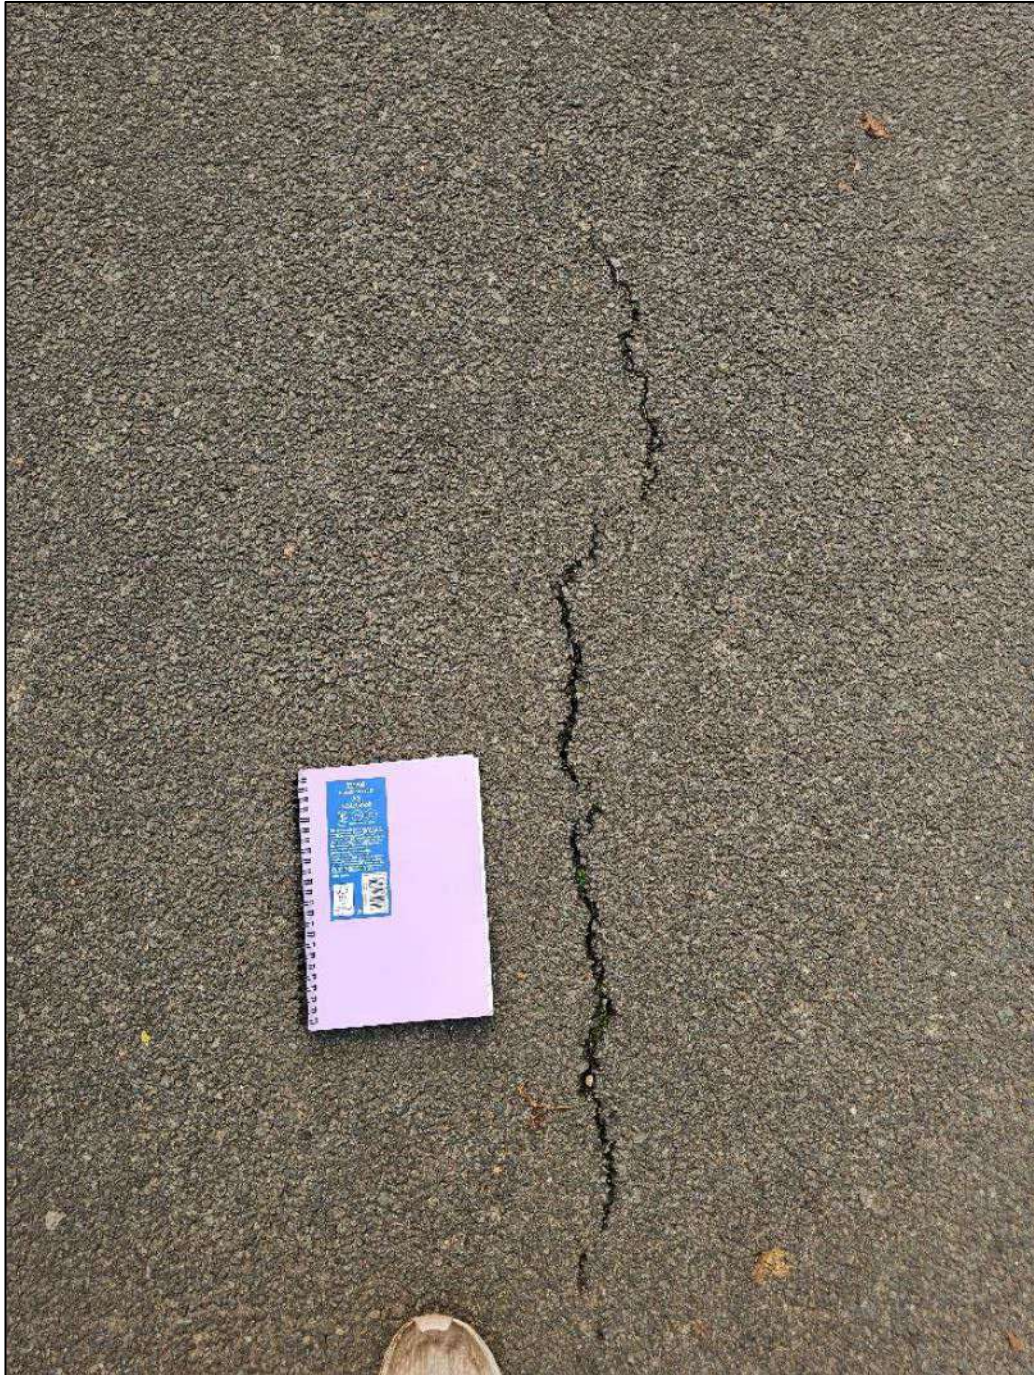
**Figure 68: Tarmac Cracks 350m East of the Parcel A Access**

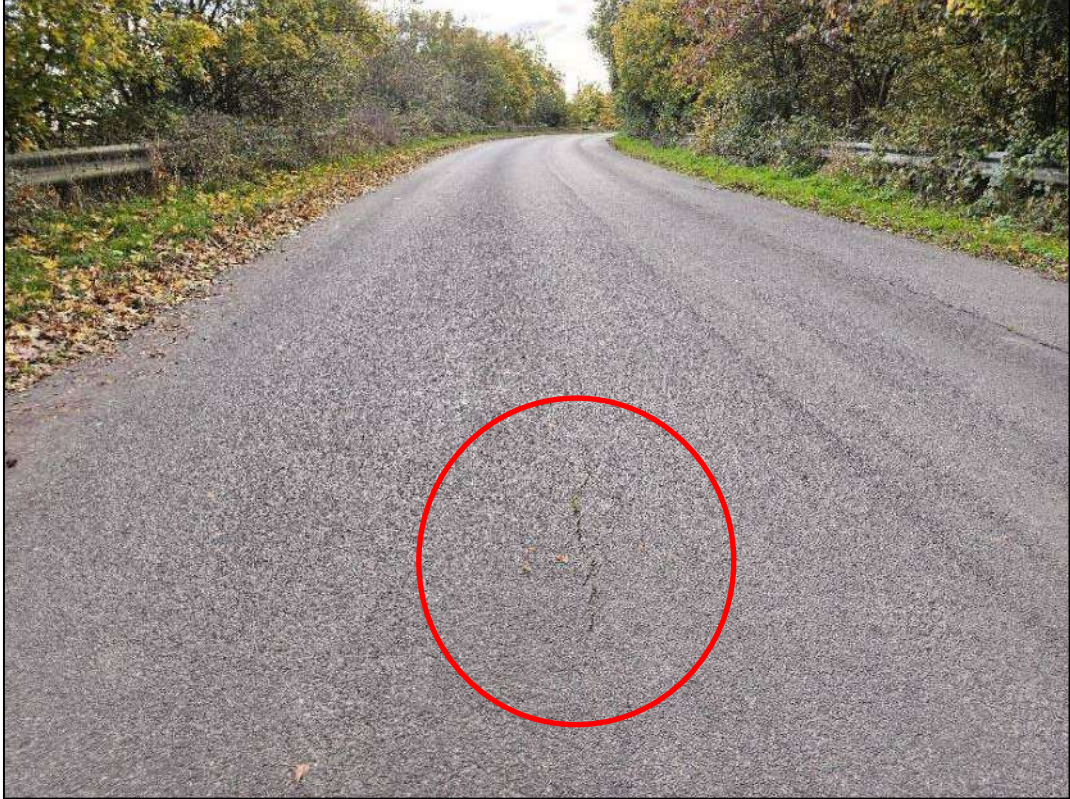
**Figure 69: General Carriageway Condition 300-350m East of the Parcel A Access, with Tarmac Crack In Centre of Carriageway**

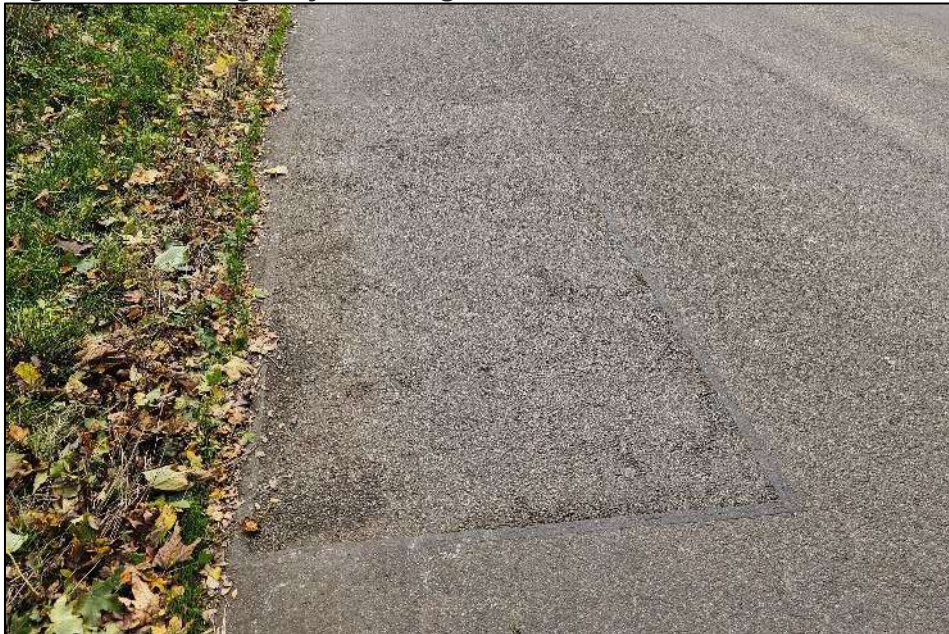
**Figure 70: Carriageway Patching 300m East of the Parcel A Access**

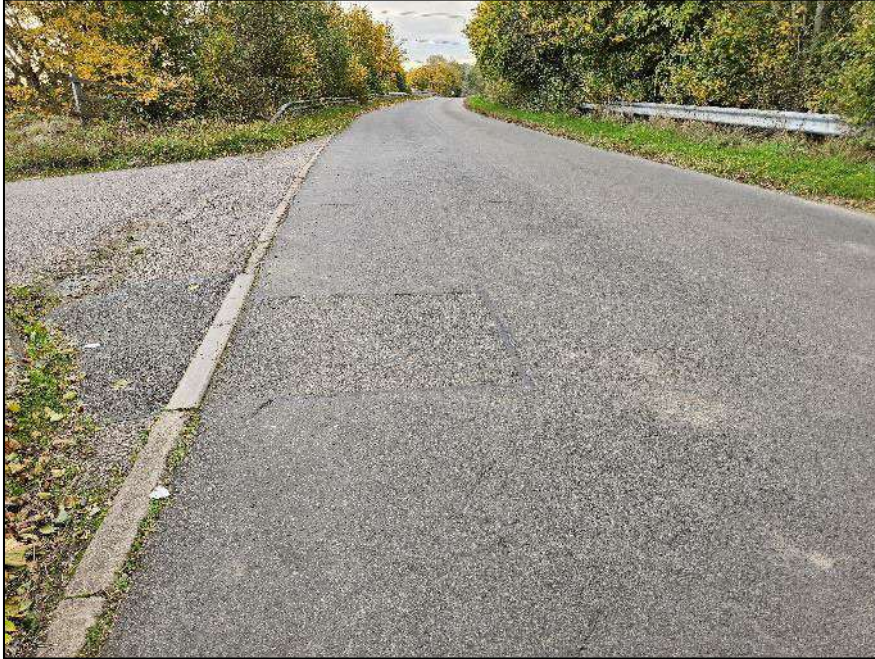
**Figure 71: Carriageway Patching 250m East of the Parcel A Access**

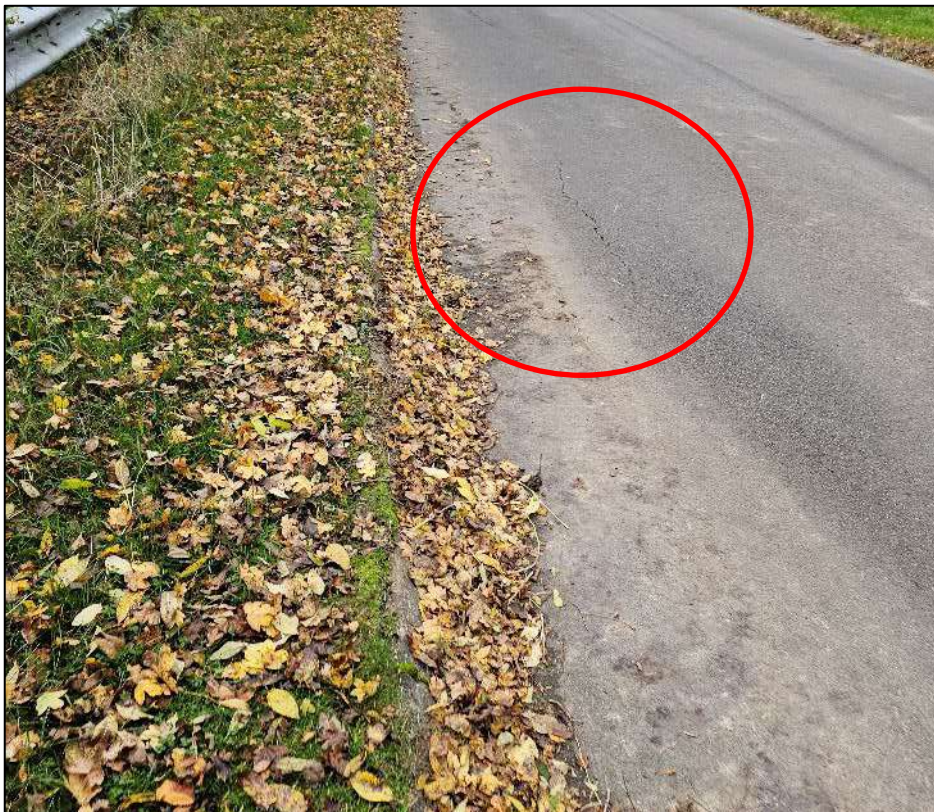
**Figure 72: Debris Adjacent to Kerbing, and Tarmac Cracks 220-230m East of the Parcel A Access**

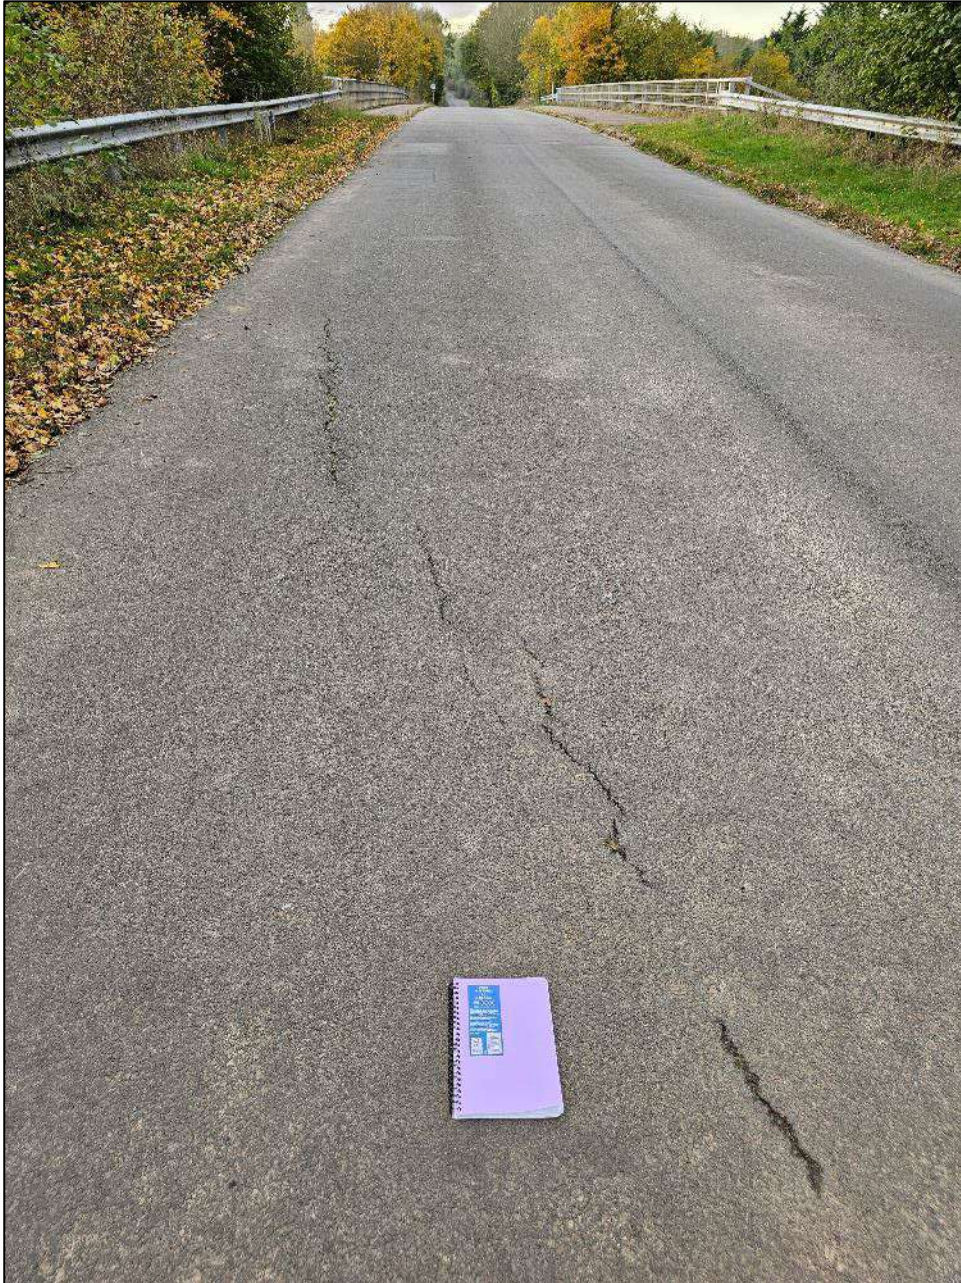
**Figure 73: Tarmac Cracks 180m East of the Parcel A Access**
