## Westbound Carriageway Condition

## Section 2: Sharnford Road and Aston Lane

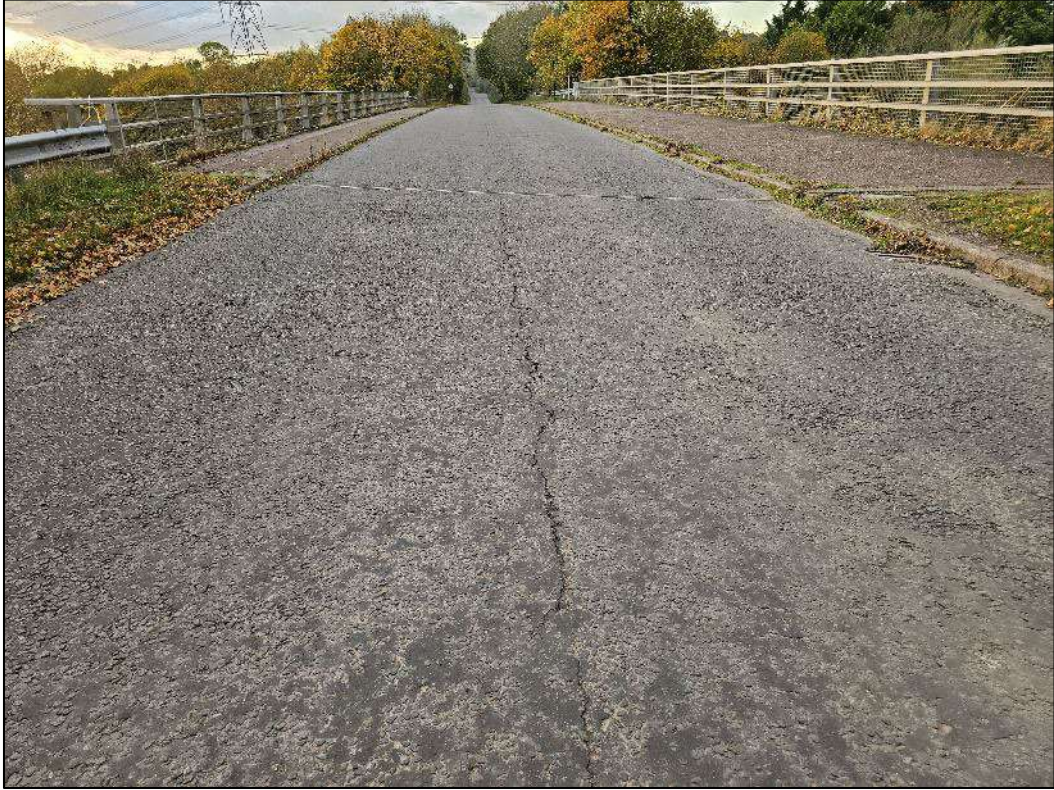
**Figure 74: Surface Tarmac Cracks 170m East of the Parcel A Access**

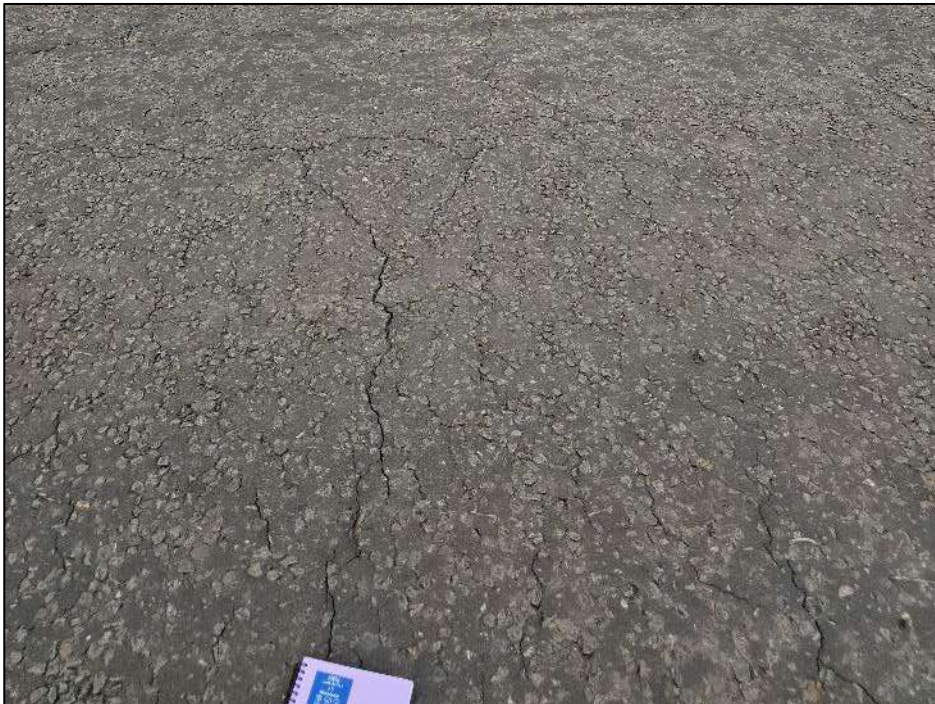
**Figure 75: Surface Tarmac Transverse Cracks 160m East of the Parcel A Access**

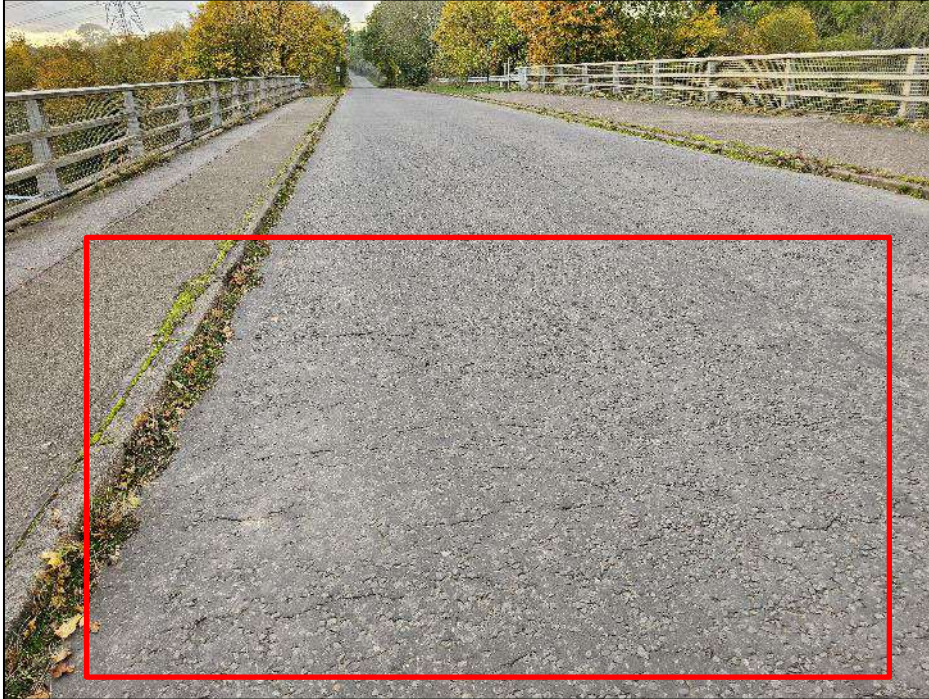
**Figure 76: Transverse Surface Cracks 150-160m east of the Parcel A Access**

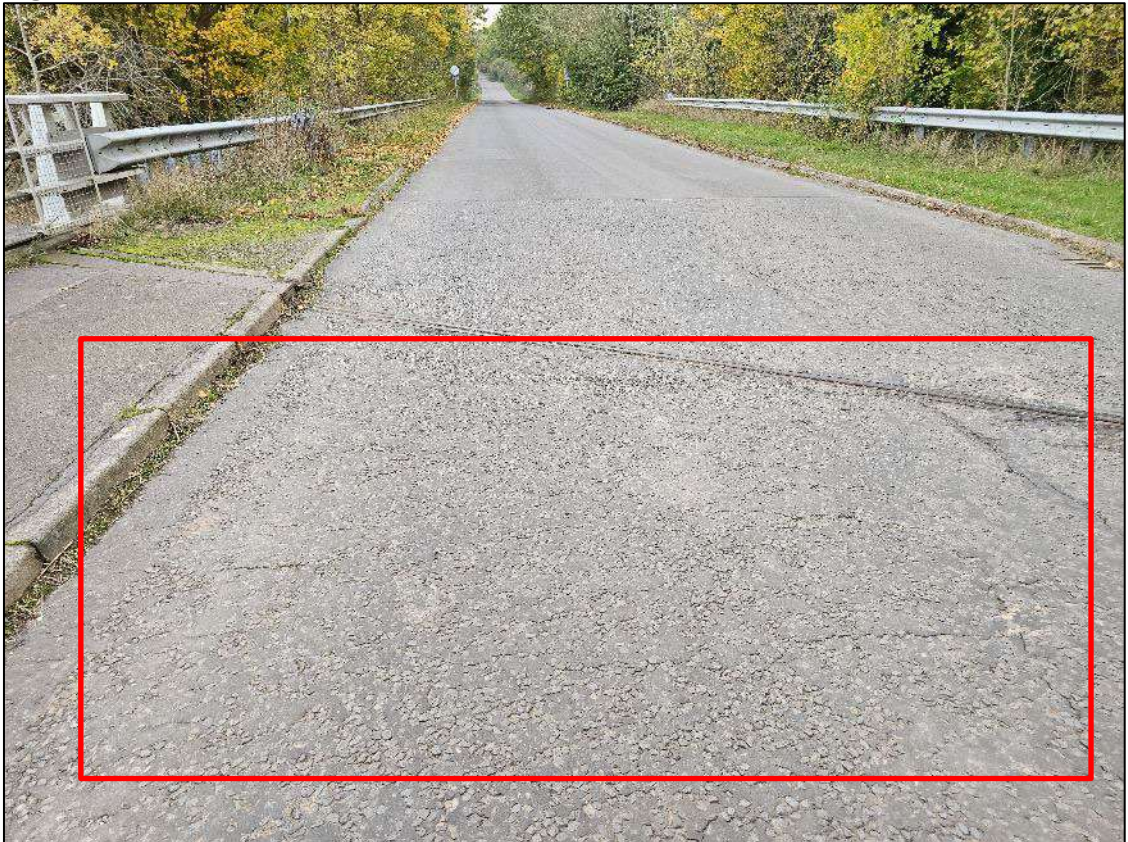
**Figure 77: Transverse Surface Cracks 120m east of the Parcel A Access**

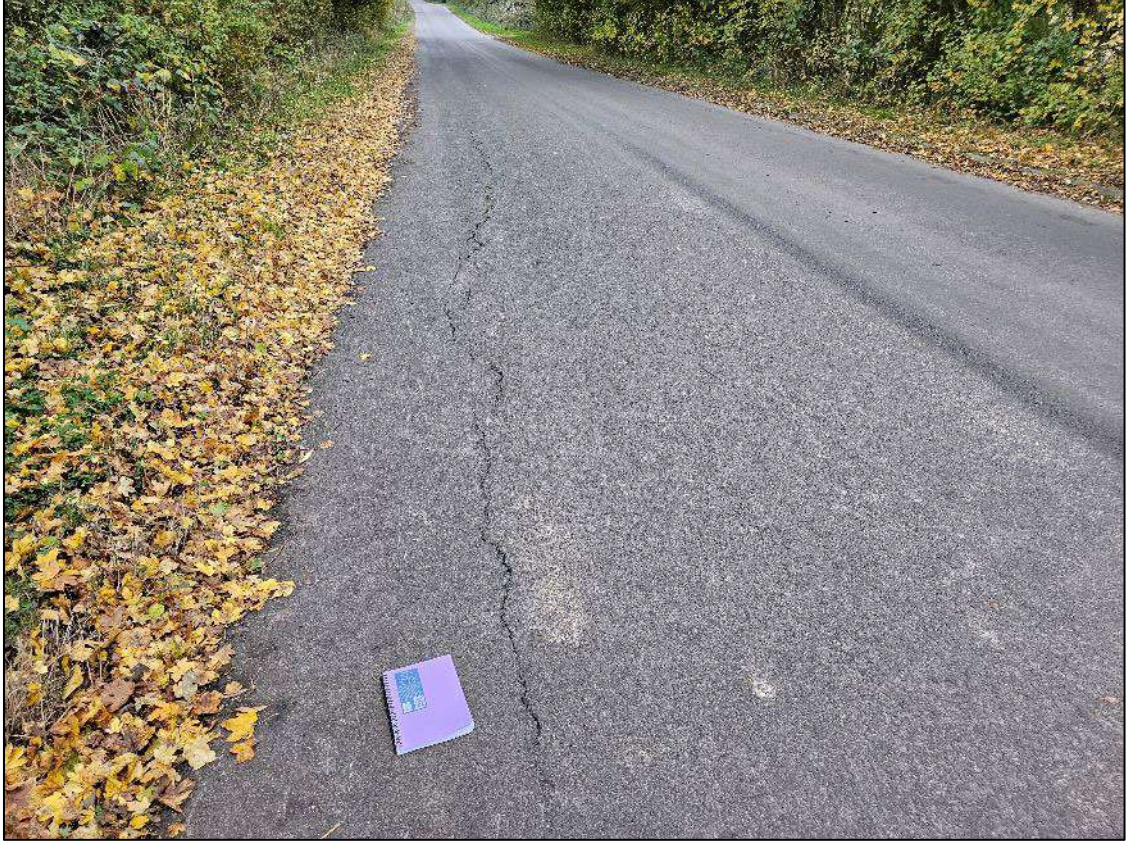
**Figure 78: Tarmac Surface Cracks Parallel to Kerblines, 100m East of the Parcel A Access**

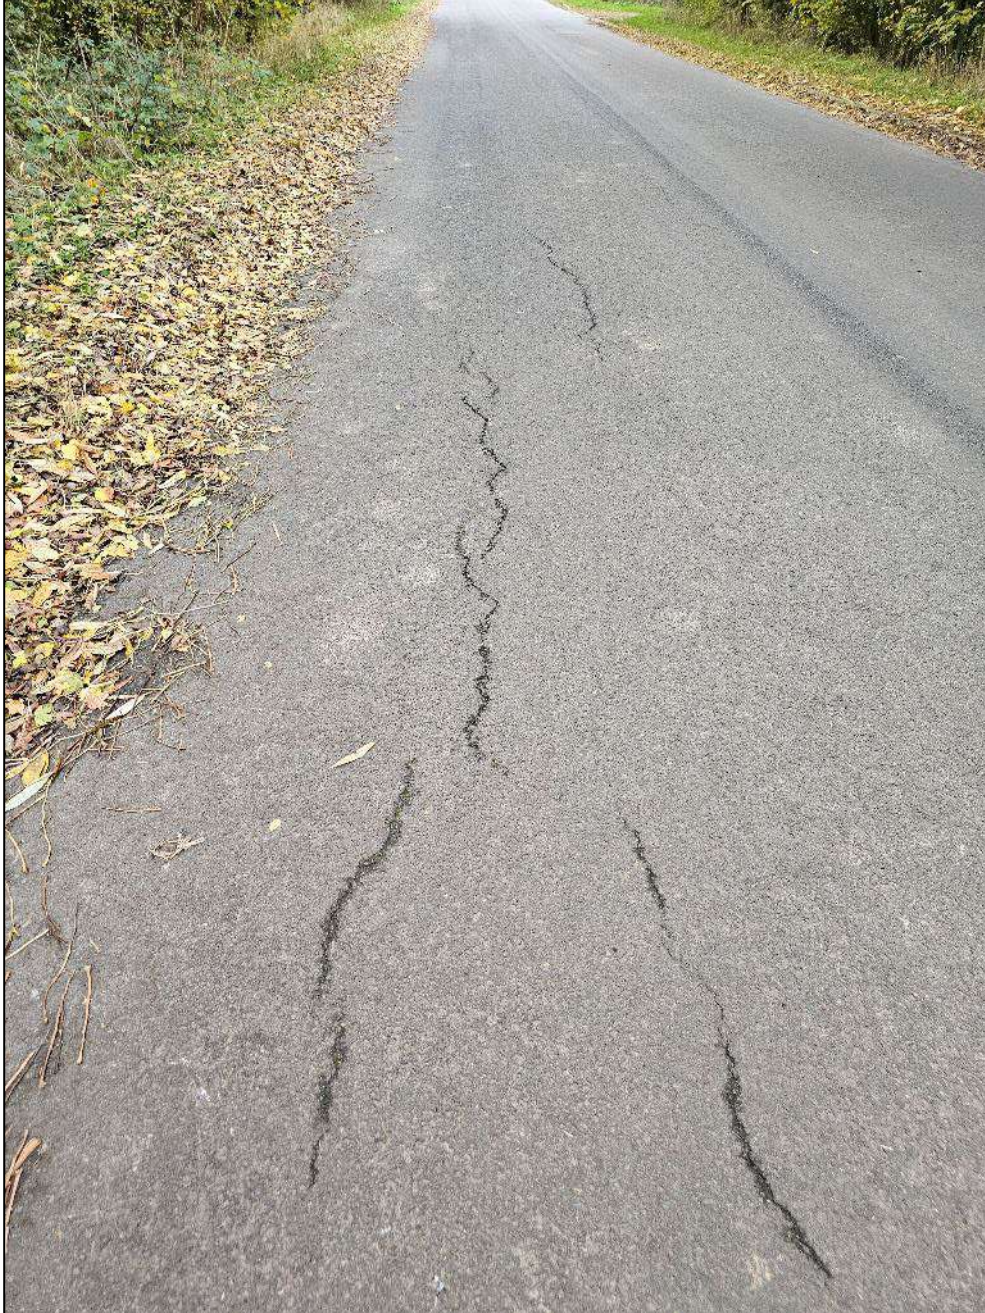
**Figure 79: Tarmac Surface Cracks Parallel to Kerblines, 65m East of the Parcel A Access**

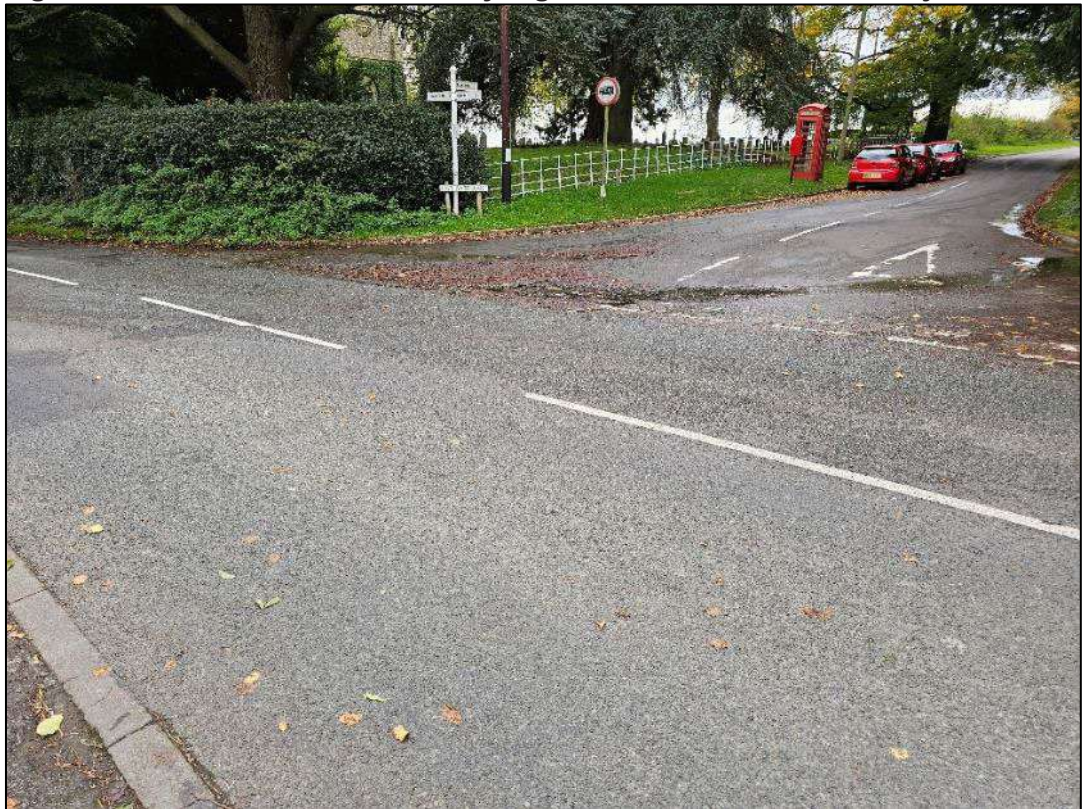
**Figure 80: Southeast View of the Lychgate Lane / Sharnford Road junction**

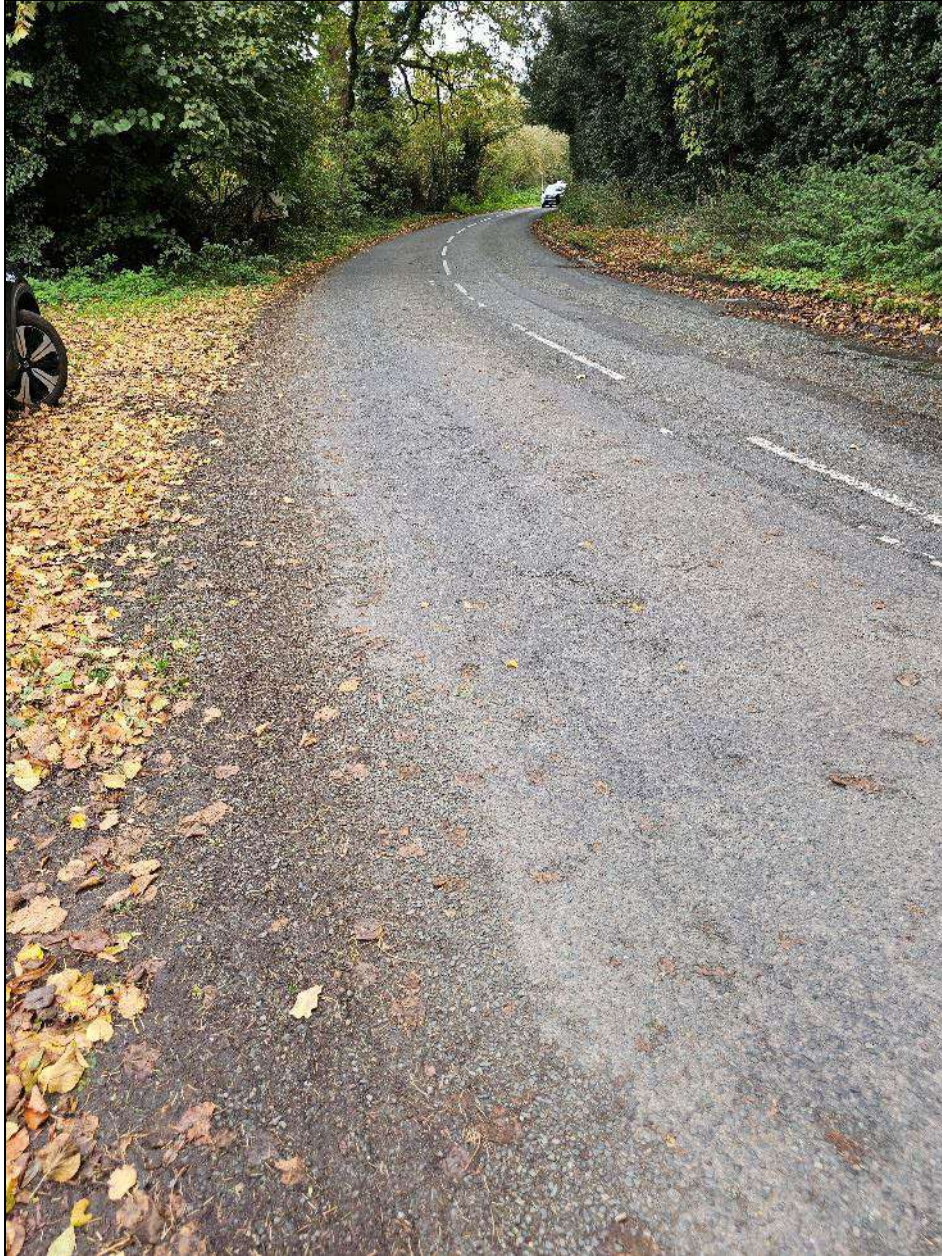
**Figure 81: General Carriageway Condition 40-50m east of the Lychgate Lane Junction**

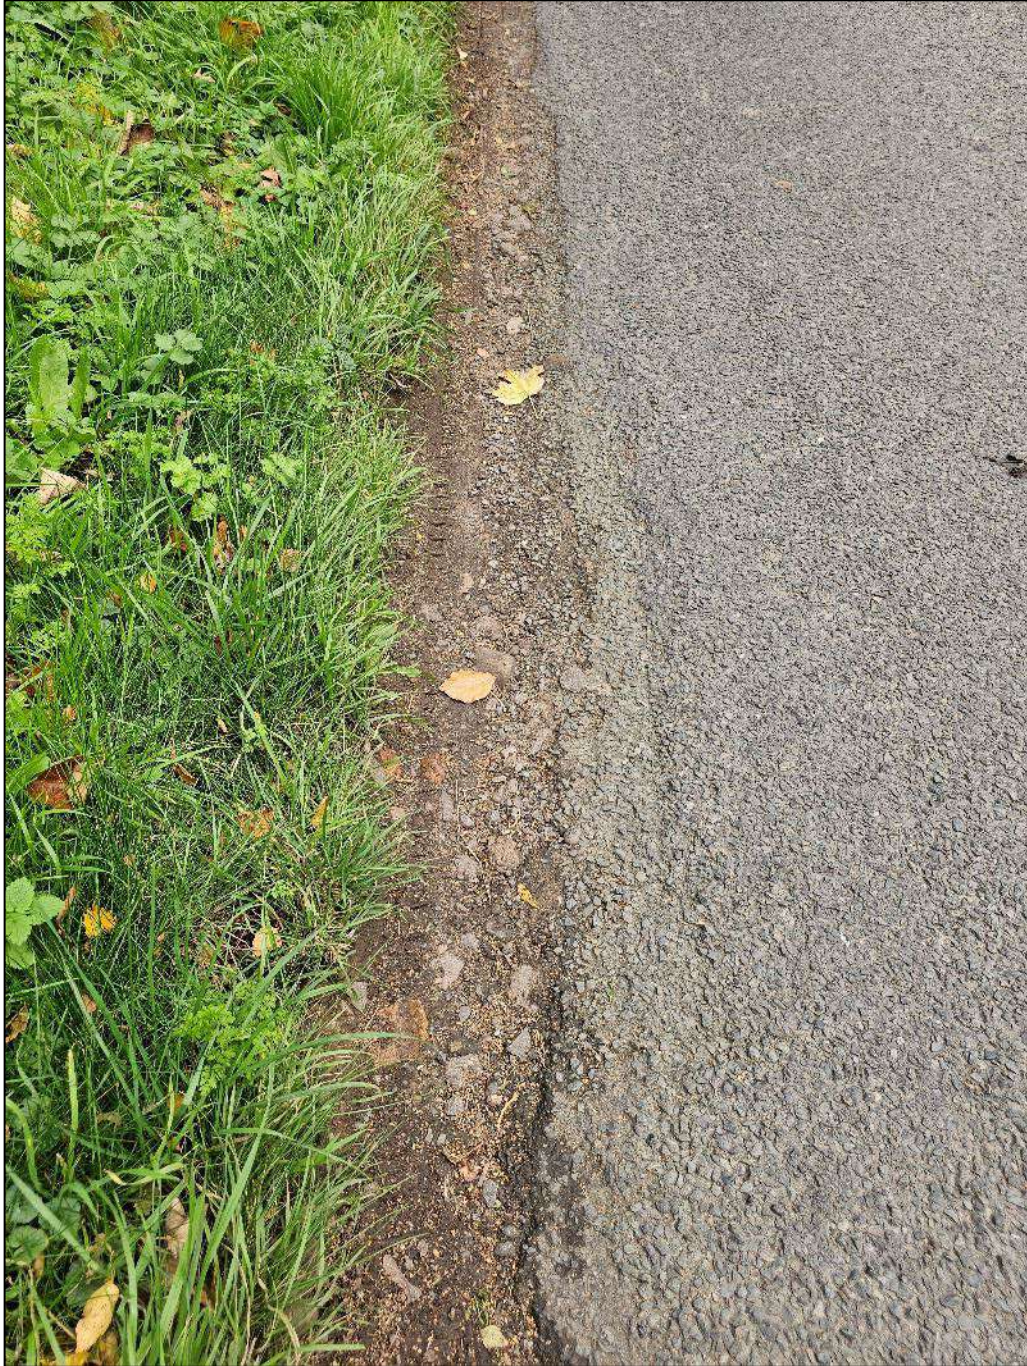
**Figure 82: Damage to Surface Level tarmac 100m East of the Lychgate Lane Junction**

- 2.24 The patterns of tarmac damage are consistent, with particular damage to the edge of carriageway, shown on **Figures 82, 83, 84, 85 and 89**.
- 2.25 There is an area of tarmac damage where it appeared an object had been burned adjacent to the carriageway within the extent of the grass verge. The damage caused to the carriageway is shown on **Figure 92**. The general carriageway condition on Aston Lane is continued on **Figures 93 to 96**.

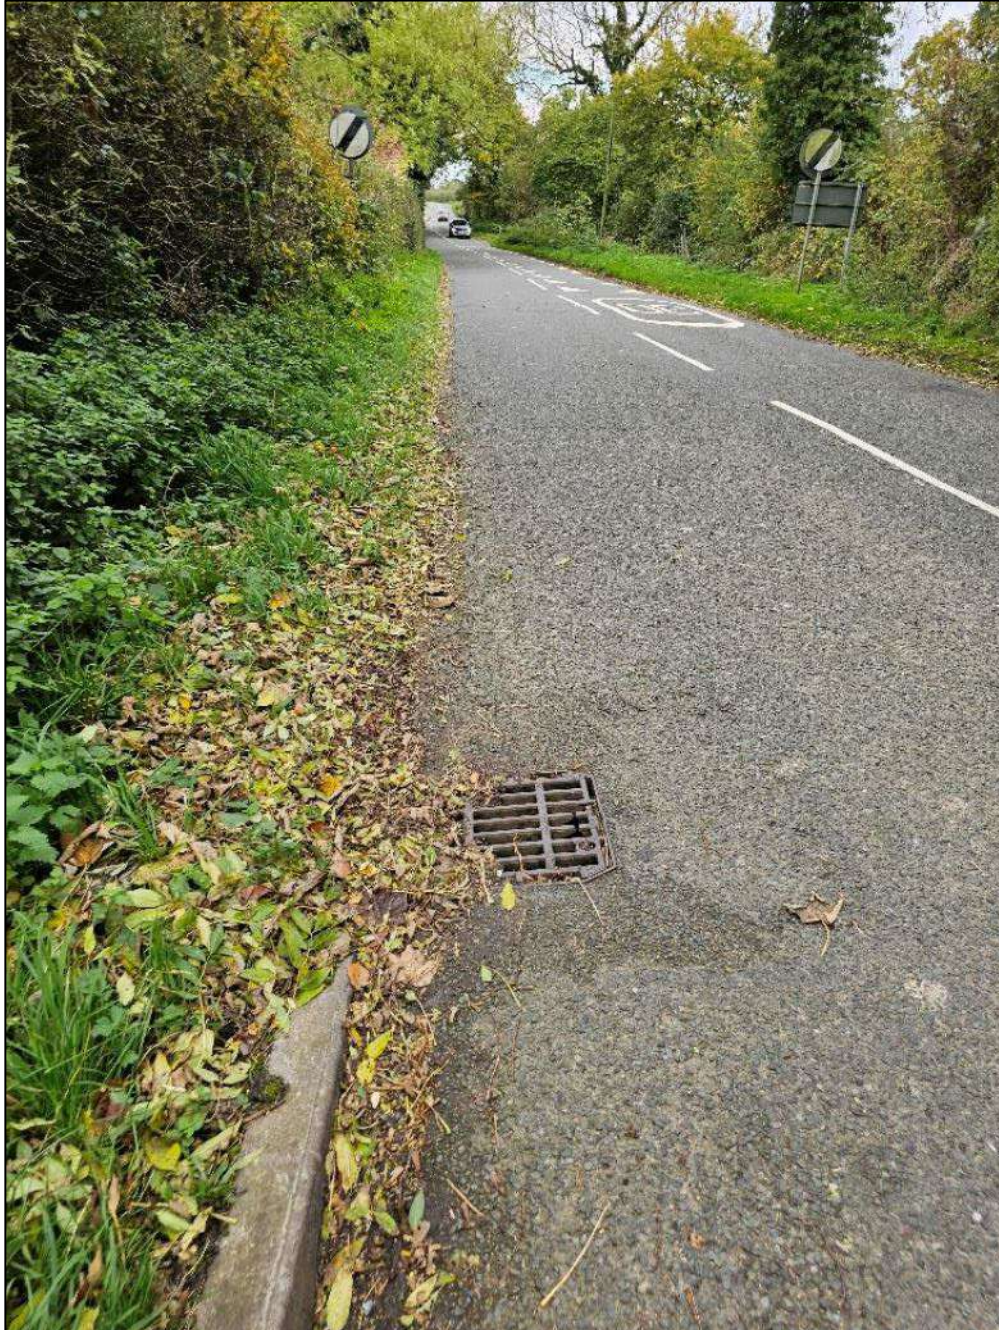
**Figure 83: General Carriageway Condition 230-240m East of the Lychgate Lane Junction**

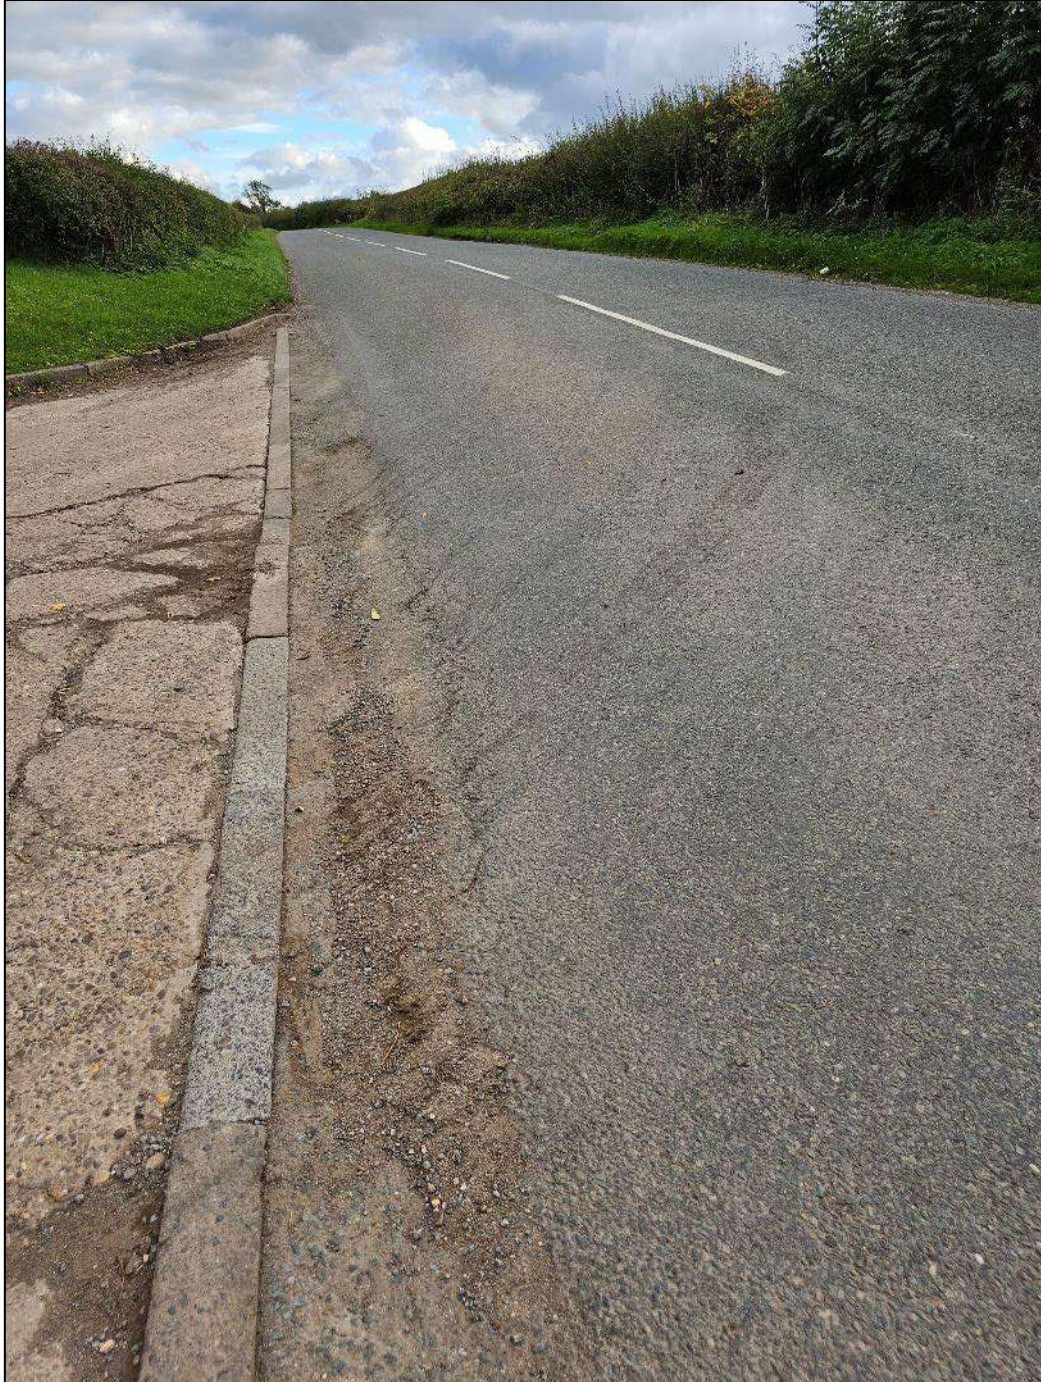
**Figure 84: General Carriageway Condition at Green Waste Recycling Access,  
400m East of Lychgate Lane Junction**

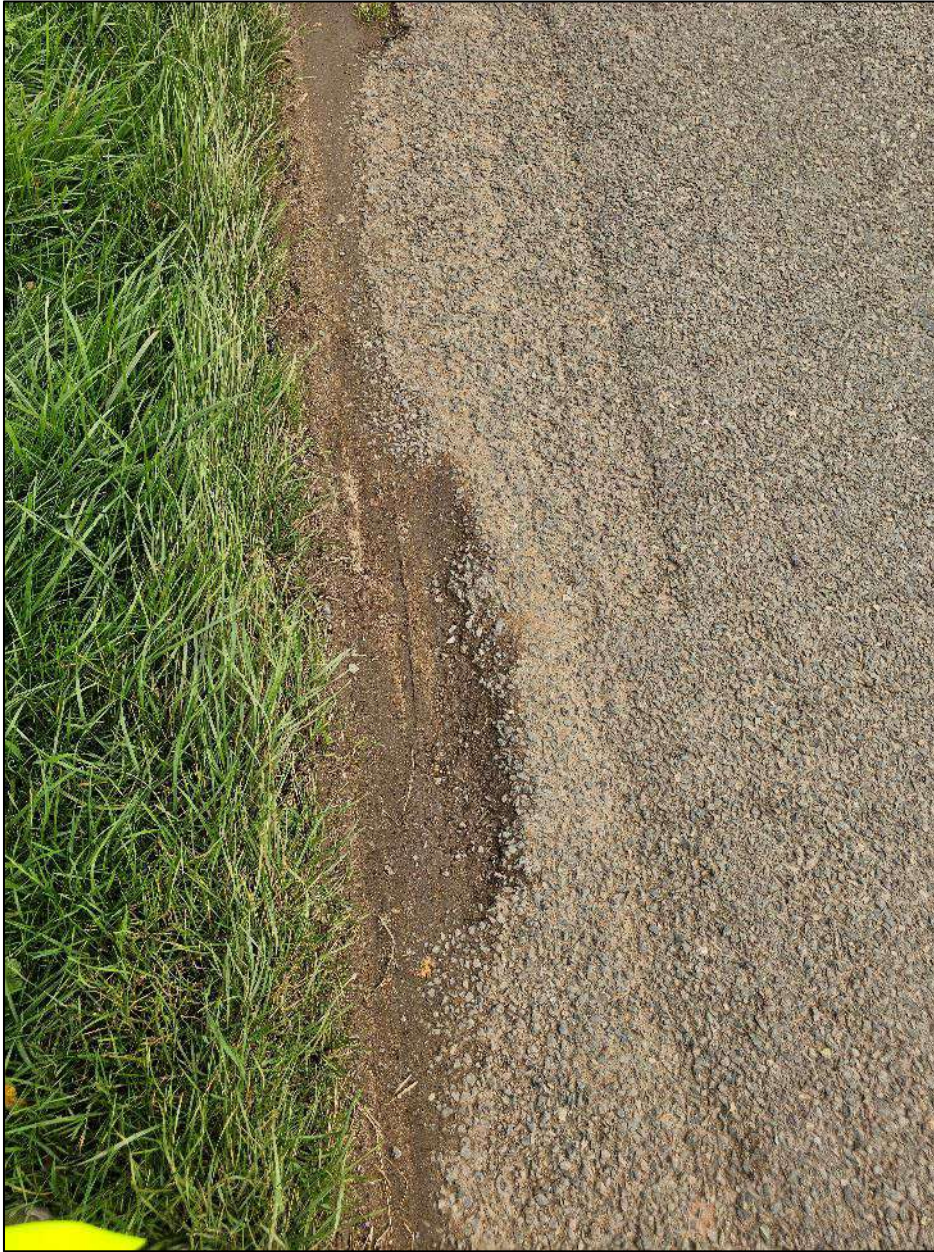
**Figure 85: Damage to Edge of Tarmac 450m East of Lychgate Lane Junction**

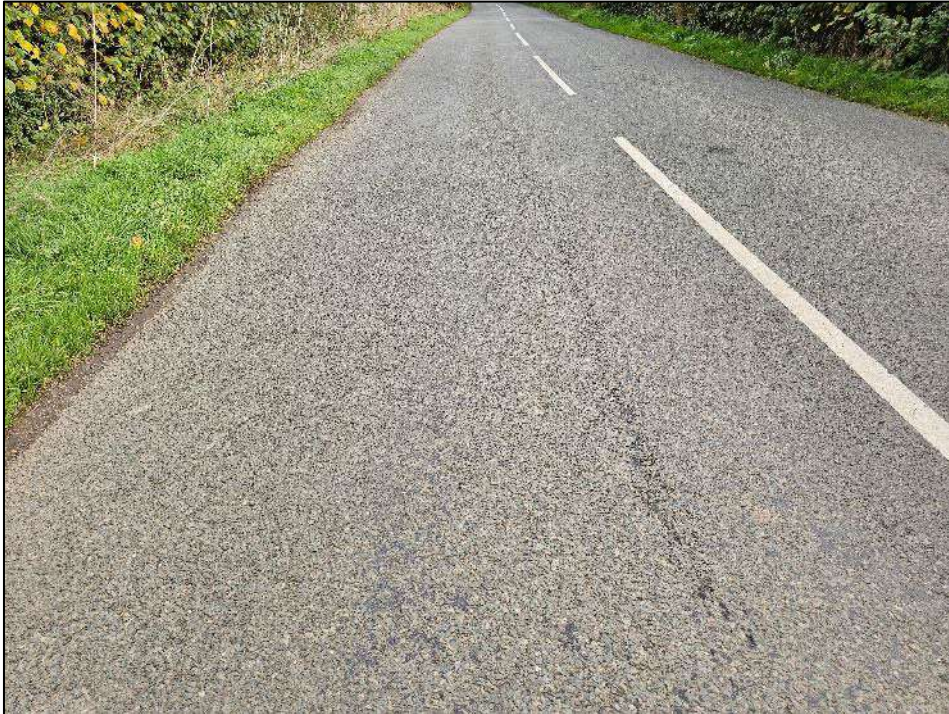
**Figure 86: General Carriageway Condition 500m East of Lychgate Lane Junction**

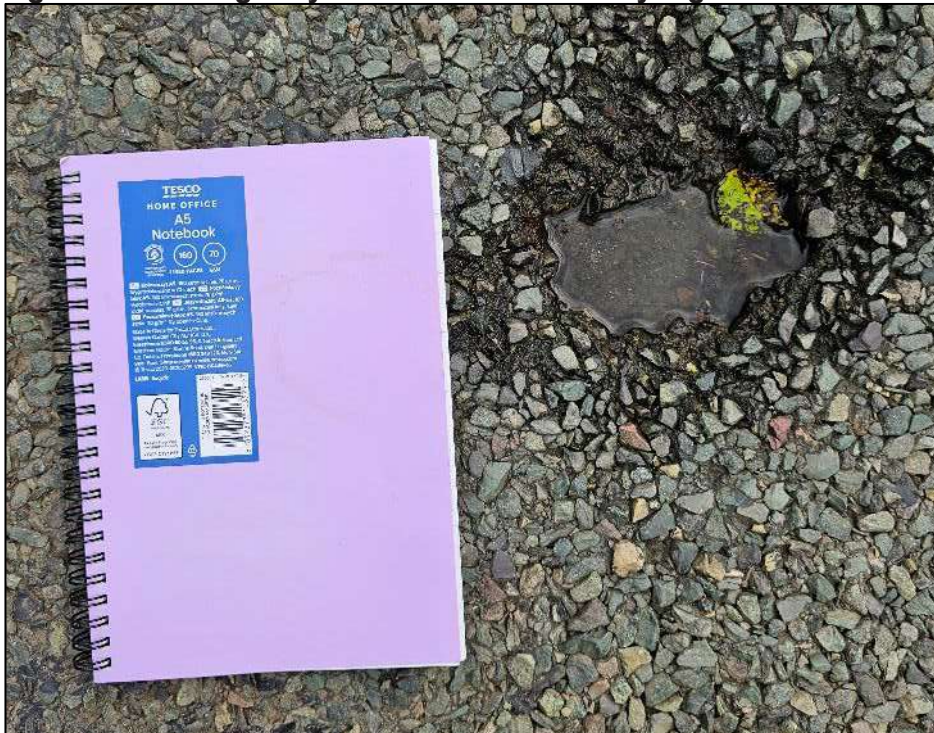
**Figure 87: Carriageway Defect 750m East of Lychgate Lane Junction**

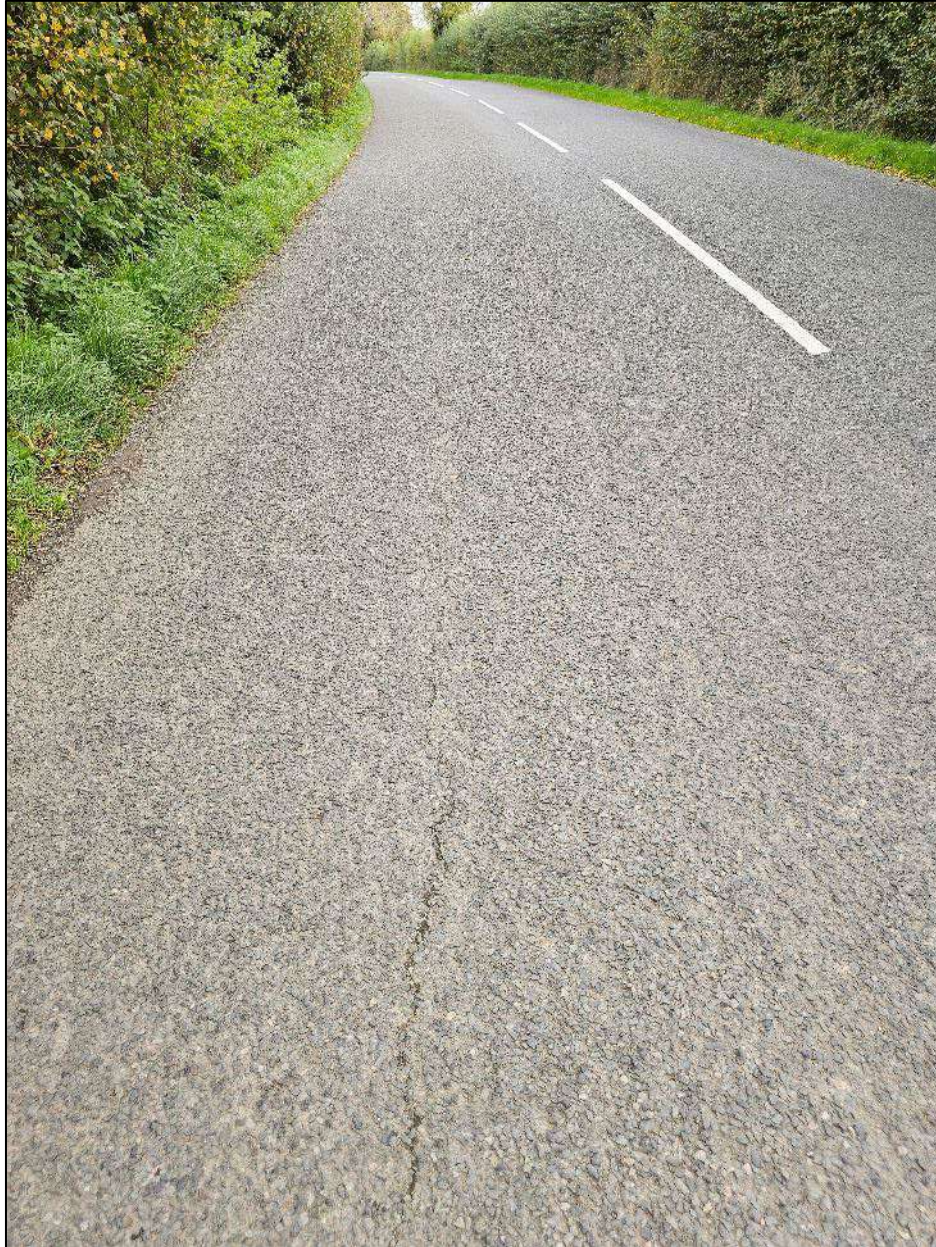
**Figure 88: General Carriageway Condition, and Tarmac Surfacing Defect 800m East of Lychgate Lane Junction**

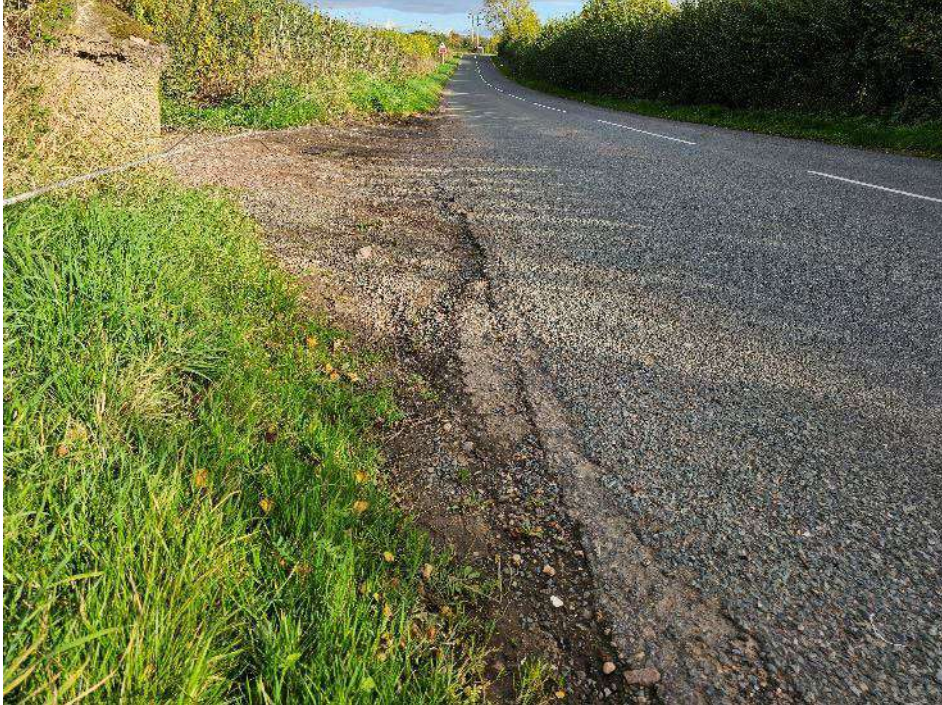
**Figure 89: Damage to Edge of Tarmac 1.4km East of Lychgate Lane Junction**

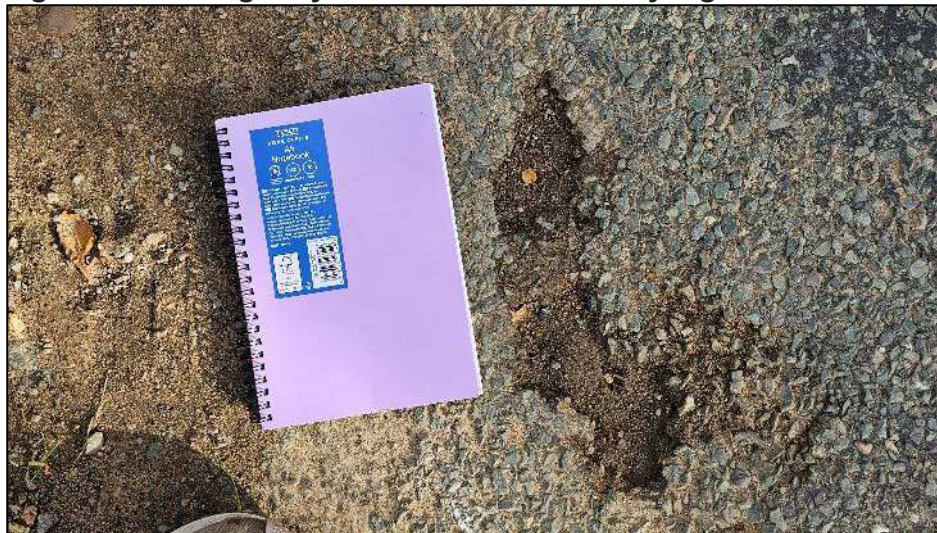
**Figure 90: Carriageway Defect 1.4km East of Lychgate Lane Junction**

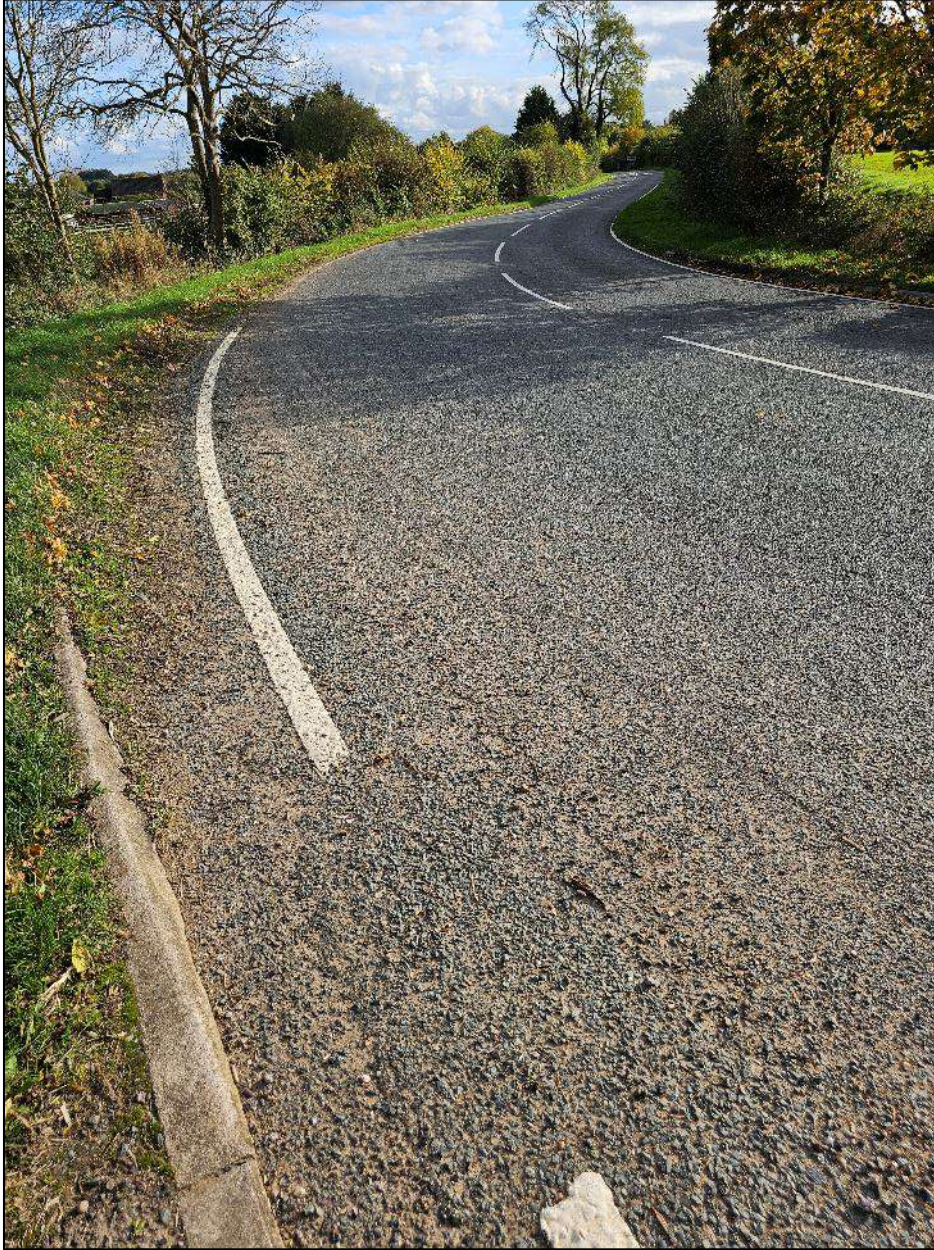
**Figure 91: General Carriageway Condition 1.6km East of Lychgate Lane Junction**

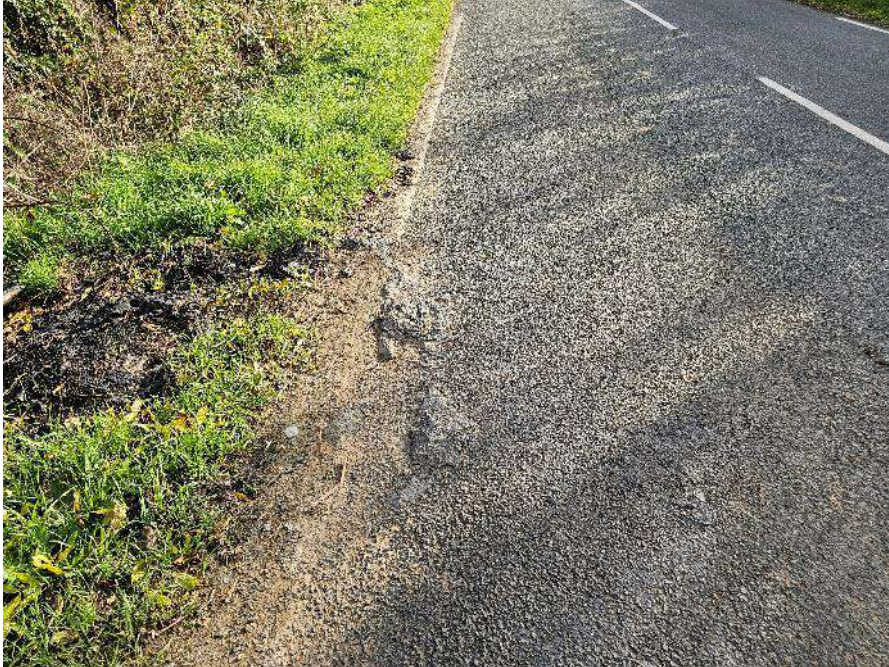
**Figure 92: Evidence of Damage on Grass Verge and Carriageway 1.65km East of Lychgate Lane Junction**

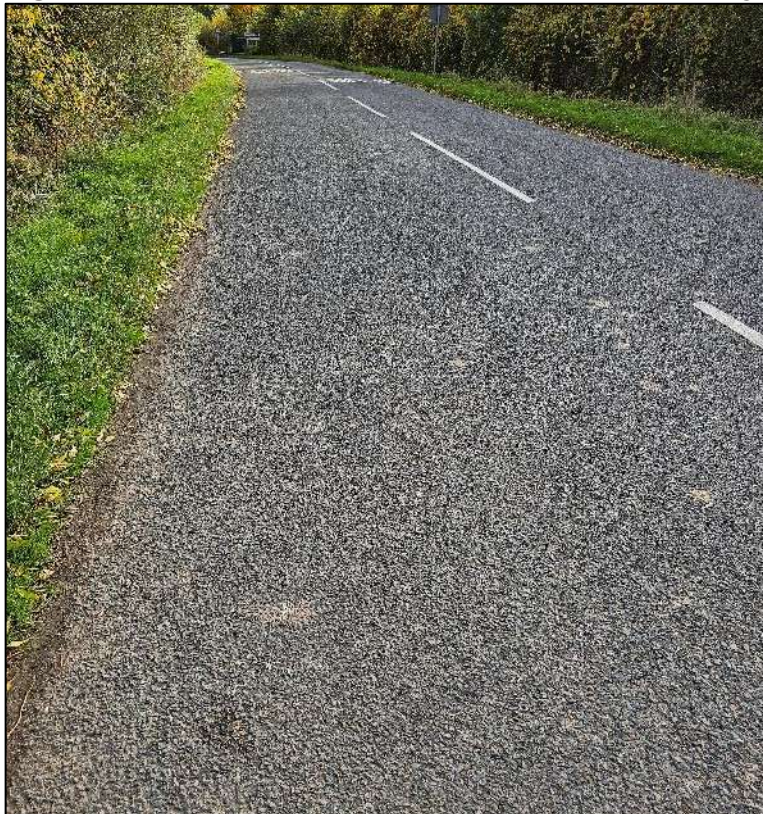
**Figure 93: General Tarmac Condition 1.7km East of Lychgate Lane Junction**

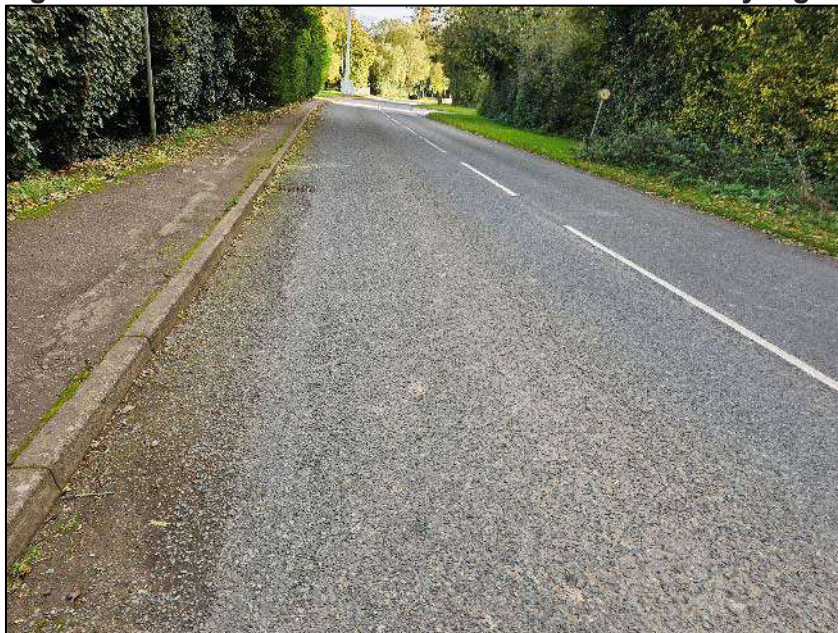
**Figure 94: General Tarmac Condition 1.8km East of Lychgate Lane Junction**

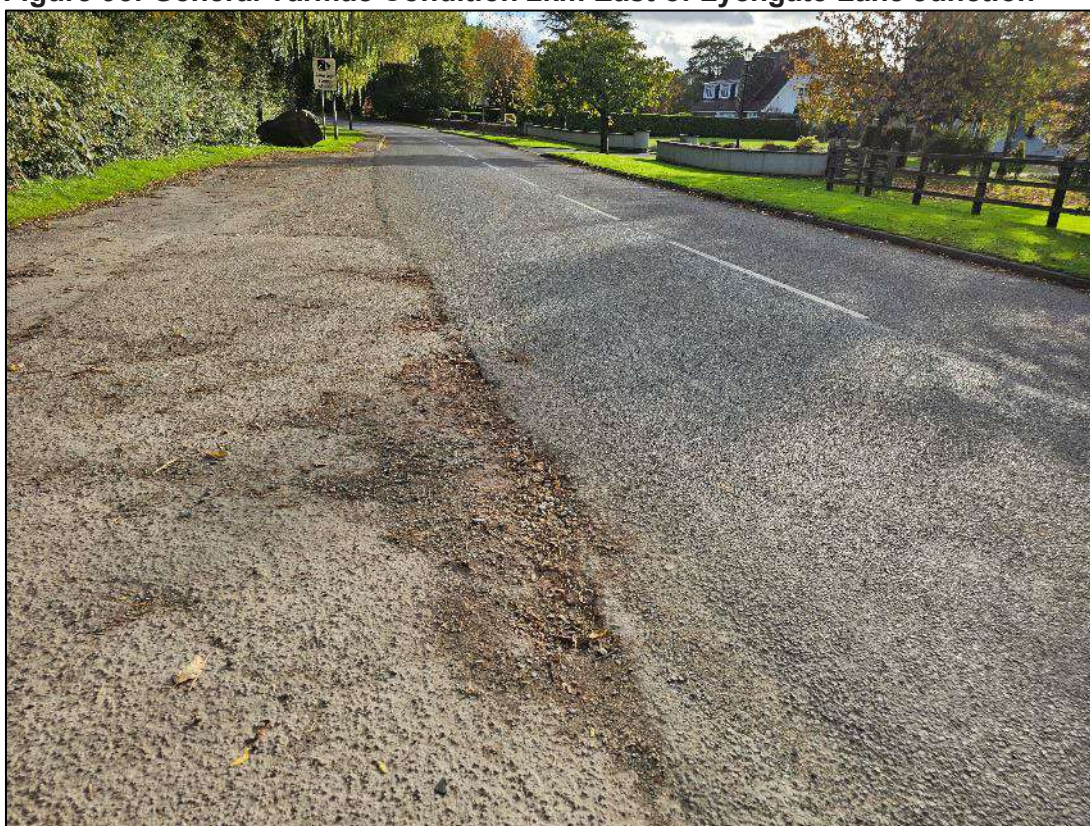
**Figure 95: General Tarmac Condition 2km East of Lychgate Lane Junction**

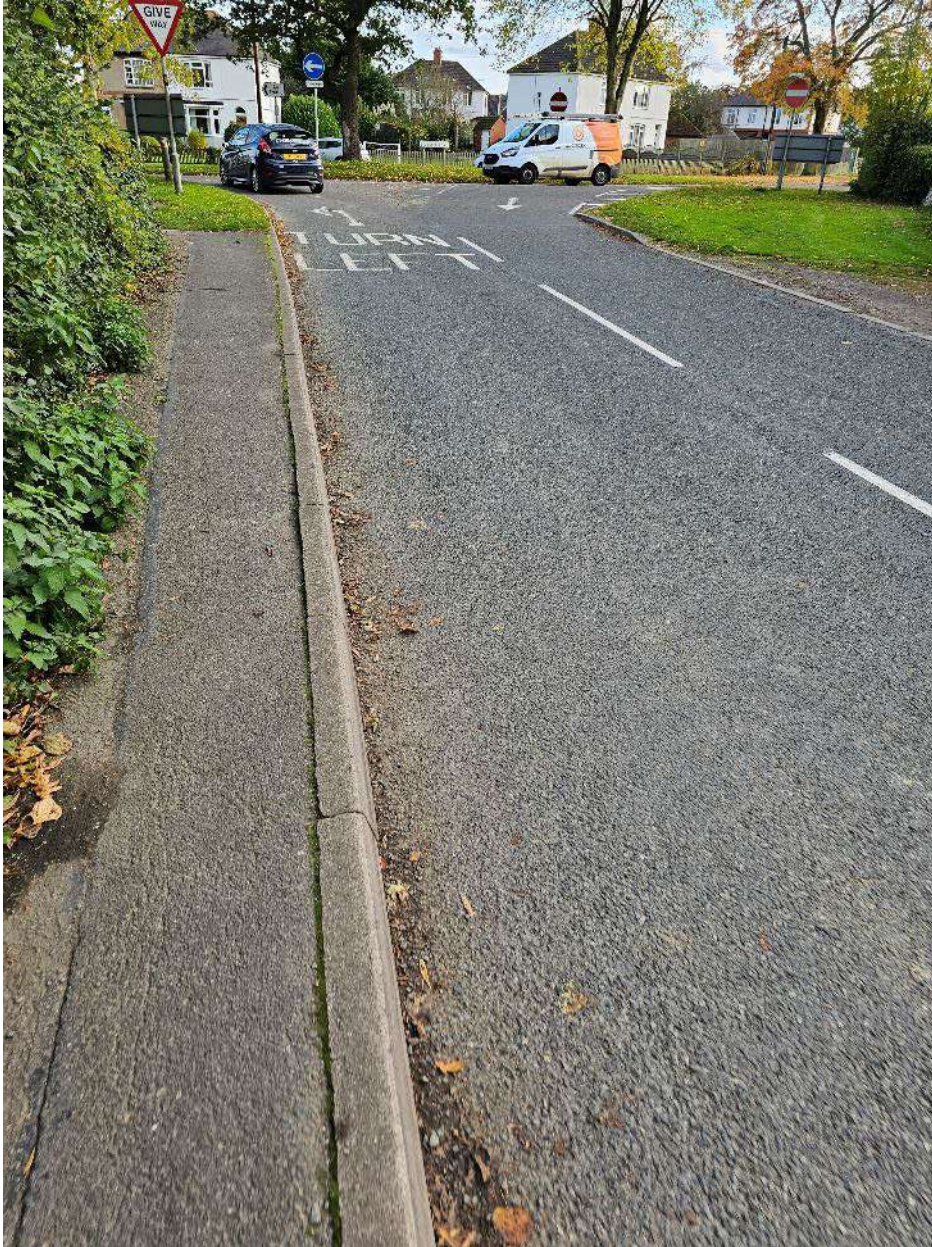
**Figure 96: General Tarmac Condition 2.1km East of Lychgate Lane Junction**
