# **Tree Condition Report Arboricultural Impact Assessment Method Statement and Tree Protection**

**Land at 2 Merrylees Road, Thornton, Coalville, LE67 1AN**

**Site Visit: 2<sup>nd</sup> February 2024**

**Report written: 6<sup>th</sup> February 2024**

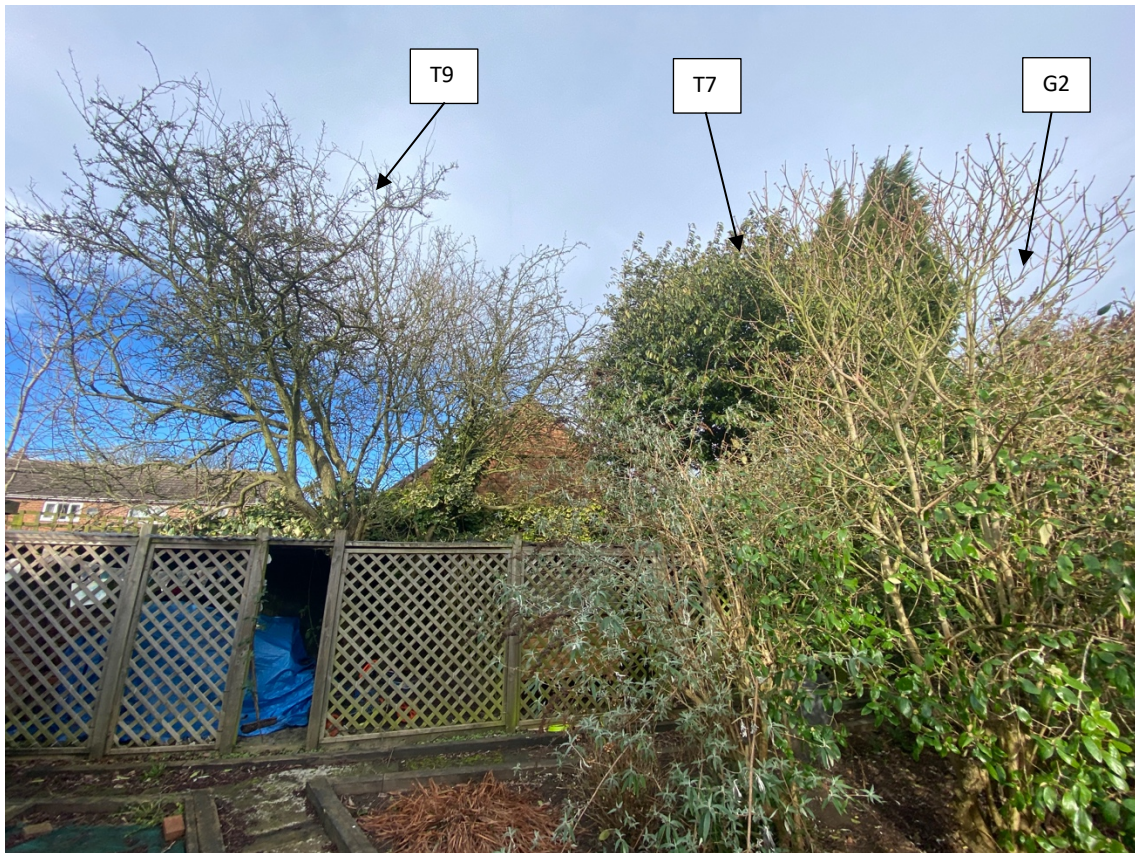
T7

| <p><b>Tree Condition:</b><br/> <b>Root:</b> no visual evidence of soil movement.<br/> <b>Stem:</b> multiple stems.<br/> <b>Crown:</b> No evidence of recent breakouts or significant dieback.<br/> <b>Tree Quality Assessment:</b> Ref.BS5837 (2012) 4.5.1 <b>Category B2:</b> 'trees present in numbers, usually growing as groups or woodlands, such that they attract a higher collective rating'.<br/> <b>Water Demand NHBC 4.2-B:</b> High<br/> <b>Root Protection Area RPA:</b> for tree of multiple diameter at 1.5m<br/> <math>\sqrt{(0.25^2 + 0.15^2 + 0.19^2)} \times 12 = 4.2\text{m Radius}</math><br/> Total RPA required at current stage of growth = 55m<sup>2</sup><br/> <b>Arboricultural Impact Assessment AIA:</b> <ul style="list-style-type: none"> <li>No alteration of soil levels or new trench excavation is permitted within RPA</li> <li>The proposed dwelling falls outside the RPA of T7</li> </ul> <b>Method Statement: construction of proposed dwelling</b> <ul style="list-style-type: none"> <li>Install section of Heras fence barrier positioned as indicated on the tree protection plan. Specification as recommended in BS5837 (2012) fig.3 appended.</li> </ul> </p> | |

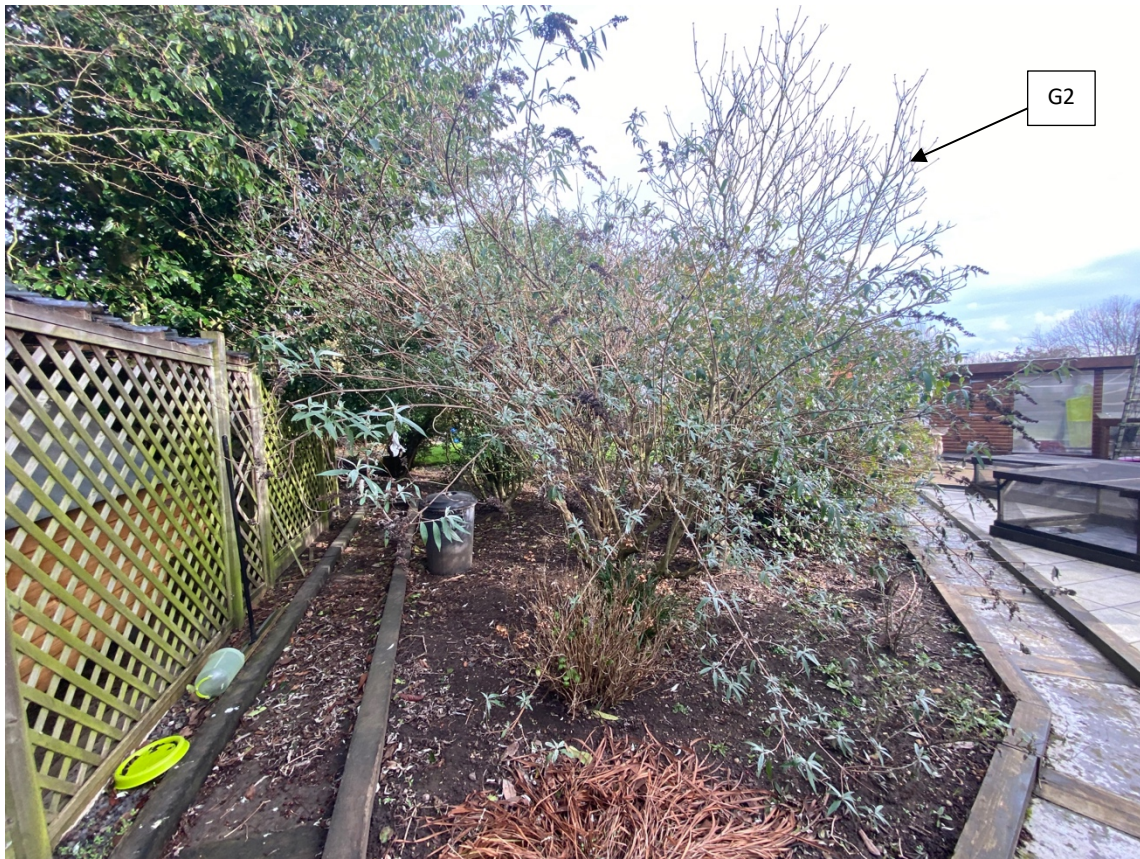
G2

| <p><b>Tree Condition:</b><br/> <b>Root:</b> no visual evidence of soil movement.<br/> <b>Stem:</b> obscured by dense foliage.<br/> <b>Crown:</b> No evidence of recent breakouts or significant dieback.<br/> <b>Tree Quality Assessment:</b> Ref.BS5837 (2012) 4.5.1 <b>Category B2:</b> 'trees present in numbers, usually growing as groups or woodlands, such that they attract a higher collective rating'.<br/> <b>Water Demand NHBC 4.2-B:</b> High<br/> <b>Root Protection Area RPA:</b> for tree of 10cm diameter at 1.5m (0.1 x 12) = <b>1.2m Radius</b><br/> Total RPA required at current stage of growth = 4.5m<sup>2</sup><br/> <b>Arboricultural Impact Assessment AIA:</b> <ul style="list-style-type: none"> <li>No alteration of soil levels or new trench excavation is permitted within RPA</li> <li>The proposed development falls outside the RPA of G2</li> </ul> <b>Method Statement: construction of proposed dwelling</b> <ul style="list-style-type: none"> <li>Group proposed for removal by the developer.</li> </ul> </p> | |
