## 8613 – Internal Photo Record

New Apartments and  
Demolition of the Laban  
Tansey Building at the  
Former Factory Works site  
Between Upper Bond St.  
/ Druid St. Hinckley

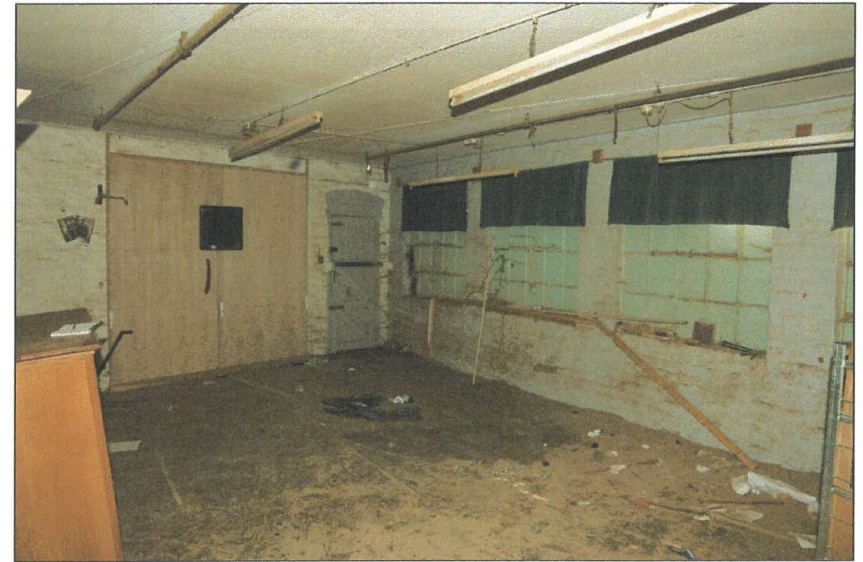
Main building, ground floor.  
Front windows and north wall. Looking north-east.

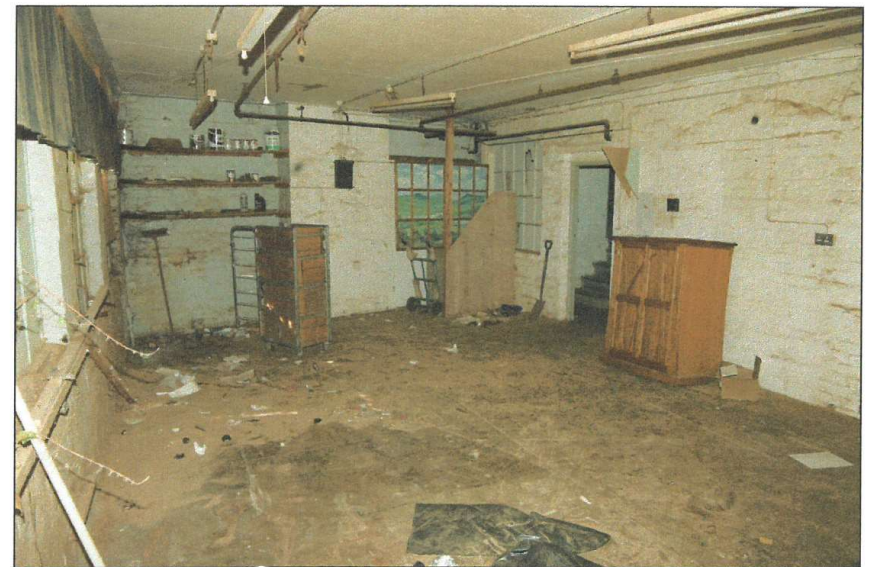
Main building, ground floor.  
Blocked windows on rear wall and inserted doorway. Looking south-west.

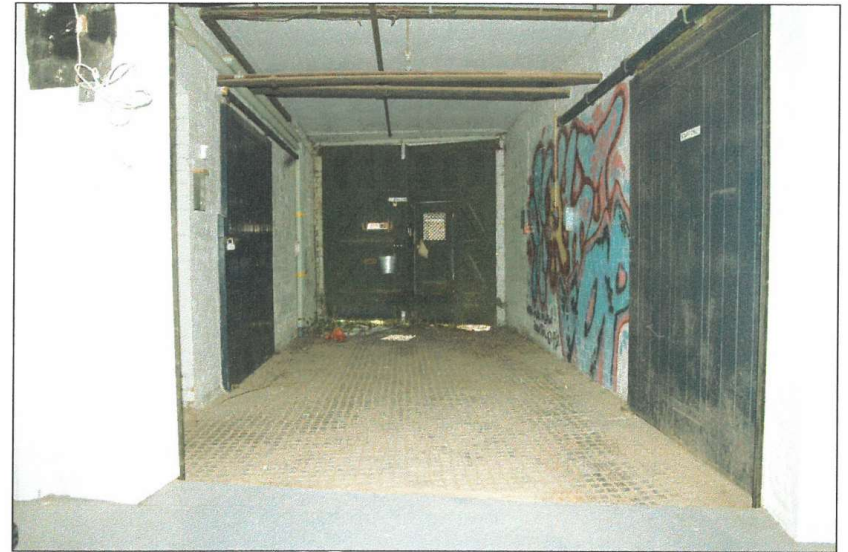
Inside of goods entrance.  
Looking east.

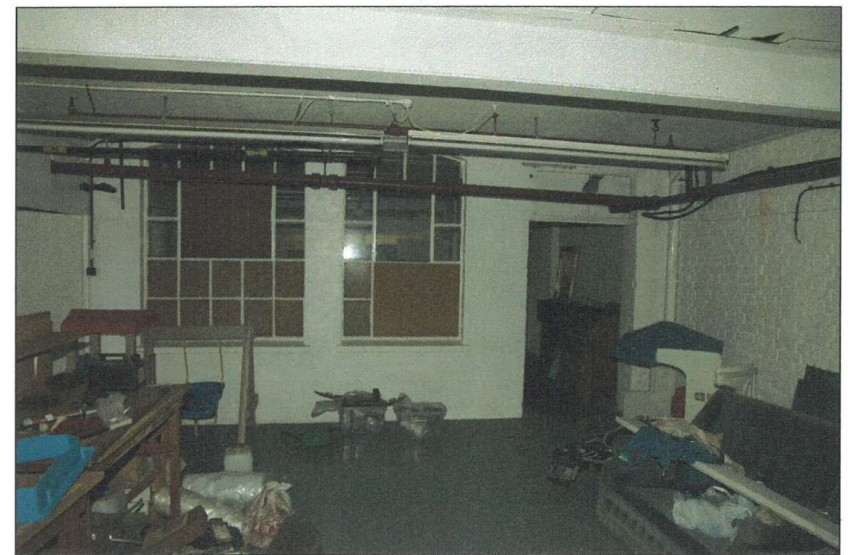
Gable-ended building, ground floor. Original back wall and windows.  
Looking east.

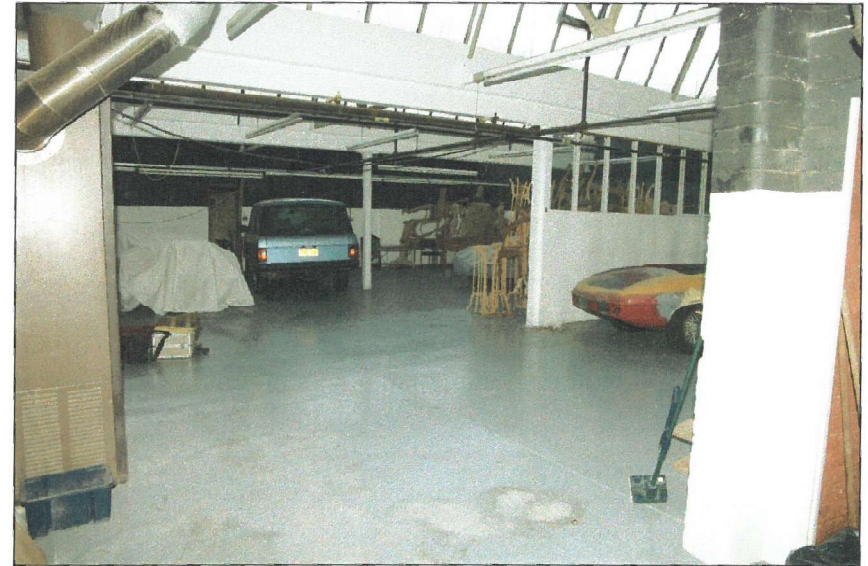
Rear workshop. Viewed from goods entrance.  
Looking north-east.

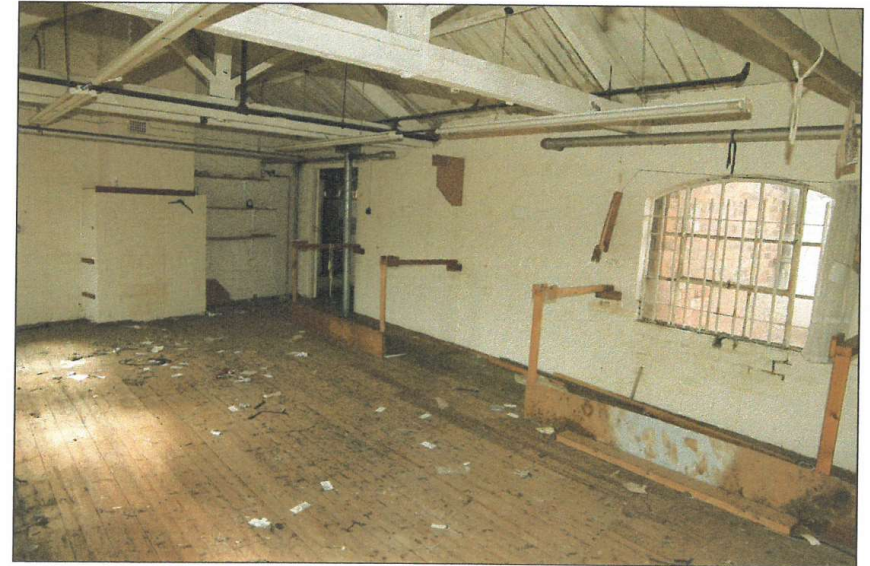
Main building, first floor.  
Blocked windows on rear wall and inserted doorway. Looking south-west.

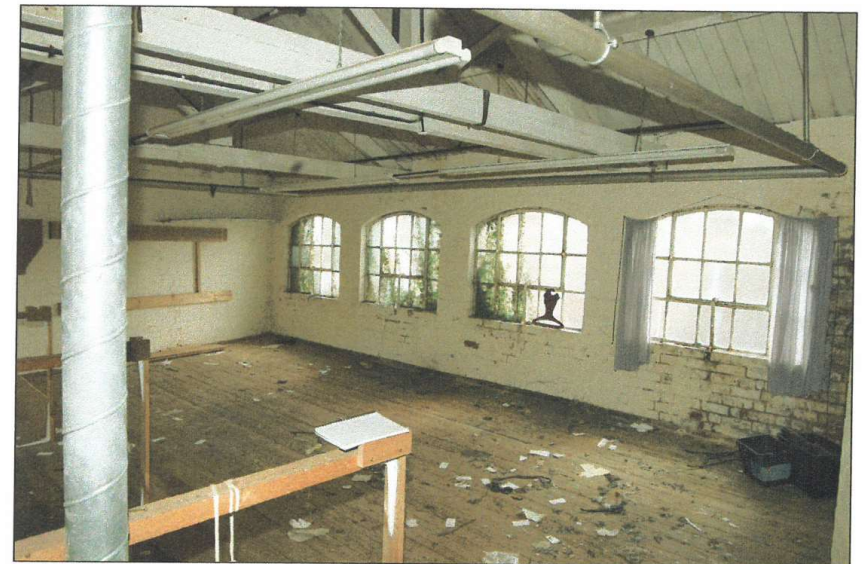
Main building, first floor.  
Front windows. Looking north-east.

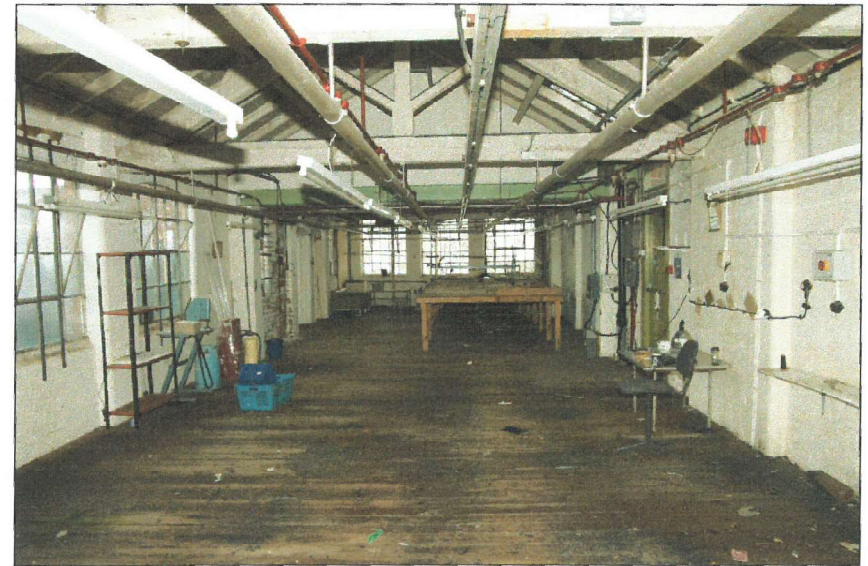
Gable-ended building, first floor. Front windows.  
Looking east.

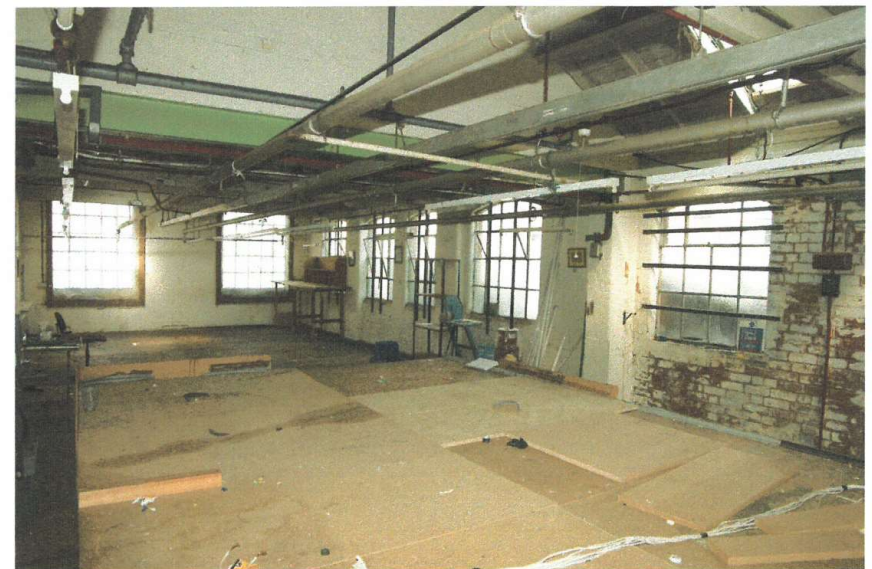
Gable-ended building, first floor. Blocked remnant of rear Venetian  
windows in gable.  
Looking north-east.
