## *Structural Inspection*

*Upper Pullins Farm  
Stoke Lane  
Higham on the Hill  
Nuneaton  
CV13 6FG*

Project No: *23-20609*

Document No: *0-030*

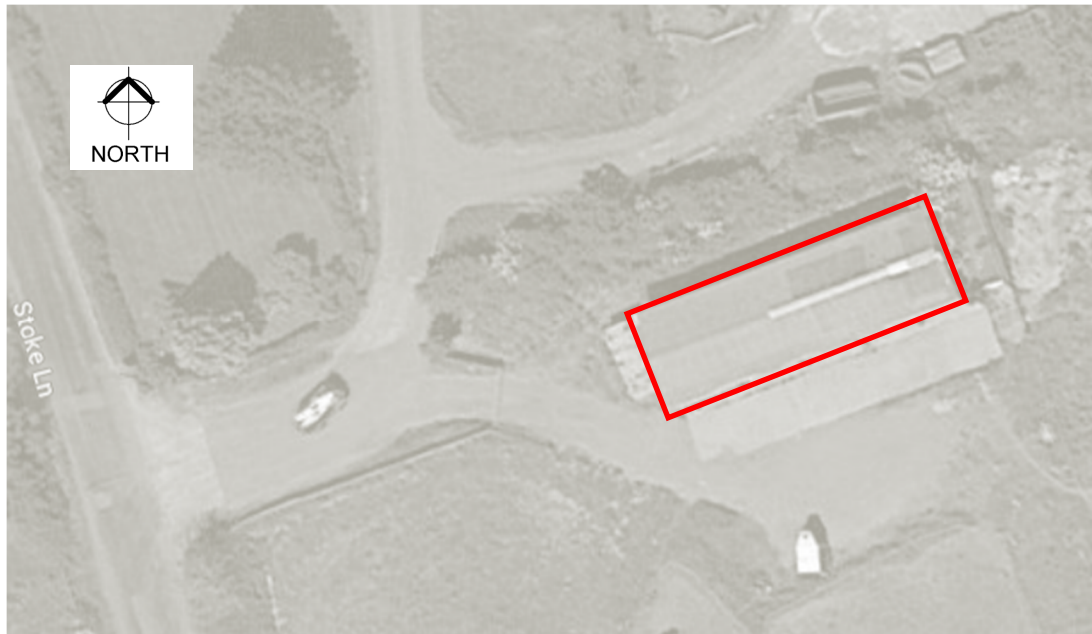
Figure 1

- 2.1 The agricultural building lies to the east of Stoke Lane and is oriented on an approximately east-west axis [Figure 1]:
