# **Structural Survey Report for Four Barn Conversions at Carlton House Farm, Carlton, Nuneaton, Warks CV13 OBX**

Reference: 83024-01

**1. INTRODUCTION**

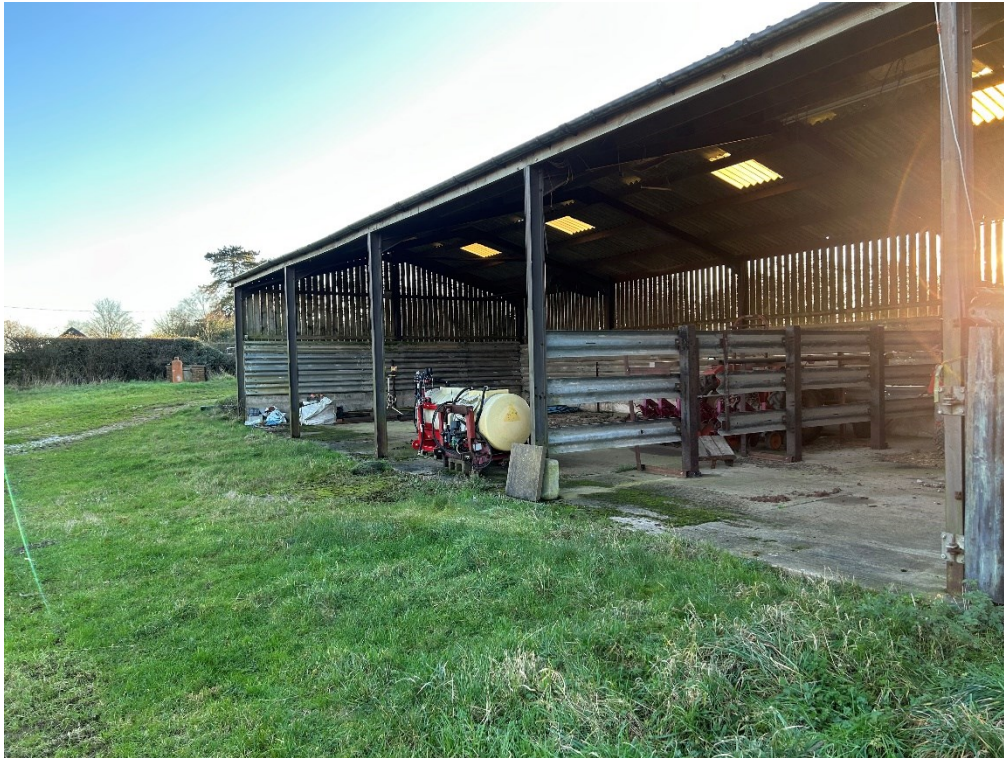
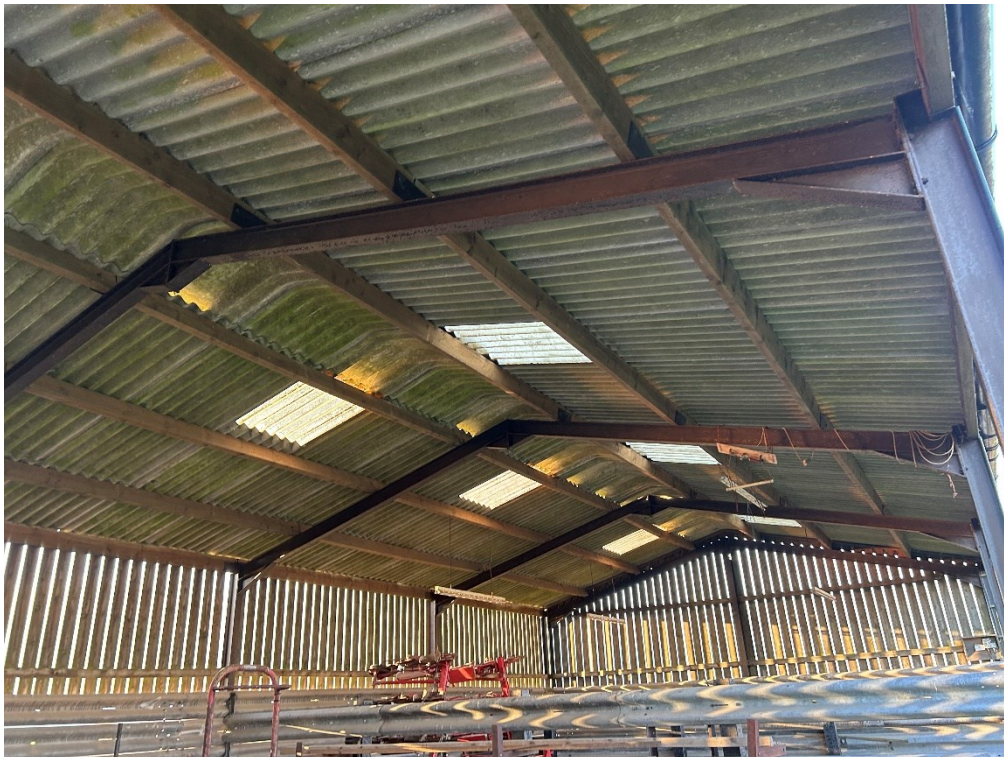
Photograph 1

2.1.3 The barn was open to the front with the walls clad in horizontally spanning corrugated metal crash barrier type sections up to 2m or so in height with hit and miss timber boarding above that level (photographs 1 and 2).

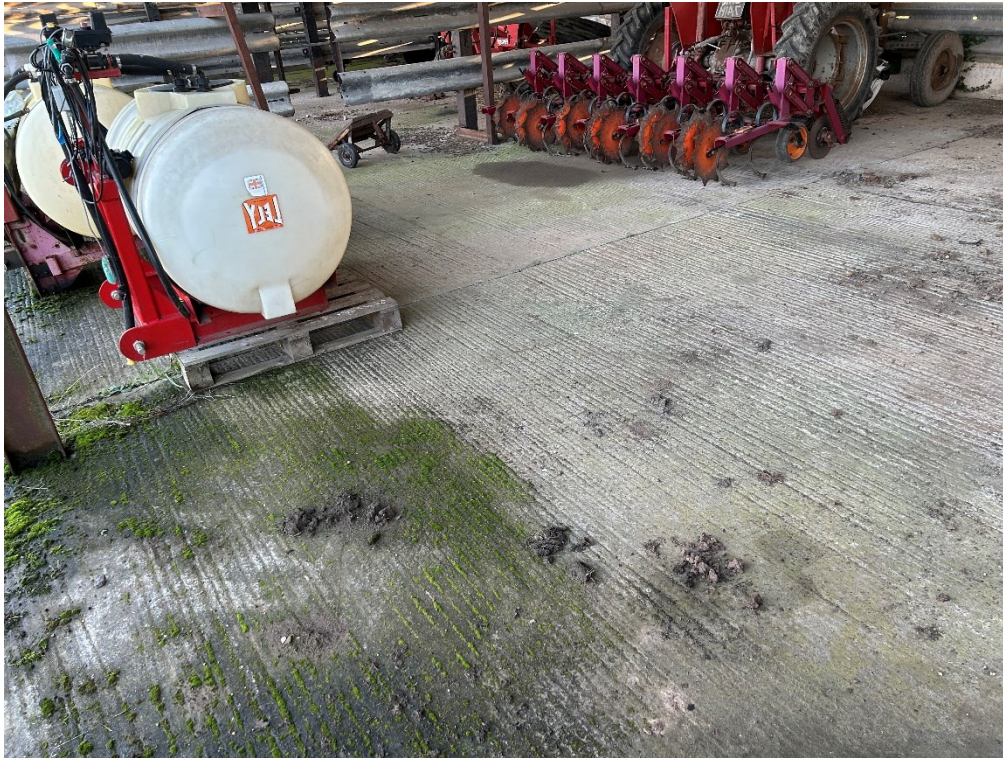
Photograph 3

2.1.4 There was a ground bearing concrete slab present throughout the building which appeared to be in serviceable condition and had been used to support heavy farm machinery such as a tractor (photograph 3).

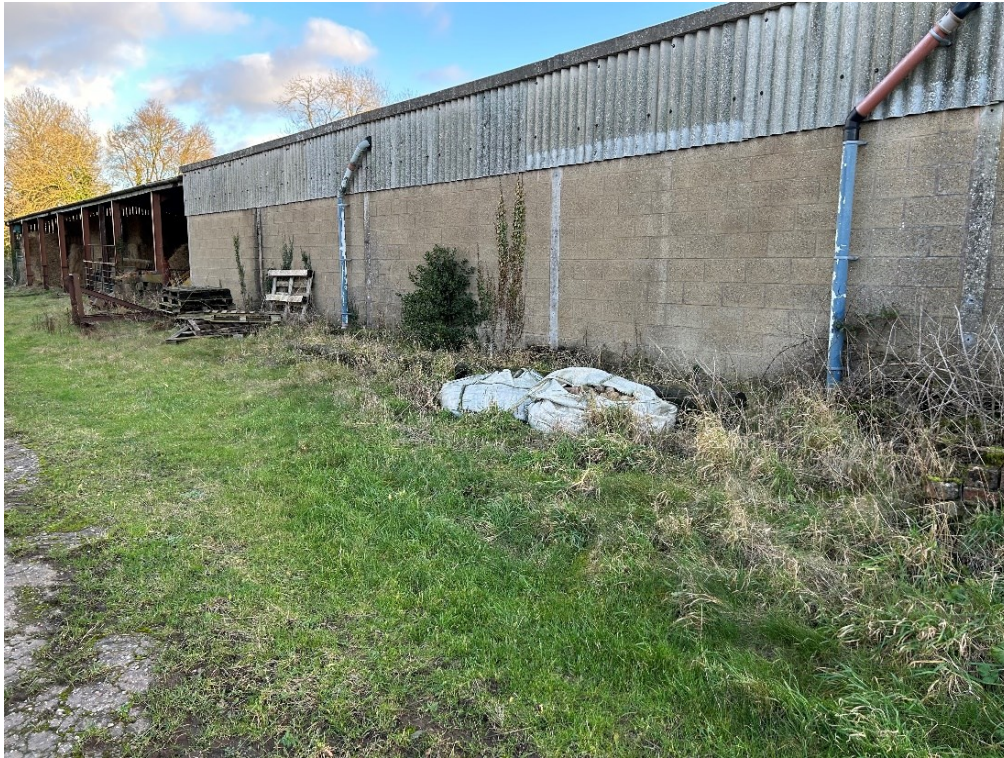
Photograph 5

2.2.1 Barn 2 was in two parts; both parts were single storey. The left hand part was clad on all four sides, whereas the right hand portion had an open side to the rear (photograph 5).

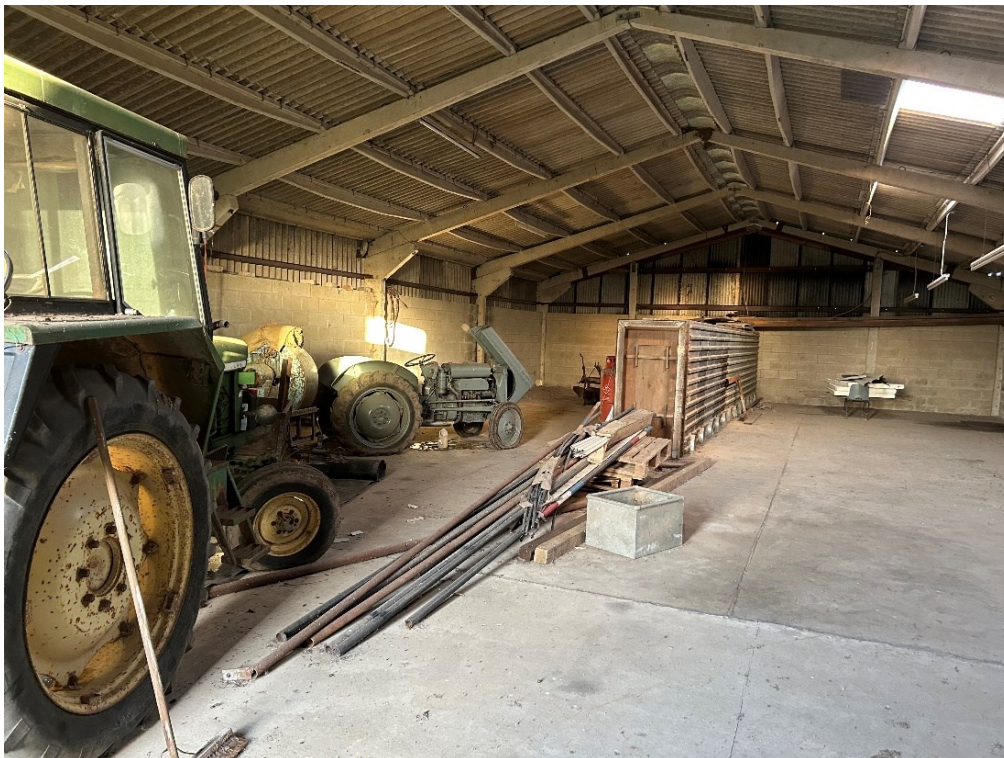
Photograph 6

2.2.2 The enclosed section was a single storey concrete portal frame with the roof supported on variable depth concrete purlins (photograph 6).

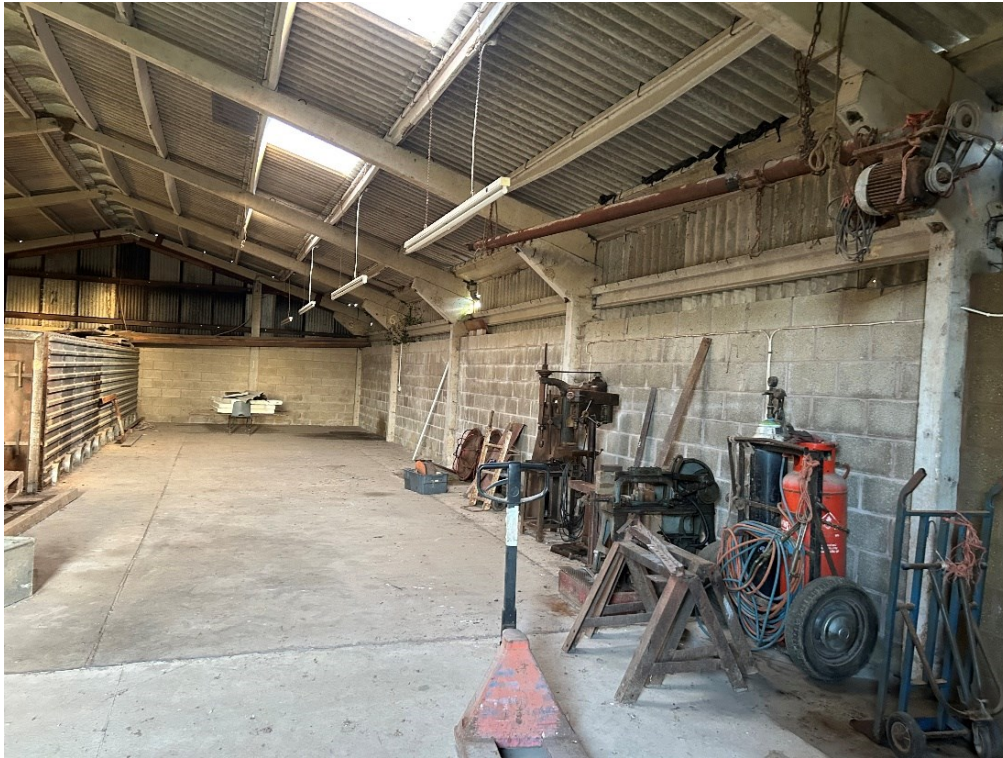
Photograph 7

2.2.3 The enclosed section had a fibre cement roof covering. The walls were clad in blockwork up to a height of 2.5m or so. Above this level, fibre cement sheets formed the wall cladding (photograph 7).

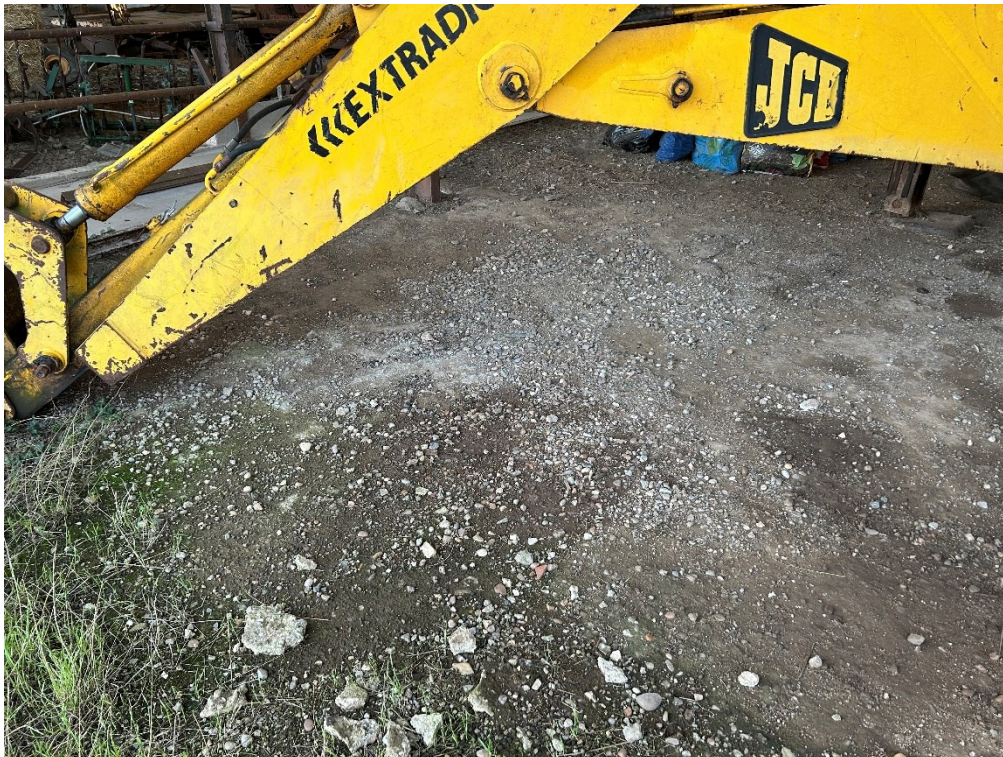
Photograph 8

2.2.6 The floor to the section was a hard gravel surface with the wall cladding being similar to barn 1 (photograph 8).

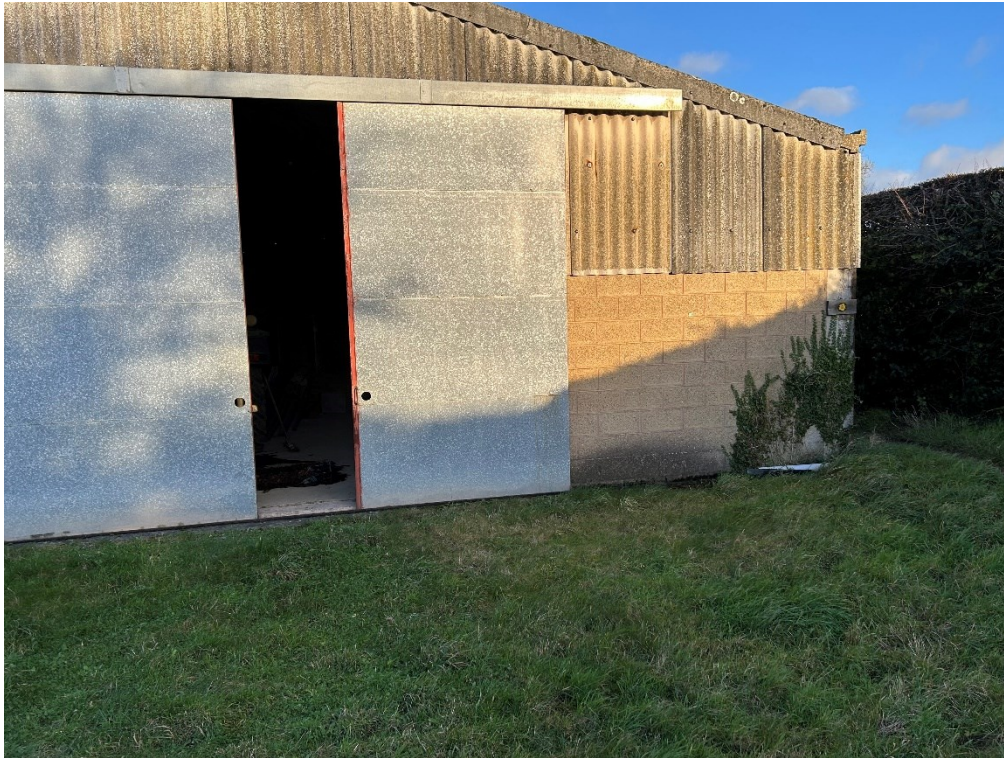
Photograph 9

2.2.7 There was a sliding access door in the left hand end wall (photograph 9).

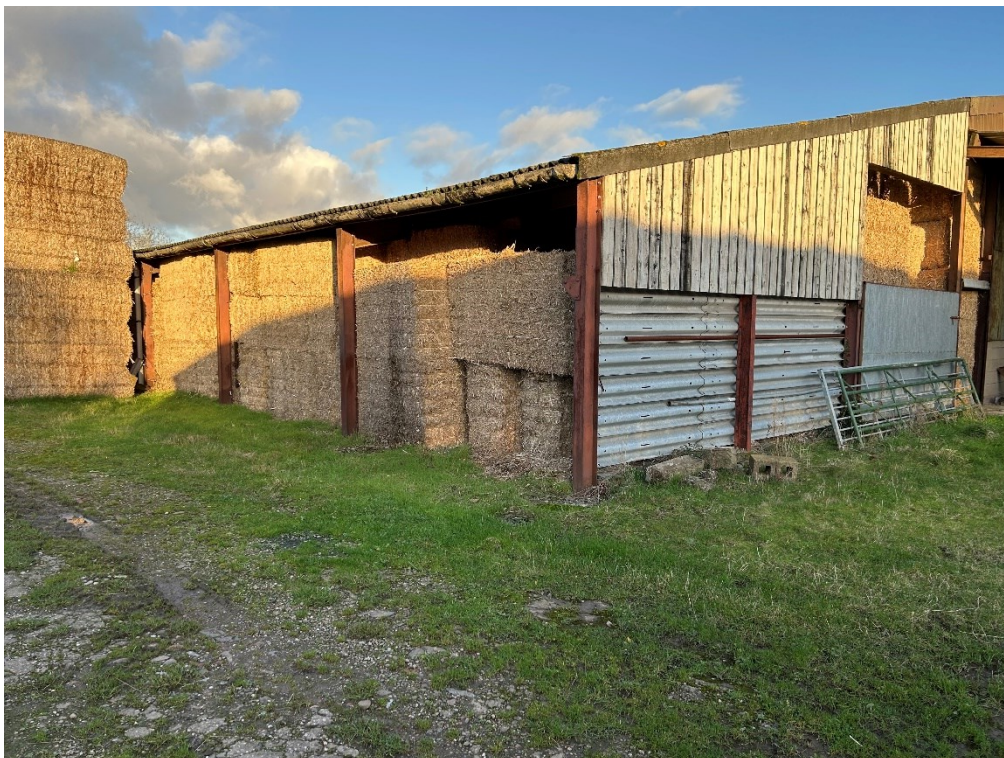
Photograph 10

2.3.1 This barn was a single storey detached steel portal framed building. The roof was clad with fibre cement profiled sheeting supported by timber purlins spanning between the steel rafters forming the portal frame. The fibre cement sheeting may contain asbestos (photograph 10).

- 4.6 A demolition and refurbishment survey should be carried out on all the buildings by a qualified asbestos surveyors (such as PRP).

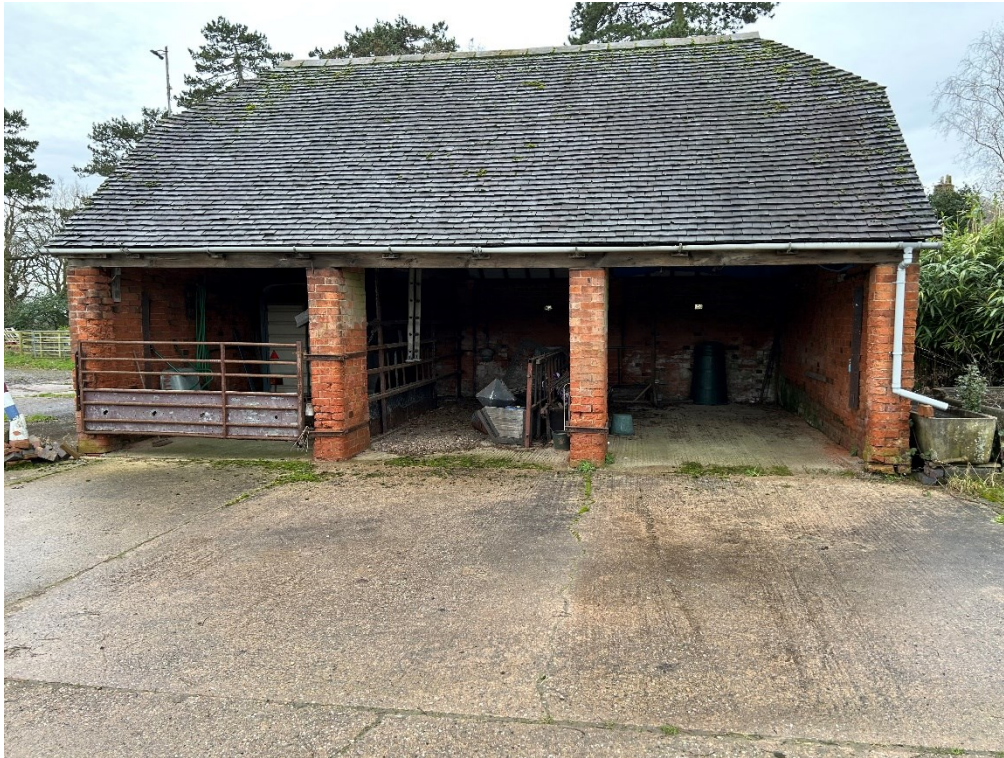
Photograph 11

2.4.1 Barn 4 was a single storey brick built structure with a slate roof (photograph 11). There were small hipped sections to the roof at the gable ends.

- 3.4.6 The brickwork walls and particularly the substantial piers at the front, were suffering from mortar joint erosion in localised areas.

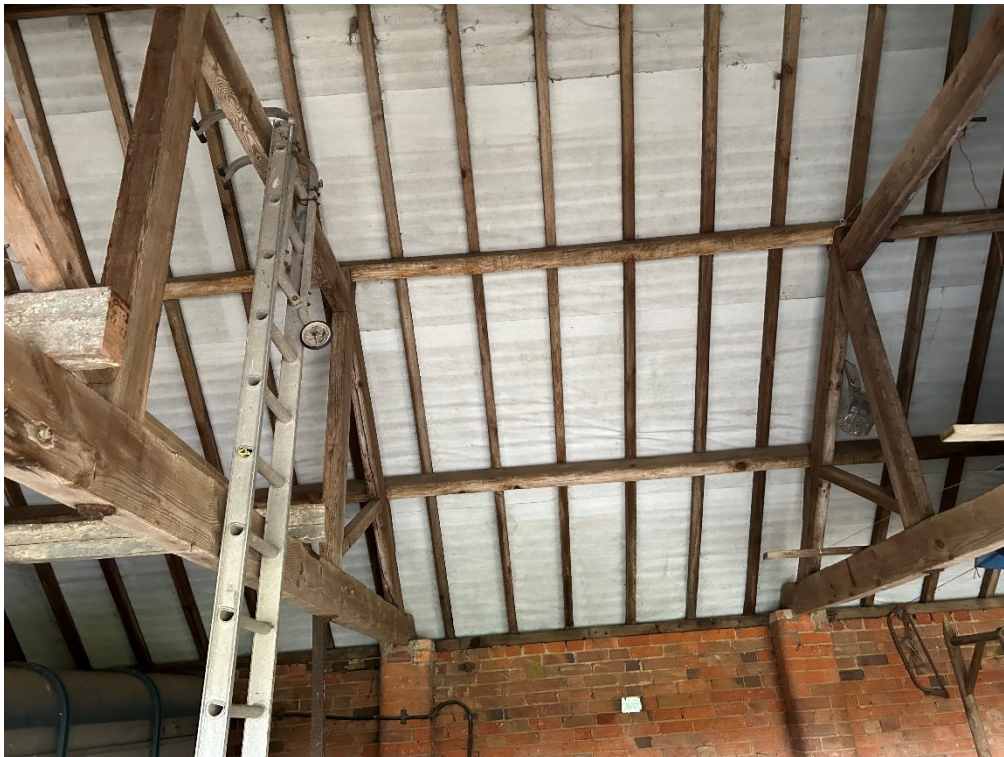
Photograph 12

2.4.2 The slated roof was supported on timber rafters and purlins and thence timber trusses (photograph 12).

- 3.4.2 Conversion to a residential property will require thermal upgrades to the wall and roof. This will probably mean additional deadloads will be applied to the rafters, purlins and trusses. That being the case these members will need to be assessed for additional loading from these materials.
