## Tree Survey & Report

7 Main Street, Peckleton, Leicestershire

Issue Date: July 2023

Ref: TS&Rpt\_7MainSt\_Peckleton\_Leic/01

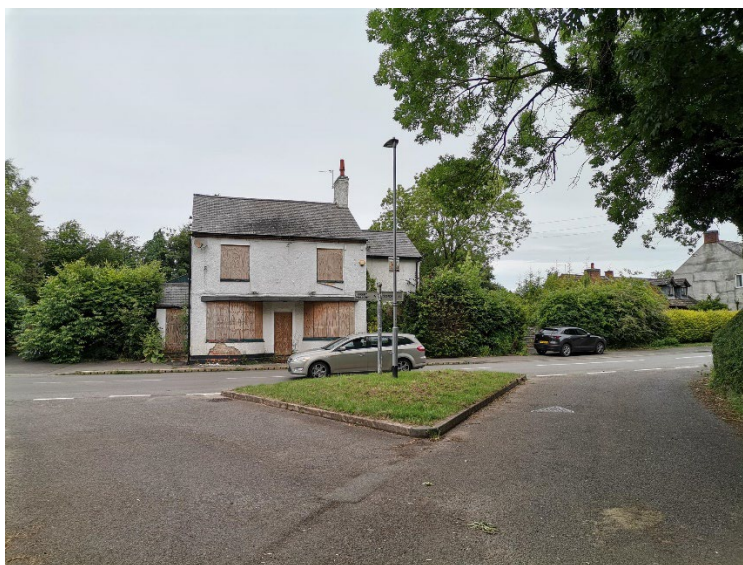
Photograph 1

- 6.1 ***The Site -Description:*** The site is situated to the west of Peckleton village centre off Main Street. It consists of a former public house building (photograph 1) with existing hard surface parking area (photograph 2 and 3) and trees primarily on the edges. Access is currently available via Main Street. The site is overgrown and access to trees was restricted.

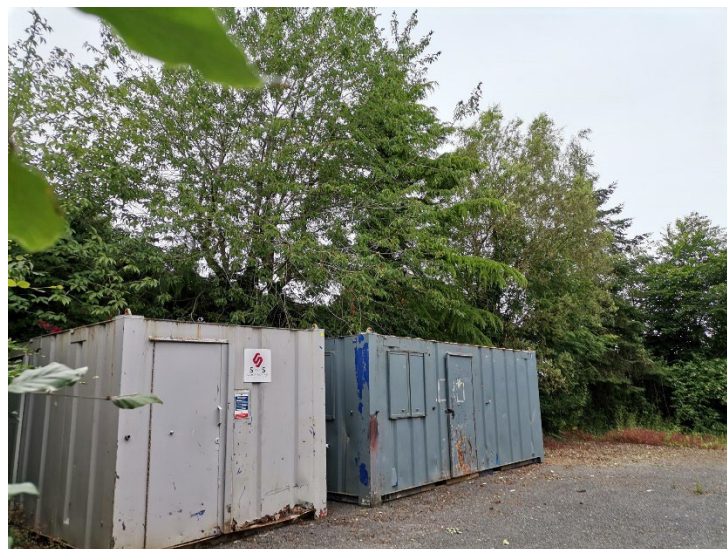
Photograph 4

- 6.11 ***Parking:*** Parking will be sited on existing hard surfaces (photograph 4). The top-surface may be removed, but the sub-base retained so as not to disturb the roots of the nearby trees T003, T004, T005, T007 and T003. The new top-surface should be permeable.
