**Phase I Desk Study**

**Geotechnical and Geo-Environmental Report**

**Mira North Plot 44**

**Report No: 24-06-07**

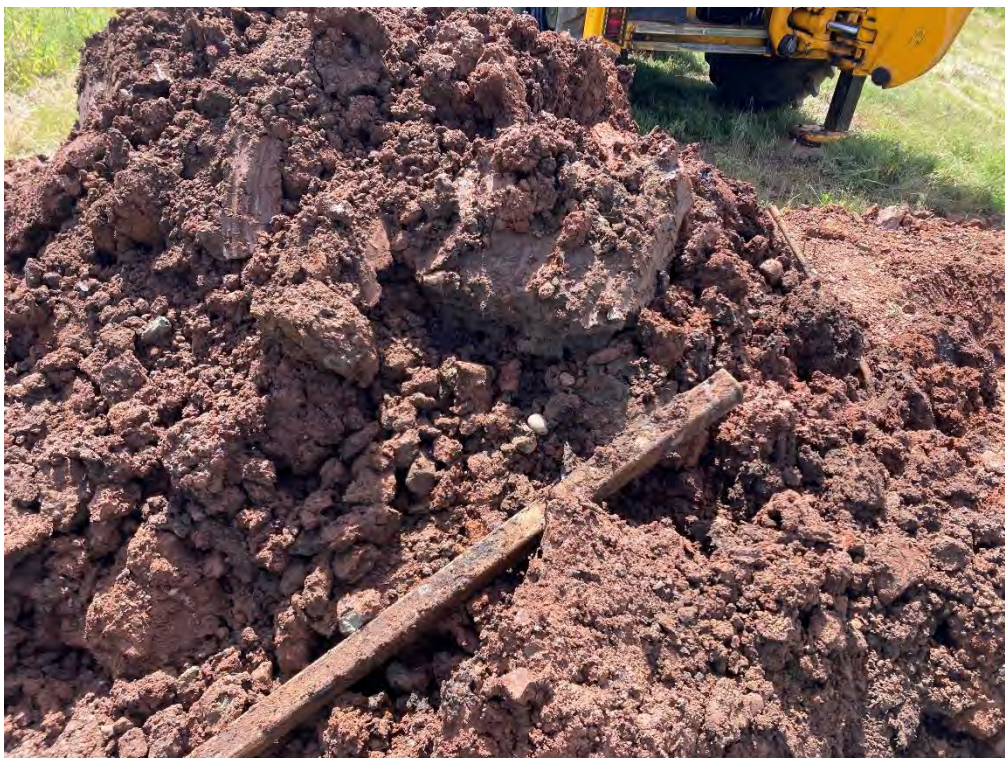
Trial Pitting (Embankment) note rare anthropogenic material

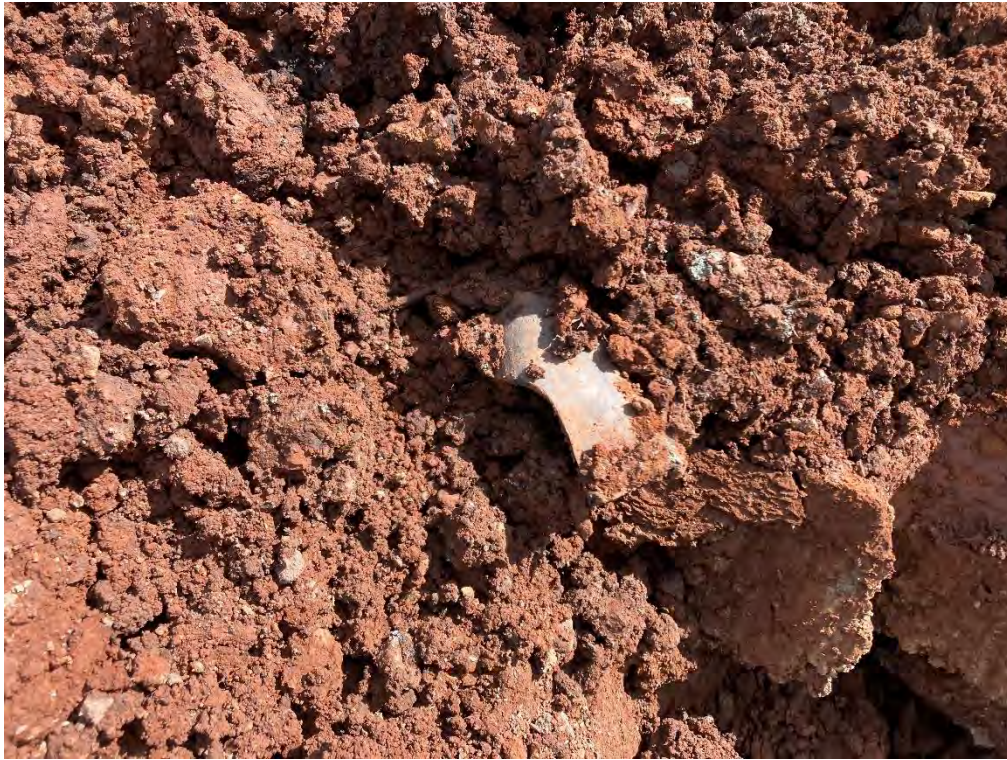
Trial Pitting (Embankment) note rare anthropogenic material

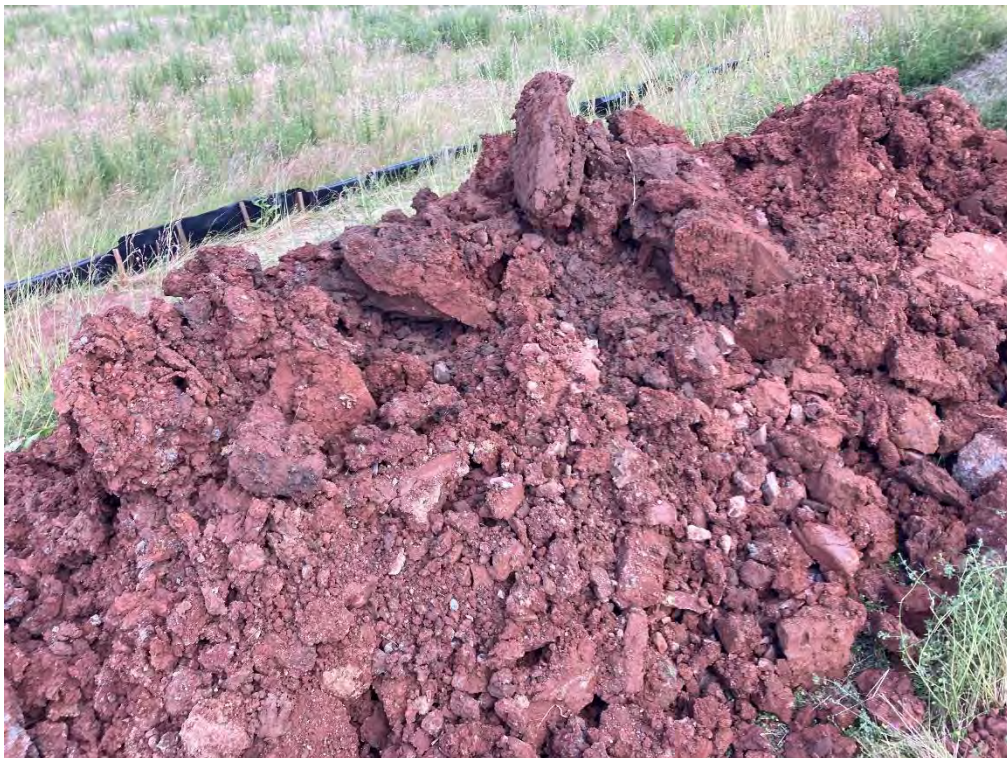
Trial Pitting (Embankment) note unconsolidated material

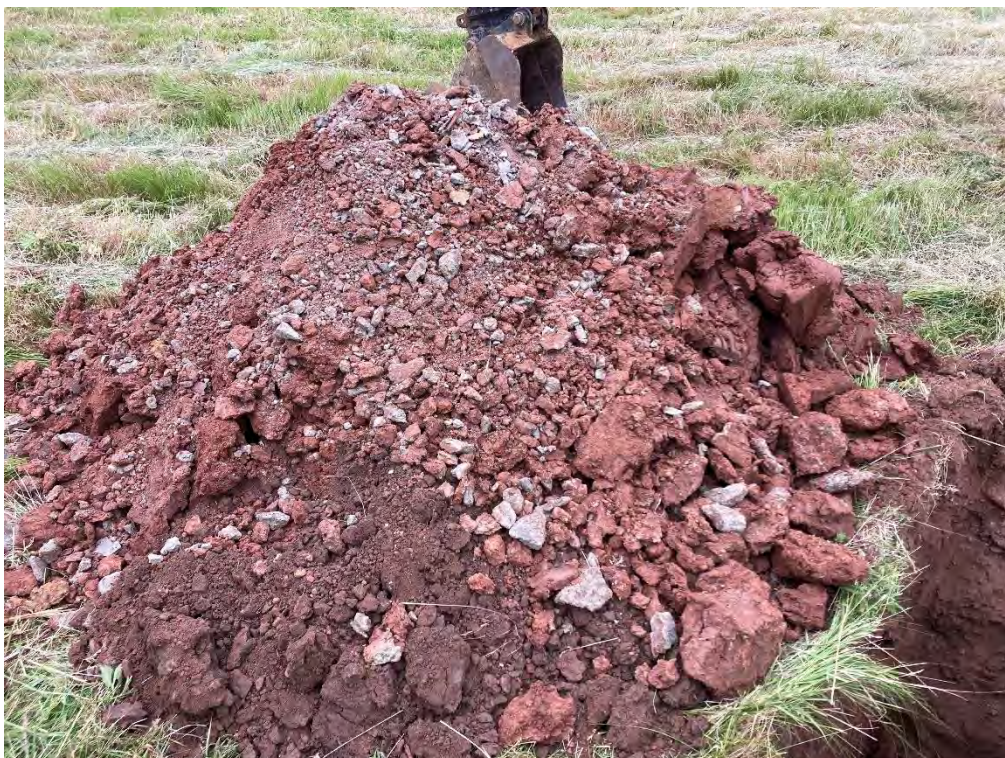
Trial Pitting note siltstone fragments

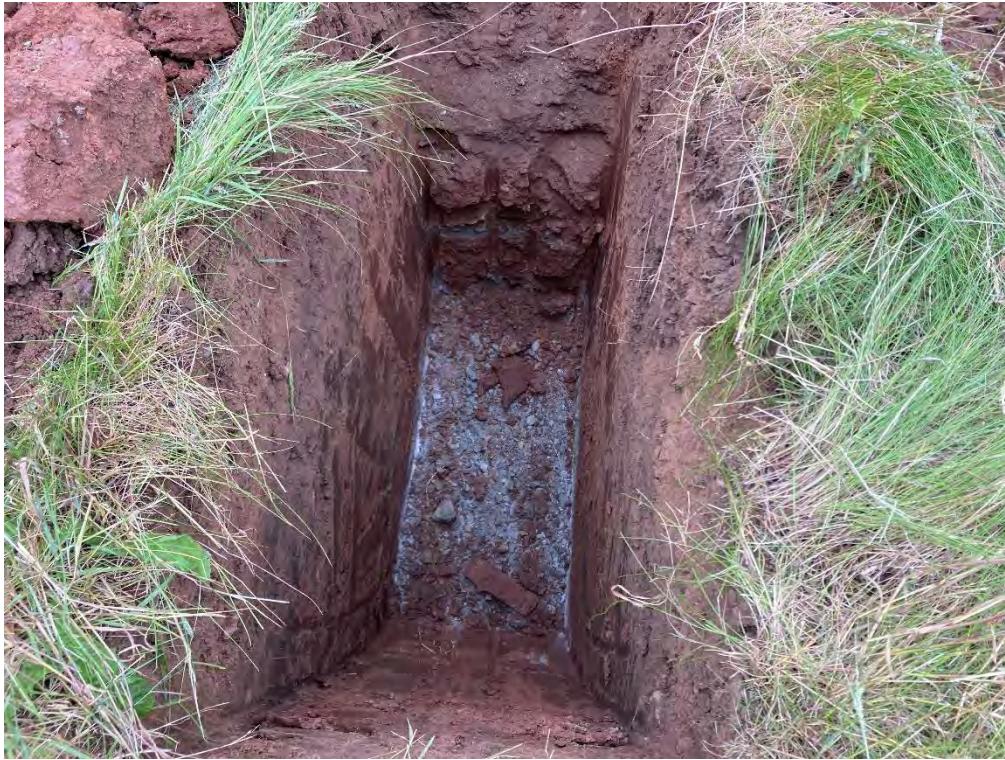
Trial Pitting note refusal on rock quality strata

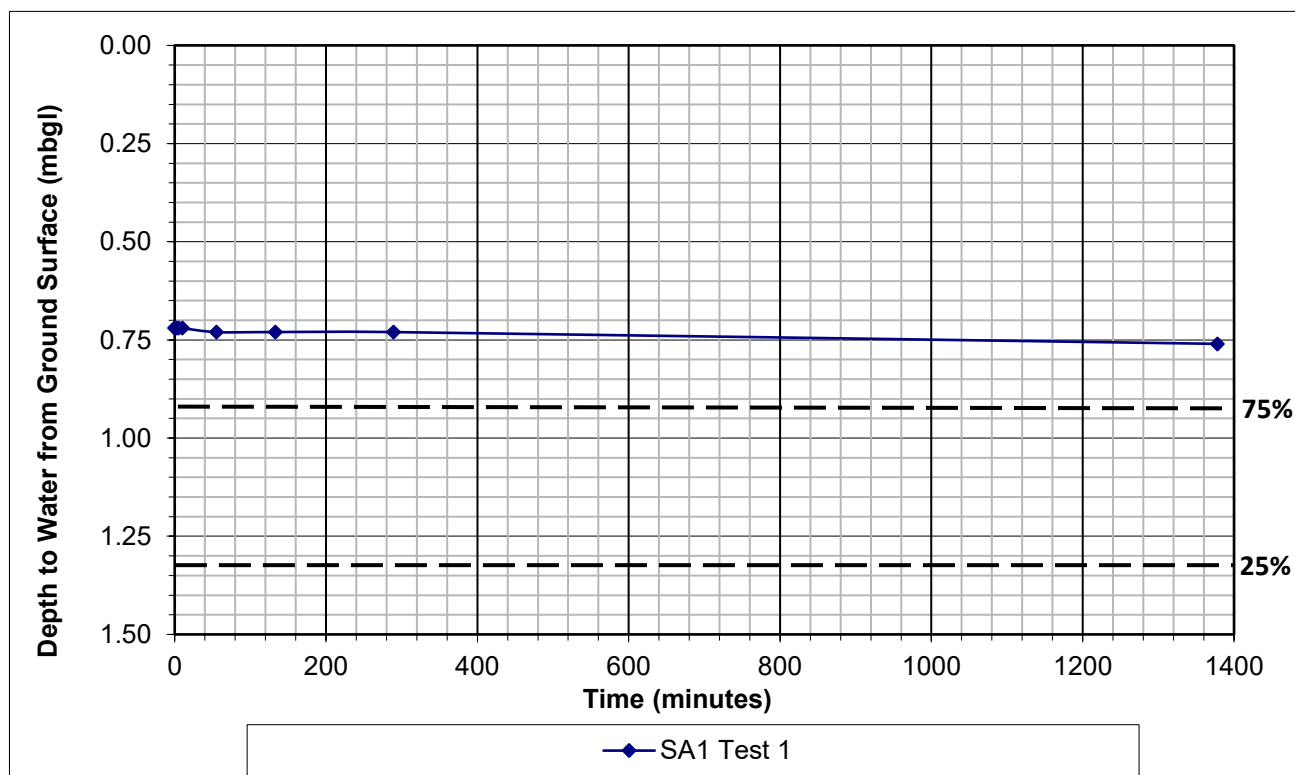
**Unable to calculate Soil Infiltration Rate**  
**Due to insufficient drop in water levels**

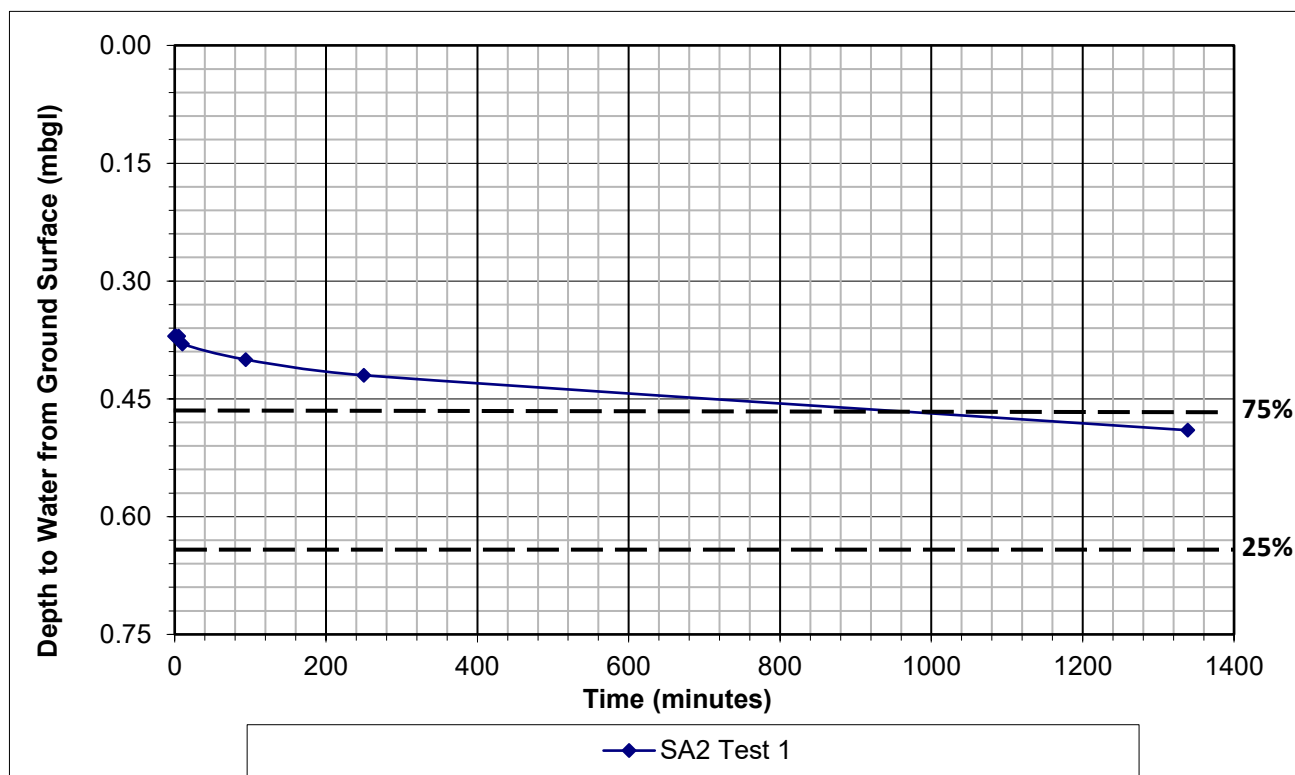
**Unable to calculate Soil Infiltration Rate  
Due to insufficient drop in water levels**

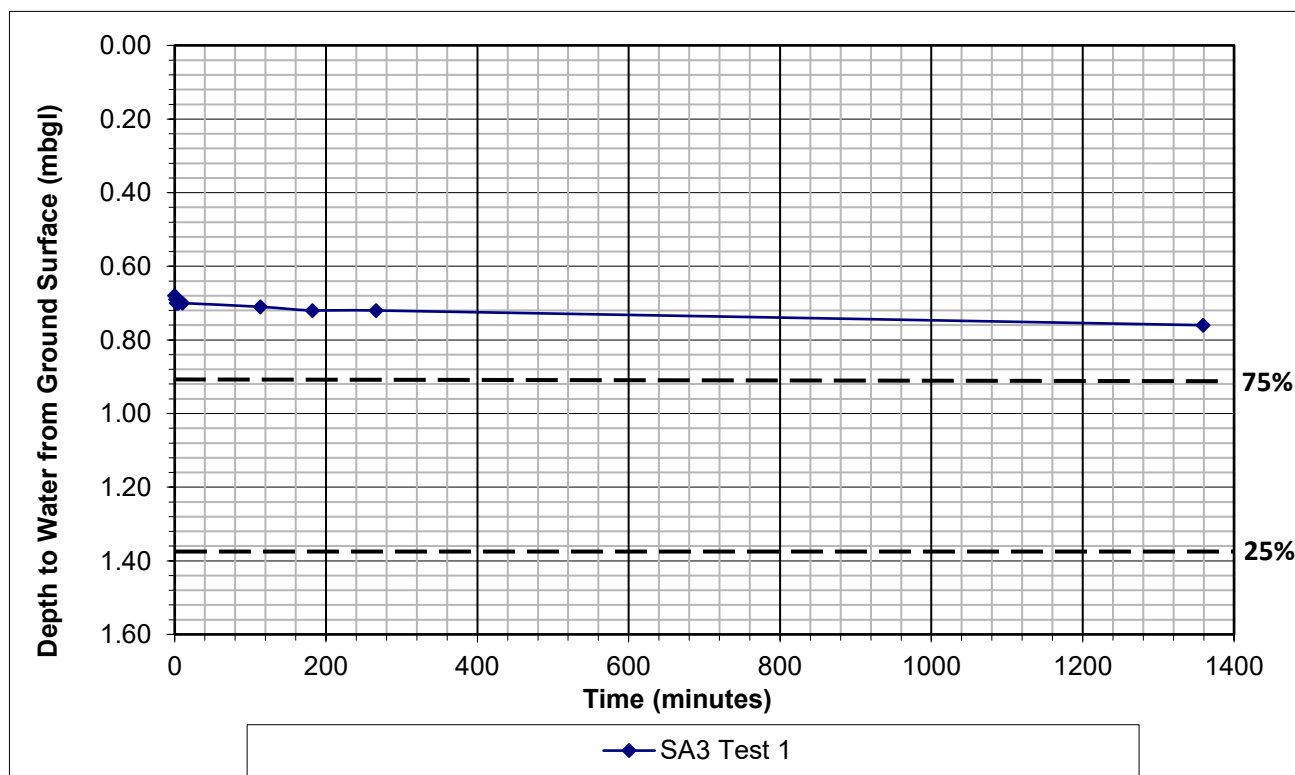
Unable to calculate Soil Infiltration Rate  
Due to insufficient drop in water level

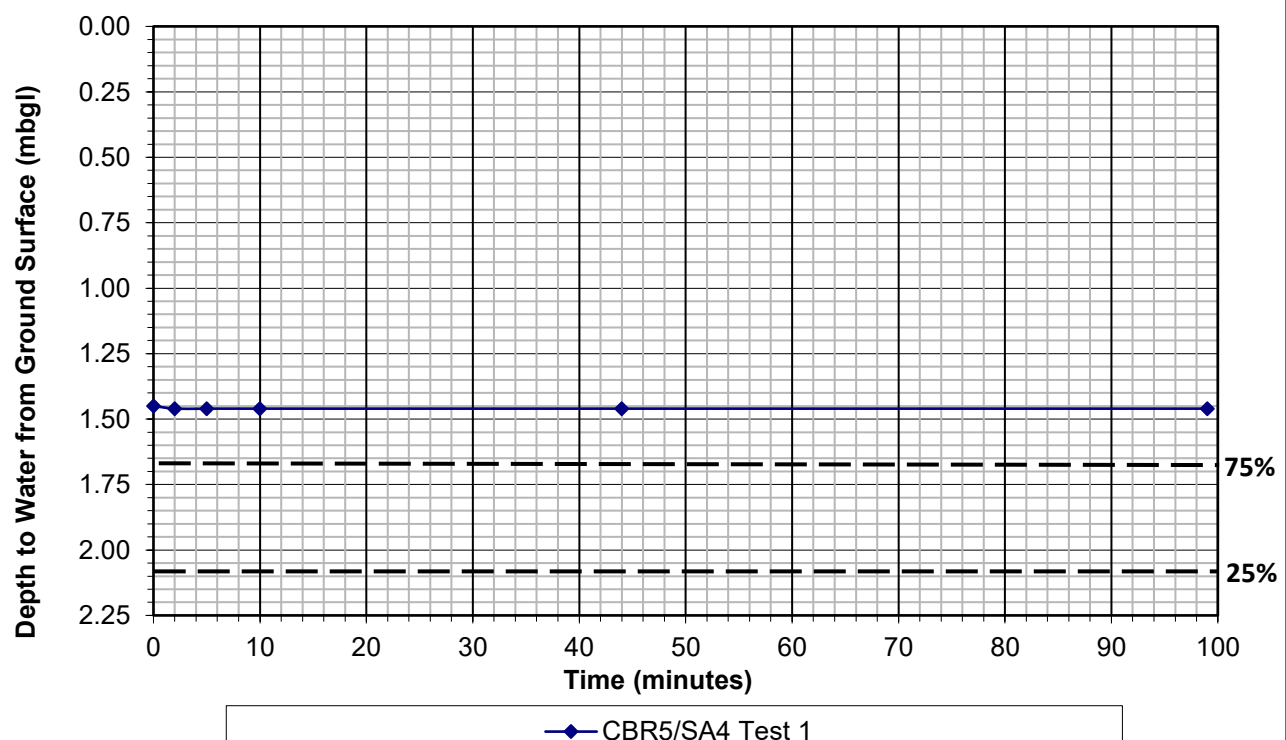
**Unable to calculate Soil Infiltration Rate**  
**Due to insufficient drop in water level**
