# **Site: Woodrowe House – Arboricultural Report**

**Client: Complete Weed Control  
Ltd.**

**Report Title:** TCR/1029 – Cygnet Woodrowe House Arboricultural Report  
2026

**Version:** V1.0  
**Issue Date:** March 2026  
**Report Ref:** TCR/1029

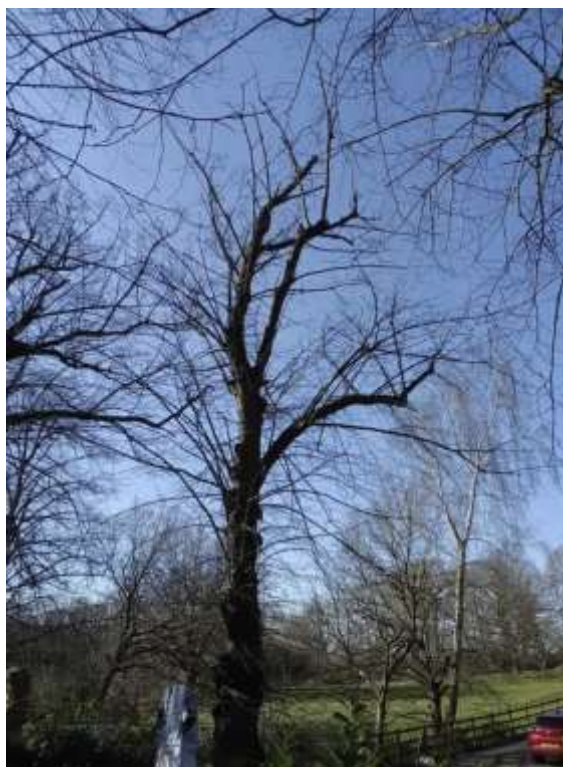
**Plate 1:** T030 in context showing dead top.

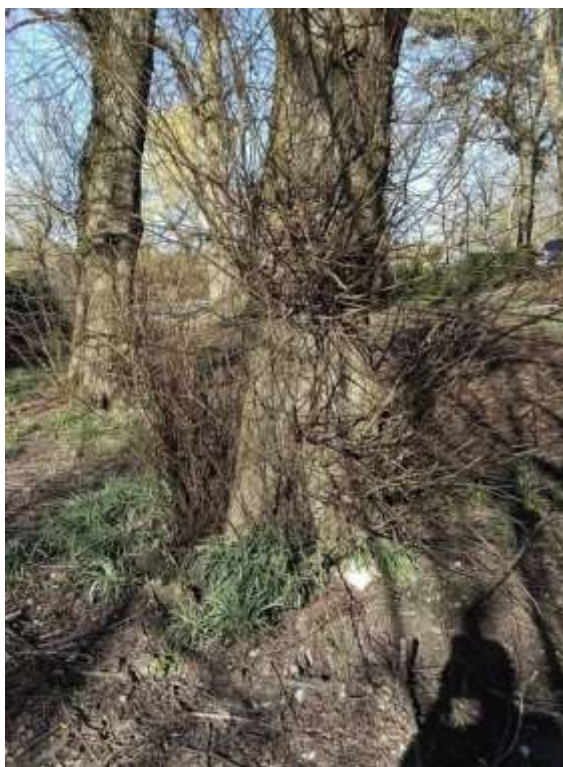
**Plate 2:** T033, with significant epicormic growth consistent with other mature lime trees on site.

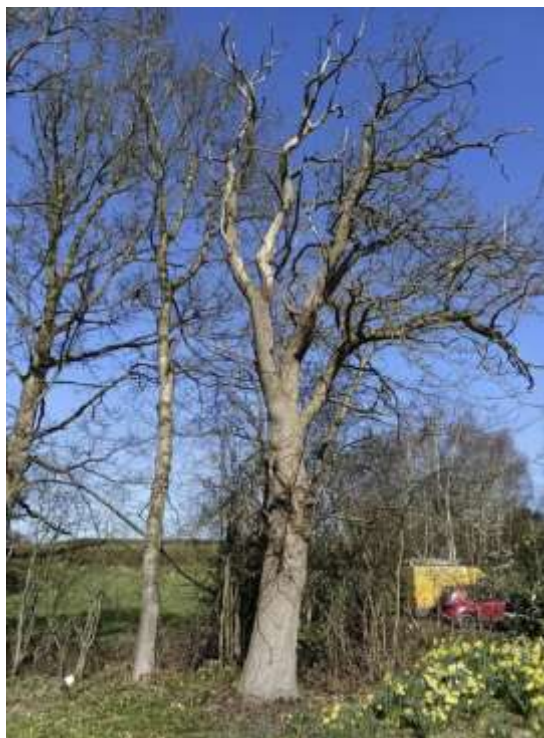
**Plate 3:** T009 in context showing significant deadwood.
