## ARBORICULTURAL REPORT

### WAR MEMORIAL AVENUE

21<sup>st</sup> May 2025

War Memorial Avenue,  
Forest View  
Botcheston  
Leicestershire  
LE9 9QH

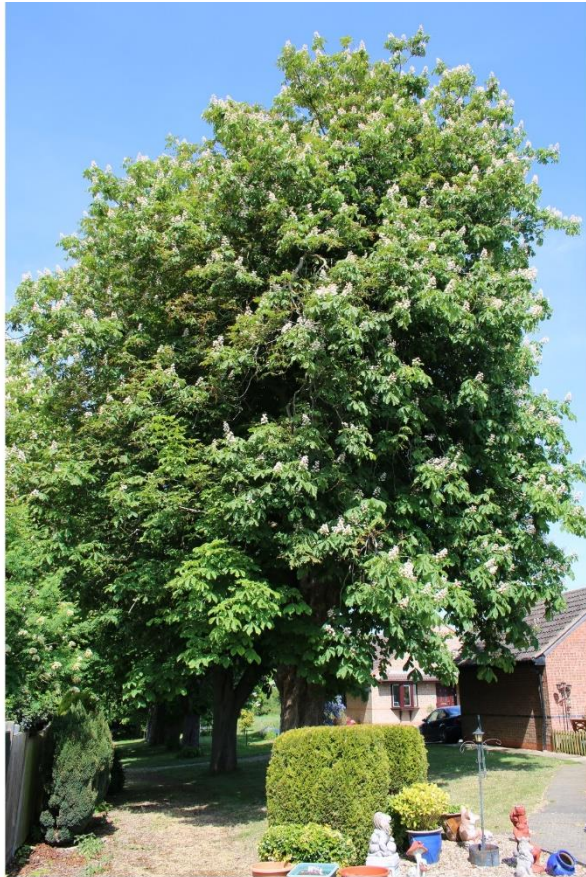
T1 Horse Chestnut

| IDENTIFIED TREES | | | | | | | | | |
|---|---|---|---|---|---|---|---|---|---|
| T1 | Horse Chestnut<br>( <i>Aesculus hippocastanum</i> ) | M | 878 | 18 | 7.5<br>N<br>7 W + E 6<br>S<br>6.5 | Areas of bacterial bleeding canker secretion and lesions appear to indicate the disease is currently in remission. Epicormic growth is present on the main stem at 2.5m. Pruning wound cavity located at 3.2m on the southern side of the main stem. A heavy limb arises at 3m and 8.2m on the North West side of the crown. | None | - | 24 |

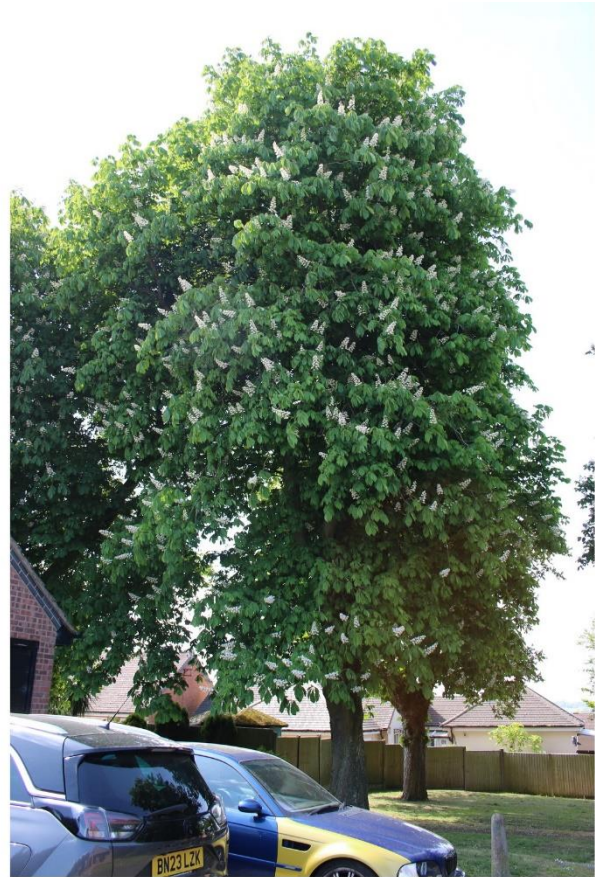
T2 Horse Chestnut

| IDENTIFIED TREES | | | | | | | | | |
|---|---|---|---|---|---|---|---|---|---|
| T2 | Horse Chestnut<br>( <i>Aesculus hippocastanum</i> ) | M | 762 | 18 | 7.6<br>N<br>5.1 W + E 7.2<br>S<br>6.3 | A physiologically healthy specimen. The main bifurcation is located at 2.2m. The arising stems then bifurcate again at 4m and 4.5m. The North Eastern side of the crown appears to have been reduced. | None | - | 24 |

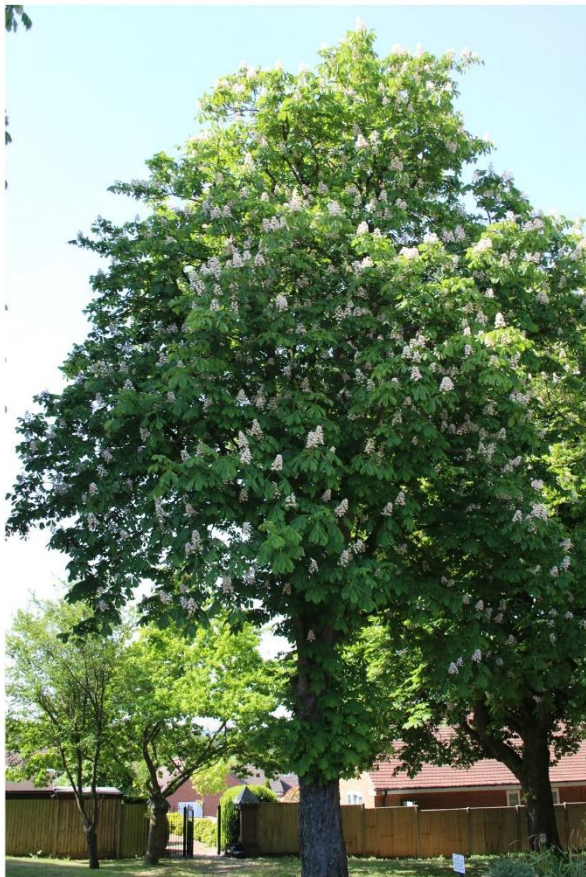
T3 Horse Chestnut

| IDENTIFIED TREES | | | | | | | | | |
|---|---|---|---|---|---|---|---|---|---|
| T3 | Horse Chestnut<br>( <i>Aesculus hippocastanum</i> ) | M | 708 | 15 | 4.9<br>N<br>4.0 W + E 4.8<br>S<br>5.0 | The main stem displays evidence of significant previous bacterial bleeding canker infection, however the disease currently appears to be in remission. An historic pruning wound at approximately 2.1m appears to be decaying. Occluded bark cracks are present on the North east side at 3m and the southwest side at 4m. Pruning wounds throughout the extremities of the crown indicate that the crown has recently been reduced. | None | - | 24 |

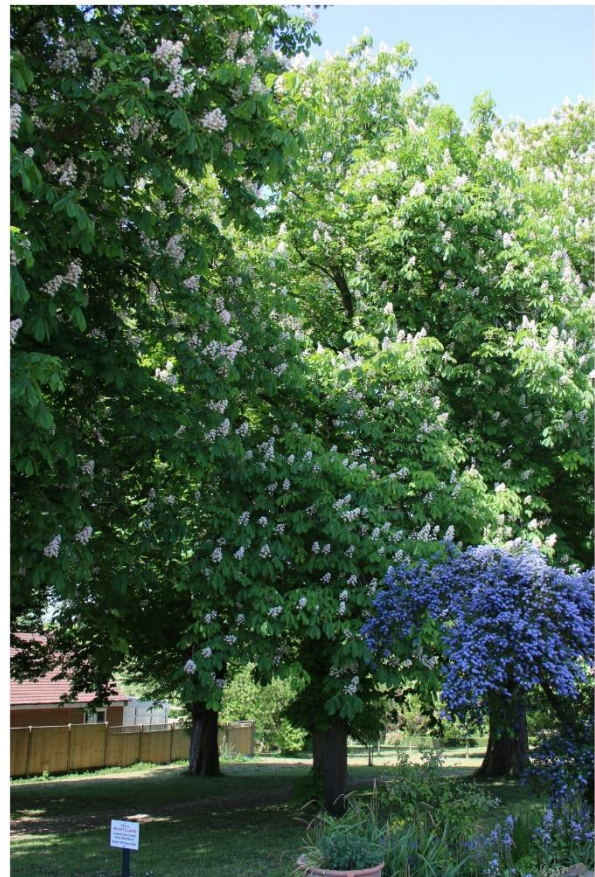
T4 Horse Chestnut

| IDENTIFIED TREES | | | | | | | | | |
|---|---|---|---|---|---|---|---|---|---|
| T4 | Horse Chestnut<br>( <i>Aesculus hippocastanum</i> ) | M | 609 | 15 | 6.2.<br>N<br>5.0 W + E 6.1<br>S<br>7.0 | The main stem of this tree has burring around the main bifurcations between 1.5m and 3.8m. A single, low, slender branch is located on the south east side of the lower crown. There are pruning wounds suggesting that this branch has previously been reduced to reduce the risk of failure. | None | - | 24 |

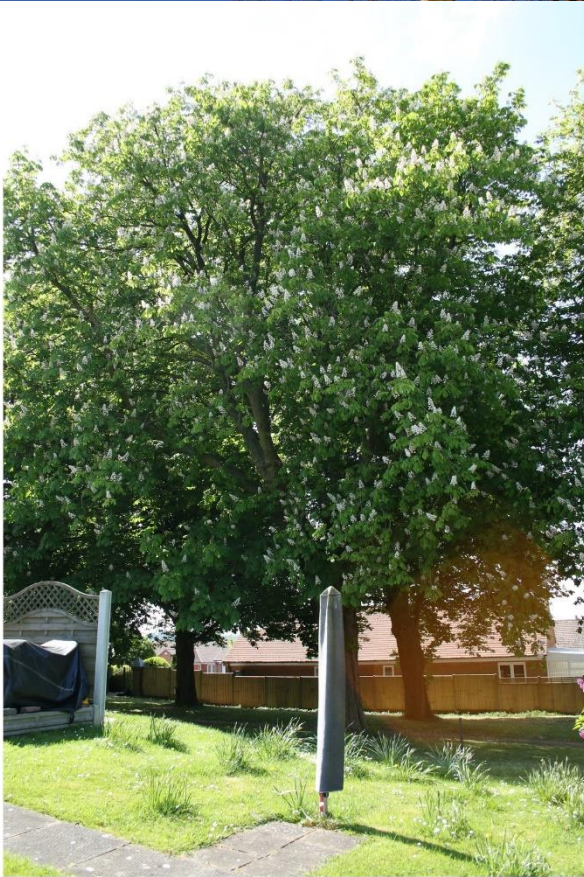
T5 Horse Chestnut

| Tree No. | Species | Age Class | Diameter (mm) | Est Height (m) | Crown Spread (m) | | Observations | Recommendations | Priority | Inspection Frequency |
|---|---|---|---|---|---|---|---|---|---|---|
| T5 | Horse Chestnut<br>( <i>Aesculus hippocastanum</i> ) | M | 912 | 17 | 8.6<br>N<br>6.7 W + E 9.0<br>S<br>6.0 | | The main union of this tree is located at 3.1m. A significant limb originates from this tight union and extends north-eastward. The north-eastern side of the crown has recently been reduced. | None | - | 24 |

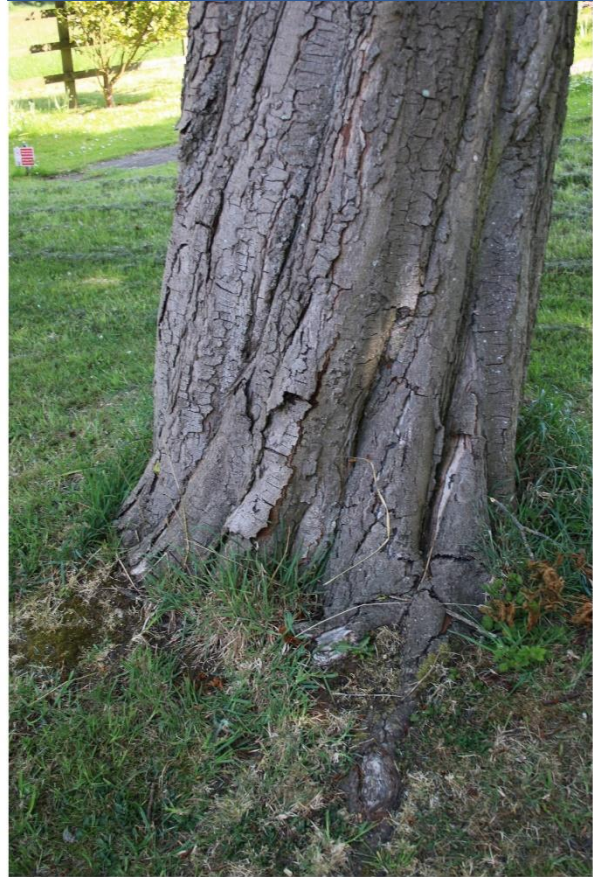
| Tree No. | Species | Age Class | Diameter (mm) | Est Height (m) | Crown Spread (m) | | Observations | Recommendations | Priority | Inspection Frequency |
|---|---|---|---|---|---|---|---|---|---|---|
| T6 | Horse Chestnut<br>( <i>Aesculus hippocastanum</i> ) | M | 743 | 17 | 5.9<br>N<br>5.5 W + E 5.6<br>S<br>5.3 | | Significant necrotic bark on the south west side of the stem base extending to 1.8m. An old pruning wound is present at 3.2m. A tall upswept limb arises from 4m. Foliage within the crown is smaller and sparser than the adjacent trees. | Monitor the physiological condition and potential decay on the south western side of the stem base<br><br>Reduce the southern upswept limb by up to 2m | 3 | 24 |

T6 Horse Chestnut - Stem Base

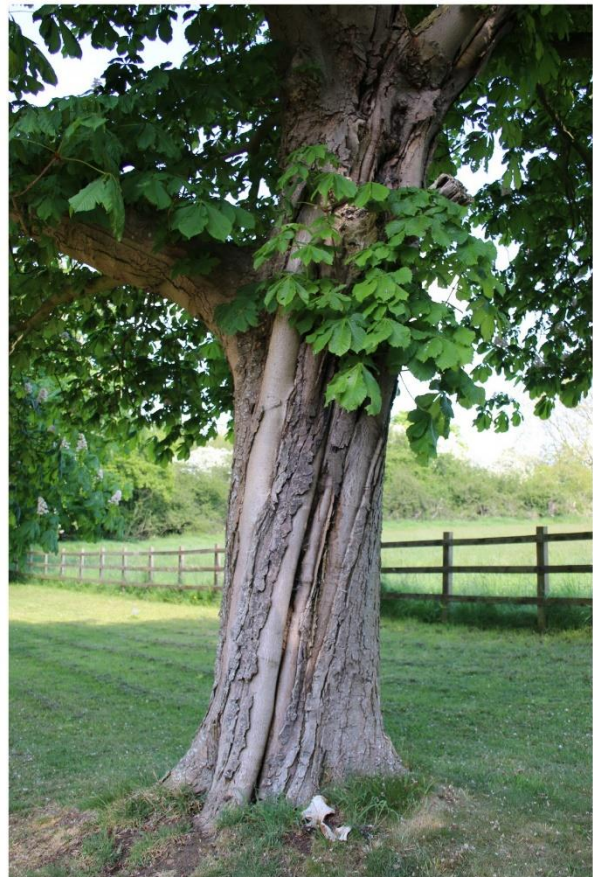
| Tree No. | Species | Age Class | Diameter (mm) | Est Height (m) | Crown Spread (m) | | Observations | Recommendations | Priority | Inspection Frequency |
|---|---|---|---|---|---|---|---|---|---|---|
| T7 | Horse Chestnut<br>( <i>Aesculus hippocastanum</i> ) | M | 736 | 17 | 6.3<br>N<br>6.4 W + E 5.5<br>S<br>5.9 | | Fallen <i>Ceriporus squamosus</i> brackets are present at the base of the tree. A necrotic strip of bark and decay extends from ground level to the branch stub at 2.3m, on the south east side of the main stem. Areas of bacterial bleeding canker secretion and lesions are also present, however, they appear to indicate the disease is currently in remission. There is an upswept limb on the western side of the crown which appears heavy. There are small diameter pruning wounds throughout the extremities of the crown which indicate a crown reduction has recently been carried out. | Reduce the western upswept limb by up to 2m | 3 | 24 |

T7 Horse Chestnut - Main Stem

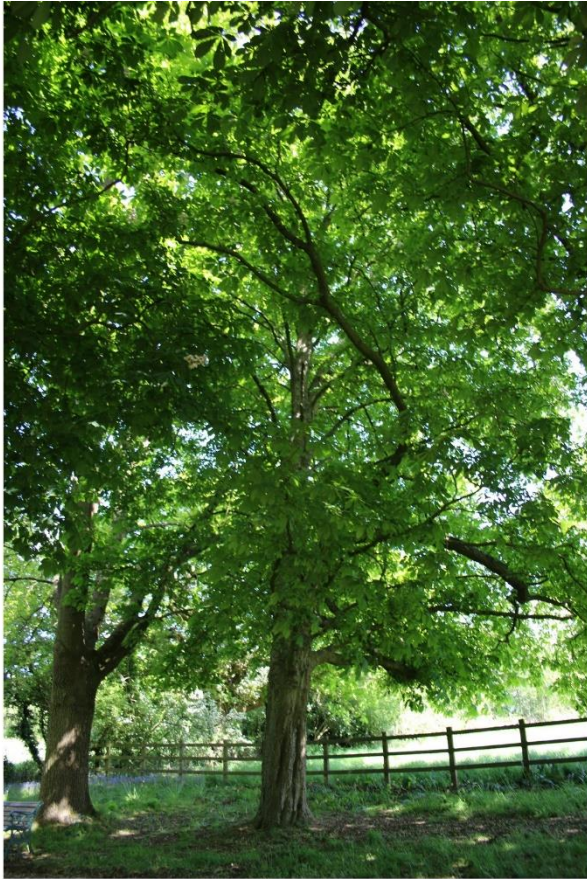
T11 Horse Chestnut

| Tree No. | Species | Age Class | Diameter (mm) | Est Height (m) | Crown Spread (m) | | Observations | Recommendations | Priority | Inspection Frequency |
|---|---|---|---|---|---|---|---|---|---|---|
| T11 | Horse Chestnut ( <i>Aesculus hippocastanum</i> ) | M | 728 | 18 | 9.4<br>N<br>4.3 W + E 5.7<br>S<br>7.3 | | The crown is predominantly formed to the north east due to competition from neighbouring trees. Heavy lateral branches extend to the north-east, however these have previously been reduced. | None | - | 24 |

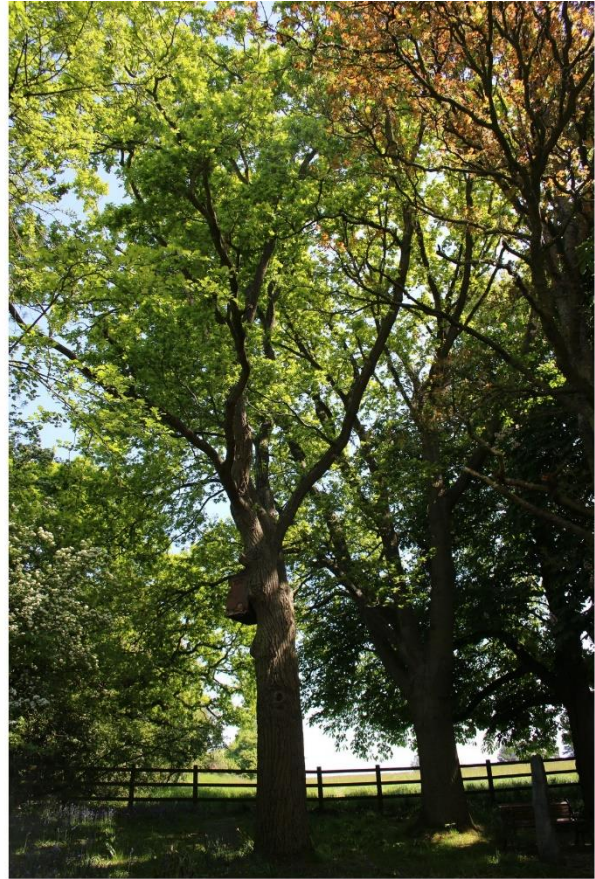
T12 & T13 English Oak

| Tree No. | Species | Age Class | Diameter (mm) | Est Height (m) | Crown Spread (m) | | Observations | Recommendations | Priority | Inspection Frequency |
|---|---|---|---|---|---|---|---|---|---|---|
| T12 | English Oak ( <i>Quercus robur</i> ) | M | 834 | 20 | 12.2<br>N<br>5.8 W + E 10.6<br>S<br>6.6 | | The first of three English Oaks. The main stem divides into 3 further main upright stem from 3.1m. Minor deadwood is present within the crown. | None | - | 24 |
| T13 | English Oak ( <i>Quercus robur</i> ) | M | 723 | 20 | 7.9<br>N<br>7.7 W + E 4.8<br>S<br>4.7 | | The main unions of this tree are located at approximately 4.1m. The crown has a slender form, however there is evidence of pruning which has reduced the slenderness. A habitat box is present on the main stem at approximately 3.8m, of which the main stem is beginning to occlude over the attachment bracket. | None | - | 24 |

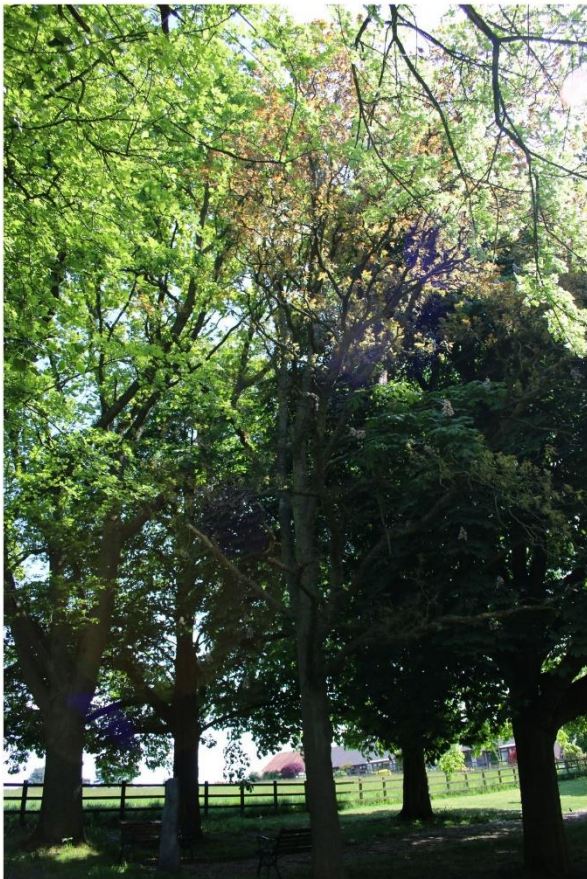
T14 English Oak

| Tree No. | Species | Age Class | Diameter (mm) | Est Height (m) | Crown Spread (m) | | Observations | Recommendations | Priority | Inspection Frequency |
|---|---|---|---|---|---|---|---|---|---|---|
| T14 | English Oak ( <i>Quercus robur</i> ) | Y | 432 | 18 | 3.4<br>N<br>8.1 W + E 4.2<br>S<br>4.0 | | A suppressed and slender formed specimen. The main union is located at 4m. Foliage flush of leaves were observed to be bronzed/scorched during initial inspection. Re-inspection on the 19/05/2025 found that the bronzing/scorch had receded. This may have been caused by an Iron deficiency. | Monitor the next several leaf flush. | R | 24 |

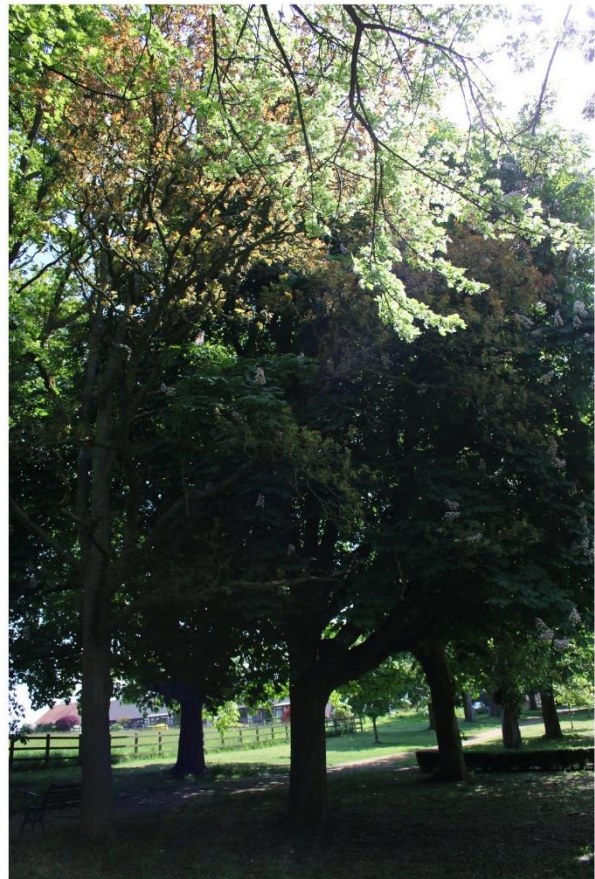
T15 Horse Chestnut

| Tree No. | Species | Age Class | Diameter (mm) | Est Height (m) | Crown Spread (m) | | Observations | Recommendations | Priority | Inspection Frequency |
|---|---|---|---|---|---|---|---|---|---|---|
| T15 | Horse Chestnut<br>( <i>Aesculus hippocastanum</i> ) | M | 707 | 18 | 7.1<br>N<br>7.2 W + E 6.2<br>S<br>6.2 | | The crown of this tree has previously had a crown reduction undertaken. The main unions are located at 2.4m with 3 no. main limbs arising from this height. The lowest southern limb has a tight union. The previous tree surgery works appears sufficient enough to reduce the risk of failure. | None | - | 24 |

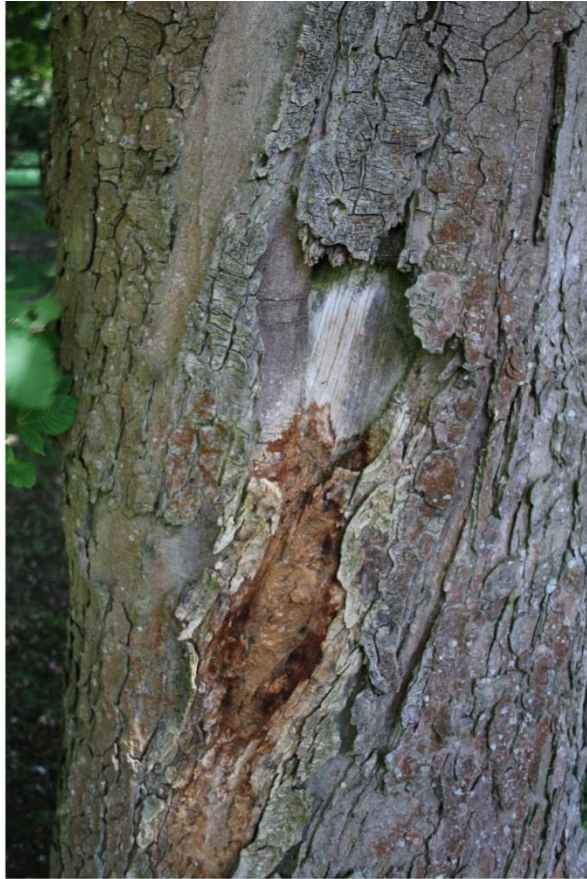
| Tree No. | Species | Age Class | Diameter (mm) | Est Height (m) | Crown Spread (m) | | Observations | Recommendations | Priority | Inspection Frequency |
|---|---|---|---|---|---|---|---|---|---|---|
| T16 | Horse Chestnut<br>( <i>Aesculus hippocastanum</i> ) | M | 698 | 17 | 6.2<br>N<br>6.5 W + E 6.0<br>S<br>6.7 | | Evidence of historic helical cracks is present on within the bark of the main stem. A wound on the south side has bacterial secretion. The main stem then bifurcates at 3.8m into north eastern and south western co-dominant stems. Burs are also present on the north eastern stem at 3m. | None | - | 24 |

T16 Horse Chestnut - Stem Wound

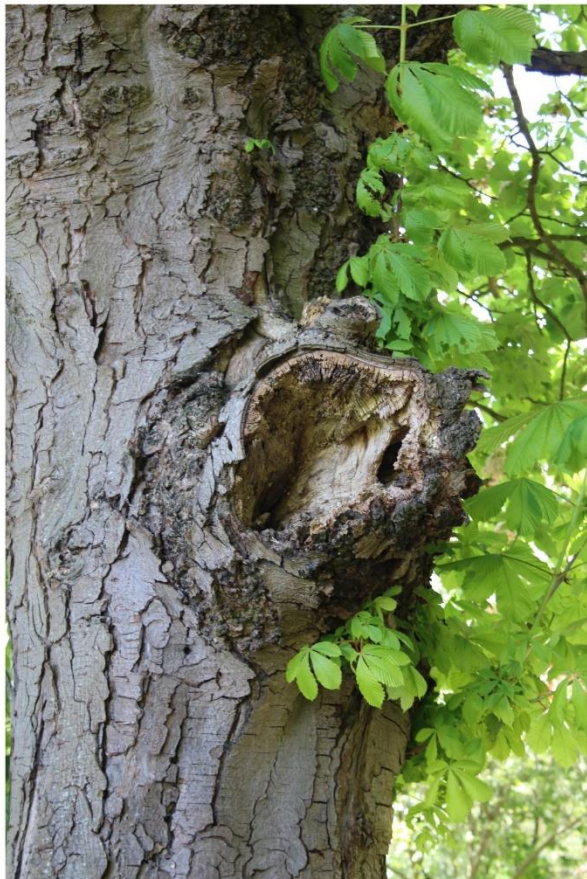
| Tree No. | Species | Age Class | Diameter (mm) | Est Height (m) | Crown Spread (m) | | Observations | Recommendations | Priority | Inspection Frequency |
|---|---|---|---|---|---|---|---|---|---|---|
| T17 | Horse Chestnut<br>( <i>Aesculus hippocastanum</i> ) | M | 690 | 16 | 5.2<br>N<br>4.8 W + E 6.3<br>S<br>5.5 | | Minor decay is present on the southern side of the stem base. An historic pruning wound is located on the western side of the main stem at 2.3m. Test drilling found insignificant decay within the main stem at this point. A minor strip of necrotic bark is present from ground level to 2.3m on the East side. | None | - | 24 |

T17 Horse Chestnut - Branch Hole

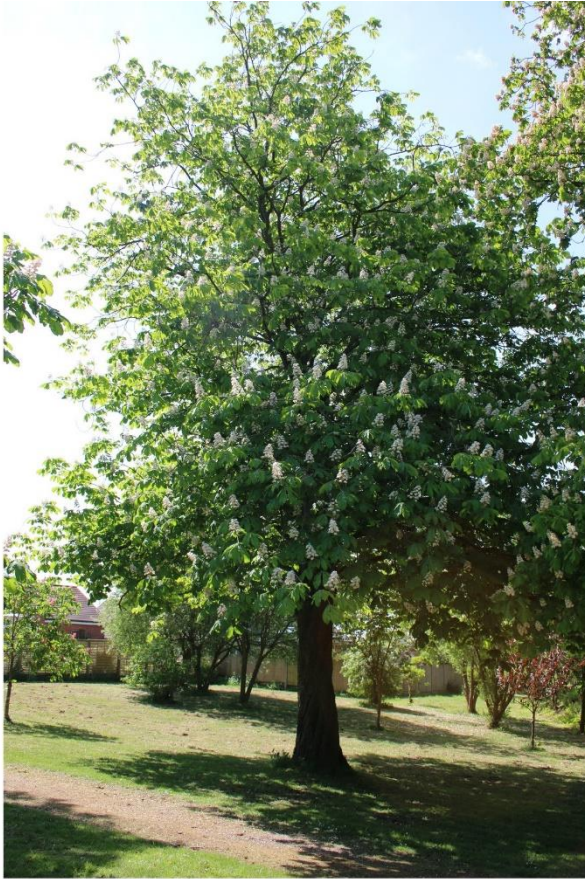
T18 Horse Chestnut

| Tree No. | Species | Age Class | Diameter (mm) | Est Height (m) | Crown Spread (m) | | Observations | Recommendations | Priority | Inspection Frequency |
|---|---|---|---|---|---|---|---|---|---|---|
| T18 | Horse Chestnut<br>( <i>Aesculus hippocastanum</i> ) | M | 735 | 16 | 6.2<br>N<br>6.5 W + E 5.9<br>S<br>5.8 | | The main stem bifurcates at 3.9m into 2 main stems. Evidence of historic helical cracks is present on the bark of the main stem. A Pruning wound is present on the southern side at 2.9m. | None | - | 24 |

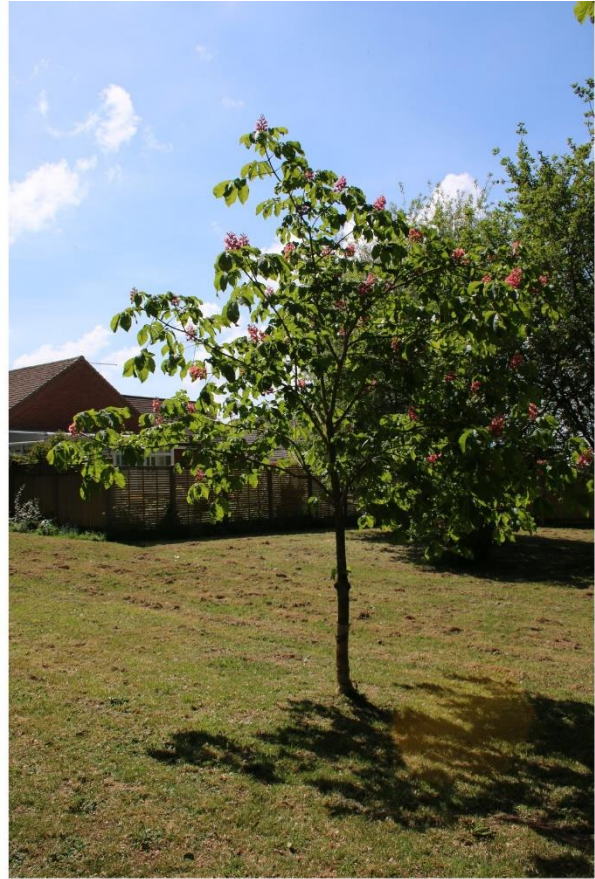
T19 Red Horse Chestnut

| Tree No. | Species | Age Class | Diameter (mm) | Est Height (m) | Crown Spread (m) | | Observations | Recommendations | Priority | Inspection Frequency |
|---|---|---|---|---|---|---|---|---|---|---|
| T19 | Red Horse Chestnut<br>( <i>Aesculus x carnea</i> ) | Y | 65 | 3 | 2.1<br>N<br>2.5 W + E 2.2<br>S<br>2.4 | | A newly planted specimen in good physiological condition, with a crown which is developing well. The stem has now outgrown its protective rabbit guard. | Remove the rabbit guard | 3 | 24 |

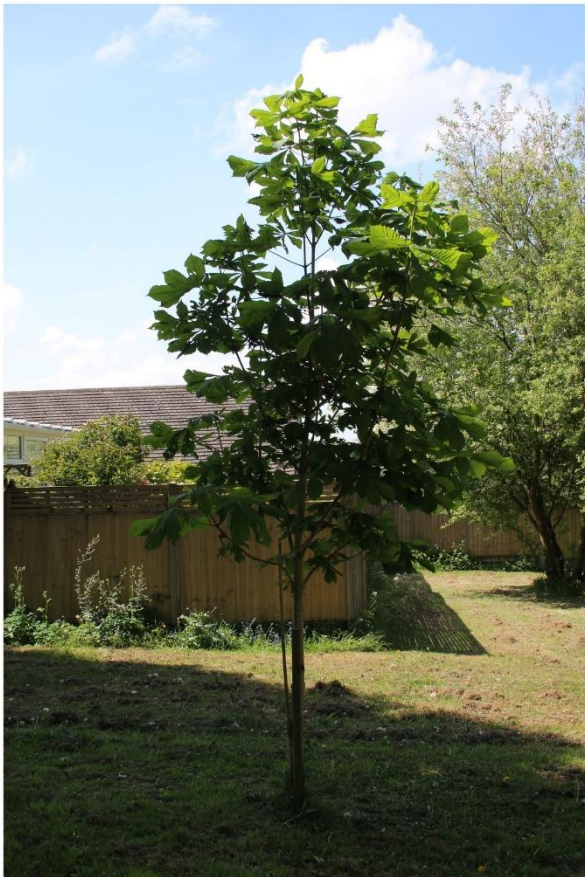
T20 Horse Chestnut

| Tree No. | Species | Age Class | Diameter (mm) | Est Height (m) | Crown Spread (m) | | Observations | Recommendations | Priority | Inspection Frequency |
|---|---|---|---|---|---|---|---|---|---|---|
| T20 | Horse Chestnut<br>( <i>Aesculus hippocastanum</i> ) | Y | 50 | 3 | 1.4<br>N<br>1.5 W + E 1.4<br>S<br>1.5 | | A newly planted specimen in good physiological condition, with a crown which is developing well. The stem has now outgrown its protective rabbit guard, stake and cane. | Remove the tree stake, cane and rabbit guard | 3 | 24 |

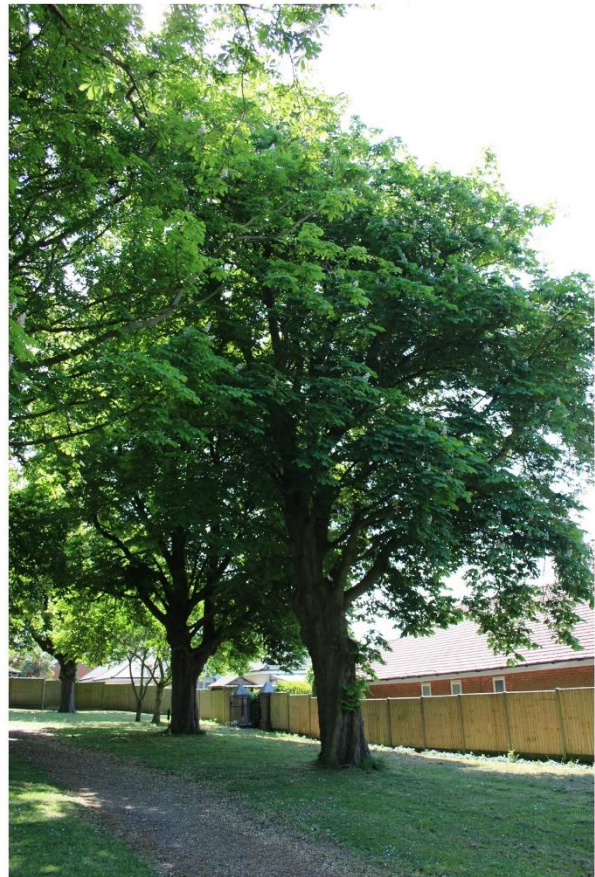
T21 Horse Chestnut

| Tree No. | Species | Age Class | Diameter (mm) | Est Height (m) | Crown Spread (m) | | Observations | Recommendations | Priority | Inspection Frequency |
|---|---|---|---|---|---|---|---|---|---|---|
| T21 | Horse Chestnut<br>( <i>Aesculus hippocastanum</i> ) | M | 840 | 17 | 5.3<br>N<br>7.0 W + E 6.0<br>S<br>6.0 | | Epicormic growth is present at 1.2m to 2.3m on the north western side of the main stem. An historic pruning wound with minor decay is present at 2.4m on the western side, and 3m the north eastern side of the main stem. A tight union is present at 3.3m on the south west side of the main stem. The crown has seen a reduction on the south to south-west side of the upper crown. Minor deadwood is present in the mid crown on the eastern side. | None | - | 24 |

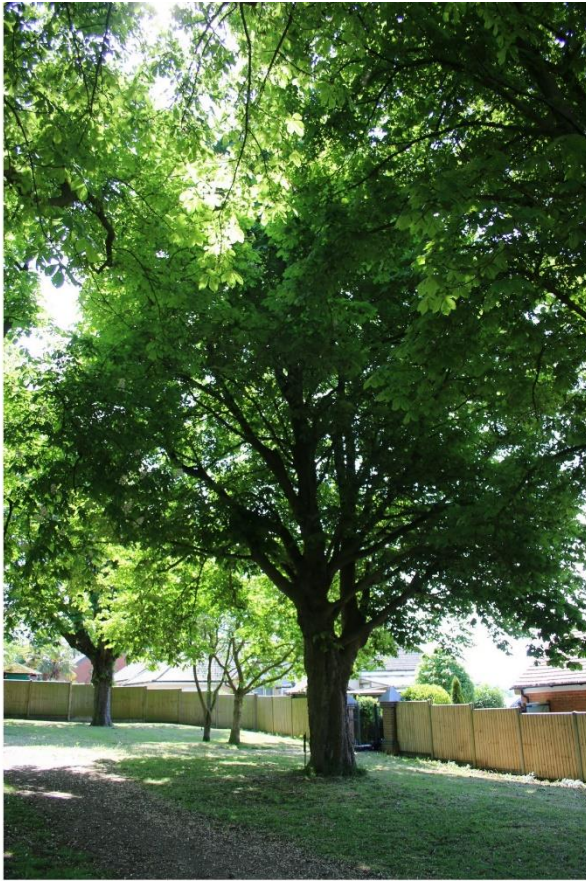
T22 Horse Chestnut

| Tree No. | Species | Age Class | Diameter (mm) | Est Height (m) | Crown Spread (m) | | Observations | Recommendations | Priority | Inspection Frequency |
|---|---|---|---|---|---|---|---|---|---|---|
| T22 | Horse Chestnut<br>( <i>Aesculus hippocastanum</i> ) | M | 793 | 17 | 6.4<br>N<br>5.5 W + E 7.2<br>S<br>7.2 | | The main stem bifurcates at 2.2m into northern and southern stems. An old branch stub is located at approximately 3.4m. Pruning wounds throughout the extremities of the crown indicate that the crown has recently been reduced. | None | - | 24 |

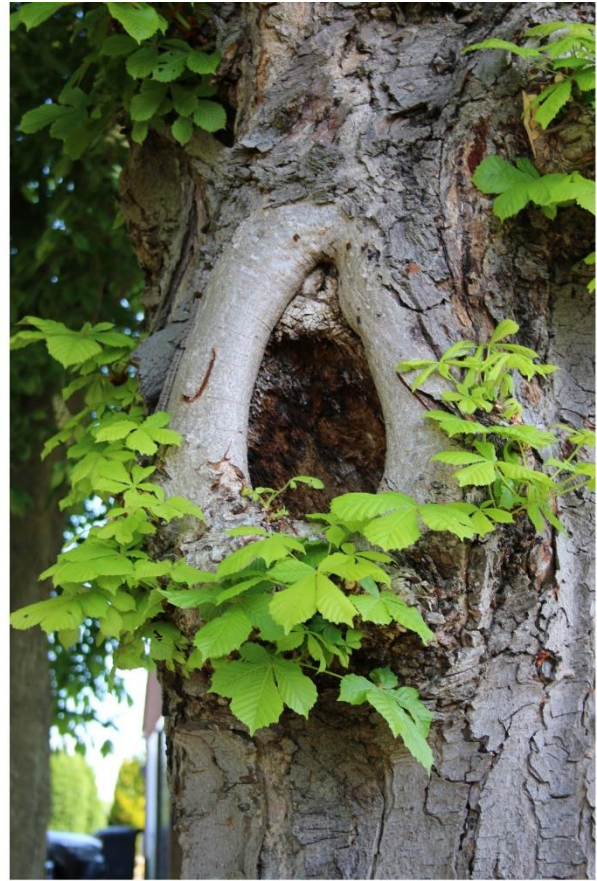
| Tree No. | Species | Age Class | Diameter (mm) | Est Height (m) | Crown Spread (m) | | Observations | Recommendations | Priority | Inspection Frequency |
|---|---|---|---|---|---|---|---|---|---|---|
| T23 | Horse Chestnut<br>( <i>Aesculus hippocastanum</i> ) | M | 701 | 17 | 6.5<br>N<br>4.9 W + E 6.3<br>S<br>6.1 | | Multiple historic wounds are present on the main stem at around 2.2m, with minor decay present within the wounds on the north east, and western side of the main stem. | None | - | 24 |

T23 Horse Chestnut - Pruning Wound
