**Phase 1 Land Contamination  
Risk Assessment  
for  
Change of Use from Agricultural  
to Commercial (Class R)  
on the site of  
Manor Farm, No.8 Wood Lane,  
Norton-Juxta-Twycross,  
Leicestershire CV9 3QB**

**Date: July 2025**

4034D P1 LonXThree – Norton-Juxta-Twycross

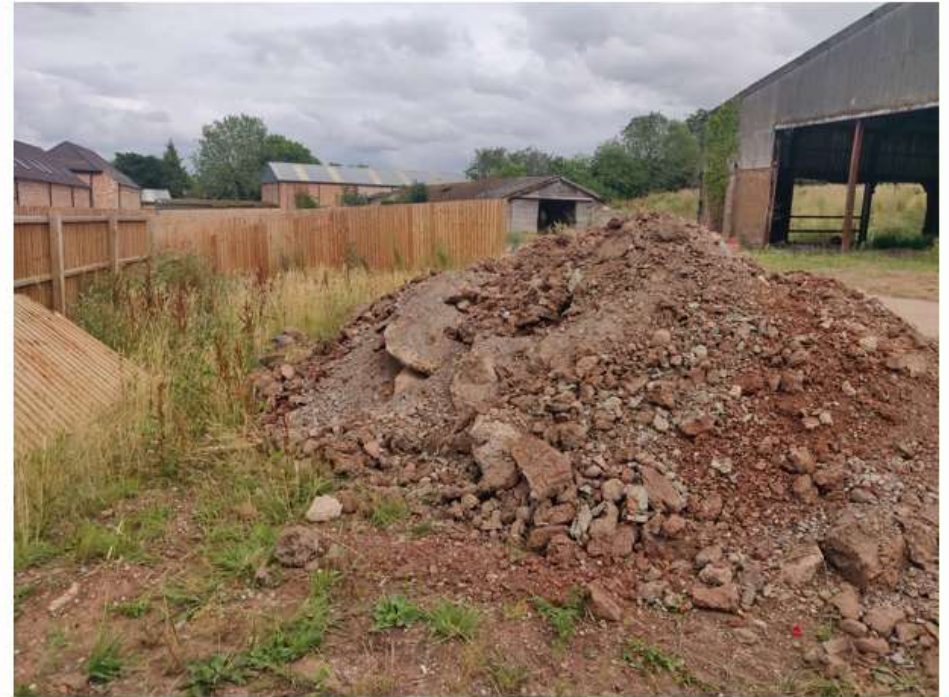
**Photo No.4: Heaped gravels and arisings adj. to site access**

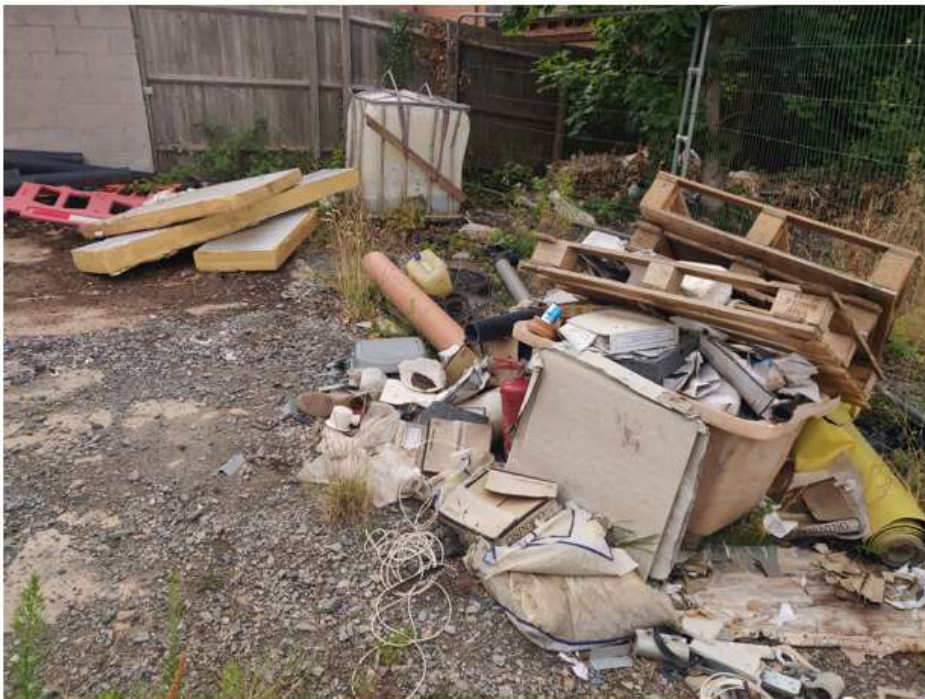
**Photo No.5: Heaped debris and refuse noted in west of site**

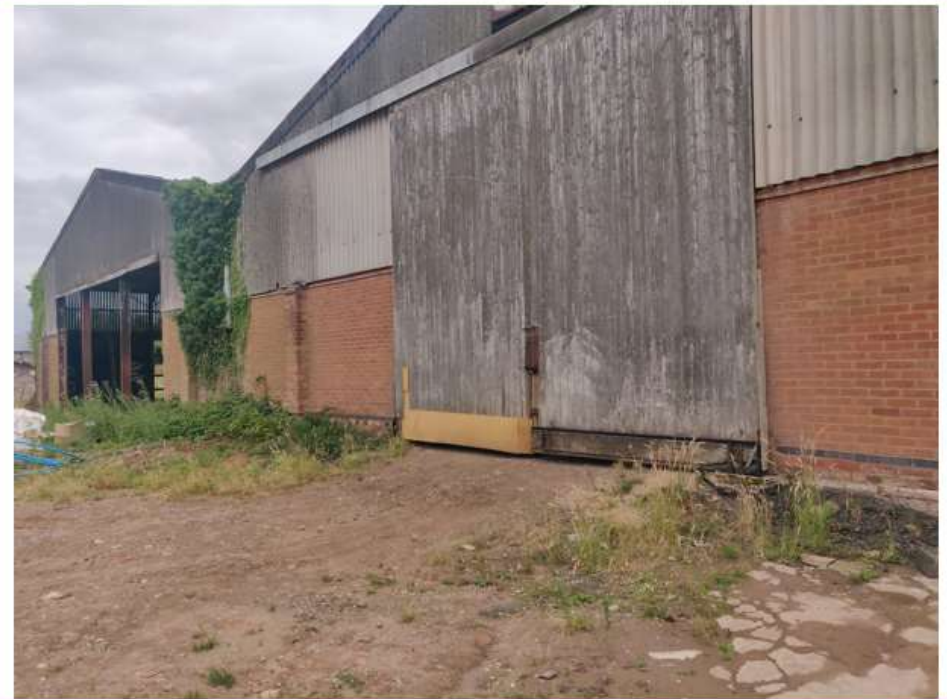
Potential sources of contamination noted on the walkover include PACM cladding and roofing (broken in areas and in pieces in others), significant made ground deposits site-wide and the storage of containers and tanks in the westernmost barn. Topographically, the site is largely level beyond a slight dip from the south to the north, with the surrounding areas also dipping off in this direction (with the new residential development north of site slightly downgradient from the site under review).

**Photo No.6: Facing SE showing front (northern) faces of barns and PACM-cladding**

**It is recommended that the structures on site be subject to an asbestos survey (and subsequent removal, if required) by appropriately qualified personnel. This should be carried out prior to any demolition or redevelopment occurring in order to ensure site works do not cause future contamination of the site.**

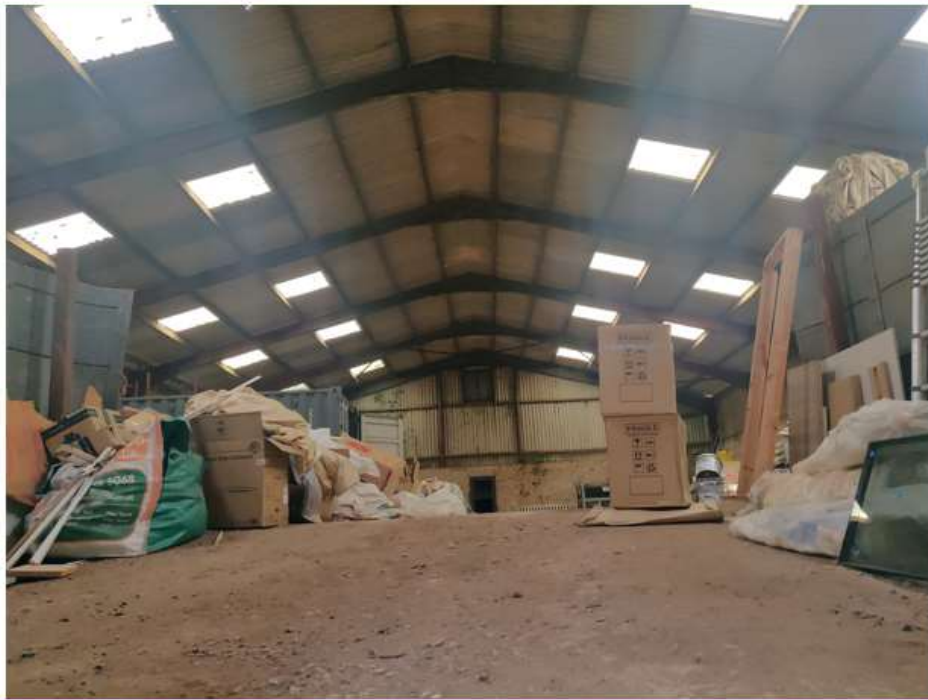
**Photo No.7: Facing south showing interior of westernmost barn with miscellaneous storages (i.e. construction materials)**

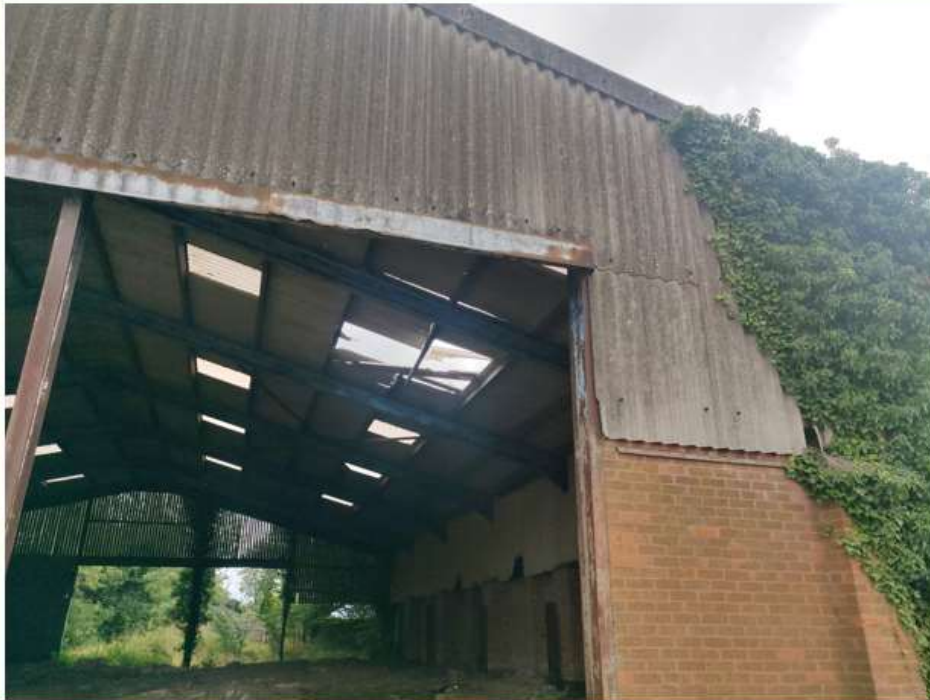
**Photo No.9: Showing PACM cladding on barns**

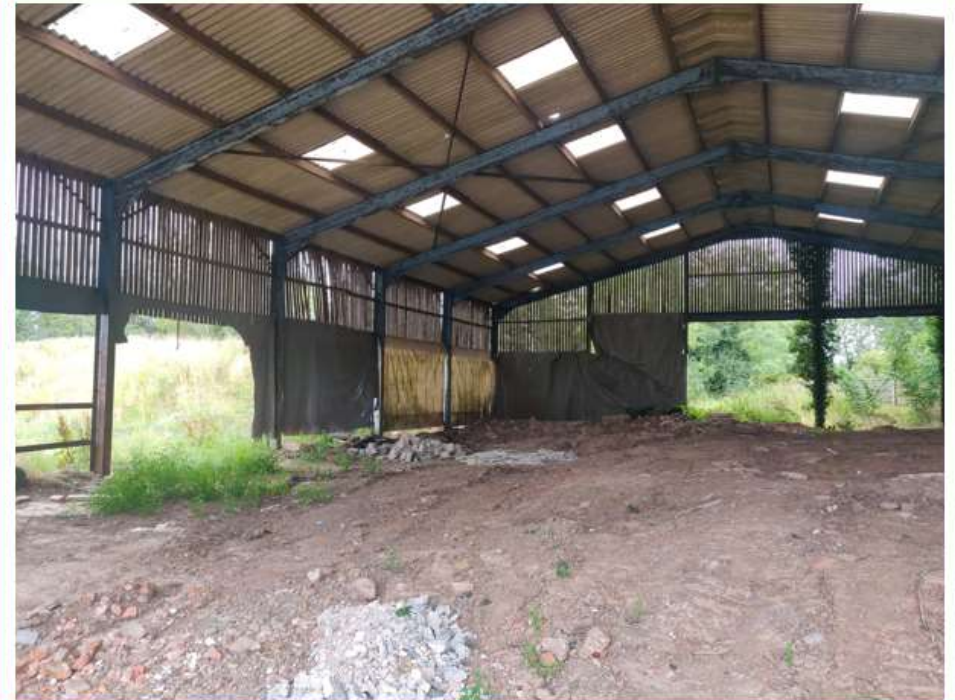
The easternmost barn, adjoined to that in the west, was then seen to be in a state of heavy disrepair, with the prior concrete flooring having been removed and made ground deposits (i.e. rubbles, some ash, road planings, brick and metal fragments) remaining insitu. Heaped stone, rubble, timber and Heras fencing were noted throughout this barn, alongside a heap of chemical containers (former contents and labelling largely obscured) located inside the north eastern corner of the barn.

**Photo No.10: facing south inside the eastern barn adjoined to that in the far west of site**

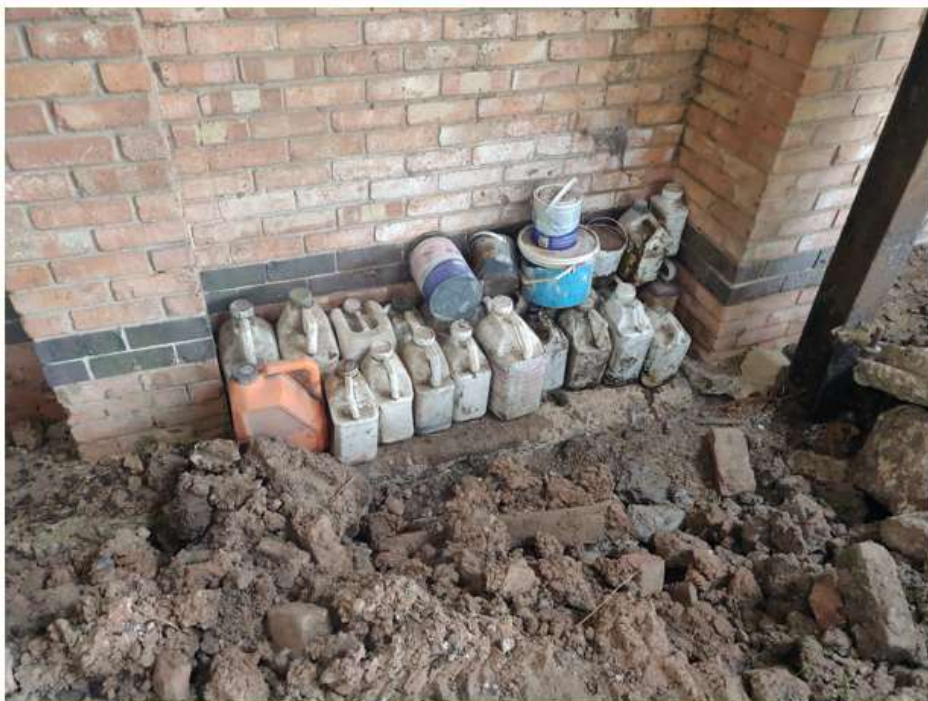
**Photo No.11: Containers noted stored in open-sided barn**

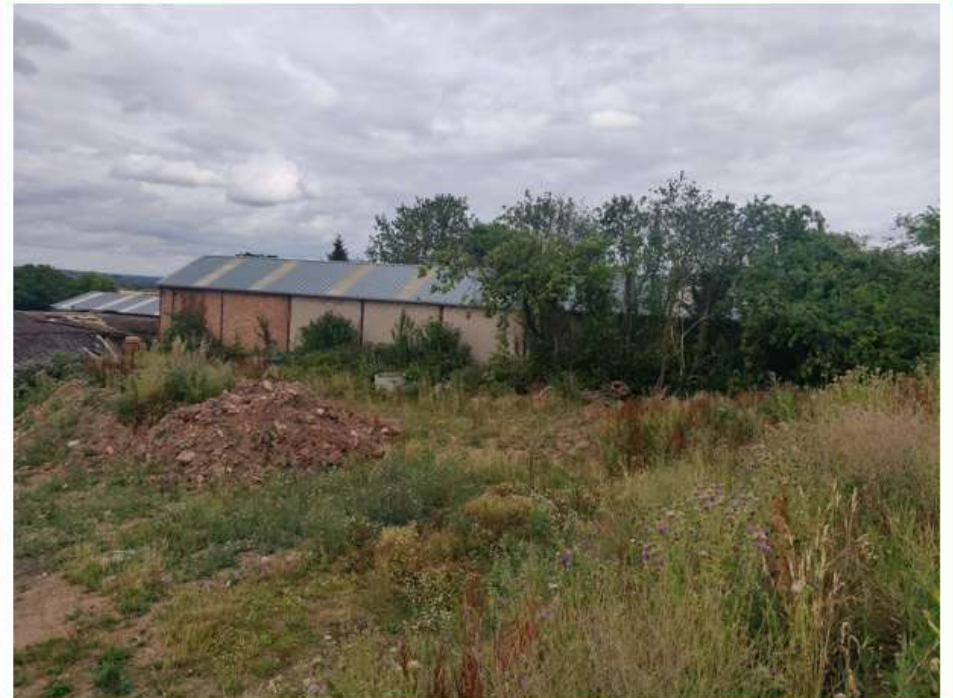
**Photo No.14: Facing east towards the eastern extent of site showing further heaps and vegetated heaps**

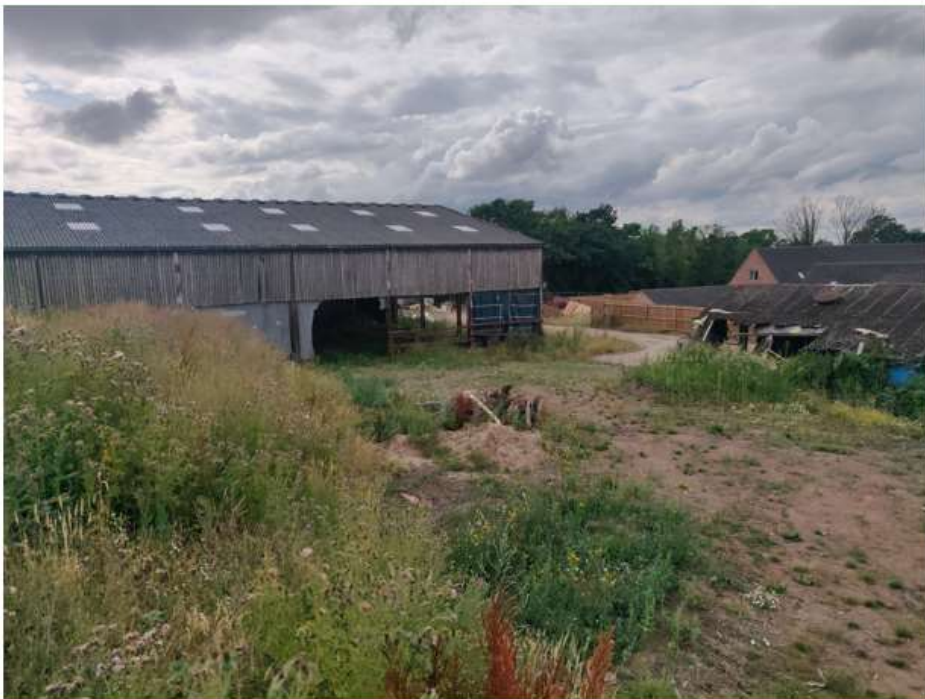
**Photo No.15: Facing NW in the east of site back towards the large barns and site access (further heaps noted)**

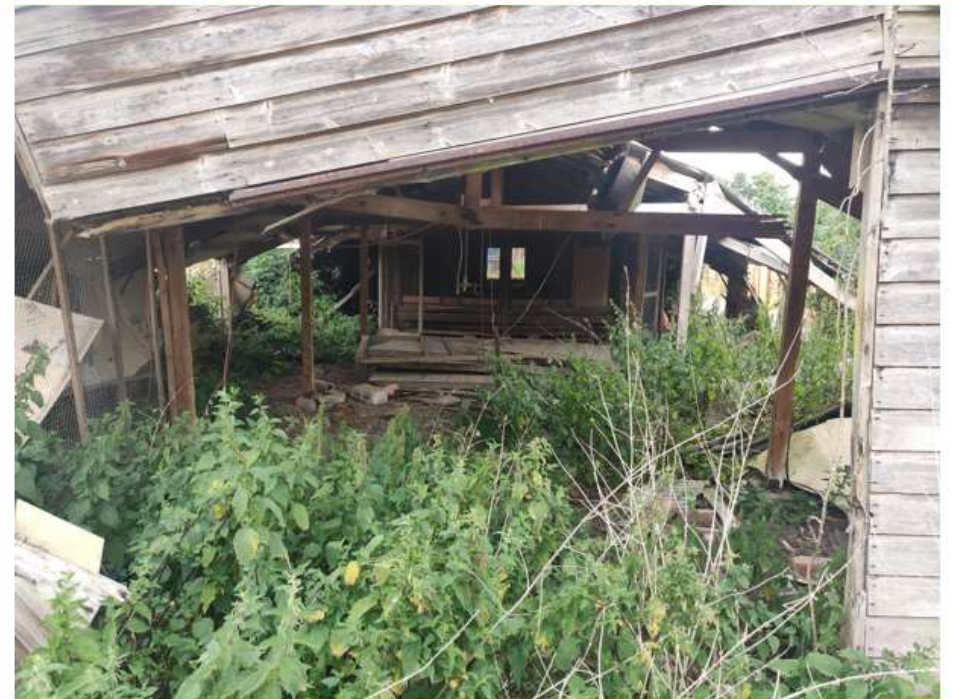
**Photo No.16: Facing west from outside the eastern face of the dilapidated linear barn forming the NE extent of site**

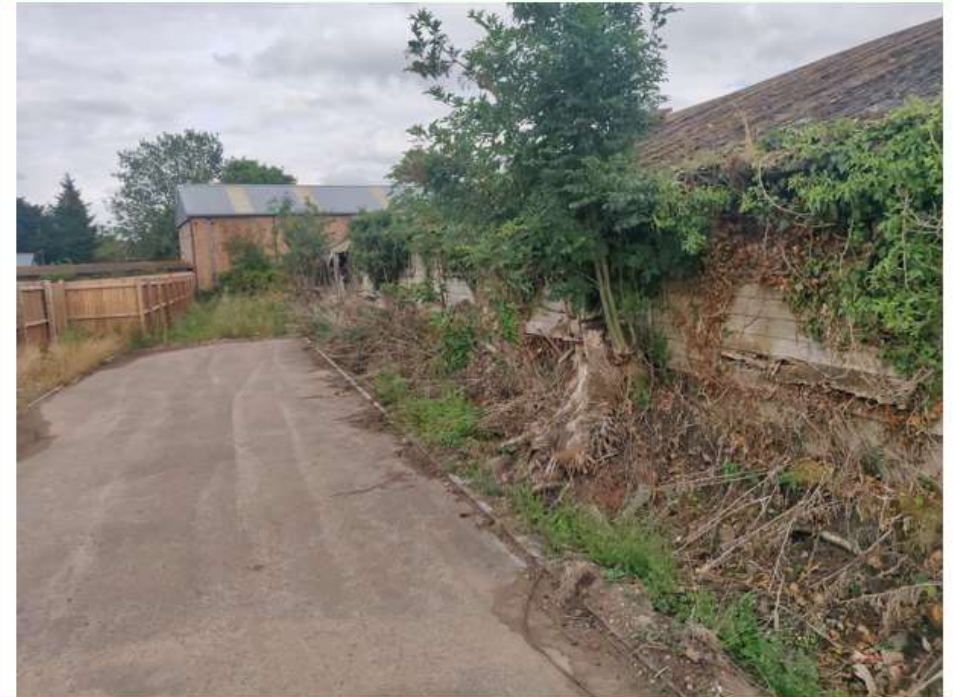
**Photo No.18: Facing east showing the rear (southern) face of the linear barn, dilapidated state and further PACM**

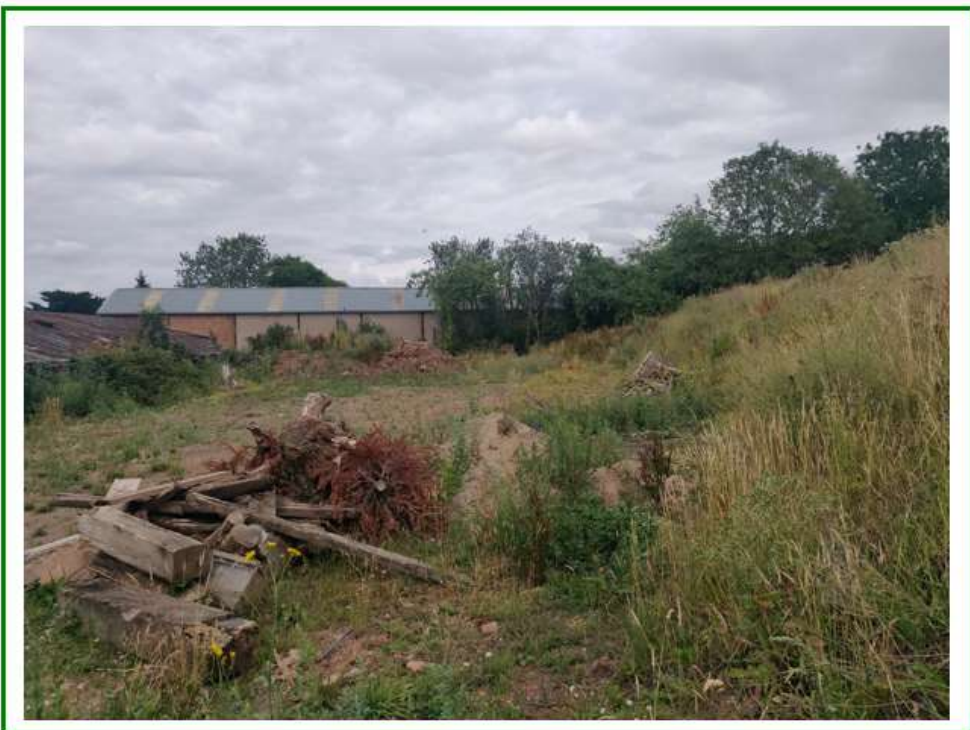
**Photo No.19: Facing east from the centre of site showing further heaped refuse and vegetated heaps forming SE of site**

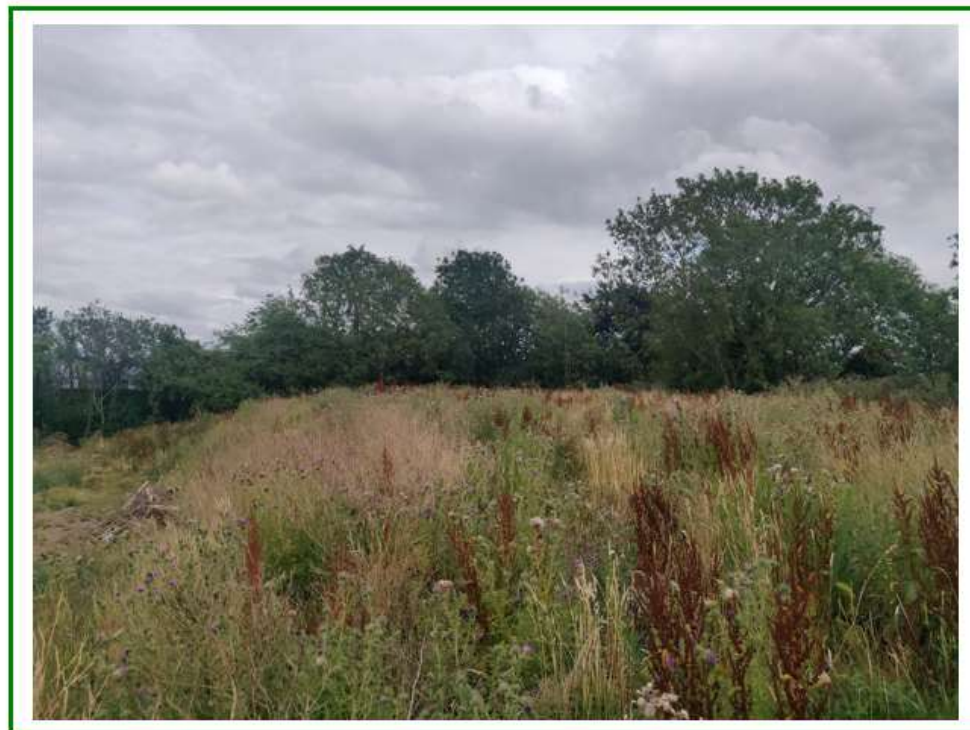
**Photo No.20: Overgrown vegetated heaps forming the eastern and SE extents of site**
