BS5837:2012 Tree Survey  
Land off Barton Lane  
Congerstone  
Leicestershire  
NGR SK36996 05611

Survey by  
Christopher Barker CEnv dipHort ACIEEM

# **BS5837 Tree Survey, Land off Barton Lane, Congerstone**

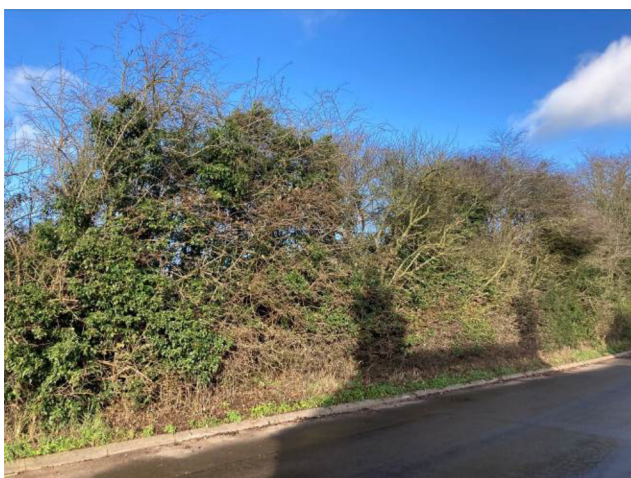
Hedgerow H1

**Hedgerow H1 – T10** form a linear canopy along Barton Road with the larger Oak dominating the eastern end. A number of the Oak are large mature specimens in good condition but are choked by dense ivy.

| Ref | Tree | Category | Potential Impact of development |
|---|---|---|---|
| H1 | Hedgerow | C2 | Likely to be trimmed to 1.8m to provide a dense tidy boundary screen. |

| Tree No | Species | Ht (m) | Stem Diam mm@ 1.5m | Canopy Spread (m) | Height of Crown Clearance | Age Class | Est yrs | Overall Condition | Structural condition | Recommendations | BS 5837 Category | RPA Radius (m) |
|---|---|---|---|---|---|---|---|---|---|---|---|---|
| H1 | Hedgerow | 3-5 | <200 | N-2<br>S-2<br>E-2<br>W-2 | 0 | M | 10+ | G | Side trimmed but not topped. Hawthorn, Holly, Elm, Oak, Blackthorn. | Top and trim. | C2 | 2.4 |

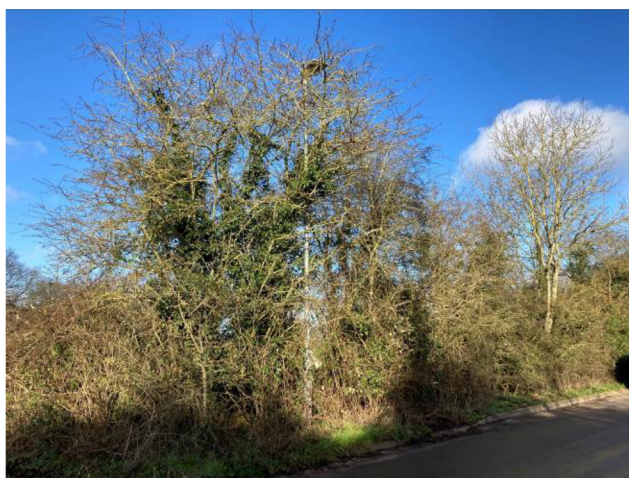
Ash T2 and T3 in H1

| Ref | Tree | Category | Potential Impact of development |
|---|---|---|---|
| T2 | Ash<br><i>Fraxinus excelsior</i> | C2 | Can presumably be retained in this boundary position. Crown poses no constraint. |
| T3 | Ash<br><i>Fraxinus excelsior</i> | C2 | Can presumably be retained in this boundary position. Crown poses no constraint. |

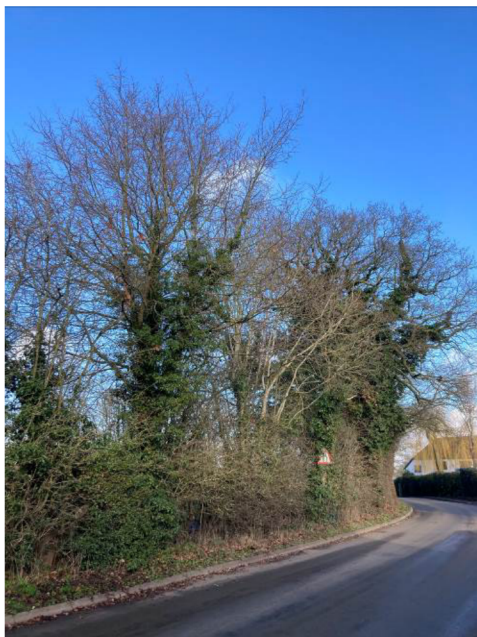
T4 and T5 in H1

| Ref | Tree | Category | Potential Impact of development |
|---|---|---|---|
| T4 | Oak<br><i>Quercus petraea</i> | B2 | Crown and RPA extending across the field boundary will require protection measures. |
| T5 | Ash<br><i>Fraxinus excelsior</i> | C2 | Crown and RPA extending across the field boundary will require protection measures. |

| Tree No | Species | Ht (m) | Stem Diam mm@ 1.5m | Canopy Spread (m) | Height of Crown Clearance | Age Class | Est yrs | Overall Condition | Structural condition | Recommendations | BS 5837 Category | RPA Radius (m) |
|---|---|---|---|---|---|---|---|---|---|---|---|---|
| T4 | Oak<br><i>Quercus petraea</i> | 8 | 230<br>150 | N-3<br>S-4<br>E-4<br>W-4 | 4 | Y | 20+ | G | Broadly ascending with dense ivy. No structural faults visible from ground level | Remove dense ivy growth. | B2 | 3.3 |

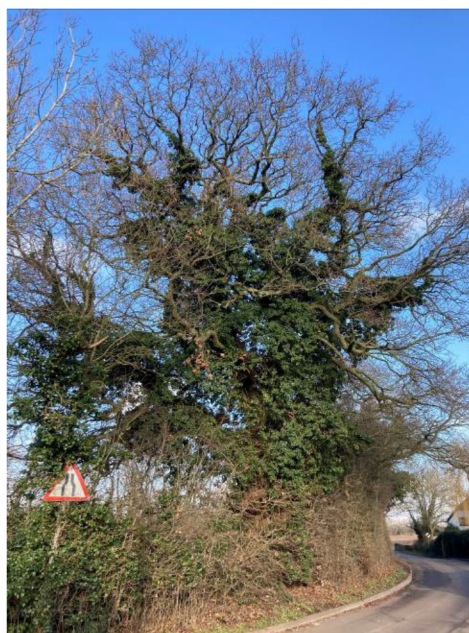
Oak T6

| Ref | Tree | Category | Potential Impact of development |
|---|---|---|---|
| T6 | Oak<br><i>Quercus petraea</i> | B1 | Large crown and RPA extending across the field boundary will require protection measures. |

| Tree No | Species | Ht (m) | Stem Diam mm@ 1.5m | Canopy Spread (m) | Height of Crown Clearance | Age Class | Est yrs | Overall Condition | Structural condition | Recommendations | BS 5837 Category | RPA Radius (m) |
|---|---|---|---|---|---|---|---|---|---|---|---|---|
| T6 | Oak<br><i>Quercus petraea</i> | 12 | 760 | N-6<br>S-7<br>E-5<br>W-6 | 3 | M | 20+ | G | Broad crown choked by dense ivy. No structural faults visible from ground level | Remove dense ivy growth. | B1 | 9.1 |

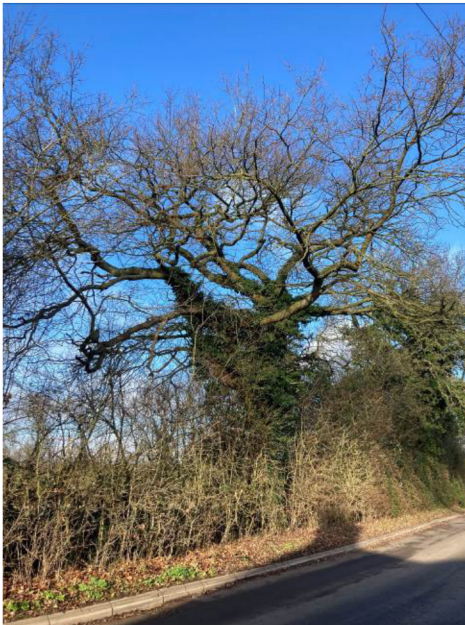
Oak T7

| Ref | Tree | Category | Potential Impact of development |
|---|---|---|---|
| T7 | Oak<br><i>Quercus petraea</i> | B2 | Large crown and RPA extending across the field boundary will require protection measures. |

| Tree No | Species | Ht (m) | Stem Diam mm@ 1.5m | Canopy Spread (m) | Height of Crown Clearance | Age Class | Est yrs | Overall Condition | Structural condition | Recommendations | BS 5837 Category | RPA Radius (m) |
|---|---|---|---|---|---|---|---|---|---|---|---|---|
| T7 | Oak<br><i>Quercus petraea</i> | 11 | 685 | N-7<br>S-7<br>E-6<br>W-6 | 4 | M | 20+ | G | Broad balanced crown. Minor dead wood throughout. No structural faults visible from ground level | | B2 | 8.2 |

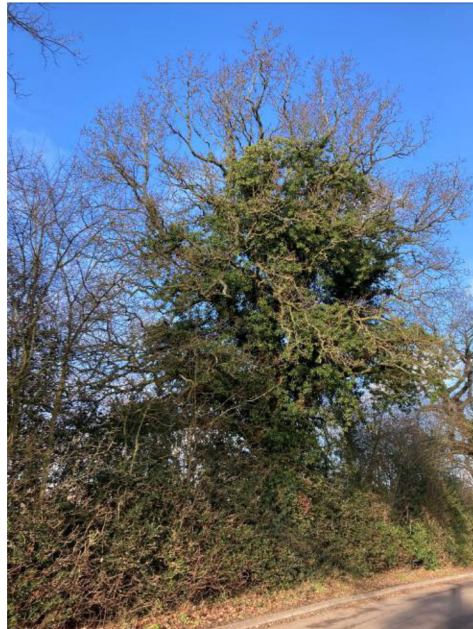
Oak T8

| Ref | Tree | Category | Potential Impact of development |
|---|---|---|---|
| T8 | Oak<br><i>Quercus petraea</i> | B1 | Large crown and RPA extending across the field boundary will require protection measures. |

| Tree No | Species | Ht (m) | Stem Diam mm@ 1.5m | Canopy Spread (m) | Height of Crown Clearance | Age Class | Est yrs | Overall Condition | Structural condition | Recommendations | BS 5837 Category | RPA Radius (m) |
|---|---|---|---|---|---|---|---|---|---|---|---|---|
| T8 | Oak<br><i>Quercus petraea</i> | 14 | 735 | N-6<br>S-6<br>E-6<br>W-6 | 4 | M | 20+ | G | Broad crown choked by dense ivy. No structural faults visible from ground level | Remove dense ivy growth. | B1 | 8.8 |

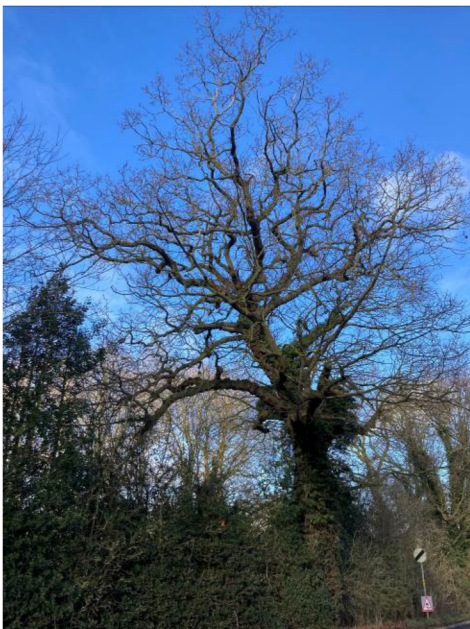
Oak T9

| Ref | Tree | Category | Potential Impact of development |
|---|---|---|---|
| T9 | Oak<br><i>Quercus petraea</i> | B1 | Large crown and RPA extending across the field boundary will require protection measures. |

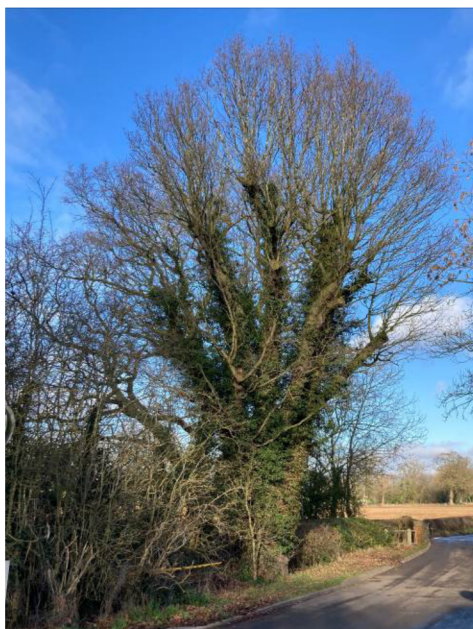
Oak T10

| Ref | Tree | Category | Potential Impact of development |
|---|---|---|---|
| T10 | Oak<br><i>Quercus petraea</i> | B1 | Large crown and RPA extending across the field boundary will require protection measures. |

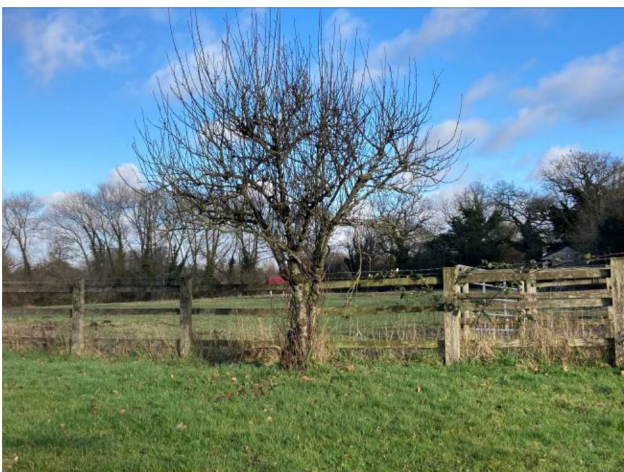
Apple T11

**Apple T11 and Cherry T12** are small specimen trees in the road verge along Chapel Lane adjacent to the western boundary of the survey area.

| Ref | Tree | Category | Potential Impact of development |
|---|---|---|---|
| T11 | Apple<br><i>Malus domestica</i> | C2 | Can presumably be retained in this boundary position. Crown poses no constraint. |

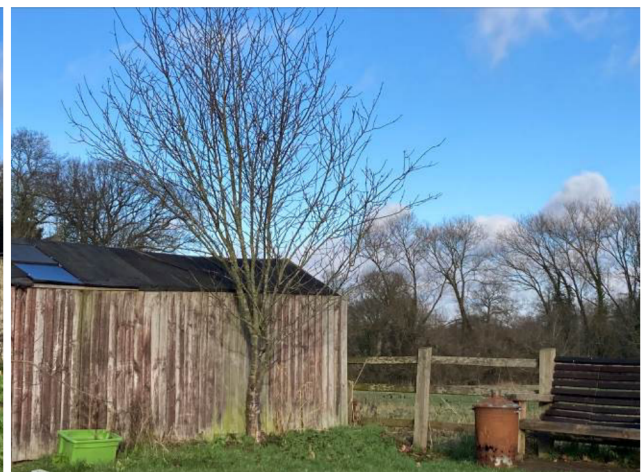
Cherry T12

| Ref | Tree | Category | Potential Impact of development |
|---|---|---|---|
| T12 | Cherry<br><i>Prunus avium</i> | C2 | Can presumably be retained in this boundary position. Crown poses no constraint. |

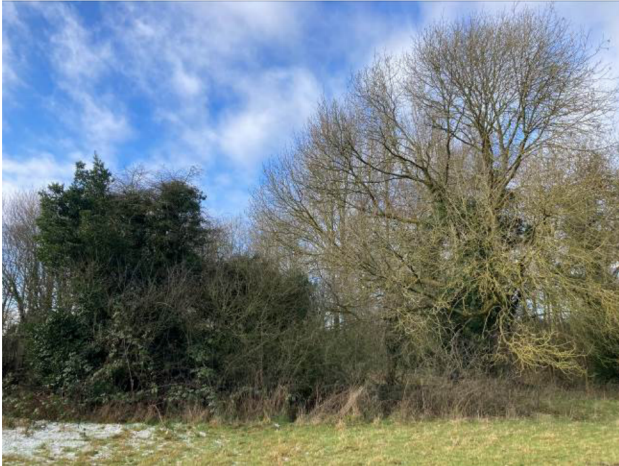
Hedgerow H13 and Ash T14

**Hedge H13 and Ash T14** are positioned in the interior of the survey area at the north end of Chapel Lane extending toward the small stream on the northern boundary. H13 comprises untrimmed Holly and Hawthorn forming a dense thicket. Ash T14 is a very large tree with a broad crown. This tree has a very deep stress fracture running through the centre of the trunk to the main crown junction which is a cause for concern as it is a point of weakness which may result in structural failure of this tree.

| Ref | Tree | Category | Potential Impact of development |
|---|---|---|---|
| H13 | Hedgerow | C2 | Likely to be trimmed back or entirely removed if access is required through this part of the field |

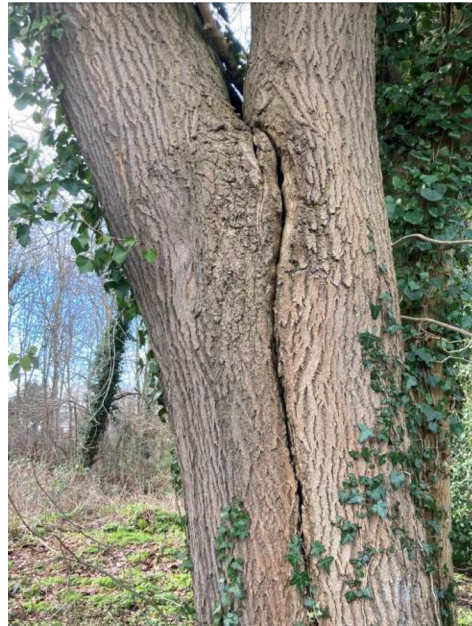
Stress fracture on Ash T14

| Ref | Tree | Category | Potential Impact of development |
|---|---|---|---|
| T14 | Ash<br><i>Fraxinus excelsior</i> | C2 | Likely to be removed as the structural concerns make this tree unsuitable for retention close to buildings or structures |

| Tree No | Species | Ht (m) | Stem Diam mm@ 1.5m | Canopy Spread (m) | Height of Crown Clearance | Age Class | Est yrs | Overall Condition | Structural condition | Recommendations | BS 5837 Category | RPA Radius (m) |
|---|---|---|---|---|---|---|---|---|---|---|---|---|
| T14 | Ash<br><i>Fraxinus excelsior</i> | 18 | 700<br>240 | N-7<br>S-6<br>E-9<br>W-7 | 3 | M | 10 | F | Broad crown extending east. Large stress fracture through centre of trunk. <b>Tree may be structurally compromised in the main trunk.</b> | Consider removal if close to new development. | C2 | 8.8 |

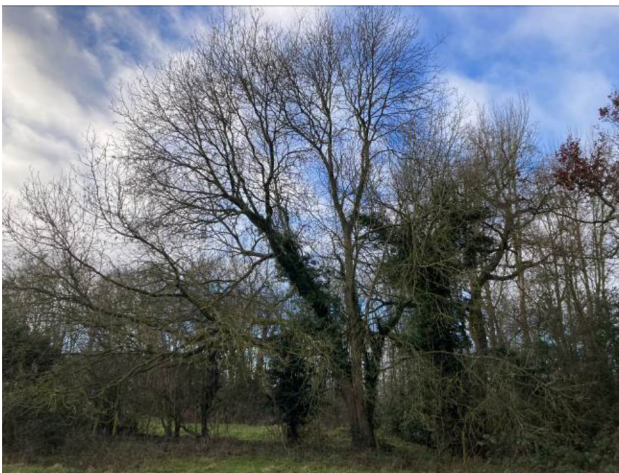
T15 and T16

**Trees T15 – T20** run along the northern and western edge of the field to the north of Chapel Lane. There is significant badger activity in this location and the trees run along the top edge of the flood zone of the stream forming a merging linear canopy. Oak and Sycamore dominate.

| Ref | Tree | Category | Potential Impact of development |
|---|---|---|---|
| T15 | Oak<br><i>Quercus petraea</i> | C2 | Large crown and RPA extending across the field boundary will require protection measures. |
| T16 | Oak<br><i>Quercus petraea</i> | B2 | Large crown and RPA extending across the field boundary will require protection measures. |

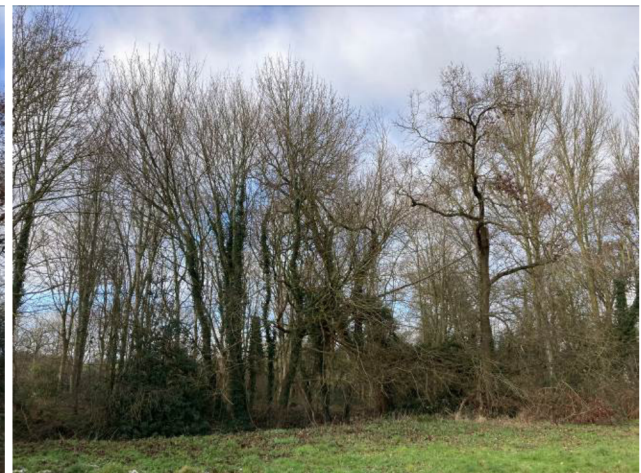
T20 (right) T17-T19 (left)

| Ref | Tree | Category | Potential Impact of development |
|---|---|---|---|
| T20 | Elm<br><i>Ulmus spp</i> | C2 | Crown and RPA extending across the field boundary will require protection measures. |

| Tree No | Species | Ht (m) | Stem Diam mm@ 1.5m | Canopy Spread (m) | Height of Crown Clearance | Age Class | Est yrs | Overall Condition | Structural condition | Recommendations | BS 5837 Category | RPA Radius (m) |
|---|---|---|---|---|---|---|---|---|---|---|---|---|
| T17 | Oak<br><i>Quercus petraea</i> | 12 | 325 | N-6<br>S-<br>E-<br>W- | 5 | SM | 10 | P | Leader lost at 7m. Irregular remaining crown extending east. <b>Lost leader may allow decay into the trunk interior.</b> | Consider removal if close to new development. | C2 | 3.9 |

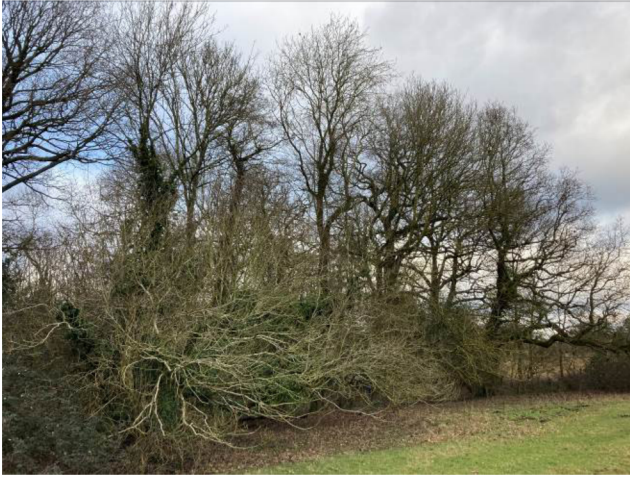
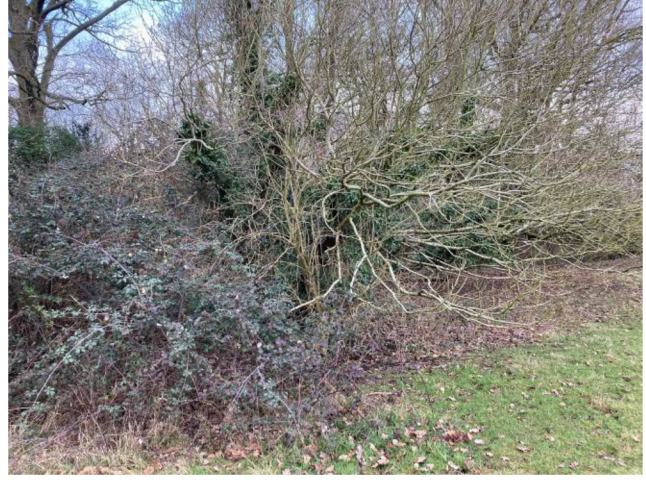
T22 – T25

**Trees T201 – T27** run along the northern edge of the field where the ground starts to fall towards the river. These trees form a linear canopy line, quite dense in places, with Oak dominating and occasional Ash present. There is dense Holly, Hawthorn and Blackthorn under canopy along the field edge.

| T22 | Ash<br><i>Fraxinus excelsior</i> | C2 | Large crown and RPA extending across the field boundary will require protection measures. |
| T23 | Oak<br><i>Quercus petraea</i> | B2 | Large crown and RPA extending across the field boundary will require protection measures. |
| T24 | Oak<br><i>Quercus petraea</i> | B2 | Large crown and RPA extending across the field boundary will require protection measures. |
| T25 | Ash<br><i>Fraxinus excelsior</i> | B2 | Large crown and RPA extending across the field boundary will require protection measures. |

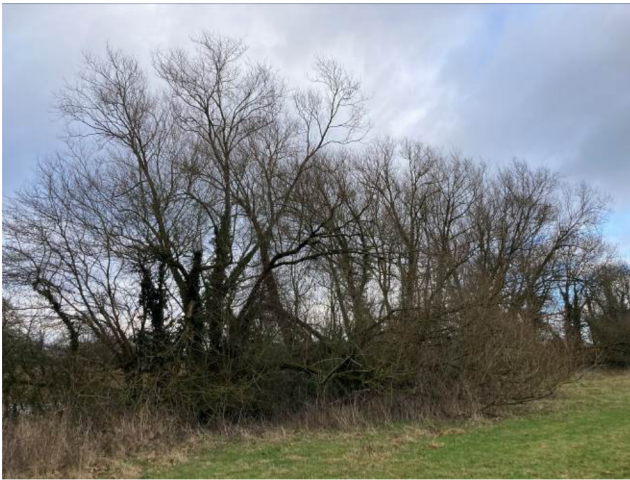
Crack Willow G28

Along the north eastern edge of the field is a line of dense **Crack Willow G28**. These trees have significant fallen timber and the crown along the south side has dropped to ground level and extend some distance into the field interior.

| G28 | 5 x Crack Willow<br><i>Salix fragilis</i> | B2 | Likely to require dead wood and low branches to be removed. RPA and canopies will require sufficient space to protect any new structures. |

| Tree No | Species | Ht (m) | Stem Diam mm@ 1.5m | Canopy Spread (m) | Height of Crown Clearance | Age Class | Est yrs | Overall Condition | Structural condition | Recommendations | BS 5837 Category | RPA Radius (m) |
|---|---|---|---|---|---|---|---|---|---|---|---|---|
| G28 | 5 x Crack Willow<br><i>Salix fragilis</i> | 20+ | <750 | Varies up to 9m south | 0 | OM | 20 | F | Liner of dense Willow merging along stream edge. Significant fallen wood on the south side with branches lying on the ground along the field edge. Large, cracked branches of structural concern. | Remove dead wood and trim back crown. | B2 | 9.0 |
