**BELLWAY HOMES DEVELOPMENT**  
**DESFORD LANE, RATBY**  
**SECTION 278 WORKS**  
STAGE 2 ROAD SAFETY AUDIT

SA 4774  
December 2024

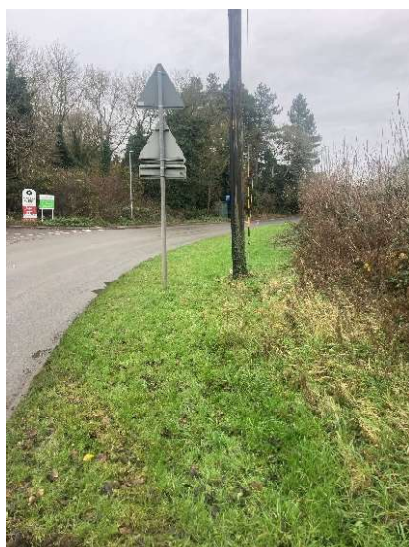
**Location:** Looking north from the proposed Toucan crossing near to the Pear Tree Business Park access.

**Summary:** **Risk of vehicles colliding with pedestrians on the crossing**

The position of the crossing location is immediately to the south-west of a relatively tight left-hand bend on Desford Lane for traffic heading south-westbound out of Ratby village centre. As such, the visibility splay for drivers of vehicles approaching the bend and crossing is reduced as is the visibility north along Desford Lane for pedestrians on the eastern side of the road waiting to cross the road. This visibility issue is exacerbated by the presence of a mature hedgerow to the rear of the highway corridor and a telegraph pole as well as existing traffic signs in the verge on the eastern side of the road in this location. If drivers cannot fully observe the crossing on their approach to it, there is a risk of them failing to see it in time to stop at a red signal and/or if a pedestrian is on the crossing, resulting in a risk of vehicles overshooting and potentially colliding with pedestrians crossing the road.

It is recommended that measures to improve visibility of the crossing and associated signal heads is improved for vehicles approaching it from the north. This could be achieved by moving the proposed position of the crossing or implementing measures to improve sightlines along the approach.

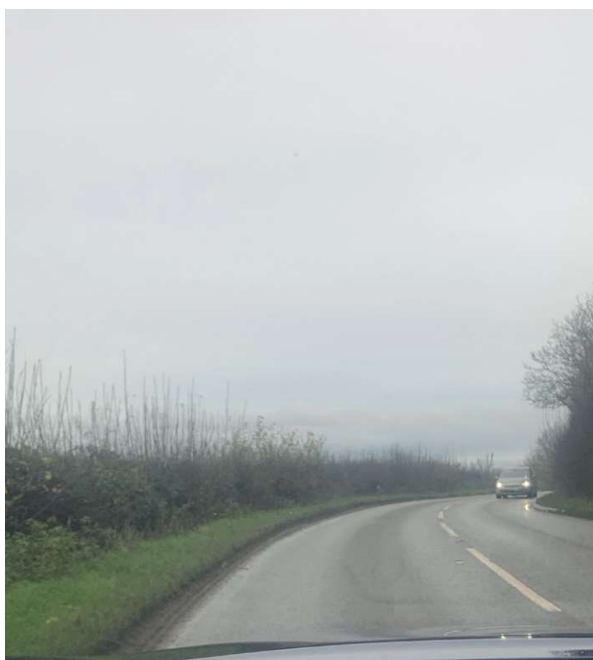
The Audit Team is concerned that the position of the proposed site access junction on the south-east side of Desford Lane is situated on a slight curve and at the brow of a hill. The resulting topography means that the land drops away to either side on Desford Lane so that visibility of oncoming vehicles in both directions is partially obscured by the cresting of the road in each direction. This issue is exacerbated by quite dense vegetation growing to the rear of the highway corridor, particularly to the north of the junction.

View looking south-west: note curve in road alignment and cresting issue

It is recommended that measures be implemented to ensure that visibility of oncoming vehicles in each direction from the site access is not obscured by limitations imposed by the existing horizontal or vertical alignment of the road and/or vegetation growth.

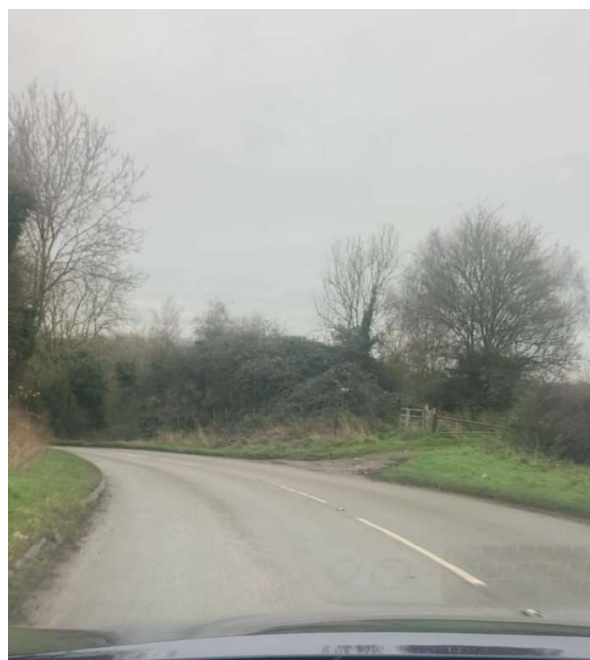
View looking north-east: similar issues with alignment and cresting
