# ARBORICULTURAL TREE INSPECTION REPORT

Visual Tree Assessment (ground-level and UAV-assisted) of four Corsican pines (*Pinus nigra* subsp. *laricio*), T1–T4

| Site address | 5 Church Road, Witherley, Atherstone, CV9 3NA |
| Date of report | 9 October 2026 |

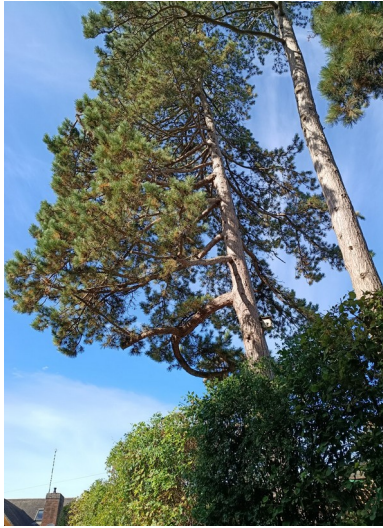
The aerial imagery confirms the ground-level finding that the trees carry several long, heavy, sweeping laterals (Photographs 1, 4, 8 and 9). The most significant is a large, curving limb with a pronounced reverse curve on T1. It extends from the stem towards or over the roof of the neighbouring dwelling and the client's timber outbuilding with roof-mounted solar panels (Photograph 9). On mature pines, long horizontal or recurved limbs develop considerable end-weight and leverage. They typically fail at or near the union, or at points of bending, under wind, snow or ice loading. Because the targets beneath include two dwellings (the neighbouring dwelling under T1 and the client's house under T4), the client's solar-panelled outbuilding, a garden/patio and vehicles parked on the neighbour's driveway, the consequences of failure could be serious. Because T1 also leans towards buildings, its risk has been upgraded to moderate-high. T4 also leans towards buildings, and the inspector found that its branches overhang the client's house. It also has long laterals over the neighbour's drive and buildings. No defects or root-plate heave were seen at its base, but because the client's house is a constantly occupied target beneath a leaning tree, T4 is also rated moderate-high. T3 has a history of limb failure and also leans, so it is rated moderate-high. T2 leans and contains deadwood but has no failure history, and is rated moderate.

Photograph 1: Looking up at T1 from the driveway side, showing its long, low, curving side branch.

A crown height reduction of approx. 3 m on all four trees is recommended, together with reduction of the long, heavy laterals by approx. 3 m, to reduce sail area, leverage and end-weight. This matters most because all four trees lean (T1 and T4 towards buildings) and because limbs extend over the neighbouring dwelling (T1), the client's house (T4), the client's solar-panelled outbuilding and the neighbour's driveway. Laterals that show signs of being failure-prone during the works should be reduced or removed. Pines respond poorly to heavy reduction: they do not reliably regenerate from bare wood, and cutting back to sections without live needles is likely to cause dieback. Each cut should be made to a suitable needle-bearing growth point, with the crown shape kept balanced and the group canopy retained. Heavy topping or blanket reduction is not appropriate. The works are specified in Section 6.1.

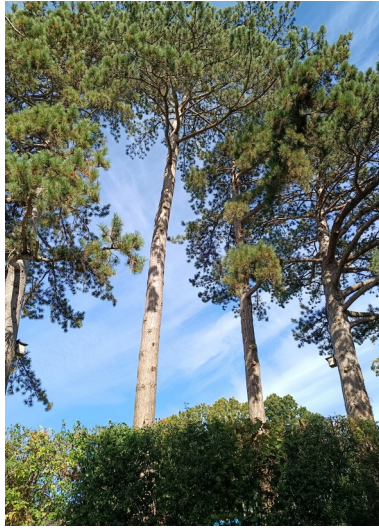
Photograph 2: The tall, bare lower trunks and high crowns of the pines rising above the hedge. Bird or bat boxes are fixed to two of the trunks.

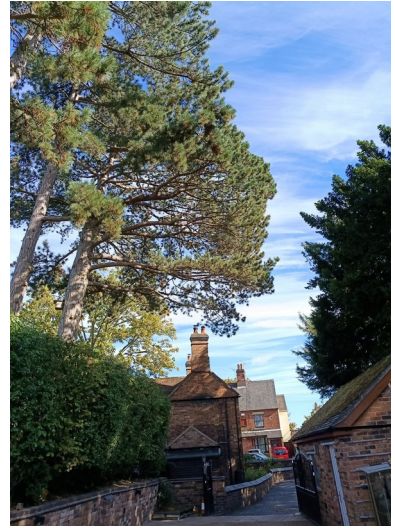
Photograph 3: Looking along the neighbour's driveway, with the pine branches spreading over the drive and the brick outbuilding and houses beyond.

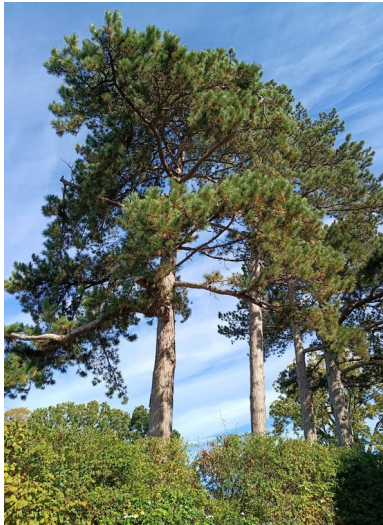
Photograph 4: The row of pines seen from the driveway side. A long side branch reaches out from the left-hand tree, and some brown needles can be seen.

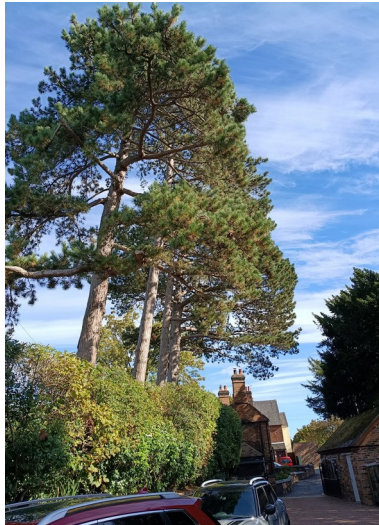
Photograph 5: The pines above the hedge, with cars parked on the neighbour's driveway below and the brick outbuilding and houses beyond.

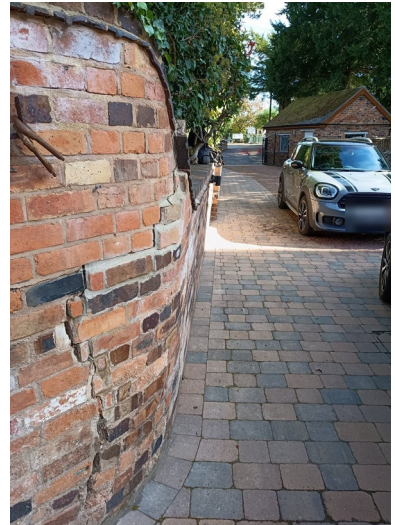
The curved brick wall retaining the raised bed (Photograph 6) is on the neighbouring property (inspector confirmation). It shows outward bulging, vertical and stepped cracking, open or lost mortar joints and displaced bricks, immediately next to the neighbour's driveway. Possible contributing factors include lateral soil pressure from the raised bed, poor drainage, frost action, the age and condition of the mortar, and radial root growth from the pines and hedge. The trees may have contributed, given their proximity, but this cannot be confirmed without investigation, and other causes are equally possible. Displaced bricks could fall onto the drive, and further movement could lead to partial collapse.

Photograph 6: The curved brick wall beside the neighbour's driveway, which is bulging and cracked, with loose and missing bricks. The car's number plate has been hidden.

Because the wall is not on the client's land, it is a matter to raise with the neighbouring owner. The client is advised to notify the neighbour of the wall's condition promptly, preferably in writing, and to share the relevant findings of this report. The neighbour should be invited to consider interim precautions, such as keeping vehicles and people away from the bulging section and removing loose bricks. A structural engineer's assessment is recommended, with its scope, commissioning and cost to be agreed with the neighbour. Any repair or rebuild should take account of the client's trees: their root protection areas (RPAs) under BS 5837:2012 (radius of  $12 \times \text{DBH}$ ; approx. 8.4–15.0 m across the four trees) are likely to extend beneath the wall and drive. Excavation for new foundations could sever significant structural roots and affect tree stability and health. Tree-sensitive solutions (for example bridging over roots, discontinuous or pier-and-beam footings, or flexible construction) should be considered. Any root exploration should be carried out by hand or air-spade under arboricultural supervision, with the agreement of both owners.

| No. | Recommendation | Tree / item | Priority | Timescale |
|---|---|---|---|---|
| 1 | Notify the neighbouring owner in writing of the condition of the retaining wall (on their land) and share the relevant findings. Suggest interim precautions (keeping vehicles and people away from the bulging section; removing loose bricks). | Wall (neighbour) | High | Immediately |
| 2 | Structural engineer's assessment of the wall, with scope, commissioning and cost to be agreed with the neighbour. Coordinate any repair design with an arboriculturist, in line with BS 5837:2012. | Wall (neighbour) | High | Within 1 month (subject to neighbour's agreement) |

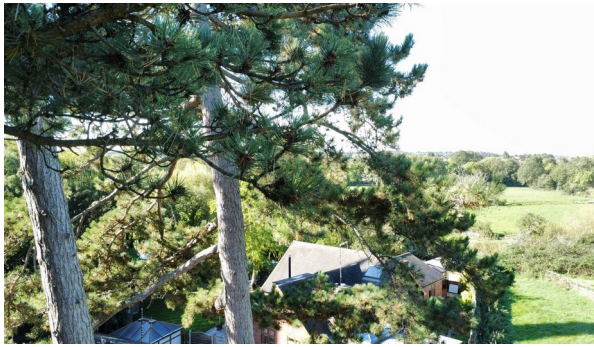
*Photograph 7: Drone view between two of the trunks, showing a pale dead branch inside the crown of T1. The neighbour's house roof and a glass-roofed garden building are below, with the paddock beyond.*

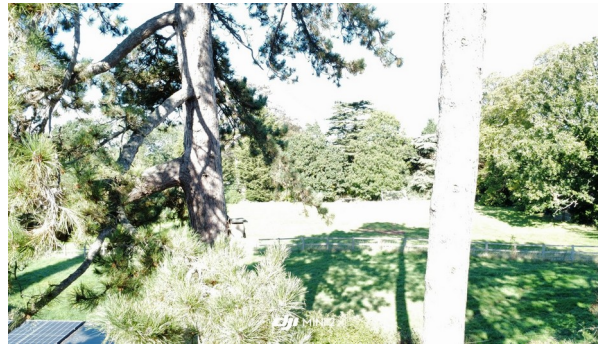
The inspector confirmed on site that T3 has evidence of previously failed limbs. Snapped or torn branch stubs and old wounds are also visible in the aerial photographs (Photographs 8 and 11). No previous failures were identified on T1, T2 or T4. Some may be natural self-pruning of shaded lower branches, but torn stubs on larger limbs show that failures have occurred in the crown. Earlier failure is a recognised indicator of a raised likelihood of future failure in similar parts of the tree, so T3 is regarded as failure-prone. Torn stubs can also

*Photograph 8: Drone view of long, heavy side branches and old broken branch stubs, with one branch hanging down towards the client's outbuilding with solar panels.*

allow decay to enter. During the works, T3's remaining limbs with similar form or defects should be identified and reduced or removed, and its torn stubs cut back. All four trees also contain deadwood, including a pale, largely needle-less lateral visible in the inner crown (Photograph 7). Dead branches over the client's house, the neighbouring dwelling, the client's solar-panelled outbuilding, other outbuildings, greenhouse, patio and the neighbour's driveway could cause damage or injury if they fall. Deadwood over targets should be removed (typically dead branches over about 25 mm in diameter, or as specified), and torn stubs cut back to sound tissue or the branch collar, under BS 3998:2010.

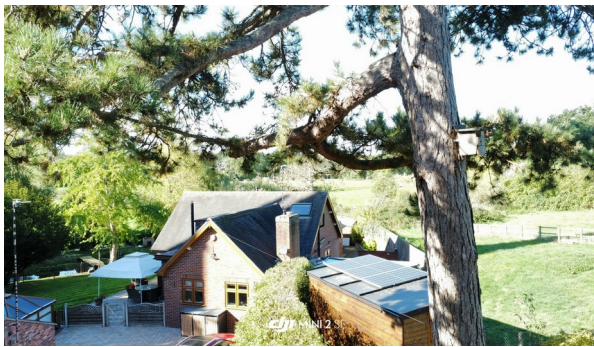
*Photograph 9: Drone view of T1's large curving branch reaching over the neighbour's house and the client's outbuilding with solar panels.*

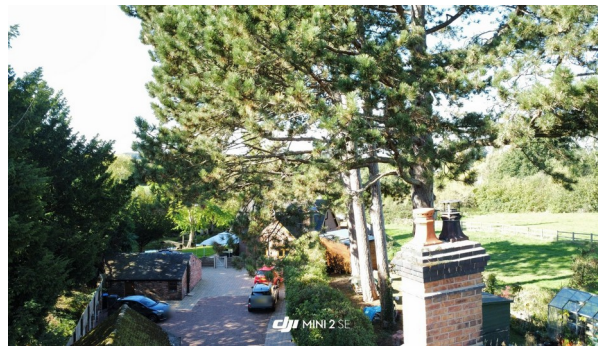
*Photograph 10: Drone view along the neighbour's driveway, showing branches over the drive and parked cars, the brick outbuilding, a chimney, the client's outbuilding, a greenhouse and the paddock. Number plates have been hidden.*

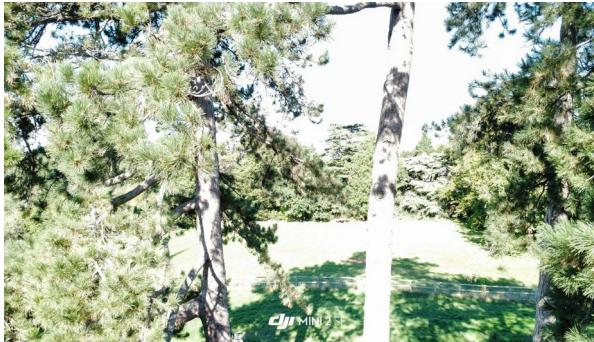
*Photograph 11: Drone view of T3's trunk, showing short, broken branch stubs where branches have snapped off in the past.*

| Tree | Crown height reduction | Lateral (limb) reduction | Other works |
|---|---|---|---|
| T3 (18 m) | Approx. 3 m | Reduce or remove failure-prone limbs (those with similar form or defects to the failed limbs). | Cut torn stubs back to sound tissue or the branch collar. Remove deadwood. Lean monitoring (No. 6). |

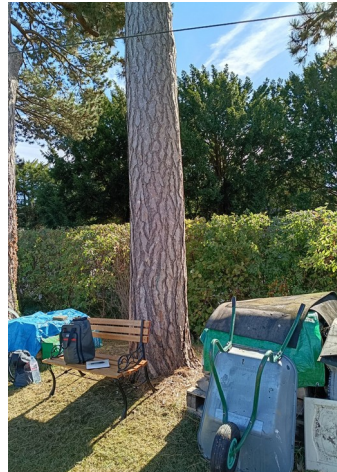
The inspector checked the bases and root flares of all four trees from the garden side (Photograph 12) and found no fungal fruiting bodies, cavities, cracks or root-plate heave. This suggests that the lean of the trees is more likely to be long-standing than recent, but it does not prove this. Because the trees grow on a raised bed with a moving retaining wall, the soil around all four trees should continue to be checked for heave or cracking as part of ongoing monitoring. The lean of all four trees should be measured (for example with a clinometer or inclinometer from fixed, recorded reference points) to give a baseline, and photographs should be taken from fixed positions. Measurements should be repeated at each re-inspection and after severe wind. Any increase in lean, or signs of root-plate movement, should be treated as urgent.

- Root protection areas:** garden items are stored around the stem bases (Photograph 12). Storage, vehicle parking, soil level changes and heavy use within the RPAs should be avoided where practicable, to prevent soil compaction and root damage.

*Photograph 12: The base of one of the pines, seen from the client's garden, with a bench, wheelbarrow and other items stored around it. No defects were found at the bases of any of the four trees.*
