**Report on a  
Phase 1 & 2  
Geoenvironmental Investigation  
For A  
Proposed Development  
On A Site Off  
Main Street  
Nailstone**

**On Behalf of Michael Beeston**

Report by: Paul Palgrave BSc (Hons) ARSM MSc C.Geol FGS  
Date: January 2025  
Report No. 746-R-01

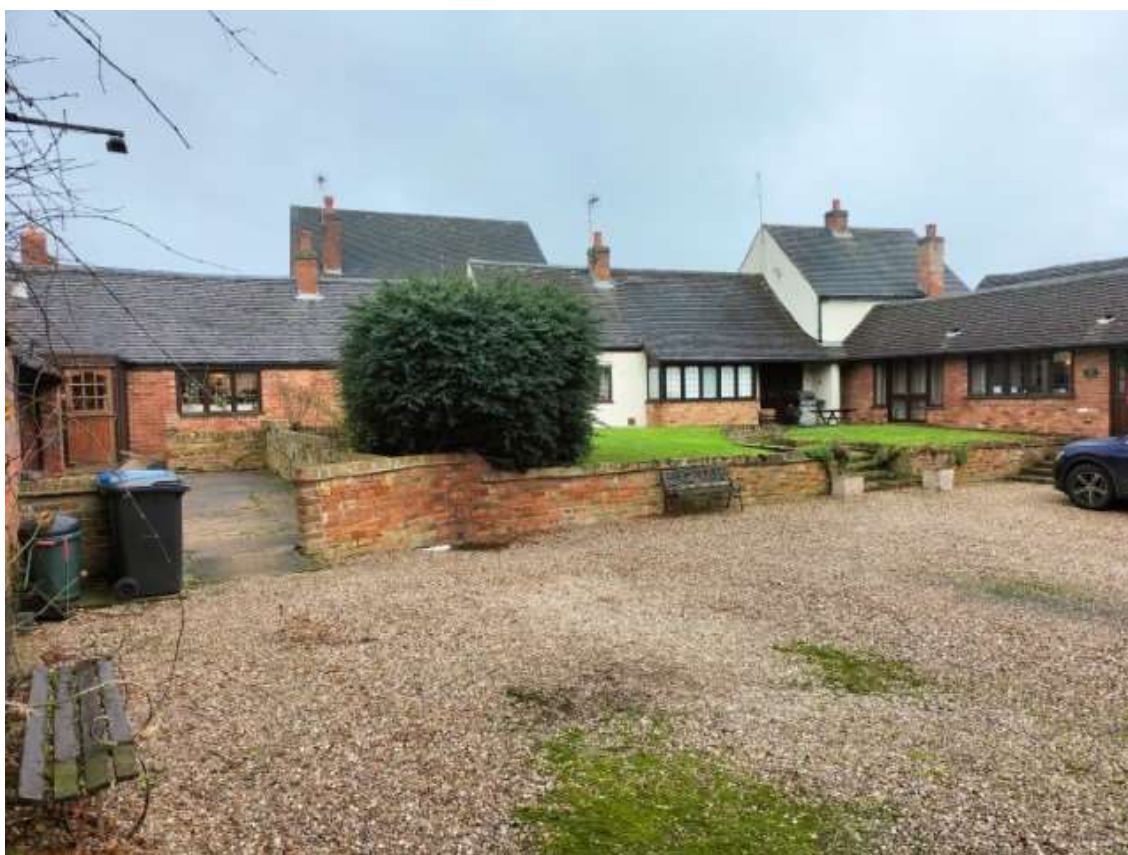
12. View towards the dwellings along the eastern side of the quadrangle. Raised soft landscaped garden constructed from imported topsoil taken from the adjacent field.

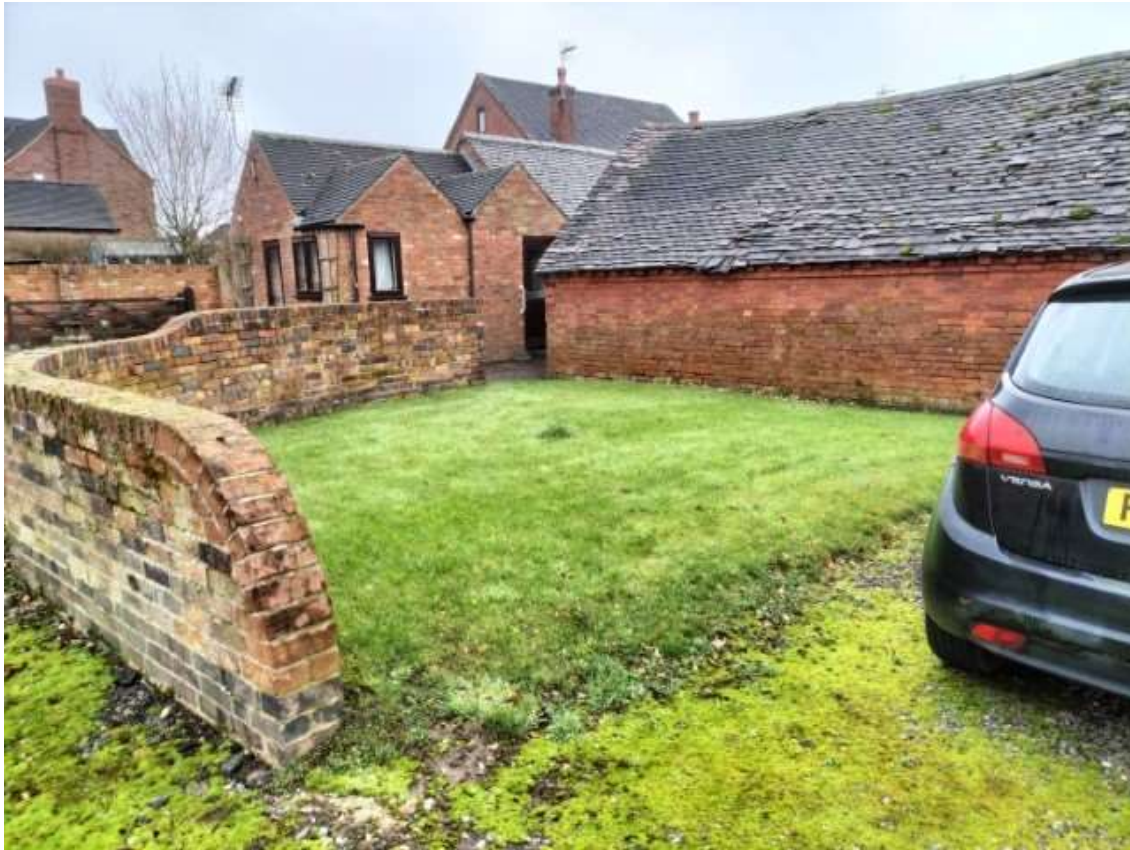
25. Area of infilled former pond located close to the north-eastern corner of the quadrangle.

The infilled pond near the north-eastern external corner of the quadrangle of buildings is considered to present a potential source of contaminated soil and hazardous ground gases, depending on the nature of the infill.

The on-site infilled pond may still represent a source of hazardous ground gases along with being a source of contaminated soil, including potentially asbestos containing materials (ACMS), toxic heavy metals, polycyclic aromatic hydrocarbons, petroleum hydrocarbons, depending on the source and nature of the infill materials.

As the pond was infilled by 1955 at the latest, it is considered unlikely that hazardous landfill gas generation will still be active, although residual landfill type gases may remain within the soil atmosphere. Volatile organic compounds if they were present initially are very likely to have largely degraded by now, but heavier hydrocarbons may remain.

This investigation has shown the former pond to have been infilled to a maximum proven depth near the centre of 1.10 metres below ground level, by the mid 1950's, using essentially a topsoil type material with a little admixed brick and a little ash. By now, any readily biodegradable material deposited, such as materials found in domestic waste, would have decayed long ago, leaving only material less resistant to decay, such as the root matter within the topsoil type backfill.

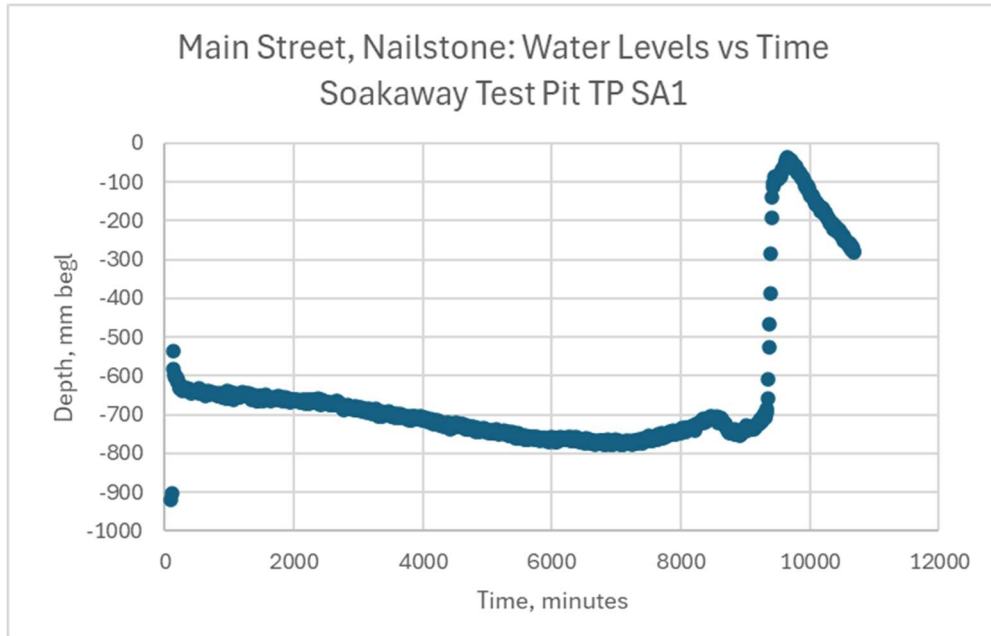
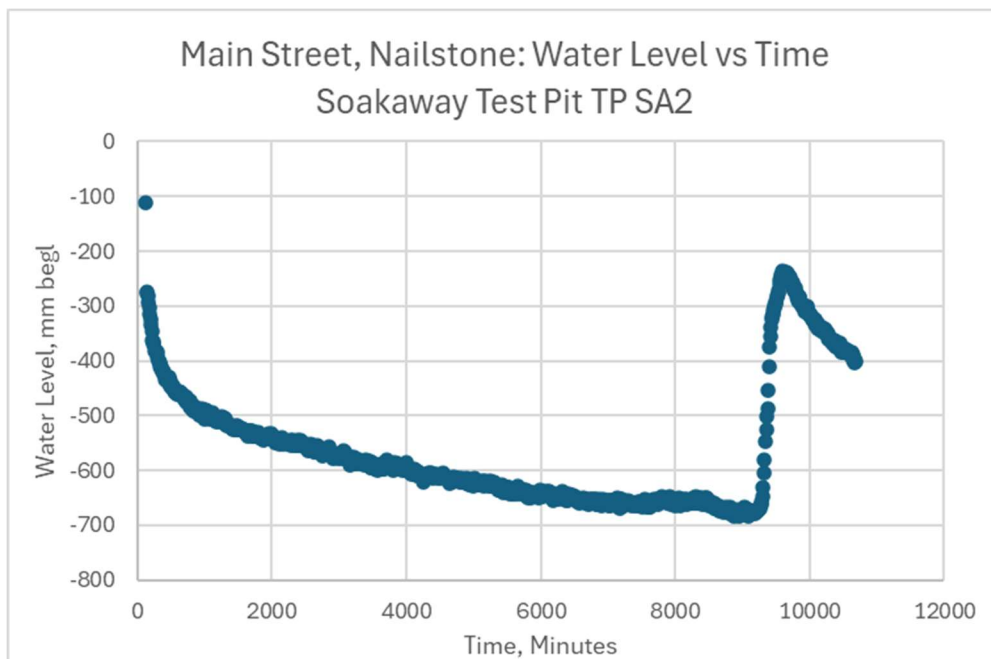
Both monitoring devices show a sudden rapid rise in the water levels in both trial pits commencing on 18<sup>th</sup> December 2024 at around 5 pm, which corresponds to a rainfall event on the 18<sup>th</sup> December 2024, as recorded at the nearby East Midlands Airport (see over-page).

The groundwater monitoring data in conjunction with the rainfall data shows a very rapid response of the groundwater table level to rainfall within both trial pits, with a rise of around 0.5m to 0.6m over the course of around eight hours.

Typically, there is a lag between a rise in groundwater level and a period of rainfall, as time for soil infiltration through the surface layers is required. However, such a rise observed beneath this site during a rainfall period indicates the groundwater beneath the site is closely connected to the surface, or a rapid infiltration within higher ground off-site is impacting on levels beneath the site through a pathway such as a buried channel or former stream.

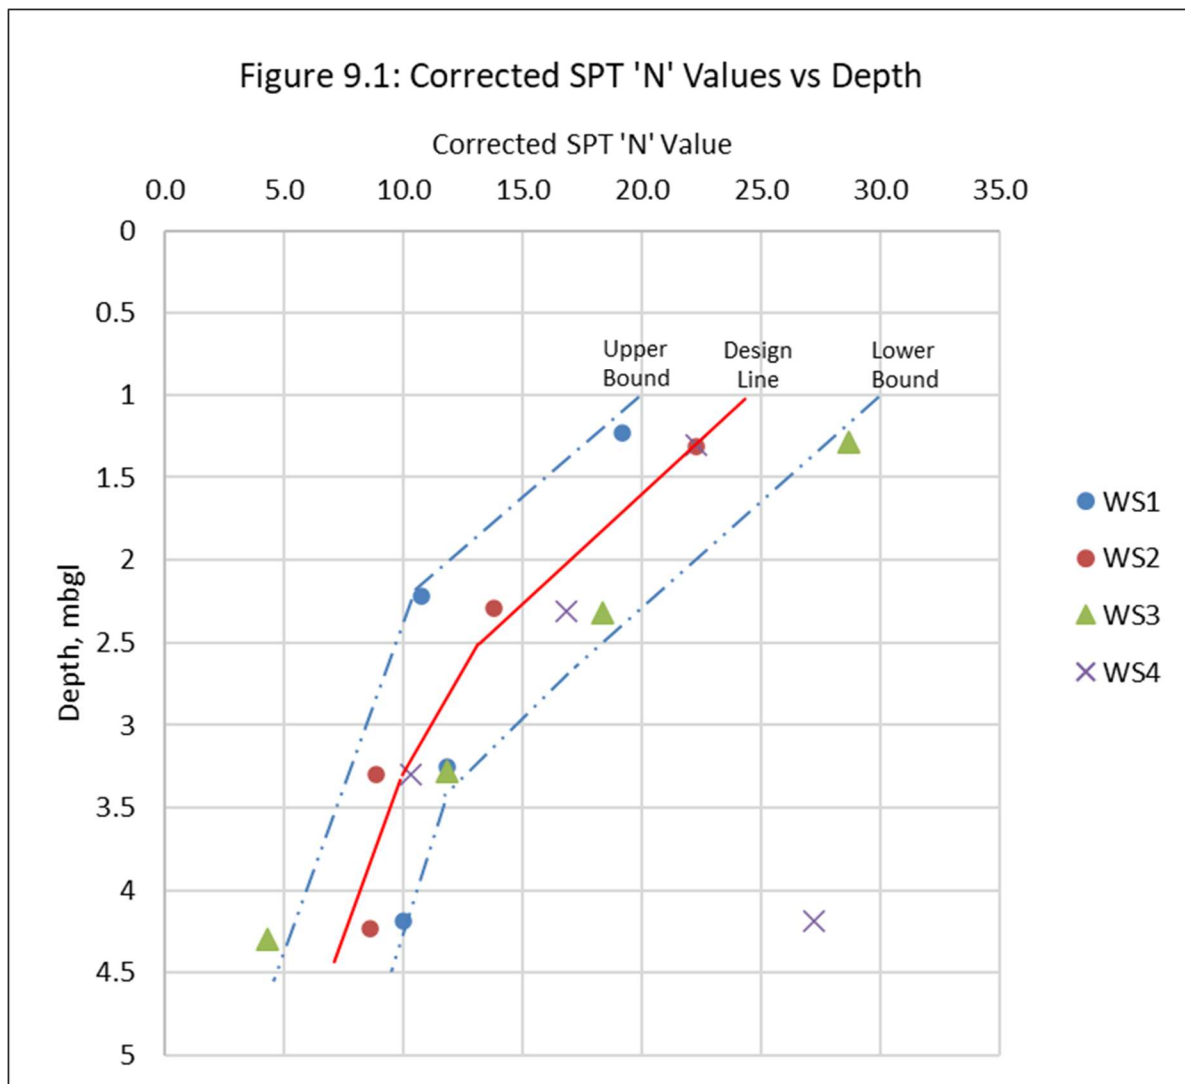
With reference to Figure 9.1, the SPT results show a marked decrease in the 'N' value with depth, with design values of  $N=25$  at 1.0m bgl,  $N=17.5$  at 2.0m,  $N=12$  at 3.0m, reducing to around 8 at 4.0m bgl.

This reduction in SPT 'N' values with depth is also reflected within the two dynamic probe logs, although to a lesser extent in DP2. Both dynamic probe logs show higher readings between 1.0m and around 2.7m bgl, then gradually falling below that depth, which is consistent with the SPT 'N' values.

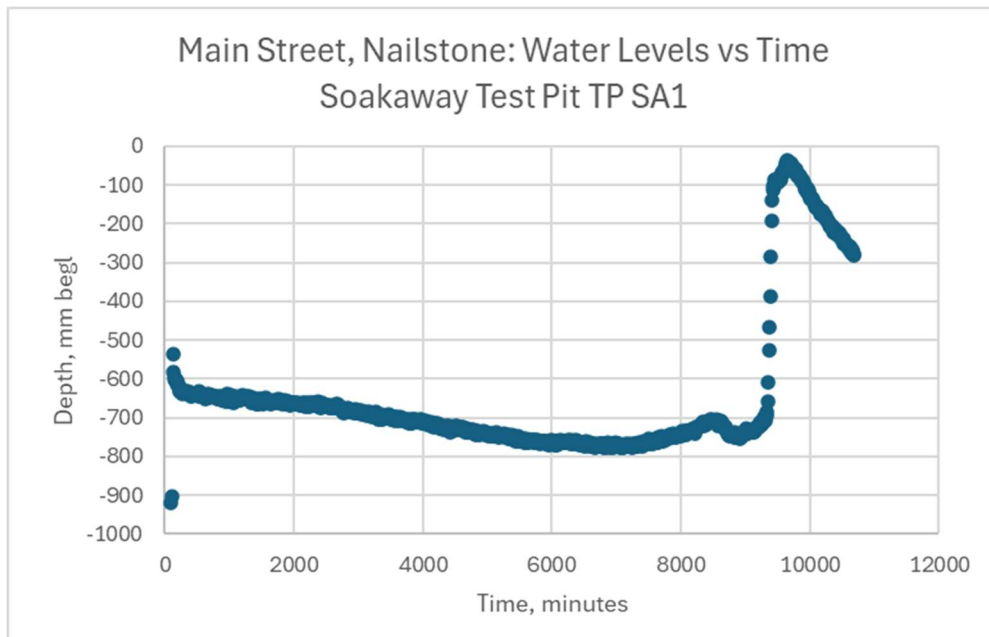
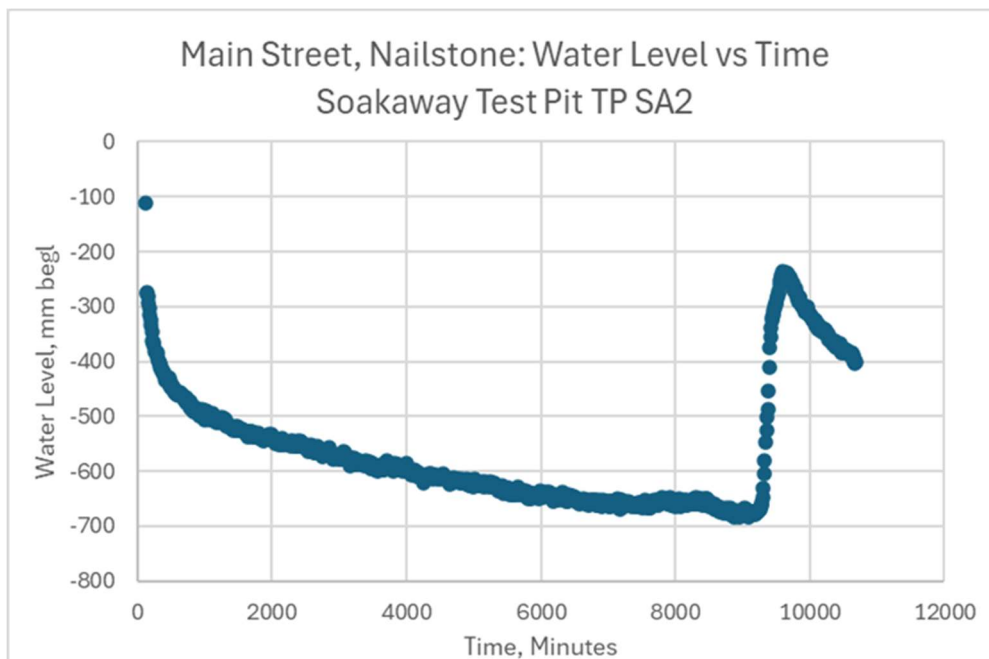
The water level plots above show that the water levels fell very slowly, taking 5 days to drop from 0.53m to 0.78m begl in TPSA1, and over 6 days for the water levels to fall from 0.28m begl to 0.68m begl in TPSA2.

As discussed within Section 7.3, the water level monitoring devices also show a rapid rise in ground water levels on 18<sup>th</sup> December 2024, which corresponds to a rainfall event and shows a rapid response to rainfall, with groundwater levels approaching the ground surface.
