# Site Inspection Report

Land off Brascote Lane, Newbold Verdon

<b>Site Inspection reference</b>	SI-8338-01	<b>Date of inspection</b>	13.03.2025
<b>Inspected by</b>	<p>Josh Birchall BSc (Hons) MCIEEM, Bat Class Survey Licence WML CL17 (Level 1), Senior Ecologist</p> <p>Joshua Sadler BSc (Hons), Arboricultural Consultant</p>		
<b>Task description</b>	<p>Brooks Ecological were instructed to carry out a further survey of T7 at the proposed entrance to new development at Brascote Lane, Newbold Verdon. This survey was commissioned in response to the local authority (Leicester County Council) statement as follows;</p> <p><i>'The report states that T7 which is due for removal contains potential roosting features and requires further surveys. I cannot see details of this survey/s within the addendum therefore please can this be provided. I notice in the table T7 is categorised as PRF-I, I think it would be challenging to categorically say the features are only suitable for a small number of bats without further inspection. As this relates to site access this information is required prior to determination.'</i></p> <p><u>A climbed endoscope inspection</u> of all potential roost features w

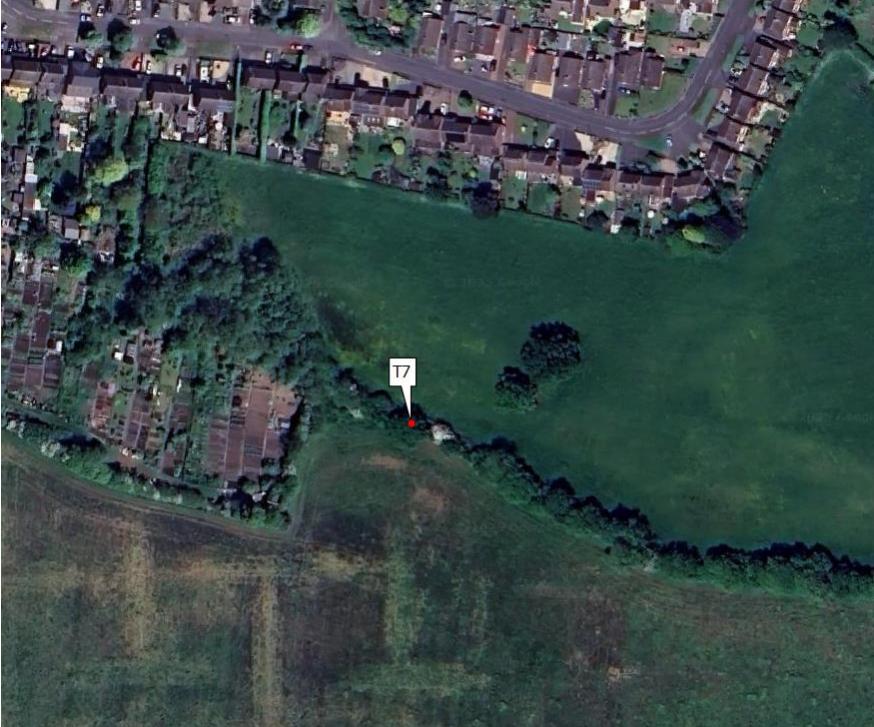
<b>Figure 1</b>	<p>Tree 7 location taken from aerial imagery and from Tyler Grange Tree retention and removal plan drawing 16602P011</p>

<b>Report</b>	<p>T7 (location shown in Figure 1) is a mature oak, adjacent a small stream, with light ivy covering. It has been identified as PRF-I in Tyler Grange Report 'TG Report No. 16602_R04a_EJ' due to 'some fallen limbs leaving potential crevice features' and 'some ivy potentially obscuring further features'.</p> <p>Inspection was carried out initially by eye and where required with the aid of a high-powered torch. Following this, if required, endoscope inspection was also carried out to ensure all areas of the cavity were closely inspected. This process was repeated from each of the access holes to allow inspection from various angles.</p> <p>Several smaller dead limbs were inspected and found to support no suitable PRFs. Shallow rot holes on the southern facing limb high up in canopy though these were found to be facing upwards so susceptible to water ingress thus precluding it as a suitable PRF. A small hazard beam on the northern elevation, this was found to be an open and shallow features c.15cm wide by c. 5cm deep, again open to inclement weather and unsuitable to support roosting. Occluded bark around a larger dead limb on the southeastern aspect, this was found to be too shallow to act as a PRF. Ivy cover was in general found to be fairly light and not supporting suitable stem diameters/ overlapping stems to support roosting bats, likewise no features that were otherwise hidden from ground level were observed.</p>

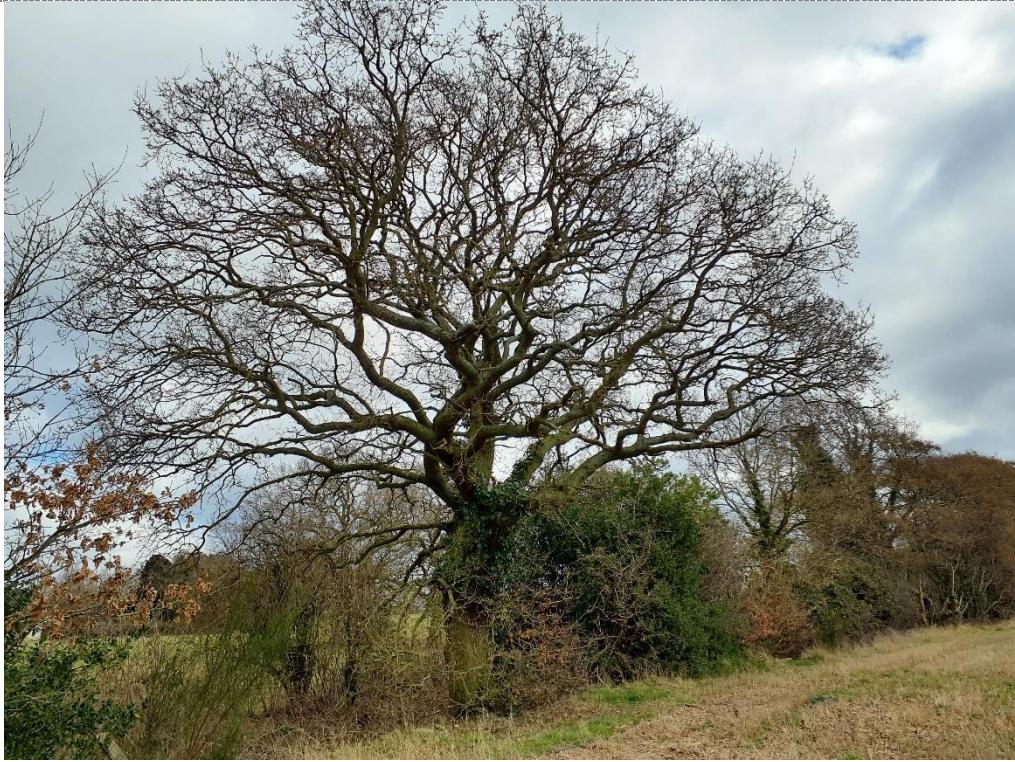
## Photograph 1

Overview of T7

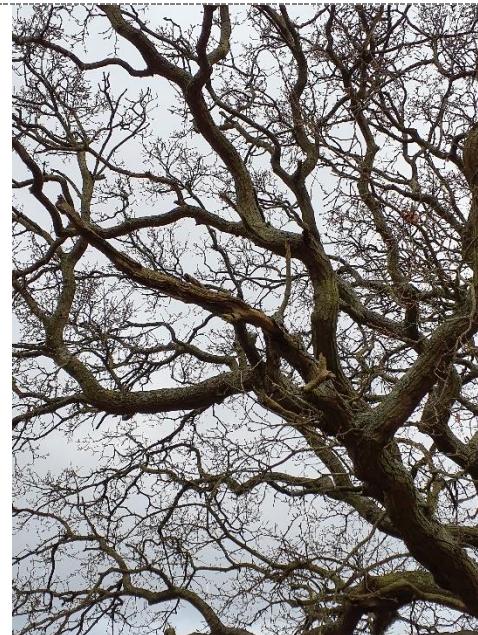
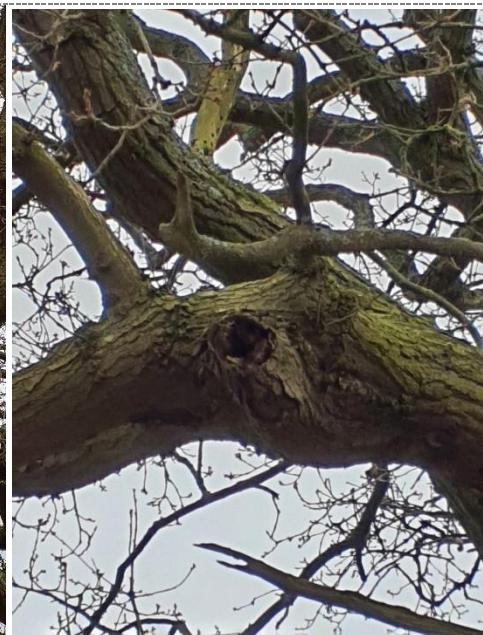
## Photograph 2

<p>A rot hole on the western elevation (shown in photos 2 and 4) was inspected via endoscope being c.15cm in depth and though only small large enough to facilitate bat access, however internally the feature was found to be wet likely limiting its suitability to support anymore than small numbers of bats.</p> <p>No bats or evidence thereof could be found in any part of this large cavity. No droppings were seen within the cavity and it emitted no odour associated with roosting bats.</p>
<b>Summary</b>	No evidence of current or historic roosting could be found in any of the PRFs identified on this tree. A likely absence of bats is concluded. The tree is considered to support a limited number of PRFs suitable for use by individual- low numbers of bats in line with its PRF-I designation in previous reporting.
<b>Further actions</b>	<p>Based on the results of this inspection, no further bat survey is considered necessary on this tree.</p> <p>Felling of this tree should be carried out in a precautionary manner; being cut in stages following a brief inspection by the tree surgeon.</p> <p>Although not found to support roosting - as per good practice, it is recommended that replacement roost features be erected on an adjacent tree or new unit built in close proximity to T7.</p>

Features identified from ground level, including dead branch (L) and rot hole (R).

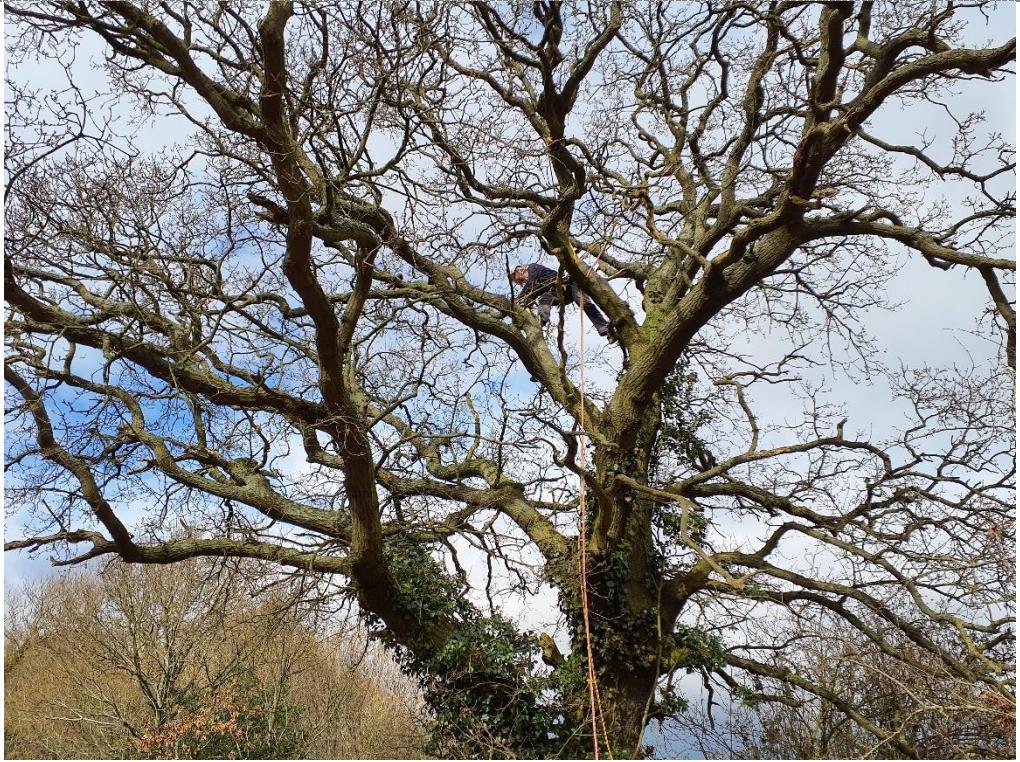
## Photograph 3

Climbed  
inspection

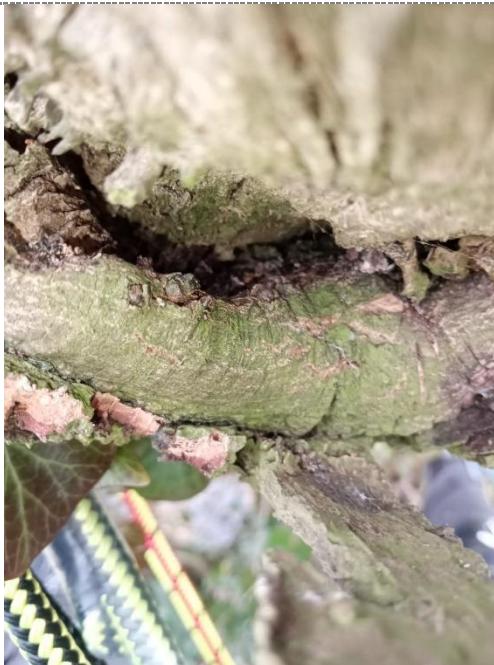
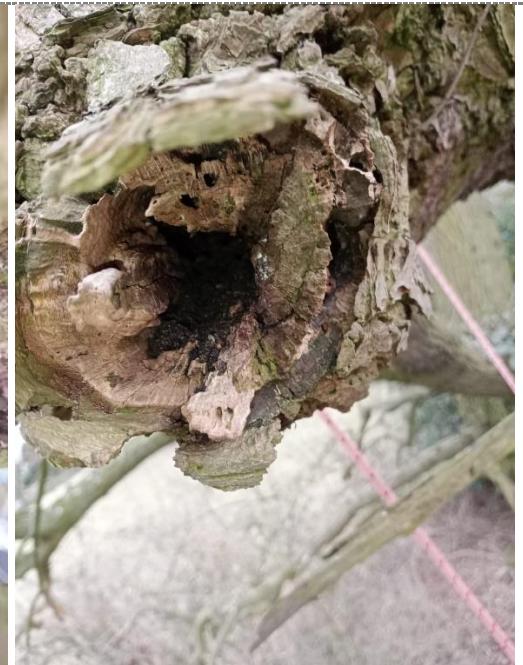
## Photograph 4

Close up of  
shallow occluded  
bark features (L)  
and rot hole (R).
