Location: Leicester Road & Shilton Road Barwell

Project: Residential Development,

Stage 1 Road Safety Audit

Date: July 2025

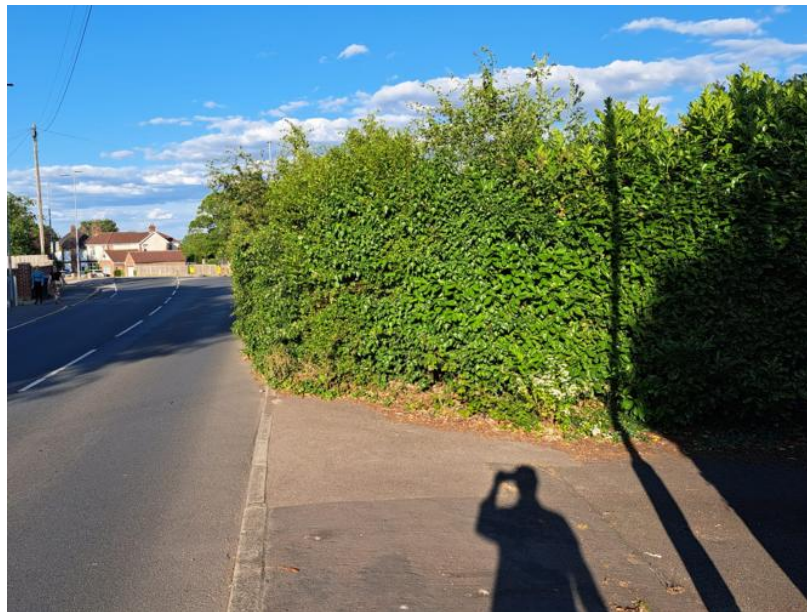
Details: During the site visit, it was observed that there is substantial vegetation located around both of the vehicular crossover and giveaway junction on Shilton Road and Leicester Lane, respectively.

Photo 1: Existing Vegetation on Shilton Road

The Audit Team notes that this vegetation encroaches into the visibility splay for drivers exiting both accesses. Reduced visibility at these locations could increase the potential risk of collisions, as drivers may not be aware of oncoming vehicles when leaving the junction, thereby heightening the possibility of vehicular conflicts.

Recommendation: It is recommended that the vegetation is cut back on both Shilton Road and Leicester Road, as well as then being maintained to ensure the minimum visibility splays are maintained in accordance with current design standards.

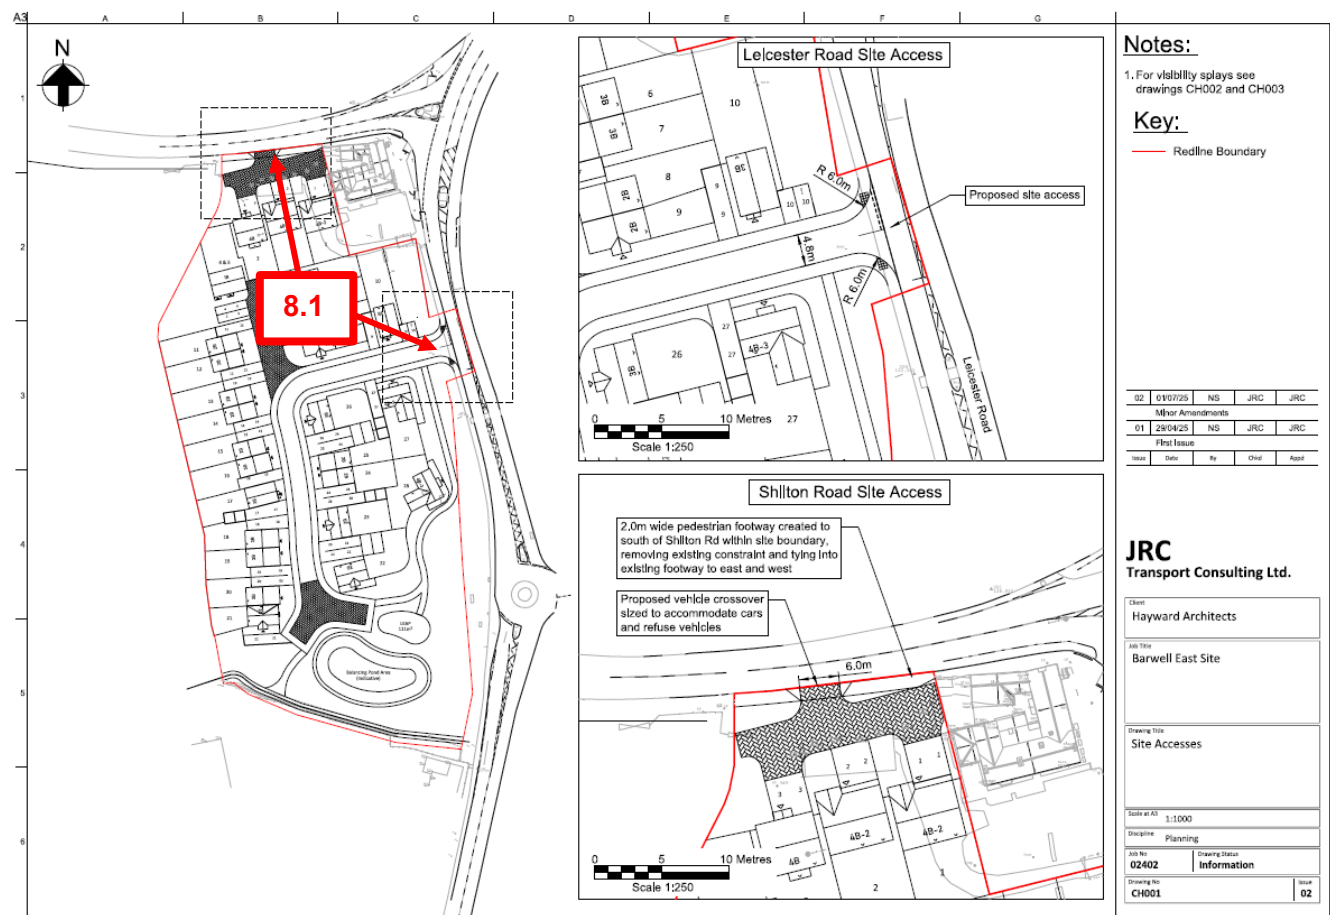
PROBLEM LOCATION PLAN

Location: New residential accesses adjoining Shilton Road and Leicester Road

Summary: Risk of vehicles colliding with other road users.
