## **Arboricultural Impact Assessment & Draft Arboricultural Method Statement**

**Client:** Invicta Universal

**Site:** 39 Station Road, Desford, New Dwelling.

**Ref:** AIA-25-01-001ND v2

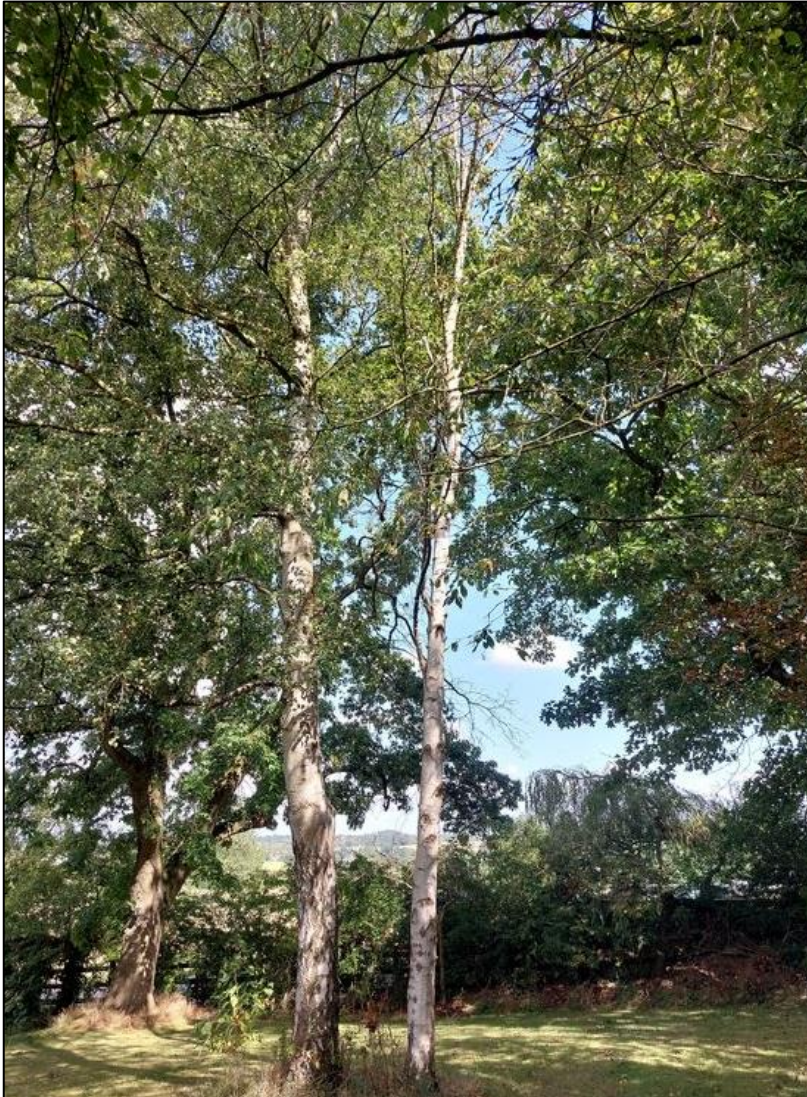
3.4. Tree T017 is recommended for removal regardless of the proposal.

Plate 1 T017 Is the right hand silver birch and is 75% dead.

| T017 | Tree | Silver birch | Betula pendula | 14 | 320 | 1 | 2 | 2 | 2 | 2 | 5 | 5 | Over Mature | Fair | Fair | Declining condition | Remove | <10 years | U | 48 | 4 | | | | | | | | | | | | | | |

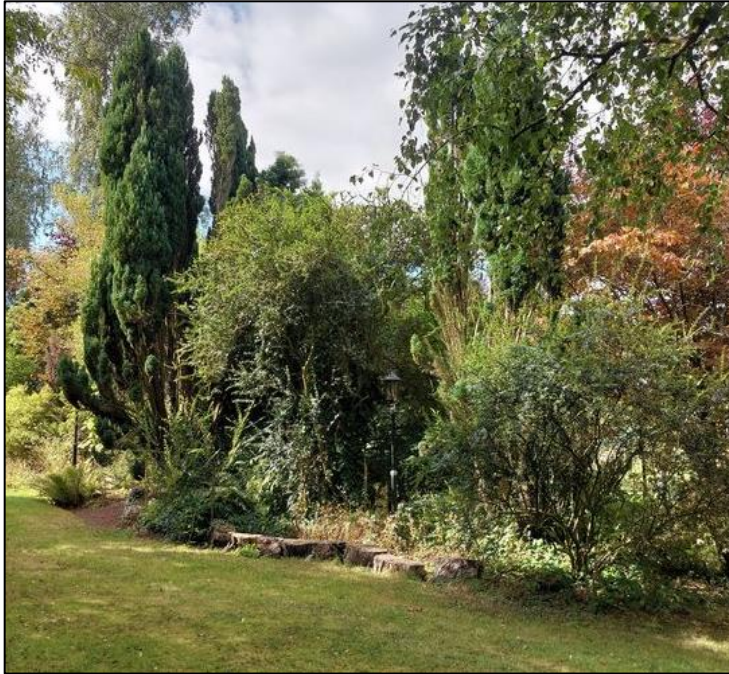
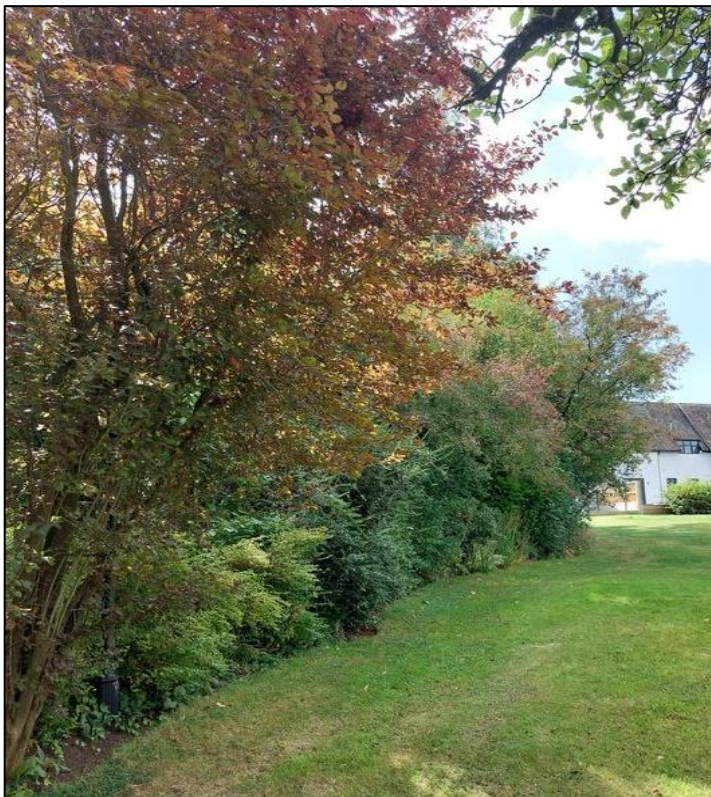
- 3.5. Groups G003, and G004, are categorised as a retention Category C, and are of low quality.
- 3.6. G003 is a group of mixed species with early mature trees and mature shrubs. They form a landscaped bed closely planted and suppressing each other.

**Plate 2 and 4 G003 Low quality trees and shrubs.**

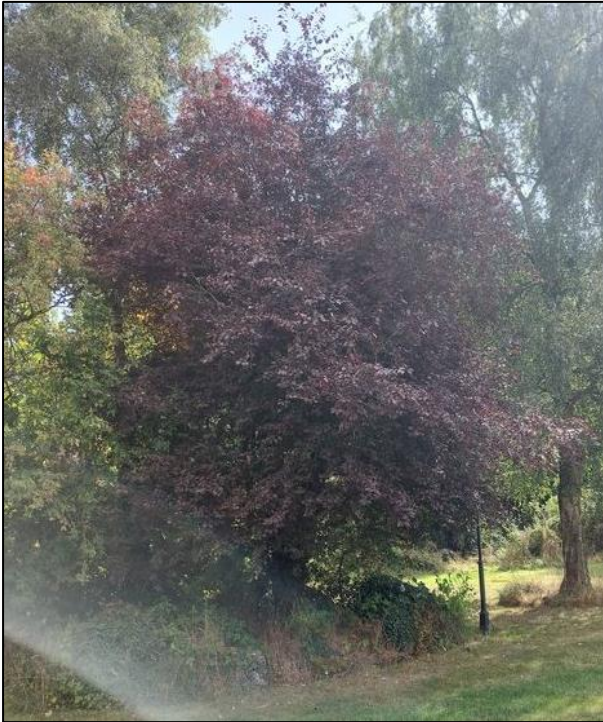
3.7. Two better quality tree T012, and T013 at the end of the group are to be retained

**Plate 4 T0012 to be retained.**

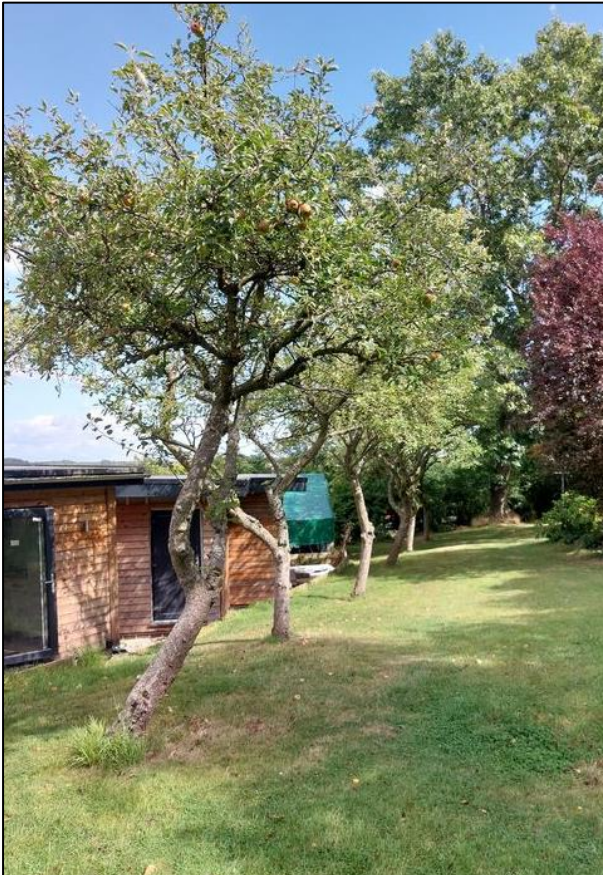
3.8. G004 is a group of low quality mature apple trees.

**Plate 5 G004 Line of mature apple trees.**

| G004 | Group | Apple x6 | Malus sp. x6 | 4 | 250 | 1 | 3 | 3 | 3 | 3 | 2 | 2 | Mature | Fair | Fair | None Noted | Remove | 10+ Years | C2 | 28 | 3 | | | | | | | | | | | | | | |
