**Phase 1 Land Contamination  
Risk Assessment  
for  
Change of Use from Agricultural  
to Residential Usage  
on the site of  
Manor Farm, No.8 Wood Lane,  
Norton-Juxta-Twycross,  
Leicestershire CV9 3QB**

4034D P1 LonXThree – Norton-Juxta-Twycross

23/02/2026

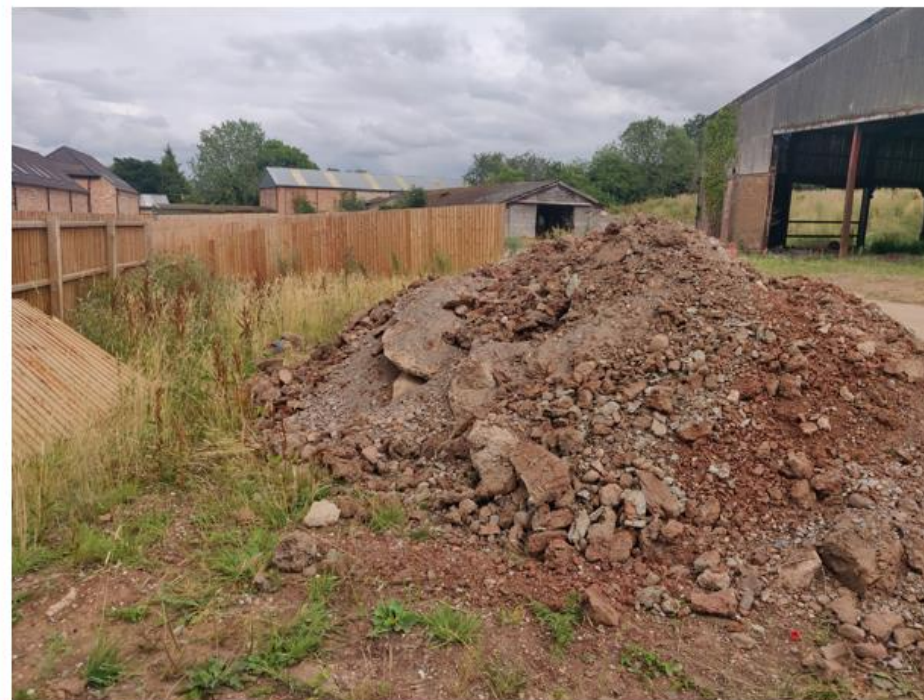
**Photo No.4: Heaped gravels and arisings adj. to site access**

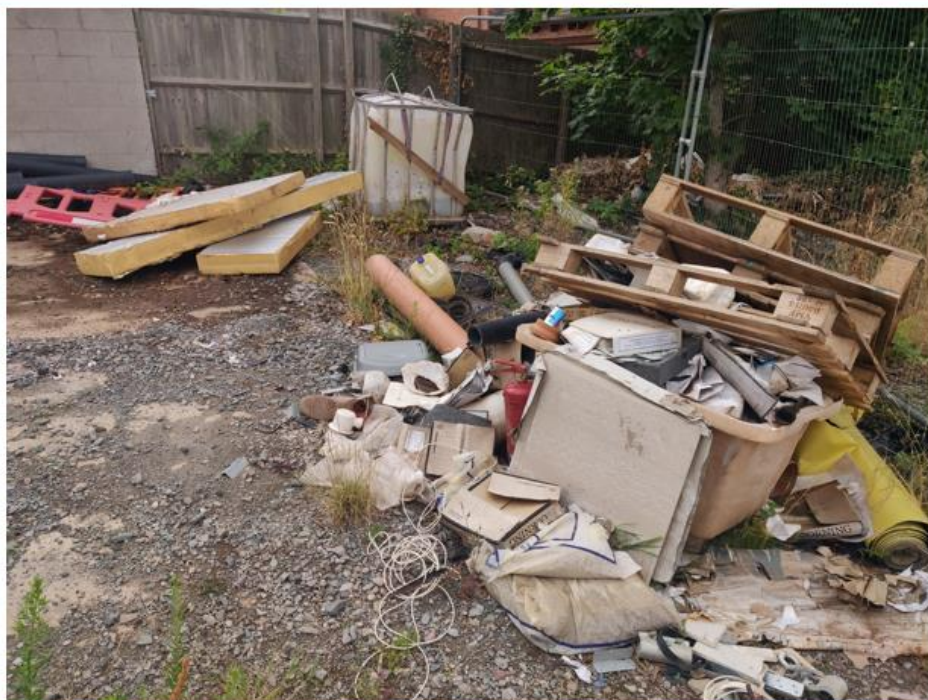
**Photo No.5: Heaped debris and refuse noted in west of site**

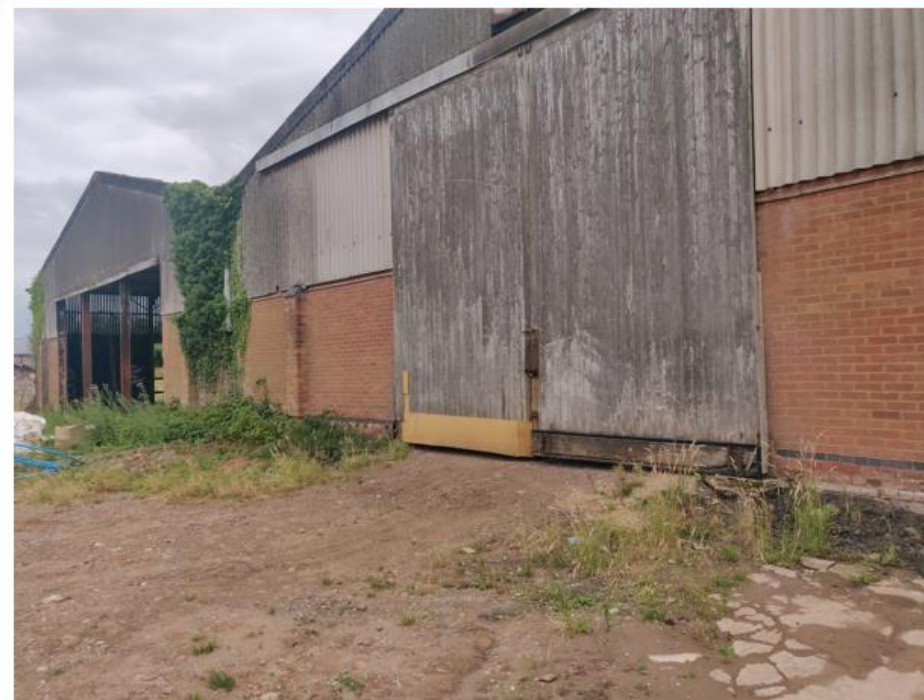
**Photo No.6: Facing SE showing front (northern) faces of barns and PACM-cladding**

**It is recommended that the structures on site be subject to an asbestos survey (and subsequent removal, if required) by appropriately qualified personnel. This should be carried out prior to any demolition or redevelopment occurring in order to ensure site works do not cause future contamination of the site.**

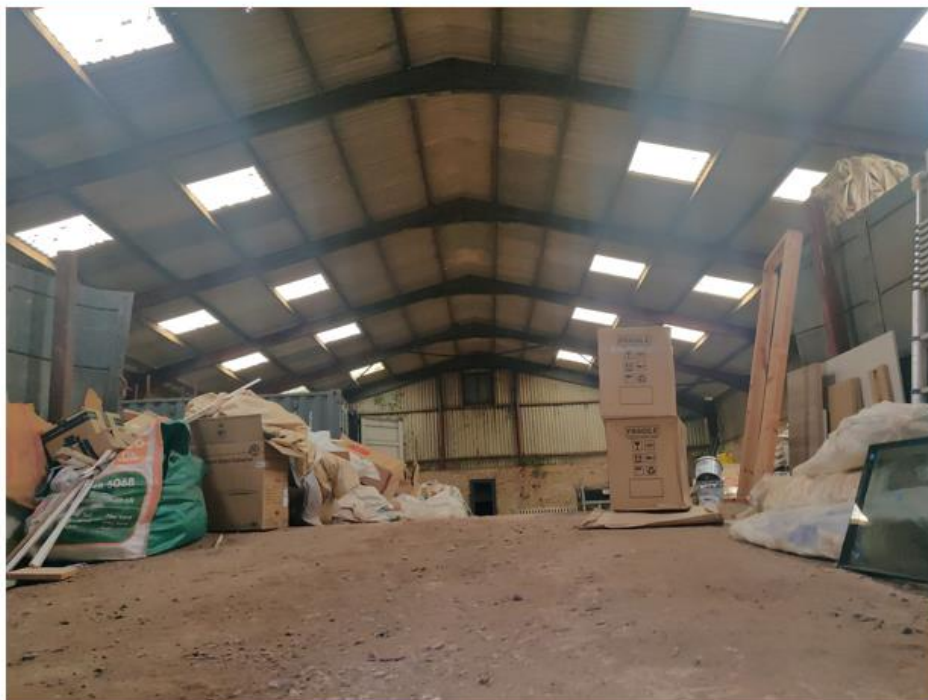
**Photo No.7: Facing south showing interior of westernmost barn with miscellaneous storages (i.e. construction materials)**

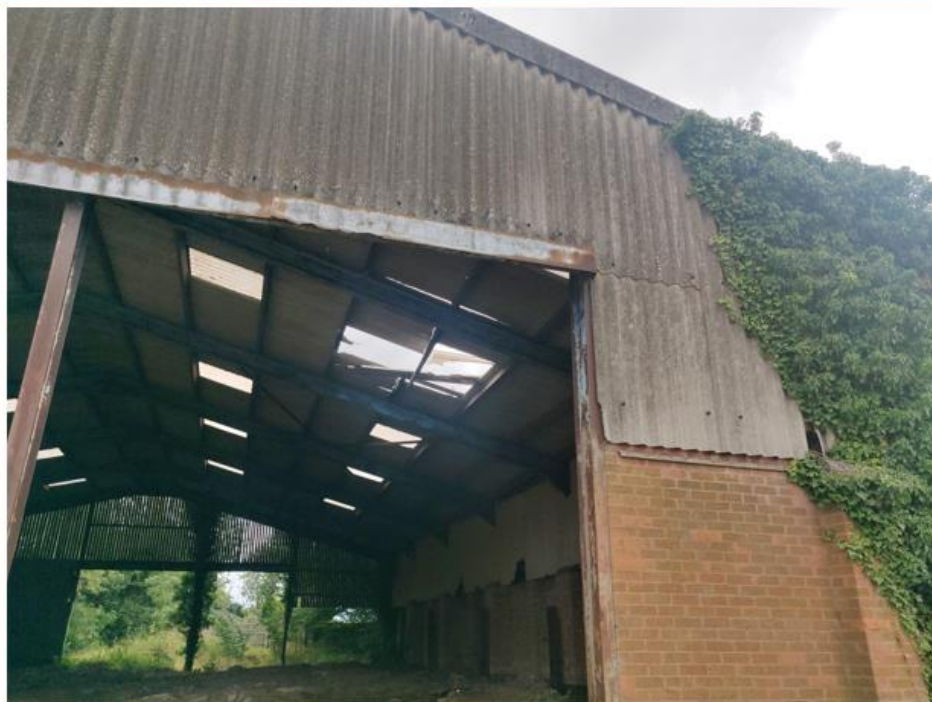
| Potential Sources and Associated Contaminants Identified | |
|---|---|
| PACM cladding and roofing (noted broken in areas on the site walkover, including lagging and piping) | Asbestos (various forms) |

**Photo No.9: Showing PACM cladding on barns**

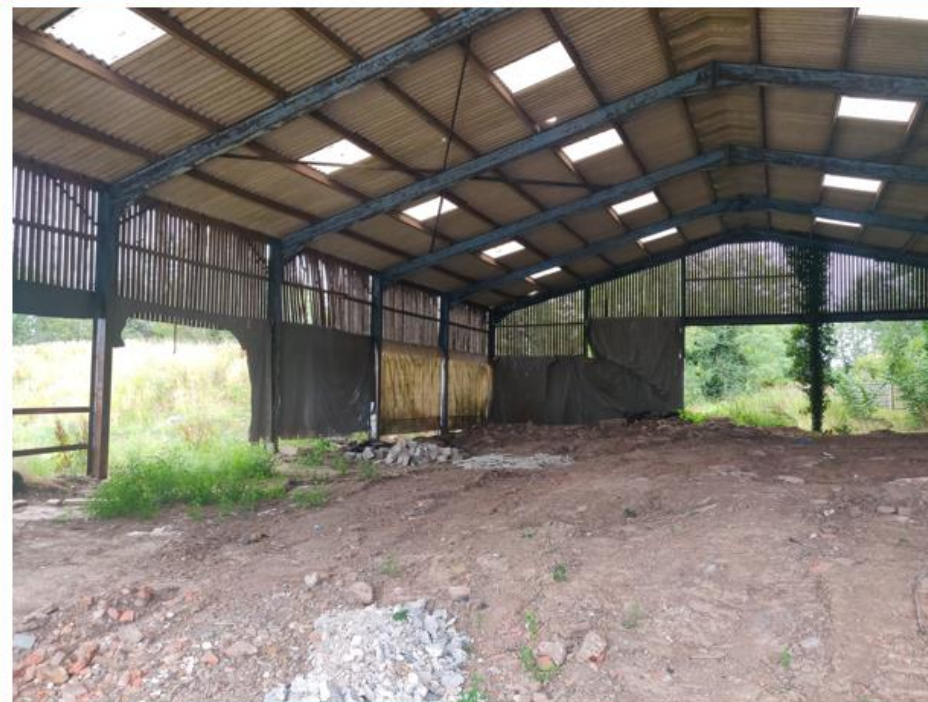
The easternmost barn, adjoined to that in the west, was then seen to be in a state of heavy disrepair, with the prior concrete flooring having been removed and made ground deposits (i.e. rubbles, some ash, road planings, brick and metal fragments) remaining insitu. Heaped stone, rubble, timber and Heras fencing were noted throughout this barn, alongside a heap of chemical containers (former contents and labelling largely obscured) located inside the north eastern corner of the barn.

**Photo No.10: facing south inside the eastern barn adjoined to that in the far west of site**

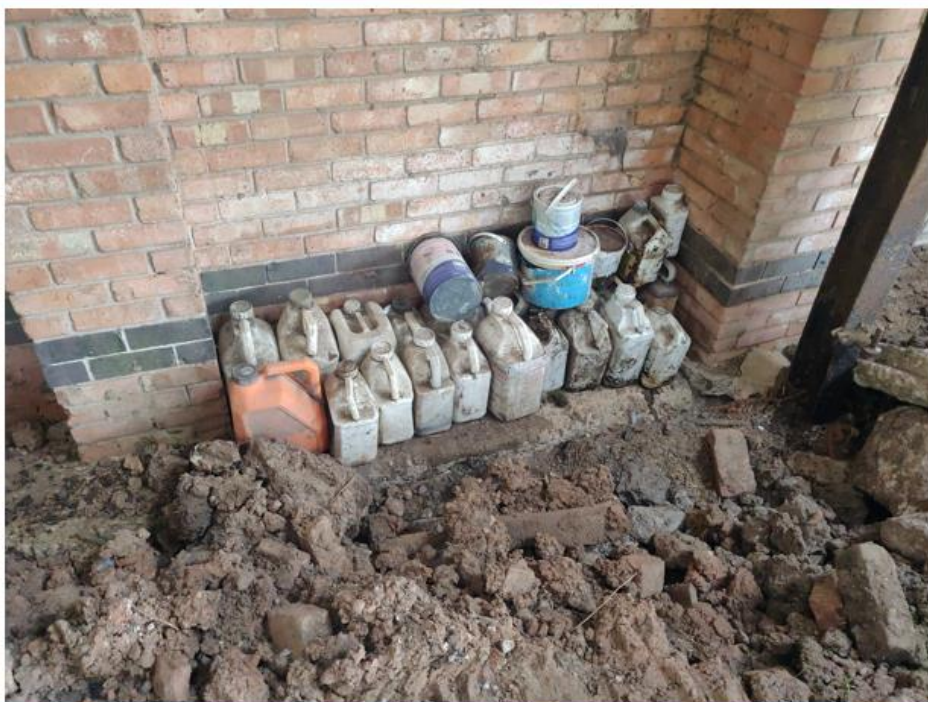
**Photo No.11: Containers noted stored in open-sided barn**

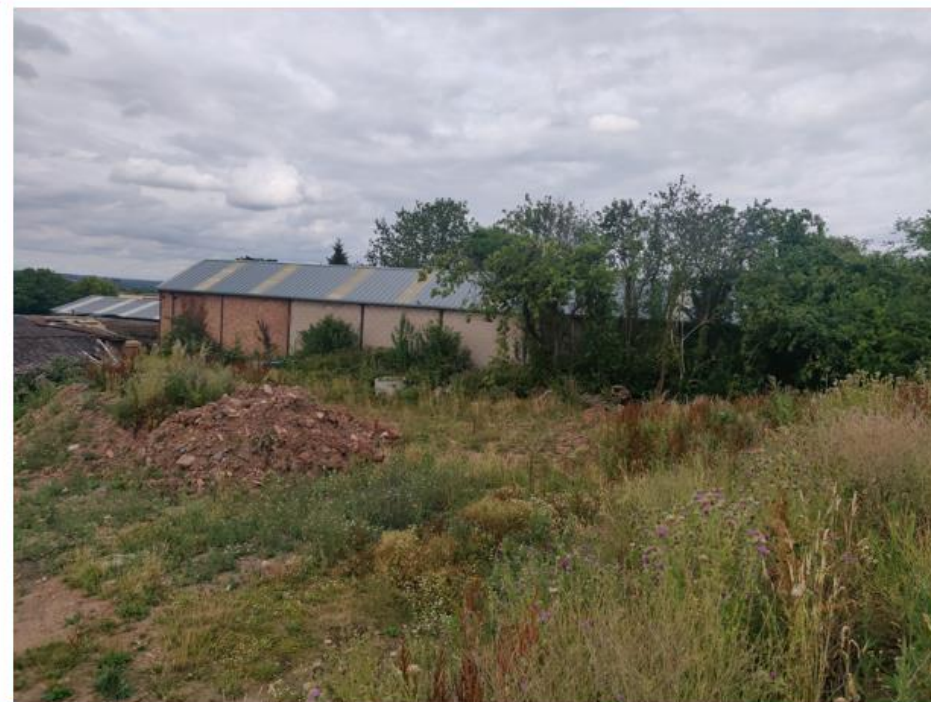
**Photo No.14: Facing east towards the eastern extent of site showing further heaps and vegetated heaps**

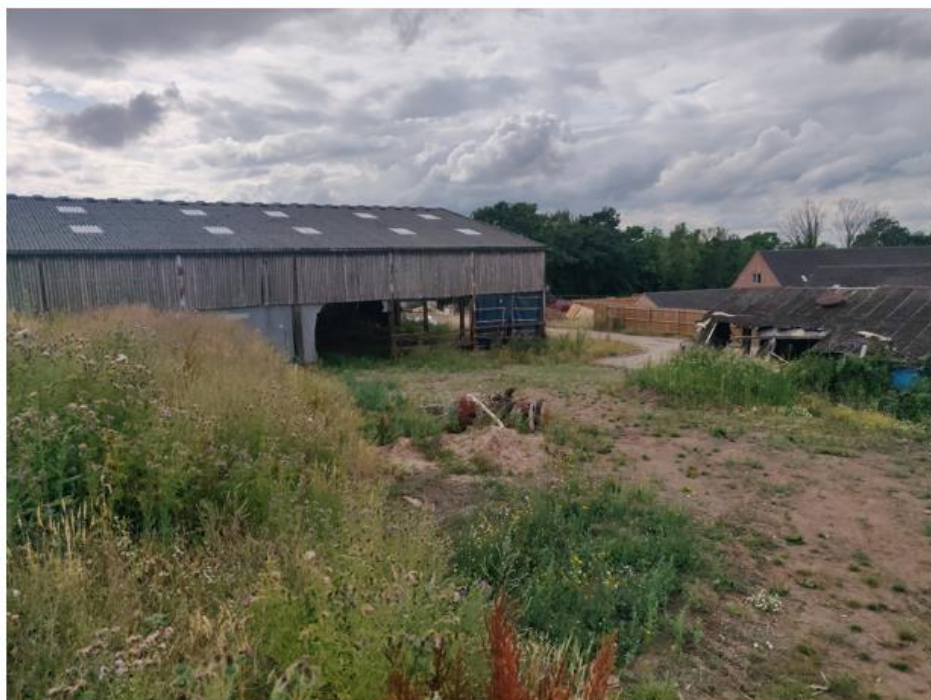
**Photo No.15: Facing NW in the east of site back towards the large barns and site access (further heaps noted)**

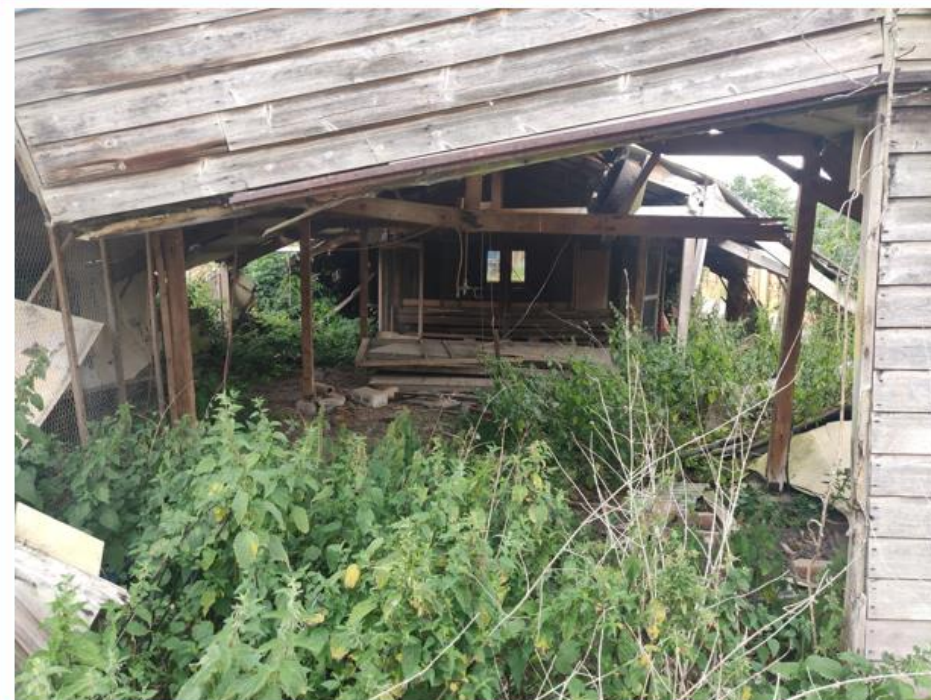
**Photo No.16: Facing west from outside the eastern face of the dilapidated linear barn forming the NE extent of site**

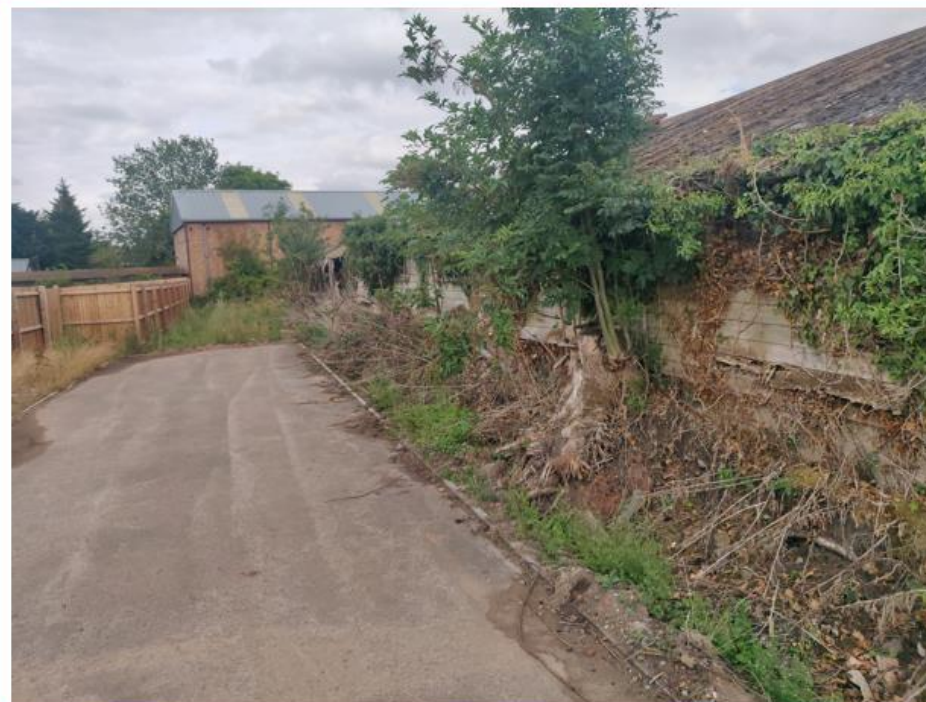
**Photo No.18: Facing east showing the rear (southern) face of the linear barn, dilapidated state and further PACM**

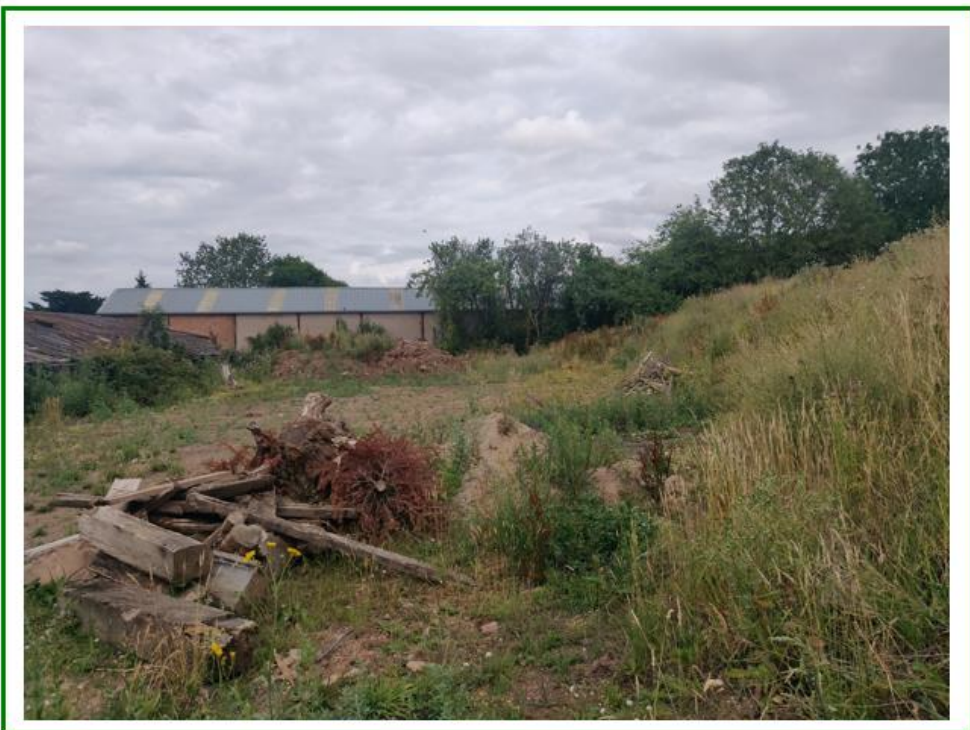
**Photo No.19: Facing east from the centre of site showing further heaped refuse and vegetated heaps forming SE of site**

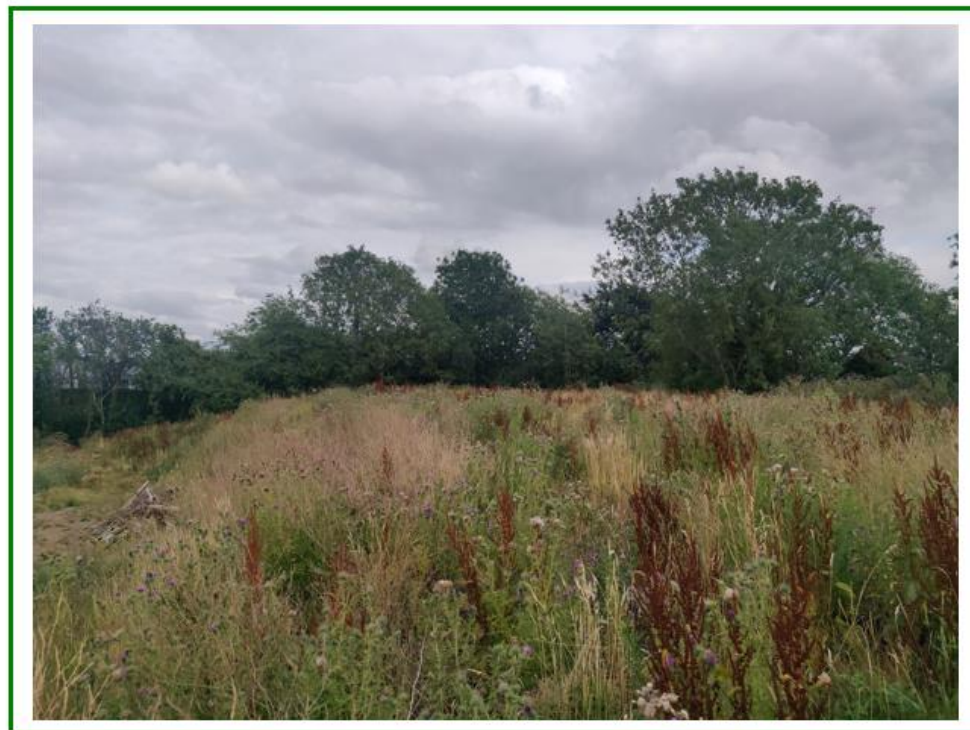
| Potential Sources and Associated Contaminants Identified | |
|---|---|
| Significant made ground deposits on site (likely arising from historical usage and noted on site walkover – site-wide) i.e. large, overgrown vegetated heaps | Agrichemicals (i.e. SVOC / VOC), heavy metals, metalloids, PAHs, TPH CWG, BTEX / MTBE (within age of usage), asbestos |

**Photo No.20: Overgrown vegetated heaps forming the eastern and SE extents of site**
