BS5837:2012 Tree Survey  
 Garden at 36 Main Street  
 Stoke Golding  
 Leicestershire  
 NGR SP 39531 97273

Survey by  
 Christopher Barker CEnv dipHort ACIEEM

# **BS5837 Tree Survey, Land at 36 Main Street, Stoke Golding**

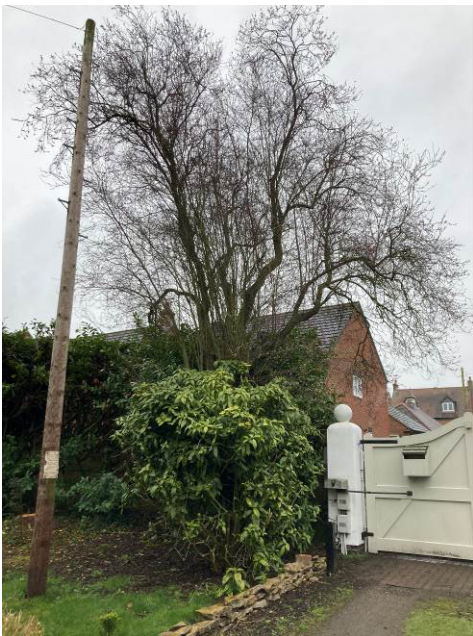
Damson T1

**Damson T1, Leylandii T2 and Ornamental Willow T3** are situated along the western edge of the surveyed garden lining the edge of the existing driveway. T1 is particularly close to the existing gated entrance and starting to crowd this. This tree is also showing some signs of loss of vigour with extensive regeneration within the crown interior. These are all trees of relatively small stature. T1 and T3 are placed within Category C but T2 is a Category B specimen with space to continue to mature for a 20-year period although significant trimming will be required to keep the edge of the crown away from the existing driveway.

| Tree No | Species | Ht (m) | Stem Diam mm@ 1.5m | Canopy Spread (m) | Height of Crown Clearance | Age Class | Est yrs | Overall Condition | Structural condition | Recommendations | BS 5837 Category | RPA Radius (m) |
|---|---|---|---|---|---|---|---|---|---|---|---|---|
| T1 | Damson<br><i>Prunus domestica</i> | 10 | 315 | N-2<br>S-3<br>E-3<br>W-2 | 3 | M | 10 | F | Broadly ascending with internal regeneration. Starting to crowd the entrance to the driveway.<br>No structural faults visible from ground level | | C2 | 3.7 |

| Ref | Tree | Category | Impact of development |
|---|---|---|---|
| 1 | Damson<br><i>Prunus domestica</i> | C2 | This tree will have to be removed to provide space for the new access into the property. |

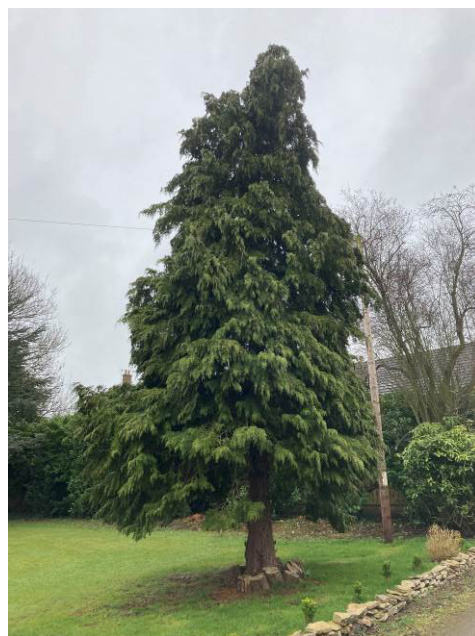
Leylandii T2

| Tree No | Species | Ht (m) | Stem Diam mm@ 1.5m | Canopy Spread (m) | Height of Crown Clearance | Age Class | Est yrs | Overall Condition | Structural condition | Recommendations | BS 5837 Category | RPA Radius (m) |
|---|---|---|---|---|---|---|---|---|---|---|---|---|
| T2 | Leylandii<br><i>Cupressocyparis Leylandii</i> | 8 | 230 | N-2<br>S-2<br>E-2<br>W-2 | 1 | SM | 20+ | G | Conical canopy close to the driveway.<br>No structural faults visible from ground level | | B2 | 2.7 |

| Ref | Tree | Category | Impact of development |
|---|---|---|---|
| 2 | Leylandii<br><i>Cupressocyparis Leylandii</i> | B2 | This tree will have to be removed to provide space for the new driveway and parking area. Replacement planting will take place elsewhere in the wider garden area controlled by the applicant. |

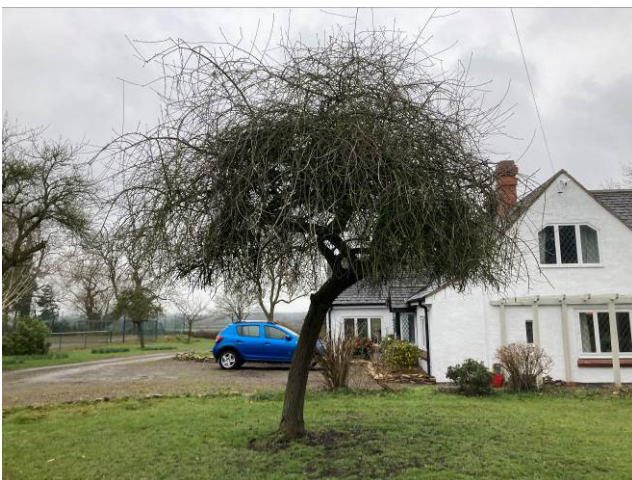
Ornamental Willow T3

| Tree No | Species | Ht (m) | Stem Diam mm@ 1.5m | Canopy Spread (m) | Height of Crown Clearance | Age Class | Est yrs | Overall Condition | Structural condition | Recommendations | BS 5837 Category | RPA Radius (m) |
|---|---|---|---|---|---|---|---|---|---|---|---|---|
| T3 | Ornamental Willow<br><i>Salix spp</i> | 4 | 210 | N-2<br>S-2<br>E-2<br>W-2 | 2 | Y | 10 | F | Small round crown lifted above the lawn.<br>No structural faults visible from ground level | | C2 | 2.5 |

| Ref | Tree | Category | Impact of development |
|---|---|---|---|
| 3 | Ornamental Willow<br><i>Salix spp</i> | C2 | This tree is not shown within the development plan and is presumably removed to provide space for new landscaping in front of the property. |

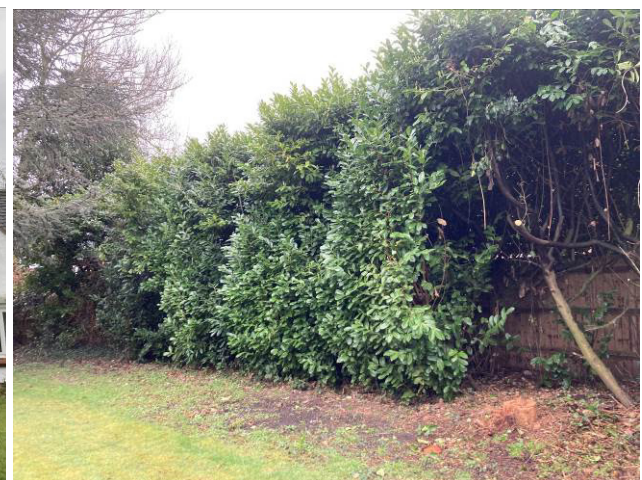
Group G4 Cherry Laurel

**Group G4** comprises a dense hedgerow of Cherry Laurel extending along the southern boundary of the garden. Whilst the side of the hedge has been trimmed in the past the top is getting very high. There are gaps appearing and the boundary fence behind the hedge is becoming overgrown. This Cherry Laurel extends along the south boundary almost to the south east corner of the garden.

| Tree No | Species | Ht (m) | Stem Diam mm@ 1.5m | Canopy Spread (m) | Height of Crown Clearance | Age Class | Est yrs | Overall Condition | Structural condition | Recommendations | BS 5837 Category | RPA Radius (m) |
|---|---|---|---|---|---|---|---|---|---|---|---|---|
| G4 | Cherry Laurel<br><i>Prunus laurocerasus</i> | 3-4 | <180 | N-2<br>S-2<br>E-2<br>W-2 | 0 | M | 10 | F | Irregularly trimmed hedge starting to spread.<br>No structural faults visible from ground level | Requires significant trimming back to create a dense, manageable hedge | C2 | 2.1 |

| Ref | Tree | Category | Impact of development |
|---|---|---|---|
| G4 | Cherry Laurel<br><i>Prunus laurocerasus</i> | C2 | This hedge will be trimmed back to 0.7m height and 0.5m spread. It should regenerate quickly and can be trimmed into a tight boundary hedgerow. Temporary ground protection will be laid down after it is trimmed to protect the ground from compaction during construction. |

The Cherry Laurel G4 along the southern boundary will be heavily trimmed back to a height of around 0.7m and spread of 0.5m This species does respond well to severe cutting back and is highly likely to regenerate quickly with new growth from the base and trimming points. The new growth can be box trimmed into a dense hedge which will screen the garden fence effectively but provide space along the southern side of the building for access.

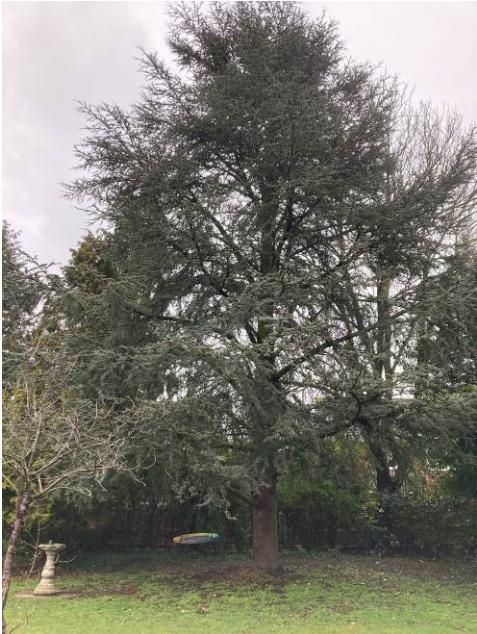
| Tree No | Species | Ht (m) | Stem Diam mm@ 1.5m | Canopy Spread (m) | Height of Crown Clearance | Age Class | Est yrs | Overall Condition | Structural condition | Recommendations | BS 5837 Category | RPA Radius (m) |
|---|---|---|---|---|---|---|---|---|---|---|---|---|
| T6 | Atlantic Cedar<br><i>Cedrus atlantica</i> | 18 | 555 | N-5<br>S-5<br>E-4<br>W-5 | 2 | M | 20+ | G | Open, broadly conical but heavier on the west side.<br>No structural faults visible from ground level but crowded by T7 | | B1 | 6.6 |

| Ref | Tree | Category | Impact of development |
|---|---|---|---|
| 6 | Atlantic Cedar<br><i>Cedrus atlantica</i> | B1 | Due to its proximity to the proposed house this tree will have to be removed to open up garden space for the new property. Replacement planting will take place elsewhere in the wider garden area controlled by the applicant. |

Cedar T6 will be the only tree of significant stature and quality to be removed from within the garden interior. It is impractical to retain this tree so close to a new house as there will be concern in the future (perceived risk) and pressure to remove or reduce the tree. It is also competing for space with Ash T7 to the south east and has already been crown lifted to allow access under the canopy for

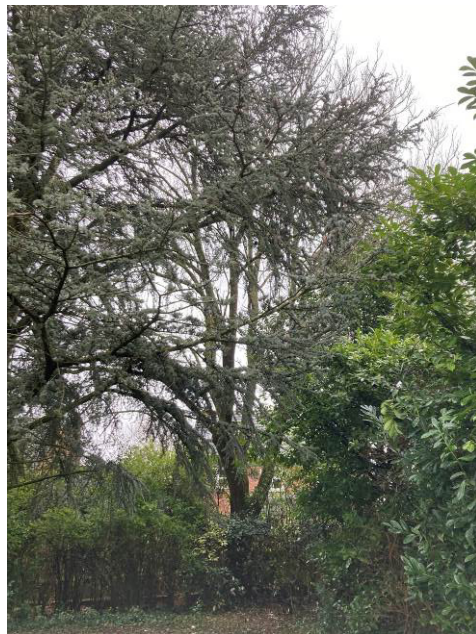
Ash T7

| Tree No | Species | Ht (m) | Stem Diam mm@ 1.5m | Canopy Spread (m) | Height of Crown Clearance | Age Class | Est yrs | Overall Condition | Structural condition | Recommendations | BS 5837 Category | RPA Radius (m) |
|---|---|---|---|---|---|---|---|---|---|---|---|---|
| T7 | Ash<br><i>Fraxinus excelsior</i> | 20 | 605 | N-7<br>S-6<br>E-5<br>W-5 | 5 | M | 20 | F | Irregular, open crown appears fairly sparse. Lifted over the adjacent gardens.<br>No structural faults visible from ground level | | B2 | 7.2 |

| Ref | Tree | Category | Impact of development |
|---|---|---|---|
| 7 | Ash<br><i>Fraxinus excelsior</i> | B2 | This tree will be retained. The crown and RPA can be fully protected by temporary fencing during construction. |

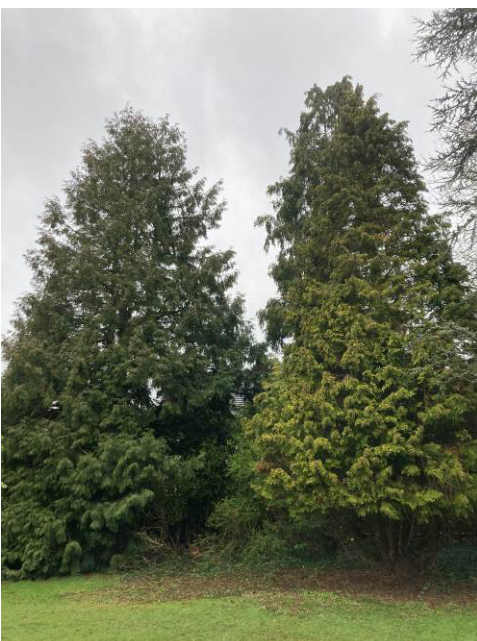
Trees T8, T9 and T10

**Trees T8, T9 and T10** are pyramidal Leylandii established to screen the north eastern edge of the garden. These three trees provide effective screening to the garden from the east. T9 and T10 are close to the boundary fence with sufficient space to continue to mature. T8 is a slightly smaller tree further into the garden interior starting to compete with T9. All three trees are placed within Category B.

| Tree No | Species | Ht (m) | Stem Diam mm@ 1.5m | Canopy Spread (m) | Height of Crown Clearance | Age Class | Est yrs | Overall Condition | Structural condition | Recommendations | BS 5837 Category | RPA Radius (m) |
|---|---|---|---|---|---|---|---|---|---|---|---|---|
| T8 | Leylandii<br><i>Cupressocyparis Leylandii</i> | 12 | 210<br>100<br>100<br>50 | N-2<br>S-2<br>E-2<br>W-2 | 0 | SM | 20+ | G | Broadly conical.<br>No structural faults visible from ground level | | B2 | 3.1 |
| T9 | Leylandii<br><i>Cupressocyparis Leylandii</i> | 15 | 310 | N-2<br>S-2<br>E-2<br>W-2 | 2 | M | 20+ | G | Broadly conical.<br>No structural faults visible from ground level | | B2 | 3.7 |
| T10 | Leylandii<br><i>Cupressocyparis Leylandii</i> | 12 | 380 | N-2<br>S-3<br>E-3<br>W-3 | 0 | M | 20 | F | Broadly conical.<br>No structural faults visible from ground level | | B2 | 4.5 |

| Ref | Tree | Category | Impact of development |
|---|---|---|---|
| 8 | Leylandii<br><i>Cupressocyparis Leylandii</i> | B2 | Due to its proximity to the proposed house this tree will have to be removed to open up garden space for the new property. Replacement planting will take place elsewhere in the wider garden area controlled by the applicant. |
| 9 | Leylandii<br><i>Cupressocyparis Leylandii</i> | B2 | This tree will be retained. The crown and RPA can be fully protected by temporary fencing during construction. |
| 10 | Leylandii<br><i>Cupressocyparis Leylandii</i> | B2 | This tree will be retained. The crown and RPA can be fully protected by temporary fencing during construction. |
