## Arboricultural Appraisal Report

### Subsidence Damage Investigation at:

39 Andrew Close  
Stoke Golding  
Nuneaton  
CV13 6EL

CLIENT: Crawford & Company  
CLIENT REF: 1804198  
MWA REF: SUB250319-16144  
MWA CONSULTANT: Andy Clark  
REPORT DATE: 12/05/2025

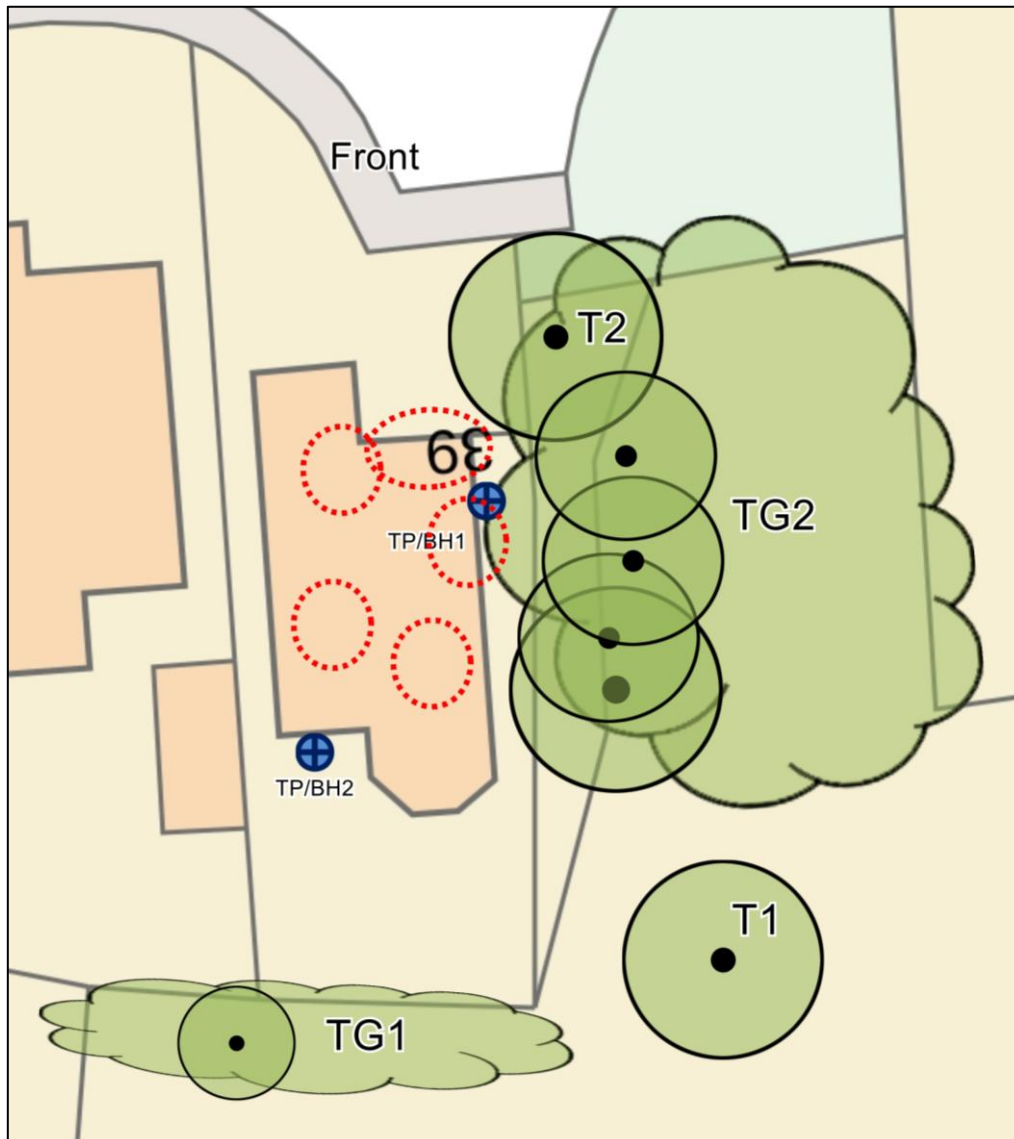
## Site Plan

Approximate areas of damage

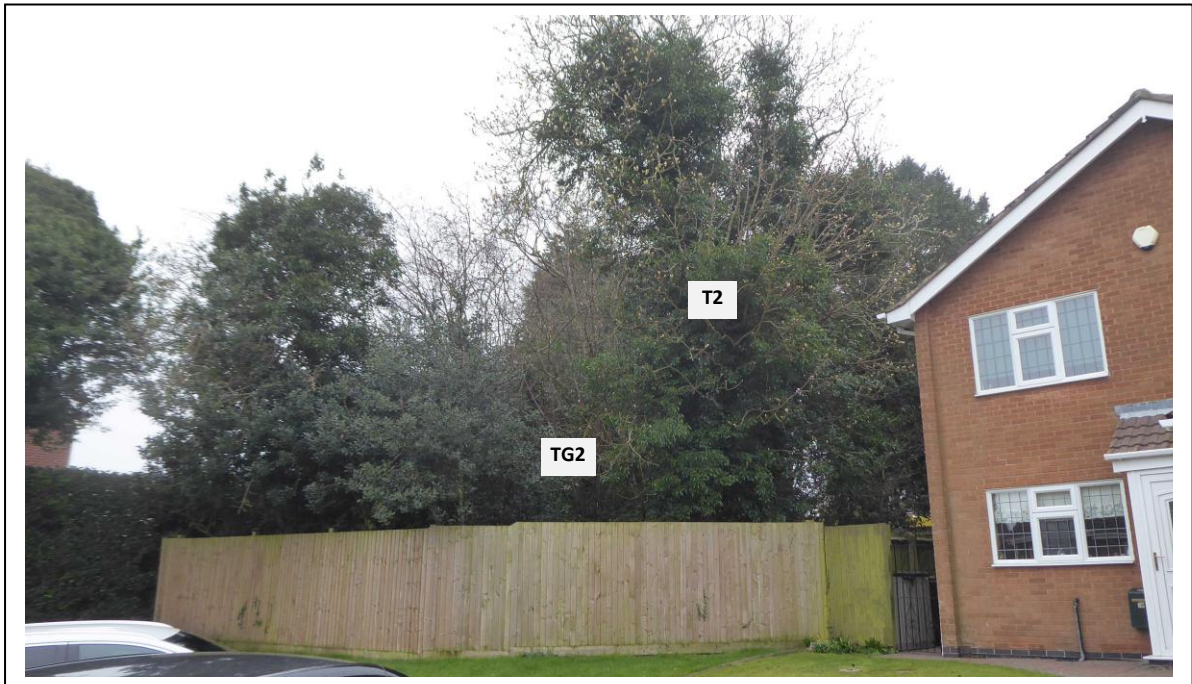
Roots were observed below foundation depth in TP/BH1 and TP/BH2 and recovered samples recovered from TP/BH1 have been positively identified (using anatomical analysis) as *Hedera* spp. or the related *Fatsia* spp. and most referable to *Aesculus* spp., the origins of which will be T2 Horse Chestnut, and the Ivy growth throughout the adjacent TG2 group.

Based on the information currently available, engineering opinion and our own site assessment we conclude there is damage consistent with shrinkage of the clay subsoil exacerbated by the soil drying effects of vegetation. Having considered the information currently available, it is our opinion that T2 Horse Chestnut and the nearby stems of TG2 group are the principal cause of the current building movement and damage.

View from property frontage of T2 Horse Chestnut and TG2 group

| Tree No. | Species | Height (m) | Dia (mm) | Crown Spread (m) | Dist. to building (m) | Age Classification | Ownership |
|---|---|---|---|---|---|---|---|
| Recommendation | | Remove (fell) to near ground level and treat stump to inhibit regrowth. | | | | | |
| Recommendation | | Remove (fell) all within 10m of the building to near ground level and treat stumps to inhibit regrowth. | | | | | |

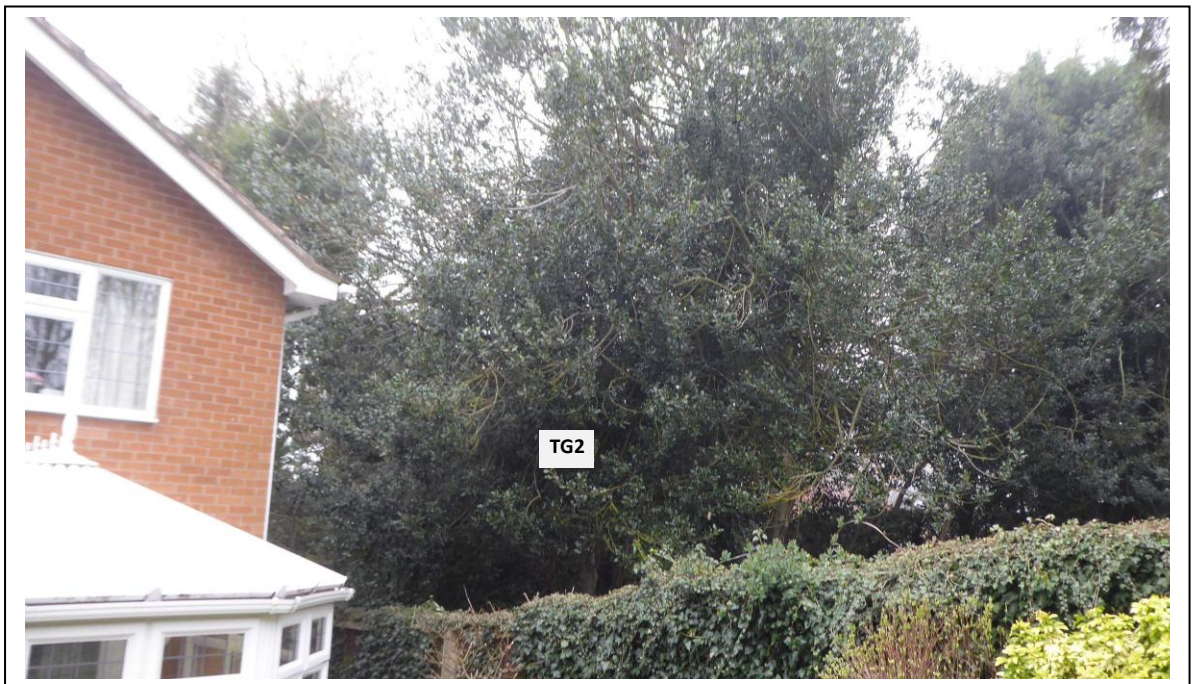
Irrespective of the identification of recovered root samples, the roots of the adjacent stems of TG2 group will also have a significant presence below foundation level of the left-hand flank with the potential to influence soil moisture and volumes.

View from property rear of TG2 group

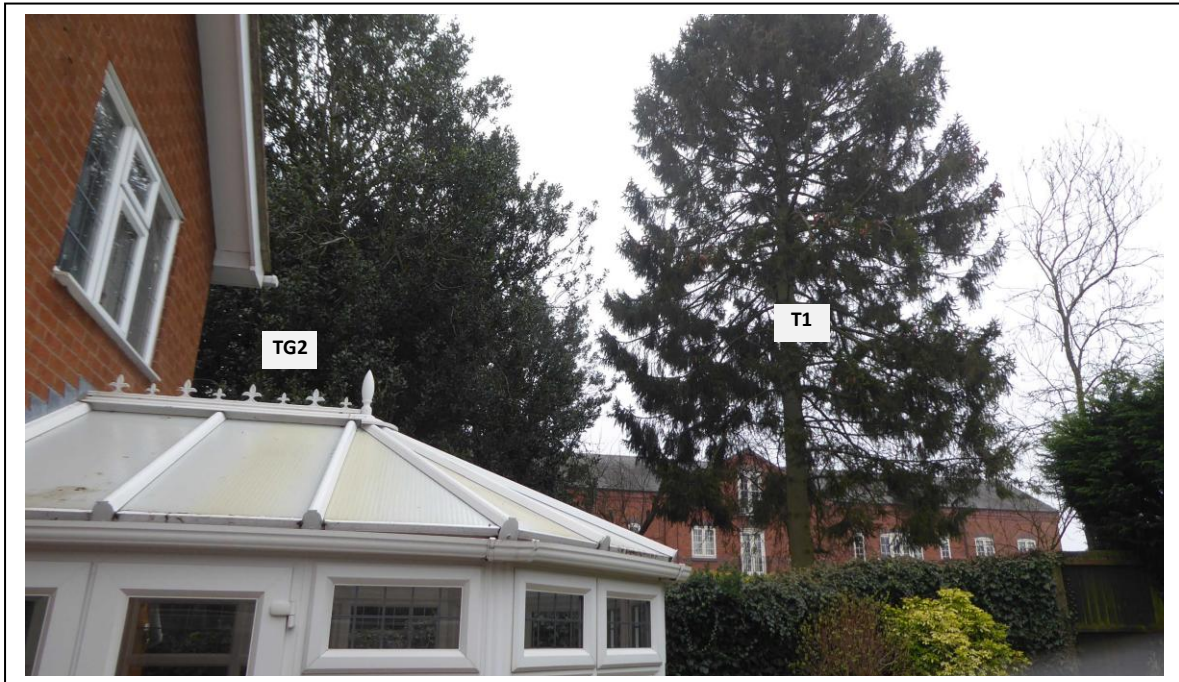
View of T1 Spruce and TG2 group

| Tree No. | Species | Height (m) | Dia (mm) | Crown Spread (m) | Dist. to building (m) | Age Classification | Ownership |
|---|---|---|---|---|---|---|---|
| Recommendation | | Maintain broadly at no larger than current dimensions by periodic pruning. | | | | | |

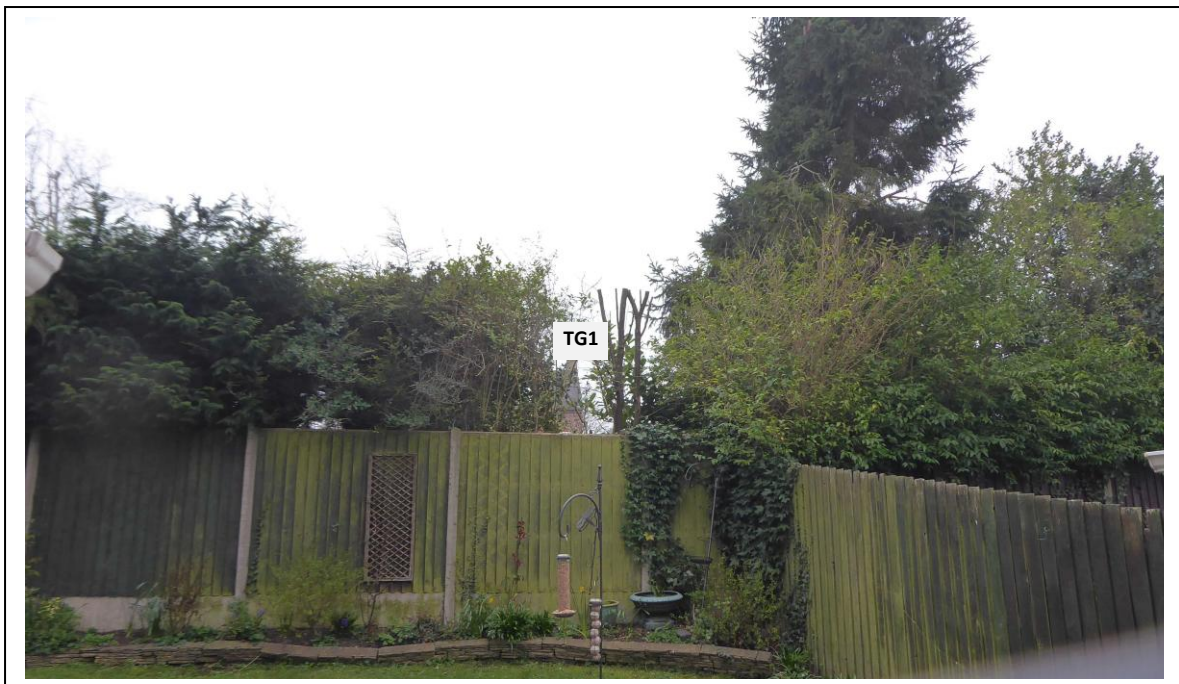
View of TG1 group beyond rear boundary

| Tree No. | Species | Height (m) | Dia (mm) | Crown Spread (m) | Dist. to building (m) | Age Classification | Ownership |
|---|---|---|---|---|---|---|---|
| Recommendation | | Maintain broadly at no larger than current dimensions by periodic pruning. | | | | | |
