BS5837:2012 Tree Survey  
Garden at 36 Main Street  
Stoke Golding  
Leicestershire  
NGR SP 39531 97273

Survey by  
Christopher Barker CEnv dipHort ACIEEM

# **BS5837 Tree Survey, Land at 36 Main Street, Stoke Golding**

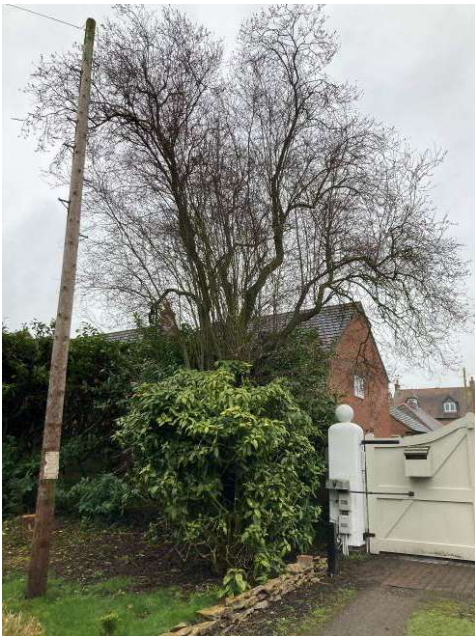
Damson T1

**Damson T1, Leylandii T2 and Ornamental Willow T3** are situated along the western edge of the surveyed garden lining the edge of the existing driveway. T1 is particularly close to the existing gated entrance and starting to crowd this. This tree is also showing some signs of loss of vigour with extensive regeneration within the crown interior. These are all trees of relatively small stature. T1 and T3 are placed within Category C but T2 is a Category B specimen with space to continue to mature for a 20-year period although significant trimming will be required to keep the edge of the crown away from the existing driveway.

| Tree No | Species | Ht (m) | Stem Diam mm@ 1.5m | Canopy Spread (m) | Height of Crown Clearance | Age Class | Est yrs | Overall Condition | Structural condition | Recommendations | BS 5837 Category | RPA Radius (m) |
|---|---|---|---|---|---|---|---|---|---|---|---|---|
| T1 | Damson<br><i>Prunus domestica</i> | 10 | 315 | N-2<br>S-3<br>E-3<br>W-2 | 3 | M | 10 | F | Broadly ascending with internal regeneration. Starting to crowd the entrance to the driveway.<br>No structural faults visible from ground level | | C2 | 3.7 |

| Ref | Tree | Category | Impact of development |
|---|---|---|---|
| 1 | Damson<br><i>Prunus domestica</i> | C2 | This tree will have to be removed to provide space for the new access into the property. |

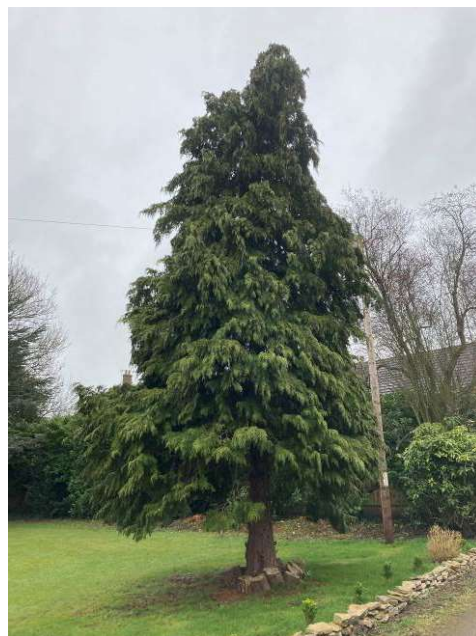
Leylandii T2

| Tree No | Species | Ht (m) | Stem Diam mm@ 1.5m | Canopy Spread (m) | Height of Crown Clearance | Age Class | Est yrs | Overall Condition | Structural condition | Recommendations | BS 5837 Category | RPA Radius (m) |
|---|---|---|---|---|---|---|---|---|---|---|---|---|
| T2 | Leylandii<br><i>Cupressocypariss Leylandii</i> | 8 | 230 | N-2<br>S-2<br>E-2<br>W-2 | 1 | SM | 20+ | G | Conical canopy close to the driveway.<br>No structural faults visible from ground level | | B2 | 2.7 |

| Ref | Tree | Category | Impact of development |
|---|---|---|---|
| 2 | Leylandii<br><i>Cupressocyparis Leylandii</i> | B2 | This tree will have to be removed to provide space for the new driveway and parking area. Replacement planting will take place elsewhere in the wider garden area controlled by the applicant. |

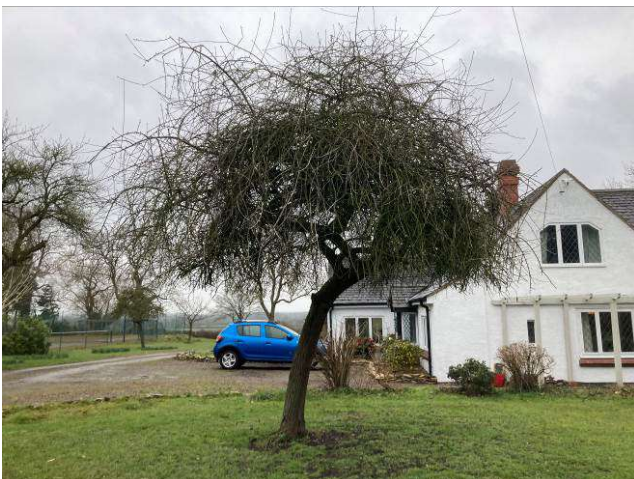
Ornamental Willow T3

| Tree No | Species | Ht (m) | Stem Diam mm@ 1.5m | Canopy Spread (m) | Height of Crown Clearance | Age Class | Est yrs | Overall Condition | Structural condition | Recommendations | BS 5837 Category | RPA Radius (m) |
|---|---|---|---|---|---|---|---|---|---|---|---|---|
| T3 | Ornamental Willow<br><i>Salix spp</i> | 4 | 210 | N-2<br>S-2<br>E-2<br>W-2 | 2 | Y | 10 | F | Small round crown lifted above the lawn.<br>No structural faults visible from ground level | | C2 | 2.5 |

| Ref | Tree | Category | Impact of development |
|---|---|---|---|
| 3 | Ornamental Willow<br><i>Salix spp</i> | C2 | This tree is not shown within the development plan and is presumably removed to provide space for new landscaping in front of the property. |

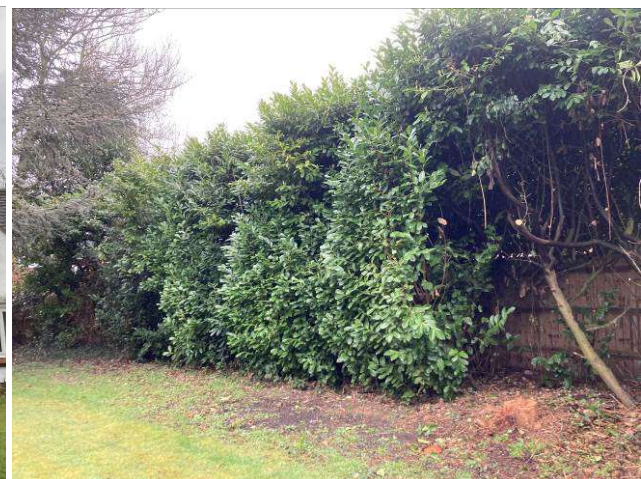
Group G4 Cherry Laurel

**Group G4** comprises a dense hedgerow of Cherry Laurel extending along the southern boundary of the garden. Whilst the side of the hedge has been trimmed in the past the top is getting very high. There are gaps appearing and the boundary fence behind the hedge is becoming overgrown. This Cherry Laurel extends along the south boundary almost to the south east corner of the garden.

| Tree No | Species | Ht (m) | Stem Diam mm@ 1.5m | Canopy Spread (m) | Height of Crown Clearance | Age Class | Est yrs | Overall Condition | Structural condition | Recommendations | BS 5837 Category | RPA Radius (m) |
|---|---|---|---|---|---|---|---|---|---|---|---|---|
| G4 | Cherry Laurel<br><i>Prunus laurocerasus</i> | 3-4 | <180 | N-2<br>S-2<br>E-2<br>W-2 | 0 | M | 10 | F | Irregularly trimmed hedge starting to spread.<br>No structural faults visible from ground level | Requires significant trimming back to create a dense, manageable hedge | C2 | 2.1 |

| Ref | Tree | Category | Impact of development |
|---|---|---|---|
| G4 | Cherry Laurel<br><i>Prunus laurocerasus</i> | C2 | This hedge will be trimmed back to 0.7m height and 0.5m spread. It should regenerate quickly and can be trimmed into a tight boundary hedgerow. Temporary ground protection will be laid down after it is trimmed to protect the ground from compaction during construction. |

The Cherry Laurel G4 along the southern boundary will be heavily trimmed back to a height of around 0.7m and spread of 0.5m This species does respond well to severe cutting back and is highly likely to regenerate quickly with new growth from the base and trimming points. The new growth can be box trimmed into a dense hedge which will screen the garden fence effectively but provide space along the southern side of the building for access.

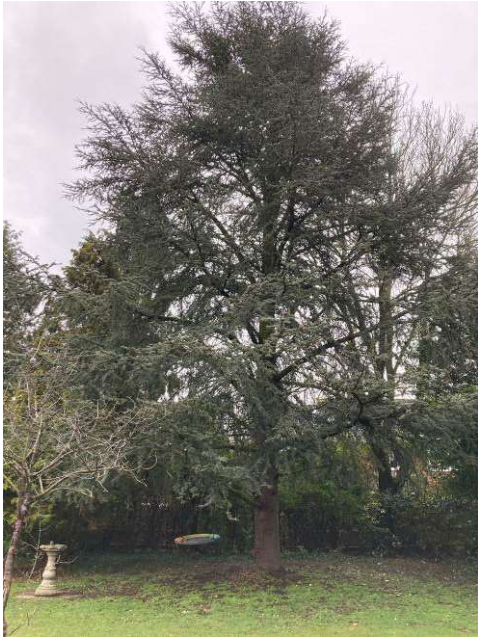
**Cherry T5** is a very small specimen tree of insignificant landscape value. **Cedar T6** and **Ash T7** are positioned in the south eastern quarter of the garden the former further within the garden interior and the latter close to the garden boundary. Both trees are starting to compete with each other for space but at the present time they appear in fairly good condition and have both been placed into Category B. The Cedar has previously been crown lifted to raise the crown above the garden.

| Tree No | Species | Ht (m) | Stem Diam mm@ 1.5m | Canopy Spread (m) | Height of Crown Clearance | Age Class | Est yrs | Overall Condition | Structural condition | Recommendations | BS 5837 Category | RPA Radius (m) |
|---|---|---|---|---|---|---|---|---|---|---|---|---|
| T6 | Atlantic Cedar<br><i>Cedrus atlantica</i> | 18 | 555 | N-5<br>S-5<br>E-4<br>W-5 | 2 | M | 20+ | G | Open, broadly conical but heavier on the west side.<br>No structural faults visible from ground level but crowded by T7 | | B1 | 6.6 |

| Ref | Tree | Category | Impact of development |
|---|---|---|---|
| 6 | Atlantic Cedar<br><i>Cedrus atlantica</i> | B1 | Due to its proximity to the proposed house this tree will have to be removed to open up garden space for the new property. Replacement planting will take place elsewhere in the wider garden area controlled by the applicant. |

Cedar T6 will be the only tree of significant stature and quality to be removed from within the garden interior. It is impractical to retain this tree so close to a new house as there will be concern in the future (perceived risk) and pressure to remove or reduce the tree. It is also competing for space with Ash T7 to the south east and has already been crown lifted to allow access under the canopy for

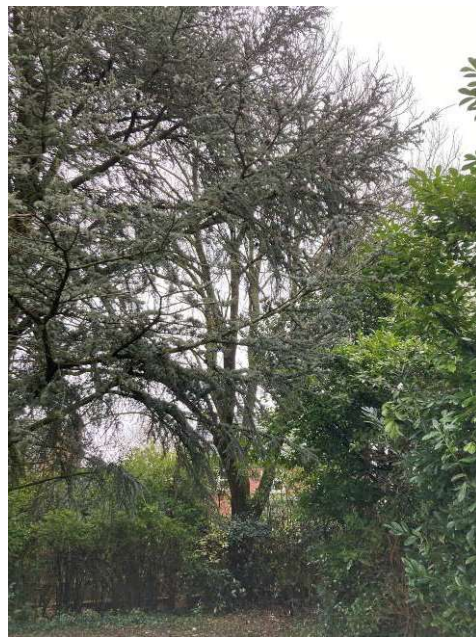
Ash T7

| Tree No | Species | Ht (m) | Stem Diam mm@ 1.5m | Canopy Spread (m) | Height of Crown Clearance | Age Class | Est yrs | Overall Condition | Structural condition | Recommendations | BS 5837 Category | RPA Radius (m) |
|---|---|---|---|---|---|---|---|---|---|---|---|---|
| T7 | Ash<br><i>Fraxinus excelsior</i> | 20 | 605 | N-7<br>S-6<br>E-5<br>W-5 | 5 | M | 20 | F | Irregular, open crown appears fairly sparse. Lifted over the adjacent gardens.<br>No structural faults visible from ground level | | B2 | 7.2 |

| Ref | Tree | Category | Impact of development |
|---|---|---|---|
| 7 | Ash<br><i>Fraxinus excelsior</i> | B2 | This tree will be retained. The crown and RPA can be fully protected by temporary fencing during construction. |

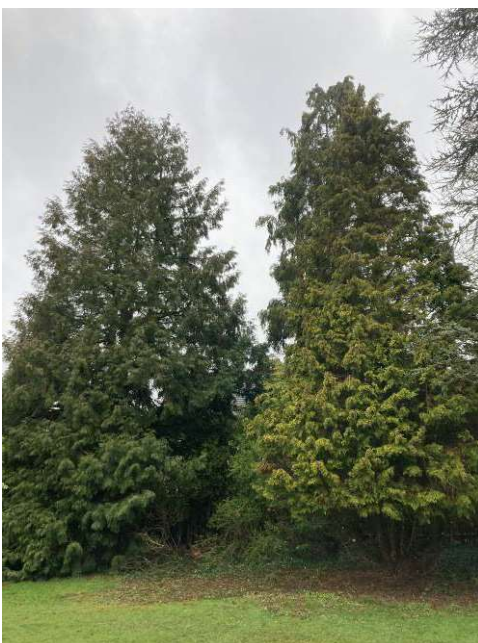
Trees T8, T9 and T10

**Trees T8, T9 and T10** are pyramidal Leylandii established to screen the north eastern edge of the garden. These three trees provide effective screening to the garden from the east. T9 and T10 are close to the boundary fence with sufficient space to continue to mature. T8 is a slightly smaller tree further into the garden interior starting to compete with T9. All three trees are placed within Category B.

| Tree No | Species | Ht (m) | Stem Diam mm@ 1.5m | Canopy Spread (m) | Height of Crown Clearance | Age Class | Est yrs | Overall Condition | Structural condition | Recommendations | BS 5837 Category | RPA Radius (m) |
|---|---|---|---|---|---|---|---|---|---|---|---|---|
| T8 | Leylandii<br><i>Cupressocyparis Leylandii</i> | 12 | 210<br>100<br>100<br>50 | N-2<br>S-2<br>E-2<br>W-2 | 0 | SM | 20+ | G | Broadly conical.<br>No structural faults visible from ground level | | B2 | 3.1 |
| T9 | Leylandii<br><i>Cupressocyparis Leylandii</i> | 15 | 310 | N-2<br>S-2<br>E-2<br>W-2 | 2 | M | 20+ | G | Broadly conical.<br>No structural faults visible from ground level | | B2 | 3.7 |
| T10 | Leylandii<br><i>Cupressocyparis Leylandii</i> | 12 | 380 | N-2<br>S-3<br>E-3<br>W-3 | 0 | M | 20 | F | Broadly conical.<br>No structural faults visible from ground level | | B2 | 4.5 |

| Ref | Tree | Category | Impact of development |
|---|---|---|---|
| 8 | Leylandii<br><i>Cupressocyparis Leylandii</i> | B2 | Due to its proximity to the proposed house this tree will have to be removed to open up garden space for the new property. Replacement planting will take place elsewhere in the wider garden area controlled by the applicant. |
| 9 | Leylandii<br><i>Cupressocyparis Leylandii</i> | B2 | This tree will be retained. The crown and RPA can be fully protected by temporary fencing during construction. |
| 10 | Leylandii<br><i>Cupressocyparis Leylandii</i> | B2 | This tree will be retained. The crown and RPA can be fully protected by temporary fencing during construction. |
