## *Structural Inspection*

*Project:* **Glebe Farm  
Sheepy Lane  
Orton on the Hill  
Leicestershire  
CV9 3NJ**

*Project No:* **19-15440**

*Date:* **June 2019**

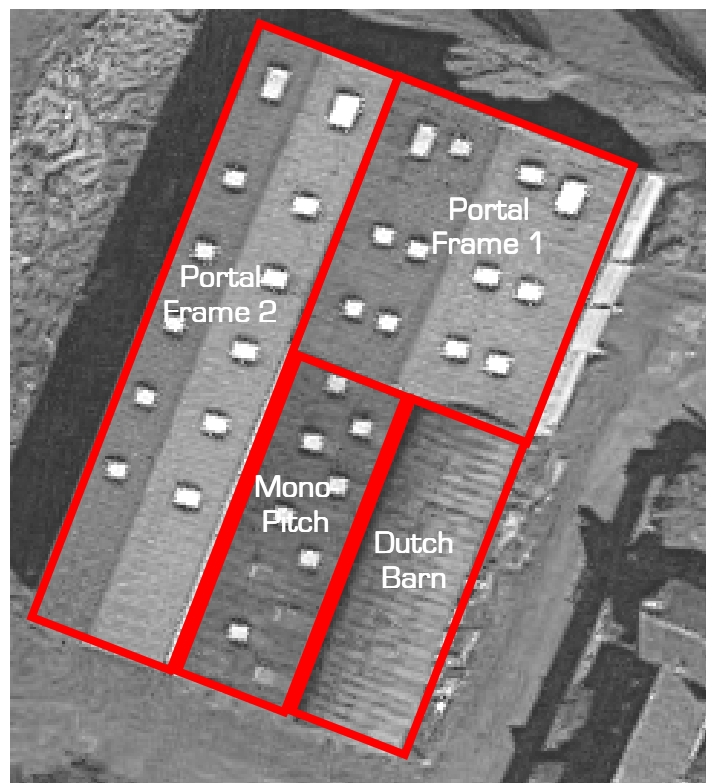
The general layout is indicated in Figure 1

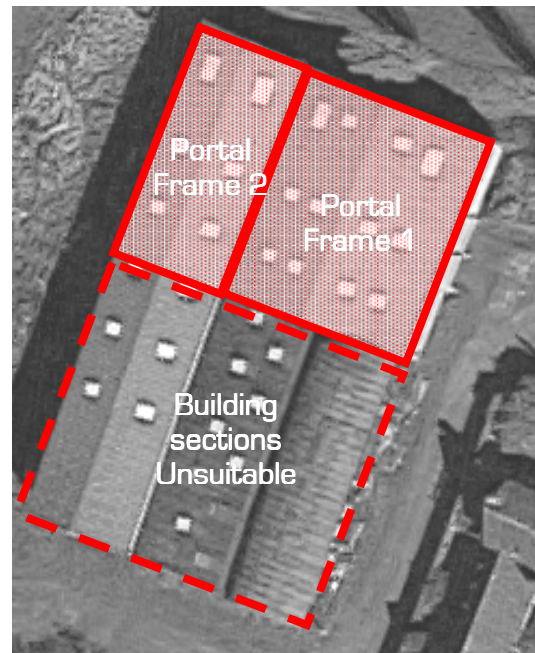
- 4.4 The sections of the structure considered to be suitable are indicated on Figure 2

- 4.1 On the basis of my inspection, I advise that the Dutch barn and mono-pitched side extension are unsuitable for conversion into habitable accommodation.

- Removal of the mono-pitched side extension will remove the column support for the remaining length of Portal Frame 2, and so the 5No. bays alongside the Dutch barn and side extension should be demolished as part of any proposals.
