## **ENGINEERS REPORT**

### **Report on a visual inspection of:**

TWO BARNS AT  
MANOR FARM  
CARLTON ROAD  
BARTON IN THE BEANS  
LEICESTERSHIRE  
CV13 0DE

24S01/02 December 2024

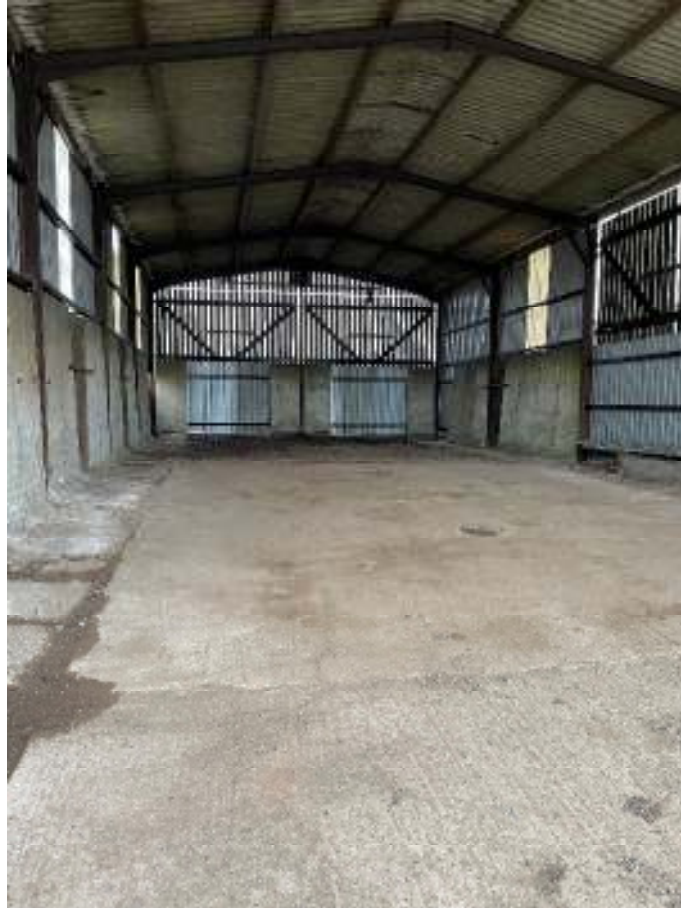
**Figure 5:** Barn A - Internal

There was widespread surface rust on most of the exposed steelwork. But this is unlikely to have had a significant impact on the performance of the structure.

- Provide additional 50x50x5 RSA rafter stays.
- Replace the front left hand side corner portal frame column with a similar sized section.
- Surface preparation and corrosion protection of the steel frame

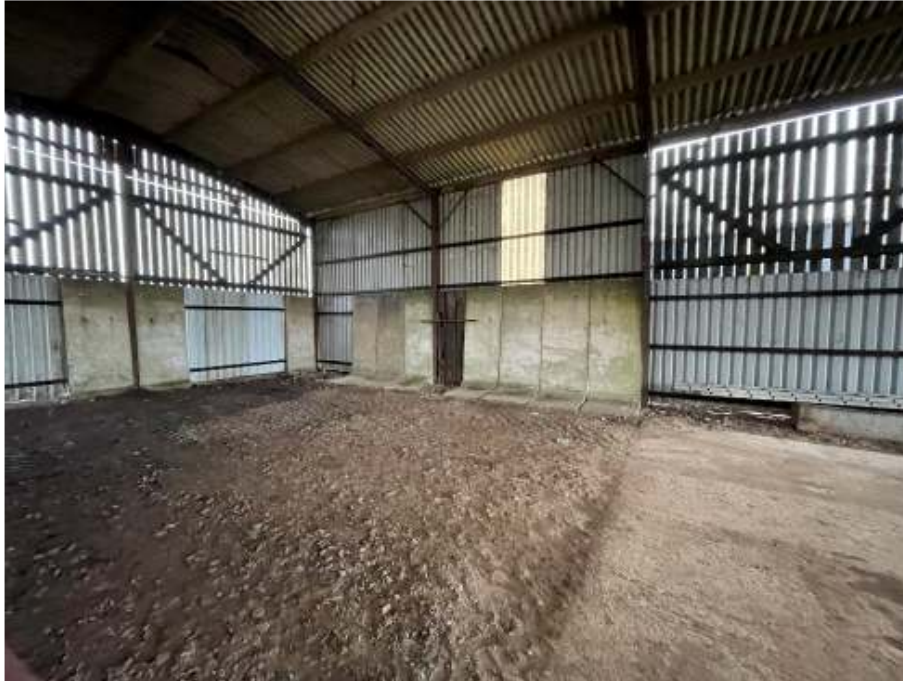
**Figure 6:** Barn A - knee bracing, purlins and cladding rails

The stability bracing comprised RSA knee bracing to the main elevation walls.

The purlins comprised 75mm x 200mm timber sections spanning between the main portal frames.

The cladding rails comprised 100mmx75mm timber sections spanning between the main portal frames.

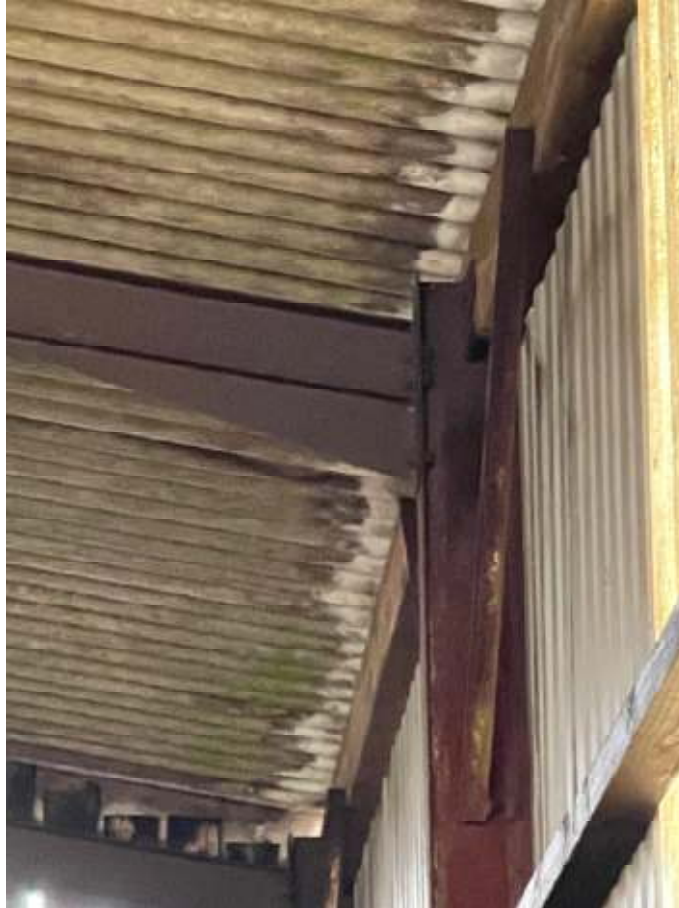
**Figure 7:** Barn A - portal frame eaves connection

The rafters will receive a degree of lateral restraint from the timber purlins, but no lateral torsional buckling restraints had been provided. This is often found in agricultural buildings and is a relatively straightforward matter to rectify.

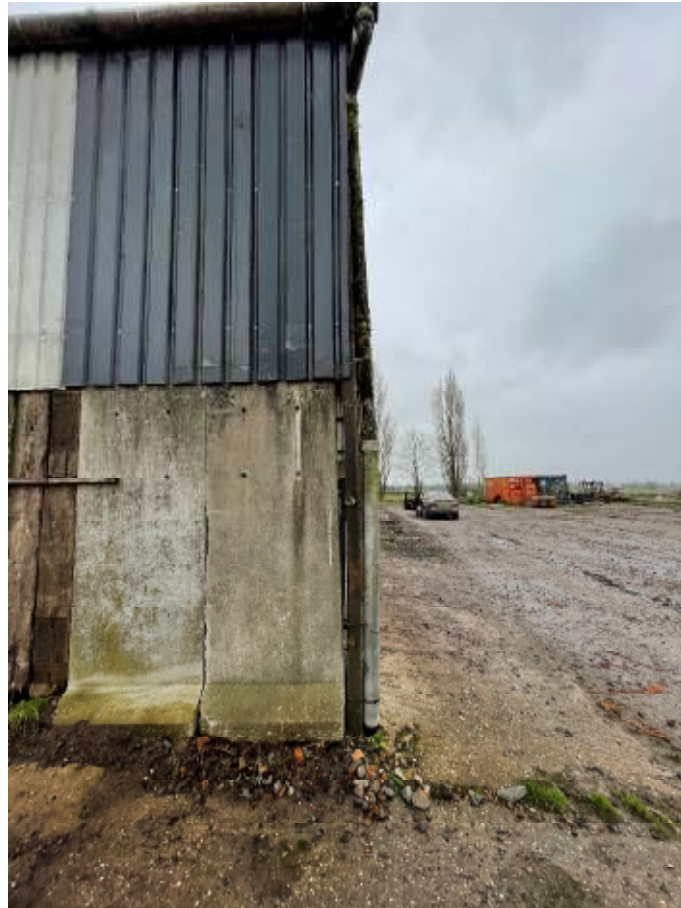
**Figure 8:** Barn A - Impacted column at the front left hand side corner of the building

There was evidence of impact damage to the front left hand side portal frame column.

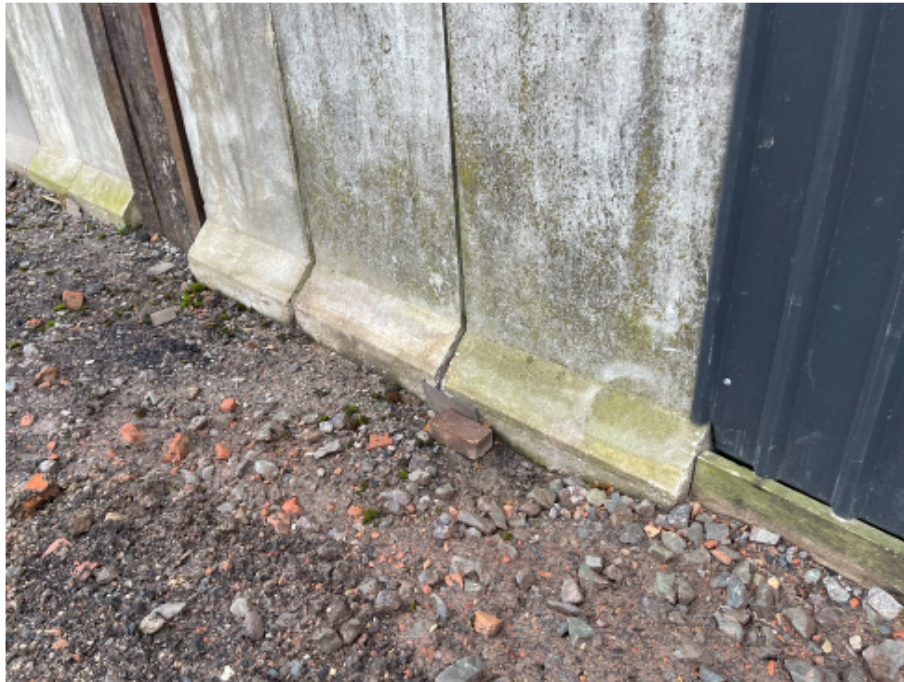
**Figure 9:** Barn A - precast concrete wall units

There had been some weathering of the top surface of the pre cast concrete bases forming part of the reinforced concrete wall panels.

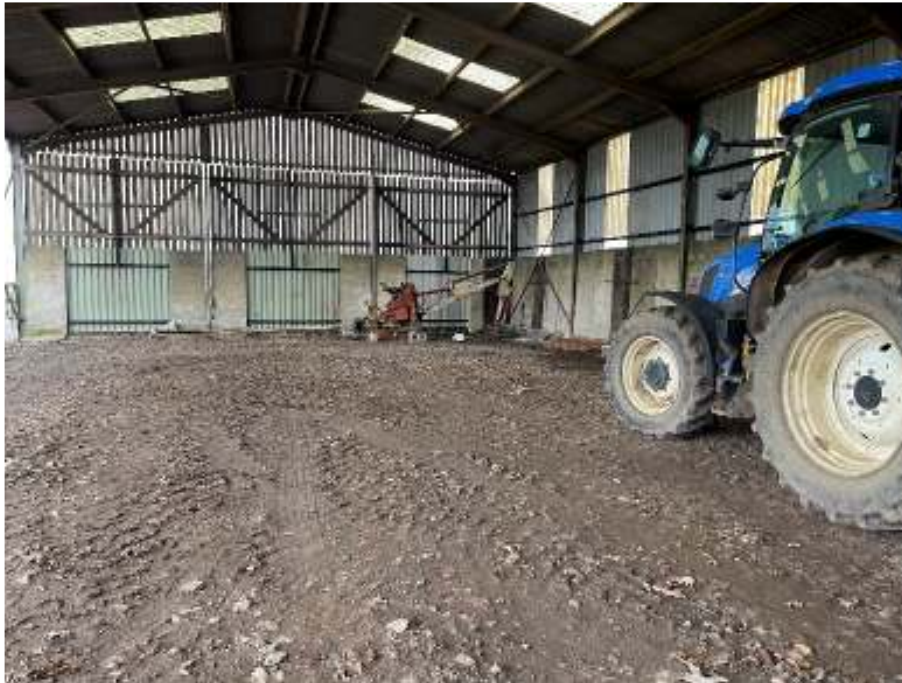
There was localised surface rust on small areas of the exposed steelwork. But this will not have any significant impact on the performance of the structure.

The rafters will receive a degree of lateral restraint from the timber purlins, but no lateral torsional buckling restraints had been provided. This is often found in agricultural buildings and is a relatively straightforward matter to rectify.

**Figure 14:** Barn B – Internal

- Provide additional 50x50x5 RSA rafter stays.
- Surface preparation and corrosion protection of the steel frame
