**A Historic Building Photographic Survey at**

**102 Main Street,**

**Nailstone,**

ULAS Report No 2025-005

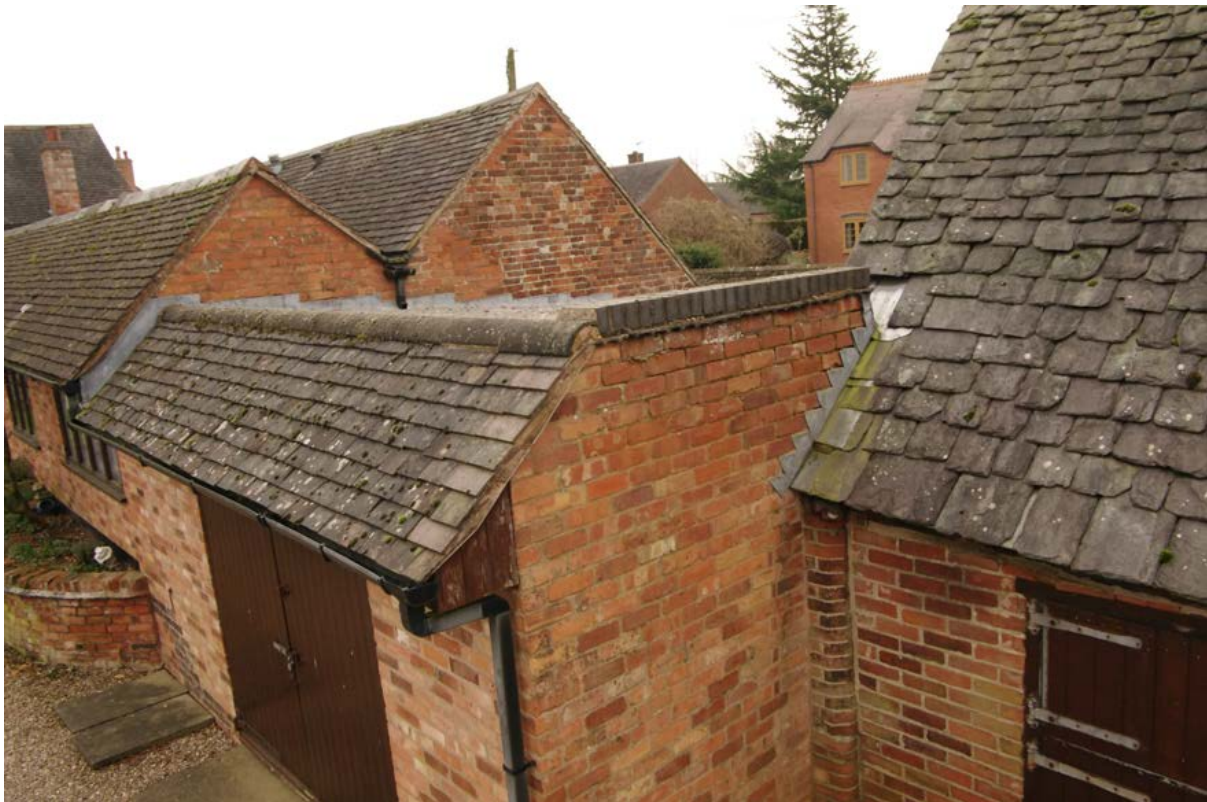
Figure 24: Flat-roofed section on the southern range

Within the yard is mix of graveled parking and landscaped lawns and paths (Figure 20 to Figure 23). The flat-roofed junction between the two barns on the southern side of the yard appears to be built using fairly modern bricks, probably later 20th century (Figure 24).

*Looking south-east towards Main Street. The brickwork on the infilled area is late 20th century. Note the different brickwork on the range behind which suggests that it has been extended. Most site buildings use roof tiles although the north-facing roof of the right hand barn has graded Swithland slates*

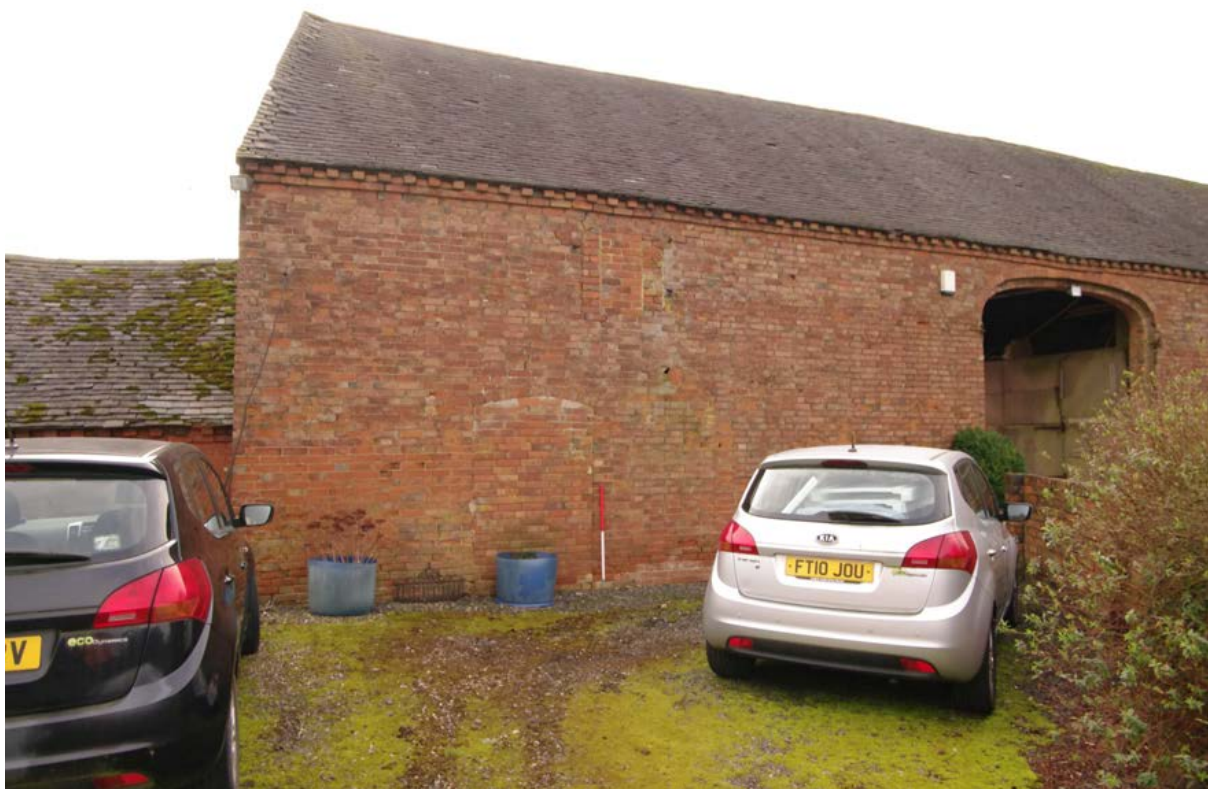
Figure 26: Threshing barn. Eastern end of the north-west facing elevation  
*Note the blocked doorway to the left of the 1m scale. Another first floor window above the scale has been blocked*

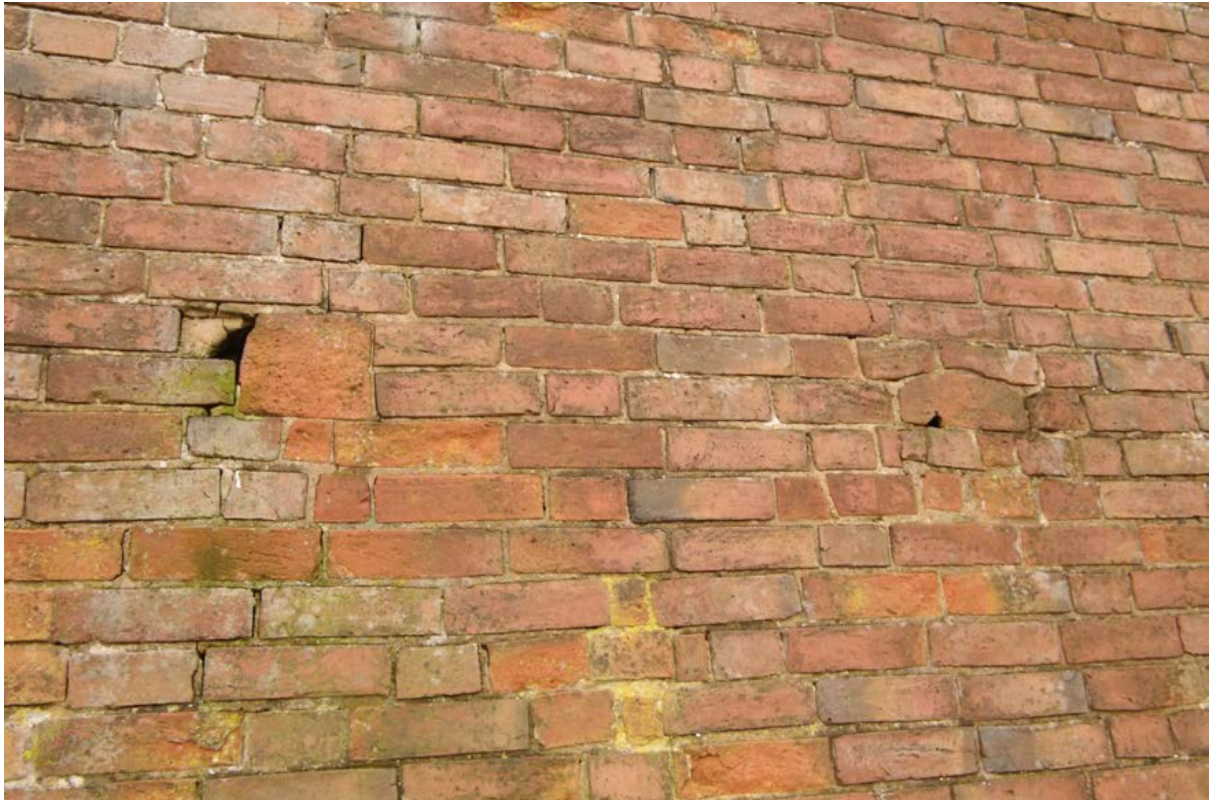
Figure 27: Threshing barn vents. Eastern end of the north-west facing elevation  
*Note the two blocked vents which are located below the blocked window shown in Figure 26*

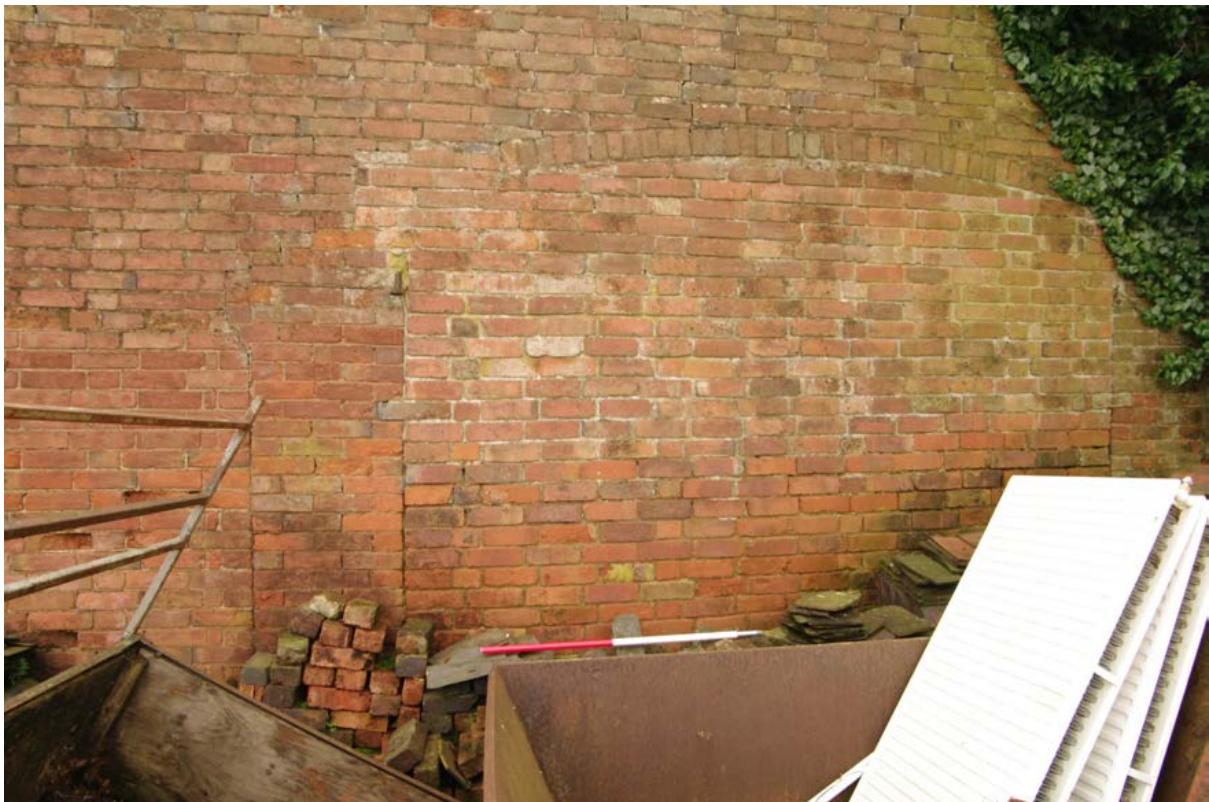
Figure 28: Threshing barn. Western end of the north-west facing elevation  
*Note the wide opening above the 1m scale. There is evidence of another blocking to the left of this*

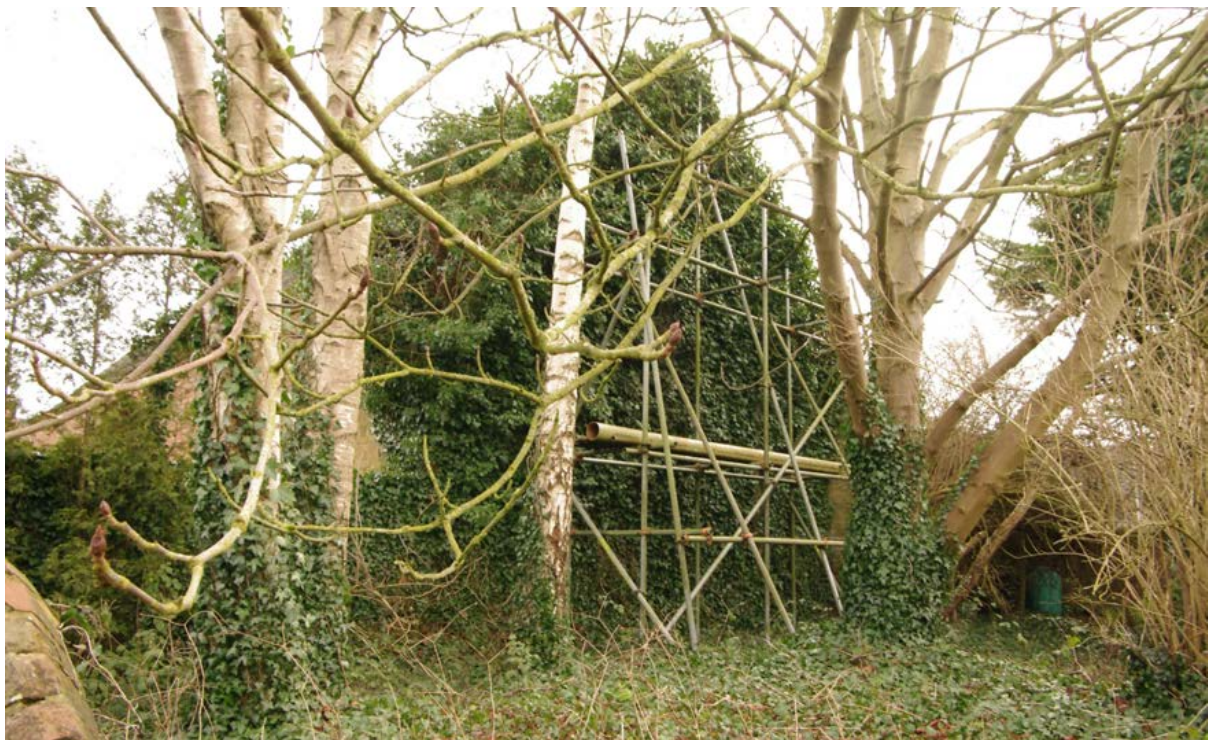
Figure 30: Threshing barn. South-west facing gable end  
*Looking east. Hardly any brickwork was visible during the survey. The scaffolding suggests a poor and unstable condition so no attempt was made to remove the vegetation*

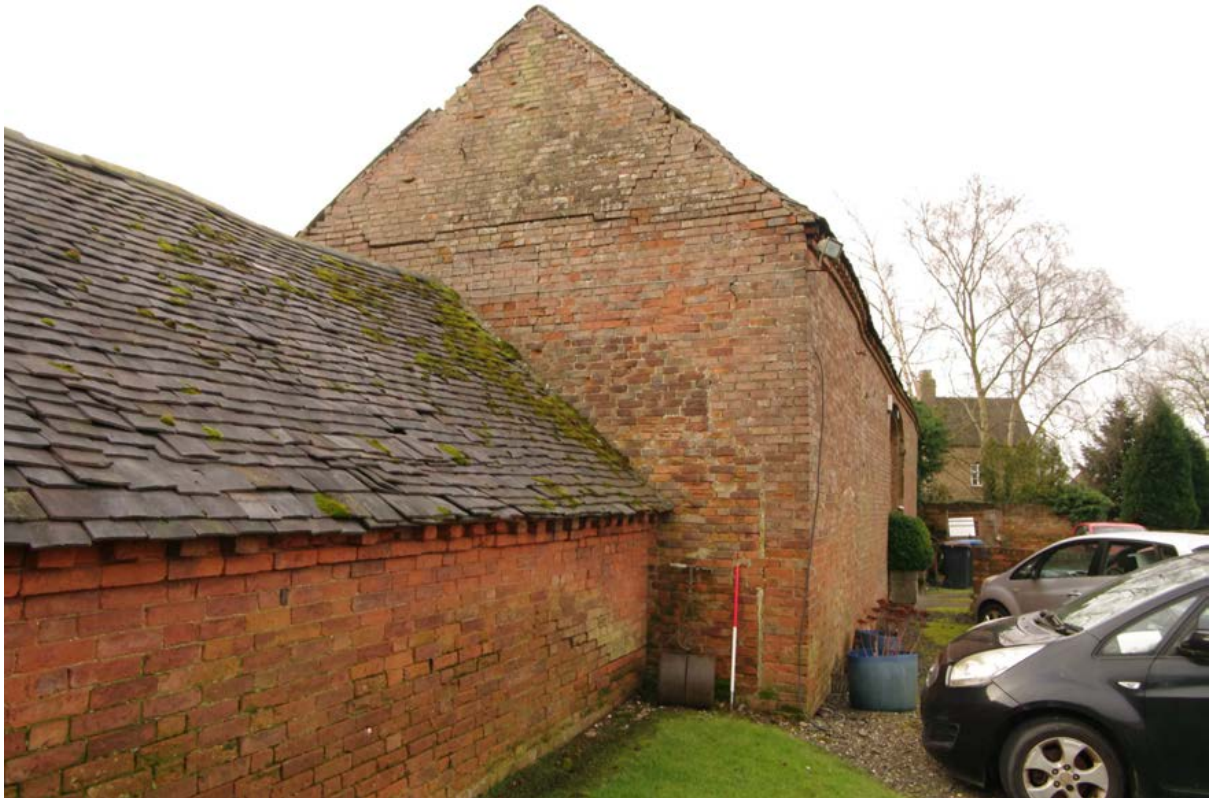
Figure 31: Threshing barn. North-east facing elevation

*Note the blocked window close to the ridgeline of the single-storey stable on the left. Also note the earlier brickwork rising up behind the 1m scale*

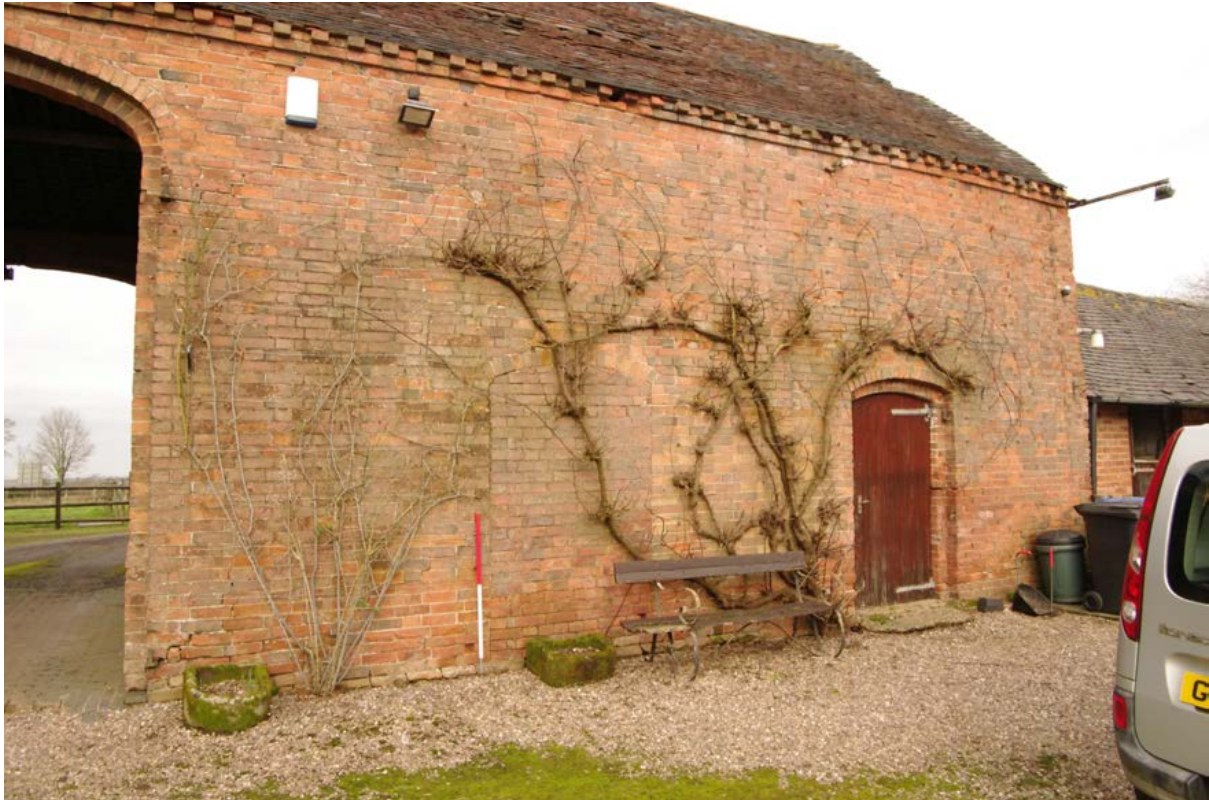
Figure 33: Threshing barn. Eastern end of the south-east facing elevation  
*Looking north. 1m scale to the right of a blocked doorway*

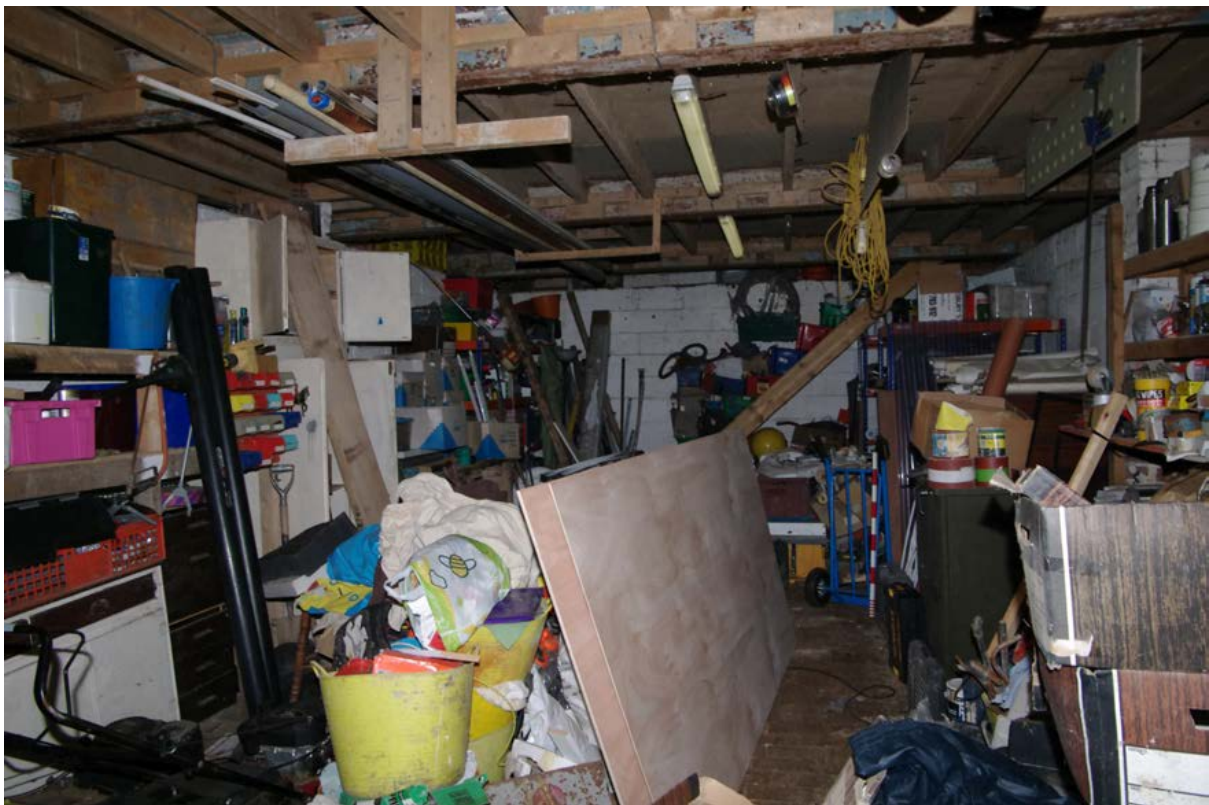
Inside the threshing barn the walls have been lined with 20th century concrete breeze blocks, probably added to support failing brickwork. This masks the earlier fabric of the building. To the west of the central doorway the ground floor room is an open single room with a low ceiling supported by modern RSJ girders (Figure 34). Modern steps lead up to the first floor to reveal the roof structure (Figure 35). The roof trusses appear to be of early to mid-19th century in date and consist of pegged (rather than bolted) king posts with cleated purlins resting on the backs of the principal rafters.

Figure 34: Threshing barn ground floor  
*Looking south-west in the western room. Note the breeze block-lined wall at the end and sides of the room and the modern RSJ girders forming the ceiling*

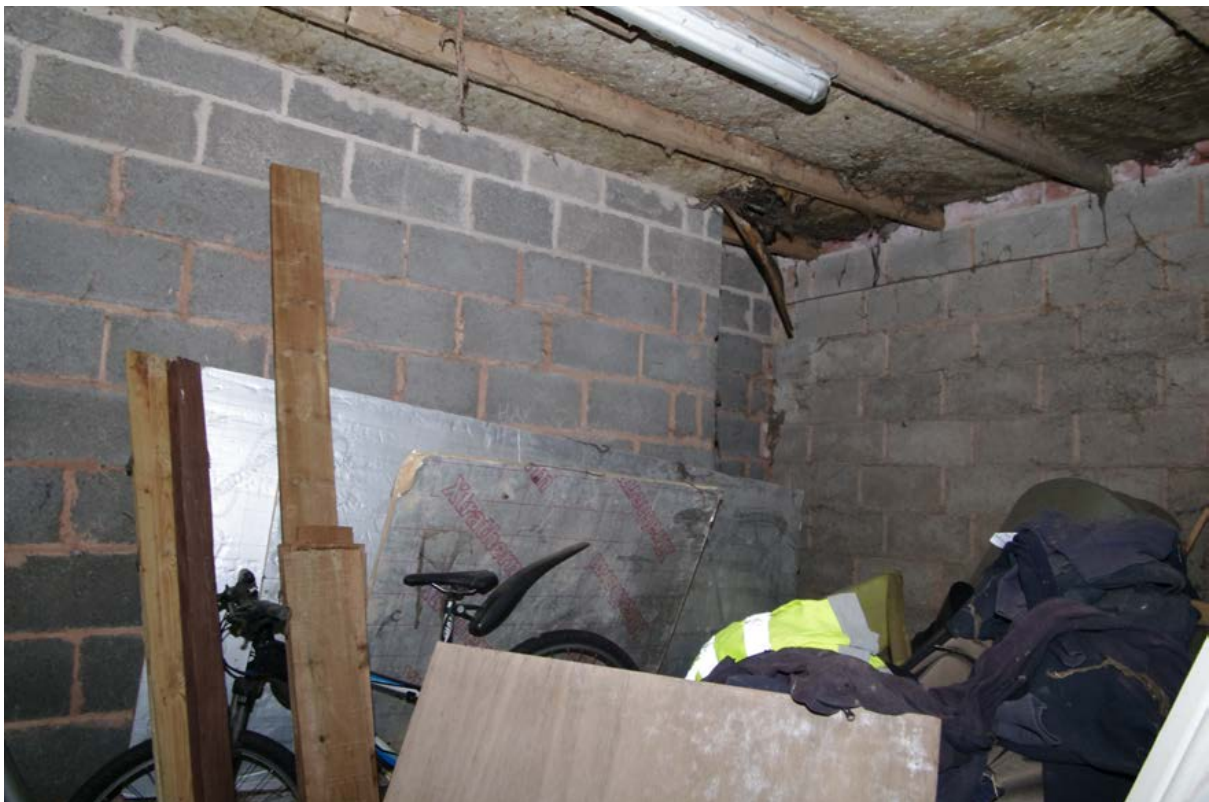
To the east of the central doorway the ground floor of the barn has been divided into four smaller storage areas all of which show that the outer walls have been lined with concrete blocks (Figure 36 and Figure 37). This modern lining means that no original fabric or features can be seen anywhere within the barn.

Figure 36: Threshing barn ground floor store to the east of the central doorway  
*Looking east. The internal dividing walls are concrete blocks as are the lined external walls (to the right of this picture)*

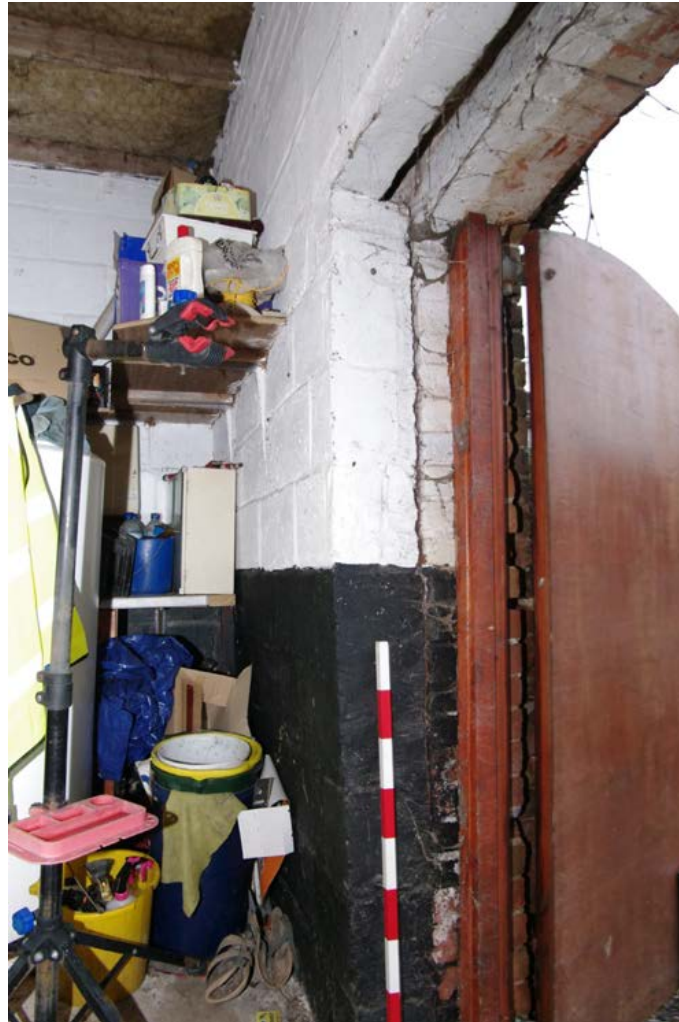
Figure 37: Threshing barn ground floor east end room

*Looking north-east at the concrete block lined wall (behind the 1m scale) and the outside doorway*

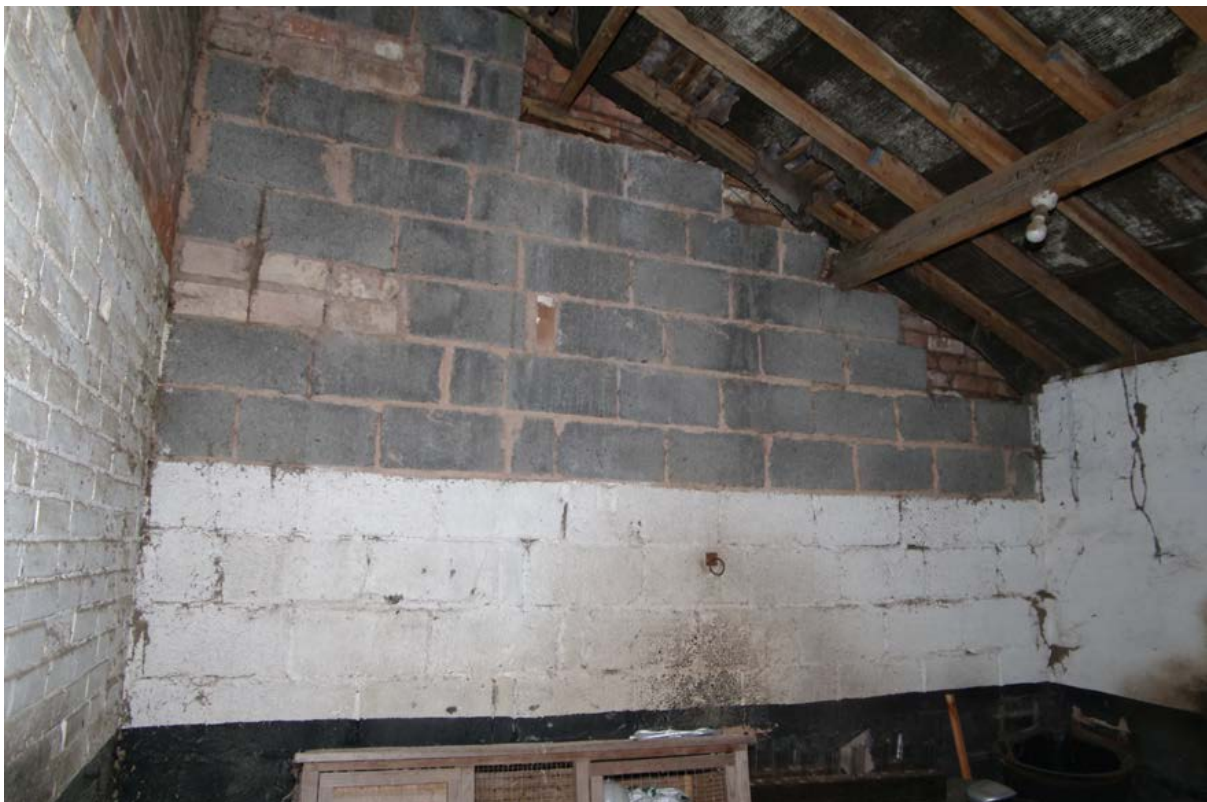
Figure 44: South-western stable, reinforced eastern end wall  
Looking north-east at the inserted skin of modern blockwork

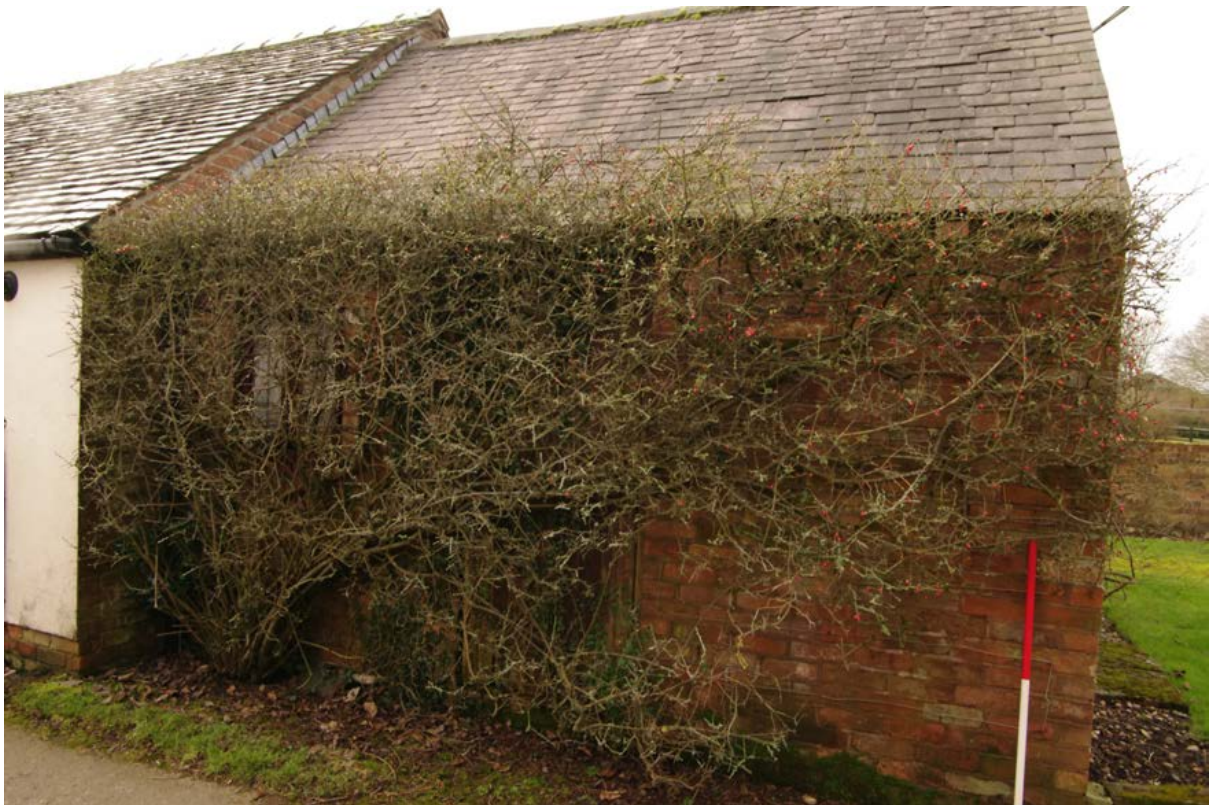
The north-east facing elevation is covered with thick vegetation but it is possible to see a single-width doorway and window (Figure 51). The window lights a small toilet and shower room. The north-west facing elevation has a small window and doorway (Figure 52). Another window and door are located on the south-west facing elevation (Figure 53). Attached to the south-west corner of the office annex is a modern timber and glass porch which will be removed during the proposed works (Figure 54).

Figure 51: North-east facing elevation of the office annex  
*Looking south-west. 1m scale. Note the obscured window and doorway behind the vegetation*
