**Structural Appraisal  
of  
Shackerstone Fields Farm,  
Snarestone, Swadlincote, DE12  
7DE**

**P A Wright and Sons**

**11472-GCA-XX-01-RP-S-0001-S02-P01**

**Release Date of Report:  
July 2026**

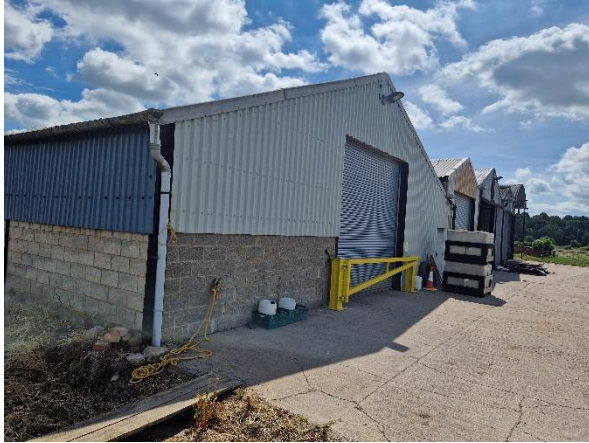
Front elevation

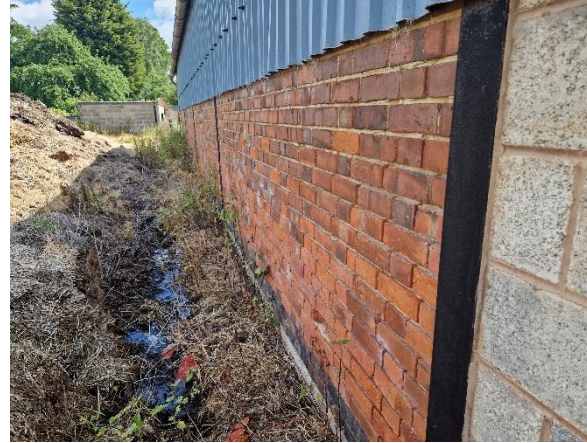
- 403 The masonry is generally in reasonable conditions for its age, with no signs of any significant structural cracking suggesting the current foundations for the wall are suitable. The blockwork is in good condition with good pointing and only occasional localised defects. The brickwork is in a slightly more weathered condition and would benefit from some repointing but the brick units are otherwise in reasonable condition for their age.

Brickwork side elevations

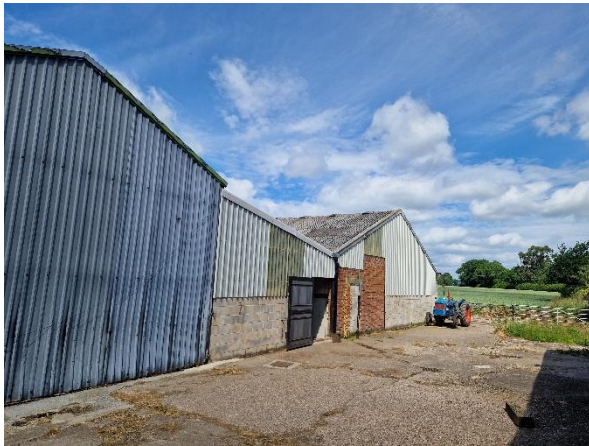
Rear elevation

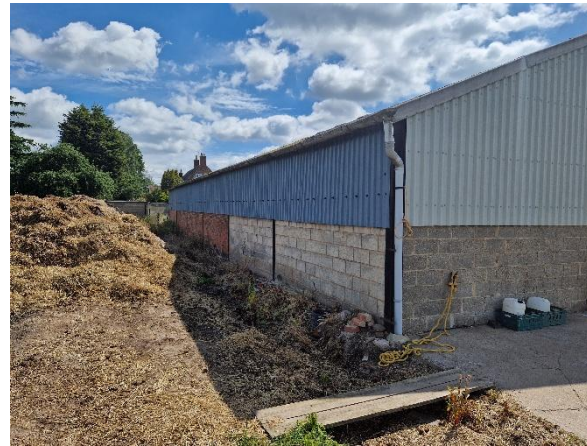
Full side elevation with brick and block

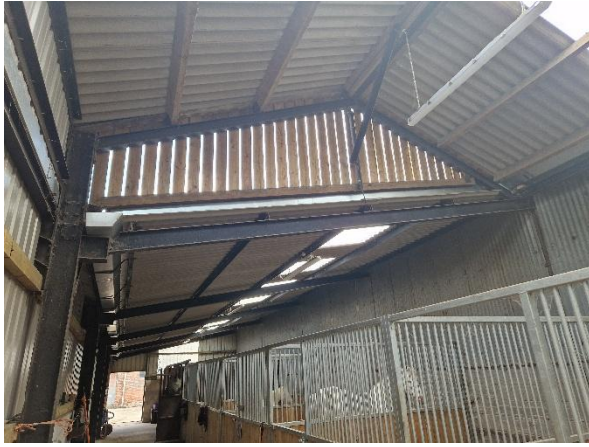
View of duo pitched and monopitched roofs

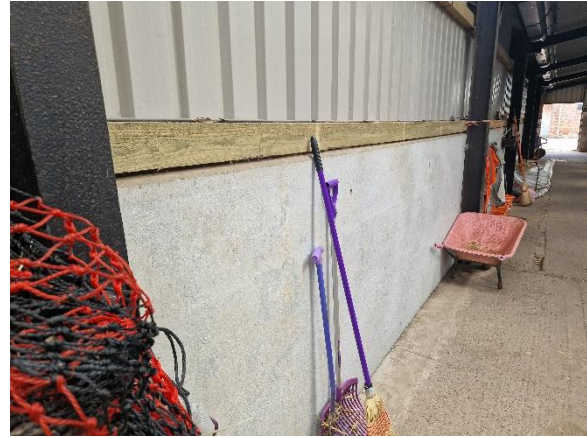
Precast panels at the base of the walls

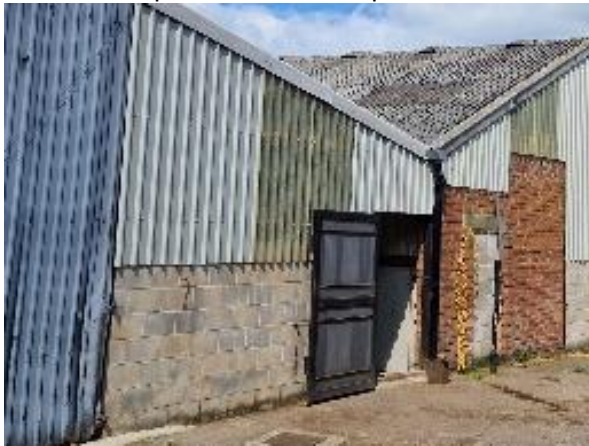
North-East elevation

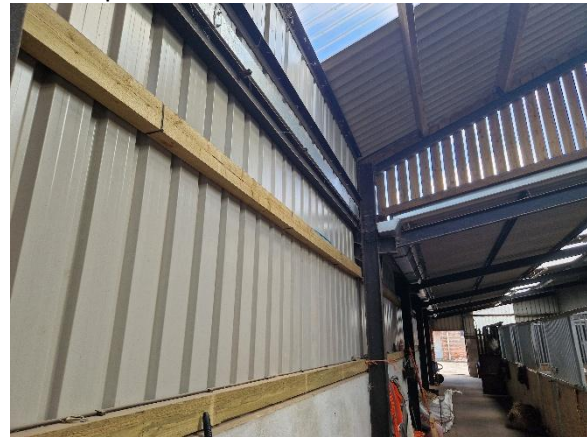
Wall cladding panels and timber rails

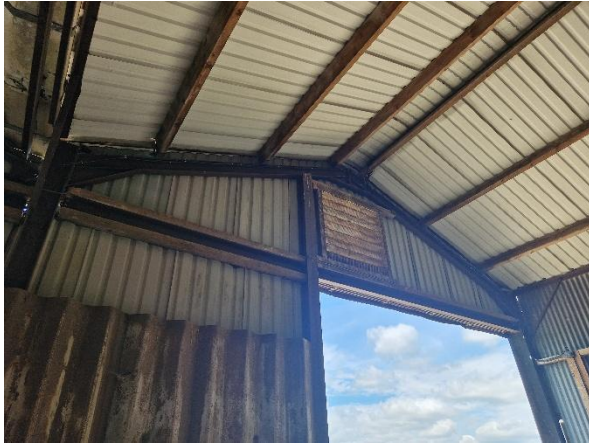
Front opening

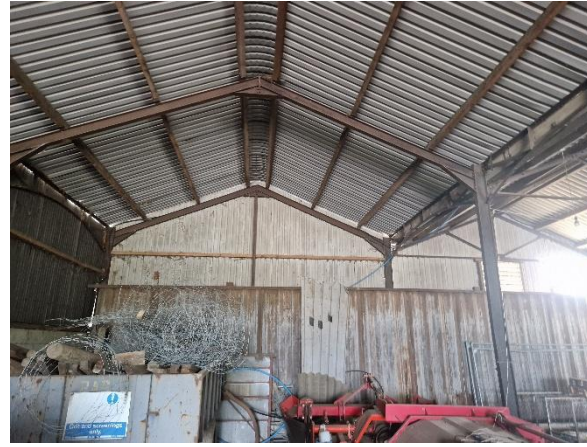
Rear inside elevation

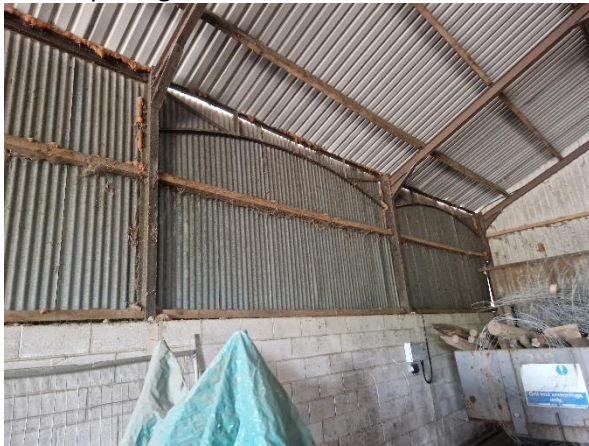
- 603 Lateral stability is provided by low level blockwork panels in the longitudinal direction, which is assisted by some bracing between columns at the head in places. Cladding sheets will also be providing some diaphragm action and assisting with lateral stability.

Typical long elevation with block wall and Dutch barn eaves bracing

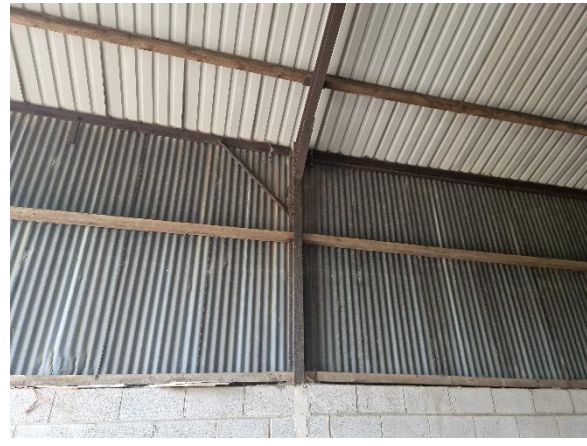
Knee brace at eaves

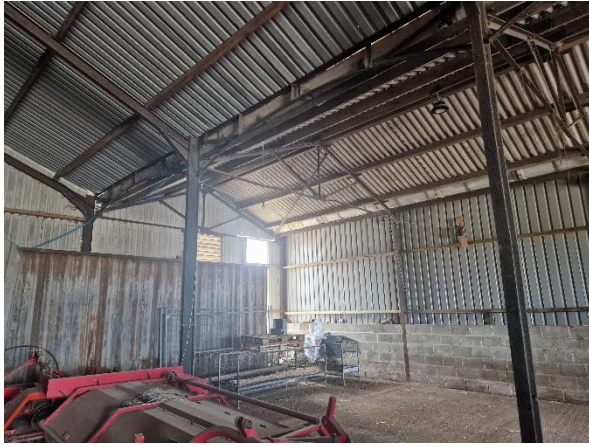
Typical internal view from Barn 3

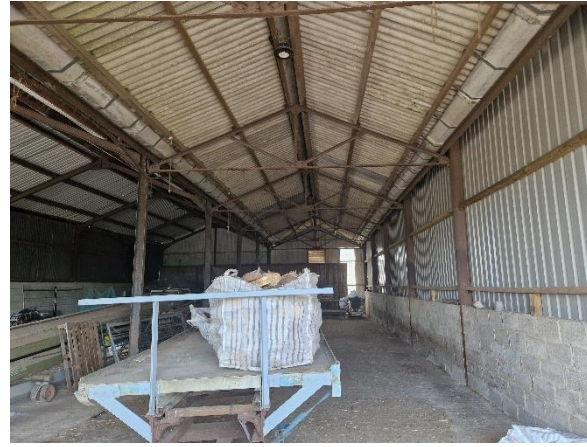
View of internal trusses and columns

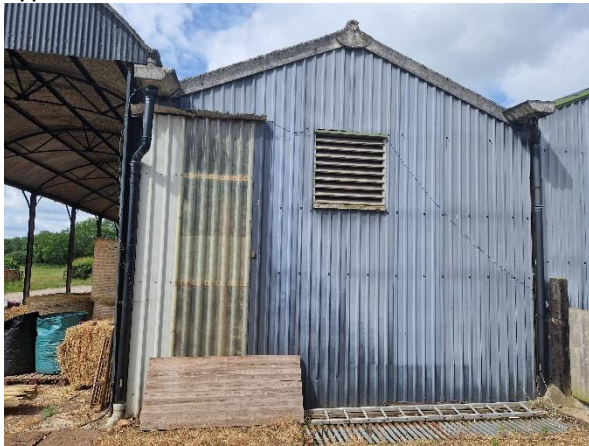
Rear elevation

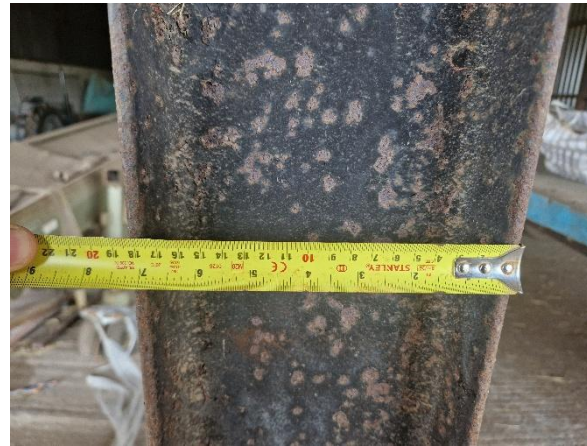
Shared column with Barn 3

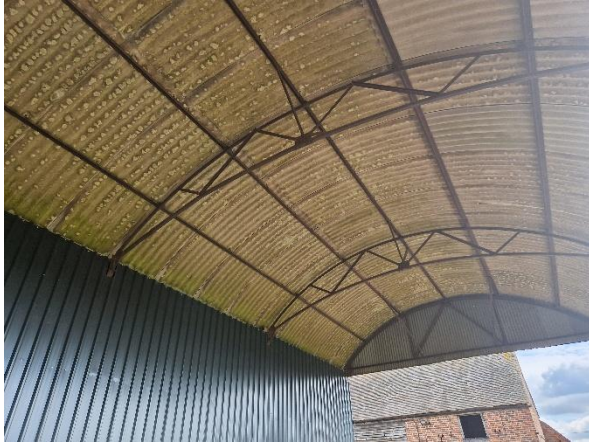
View of roof structure and trusses

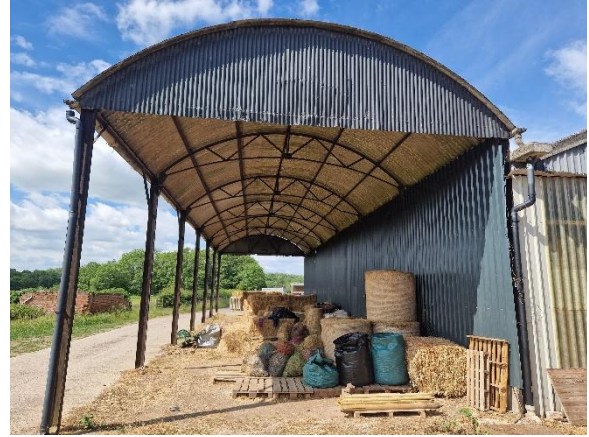
View from rear

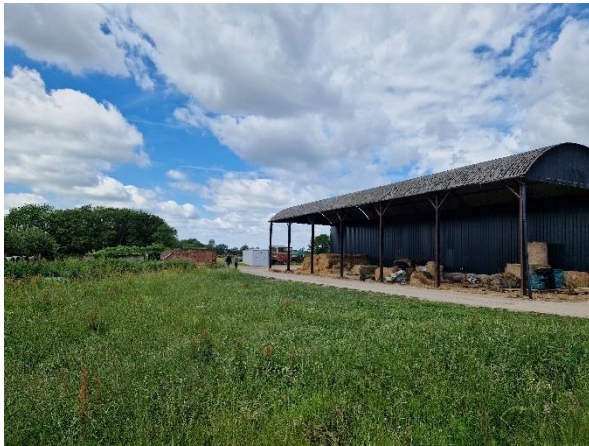
Side elevation

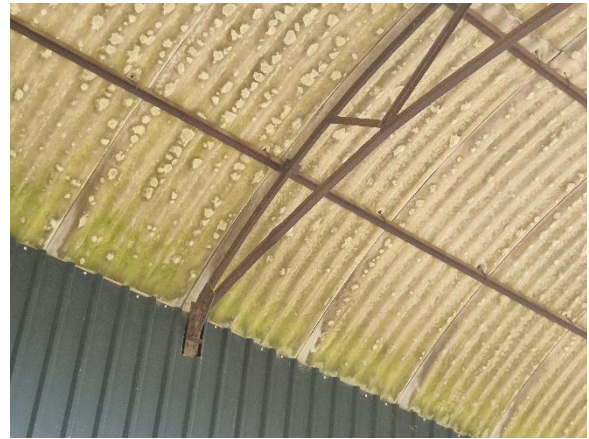
Interface with Barn 4

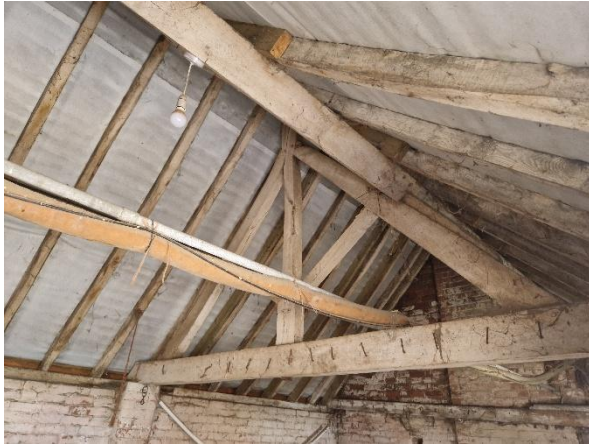
Trusses to single storey Barn

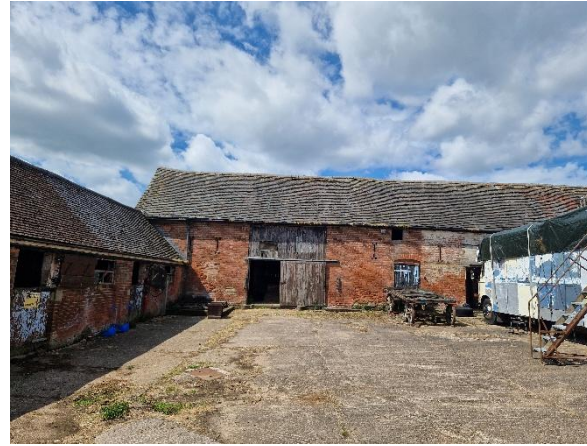
Typical View from Courtyard

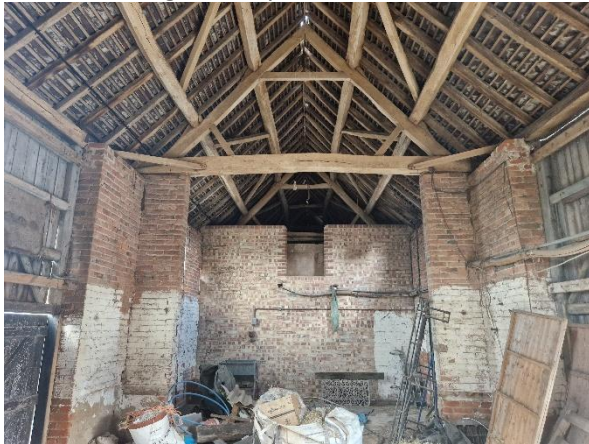
Trusses and internal view in threshing barn

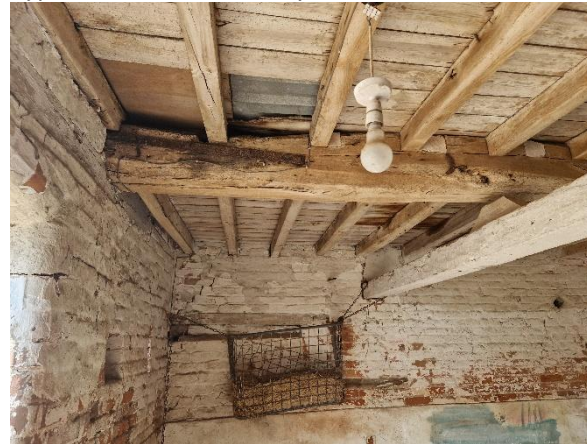
Floor in two storey elements of building

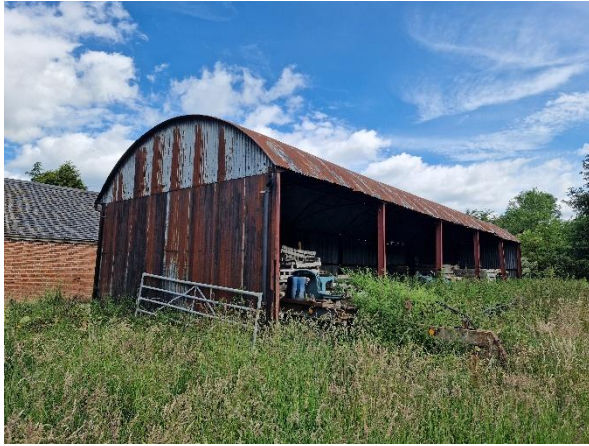
Front elevation

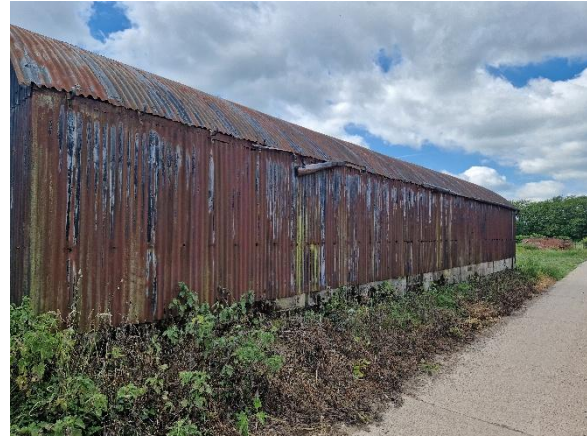
Rear elevation

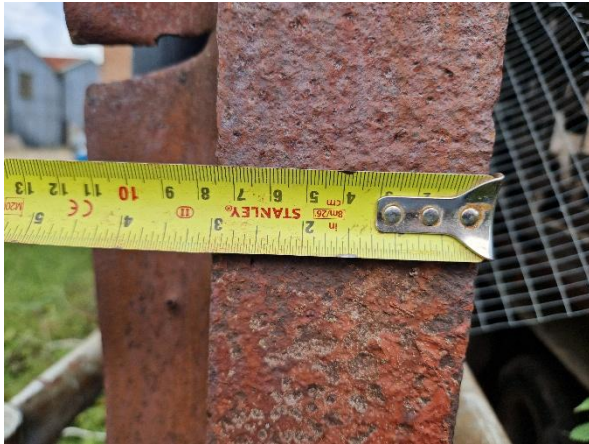
- (a) Barn 5 & 7 – Instability caused by corroded column bases
  - (i) Whilst Barns 5 & 7 are not within the scope of the survey it was noted during the course of the survey to be in particularly poor condition with significantly corroded column bases which may become unstable in high wind cases. The webs of the stanchions range from reasonable condition to completely absent (with only flanges remaining) due to corrosion.
  - (ii) Particular care should be taken around the structures in high wind conditions, and it is recommended access is restricted to the building in such times until column bases are repaired.

- 1003 The barn has similar corrosion issues at the bases of the columns which require repair.
- 1004 The barn is clad to the side and rear elevations so is likely to be stiffer than Barn 5 with less sway during high wind loads.

Column flange

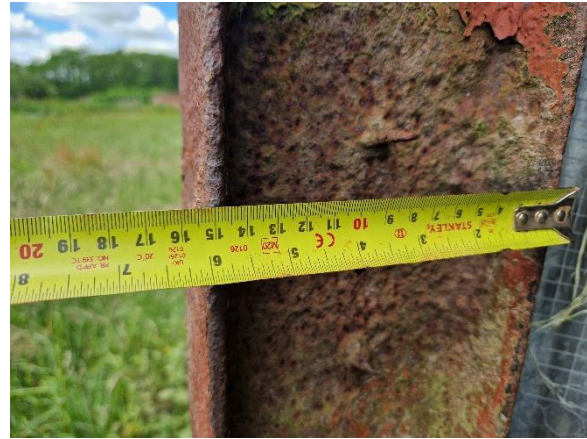
Column Web
