# DESIGN THREE SIXTY<sup>O</sup>

Desford Hall,  
Leicester Lane,  
Desford,  
Leicestershire,  
LE9 9JJ

Dear Planning, below are a list of the trees that require emergency works. The location of these trees is shown on the tree location plan.

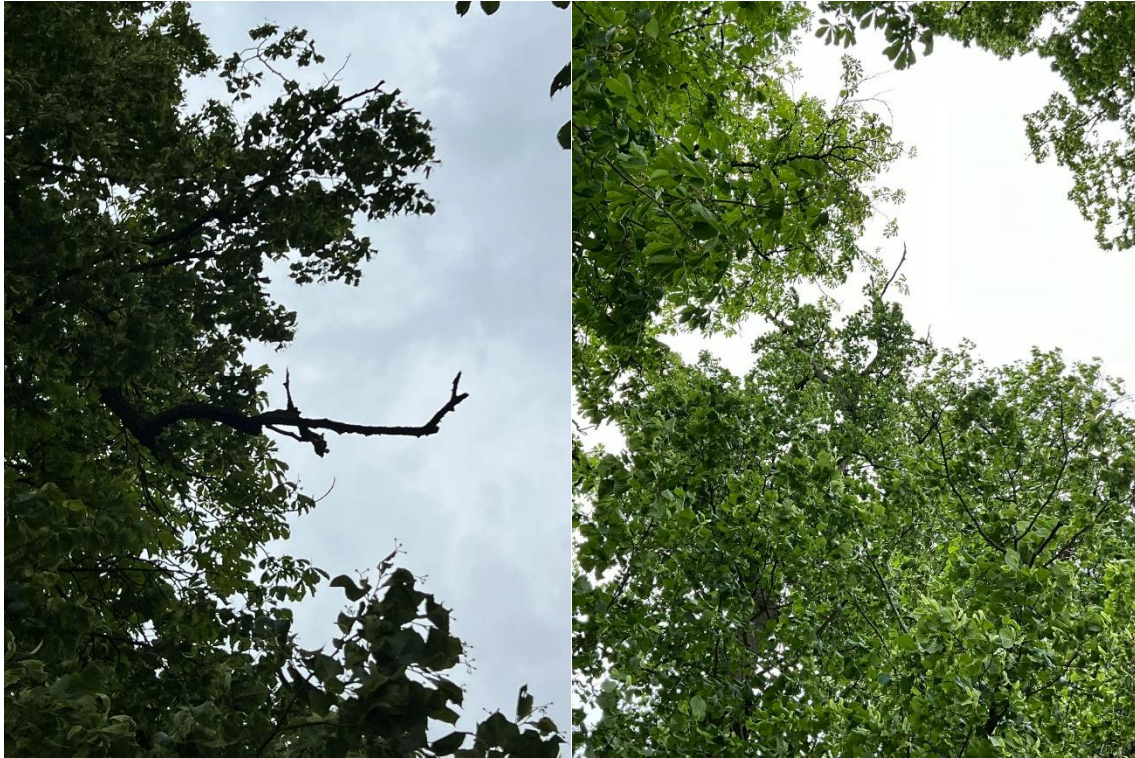
Tree T3

| Tree or Group No. | Common Tree Name | Recommendation | Priority Status |
|---|---|---|---|
| T3 | Common Lime | Deadwood (Dieback) | Emergency |

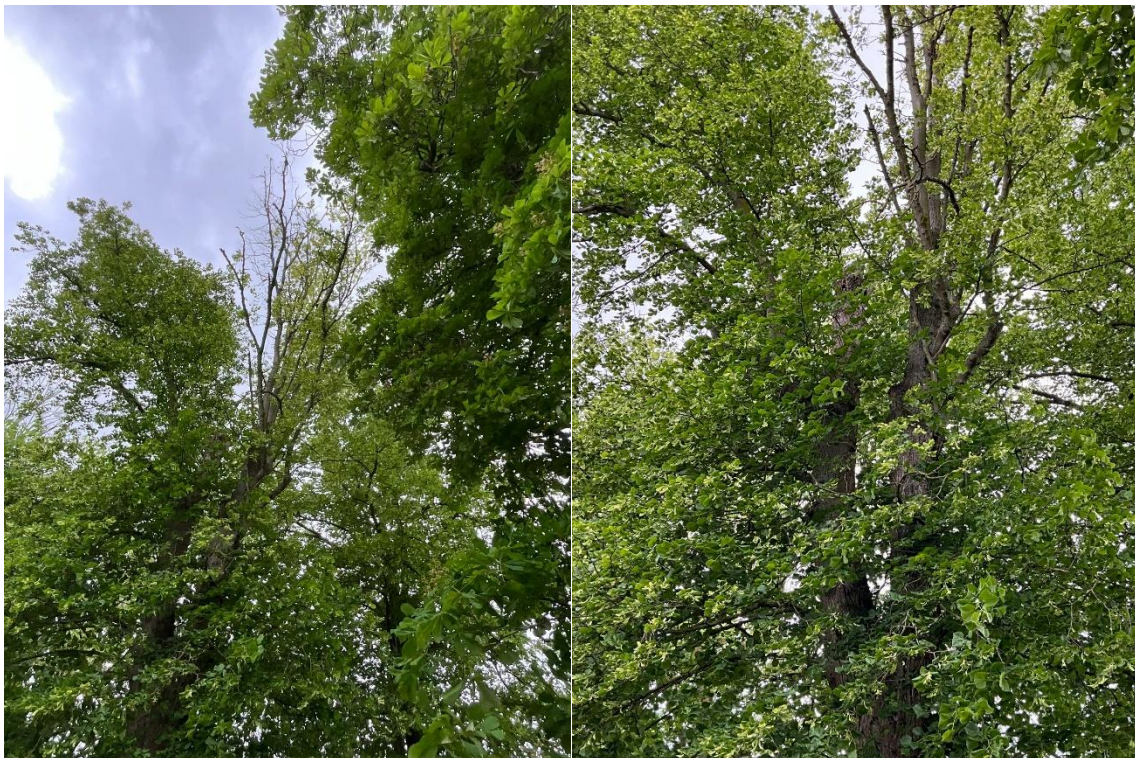
Tree T5

| Tree or Group No. | Common Tree Name | Recommendation | Priority Status |
|---|---|---|---|
| T5 | Common Lime | Deadwood & Remove Epicormic Growth Base and Stem | Emergency |

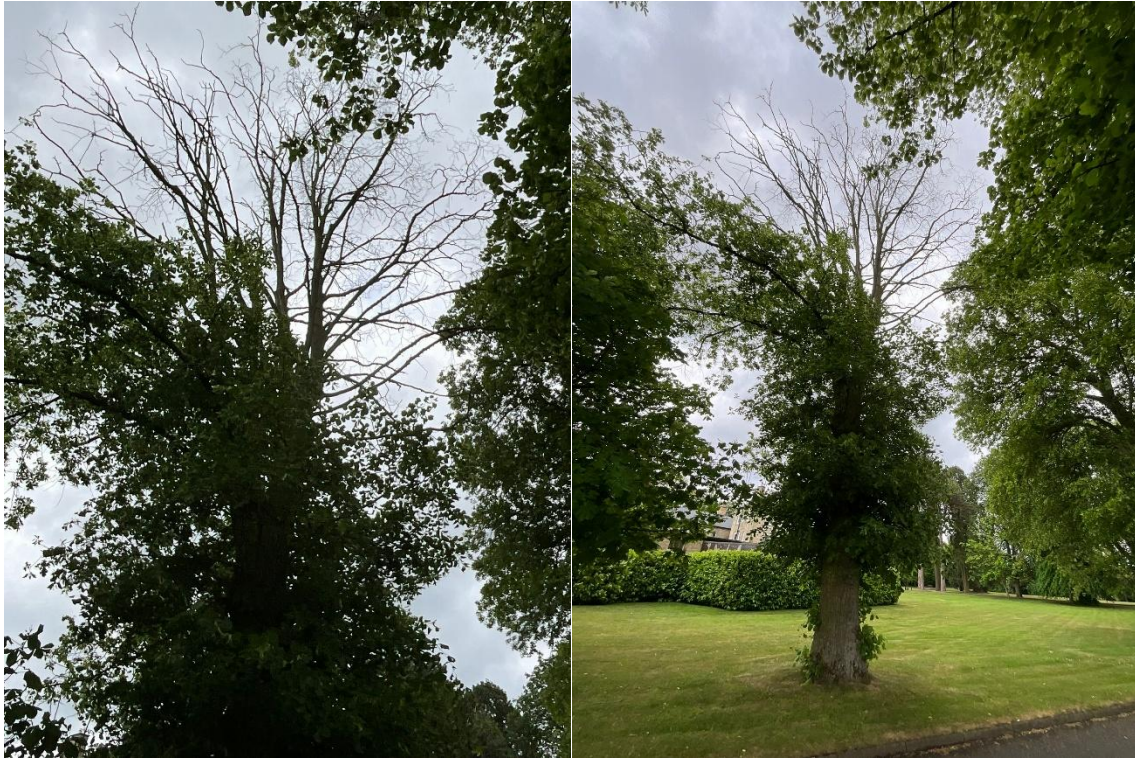
Tree T7

| Tree or Group No. | Common Tree Name | Recommendation | Priority Status |
|---|---|---|---|
| T7 | Common Lime | Deadwood (Dieback) Cut back to the previous Pollard Point | Emergency |

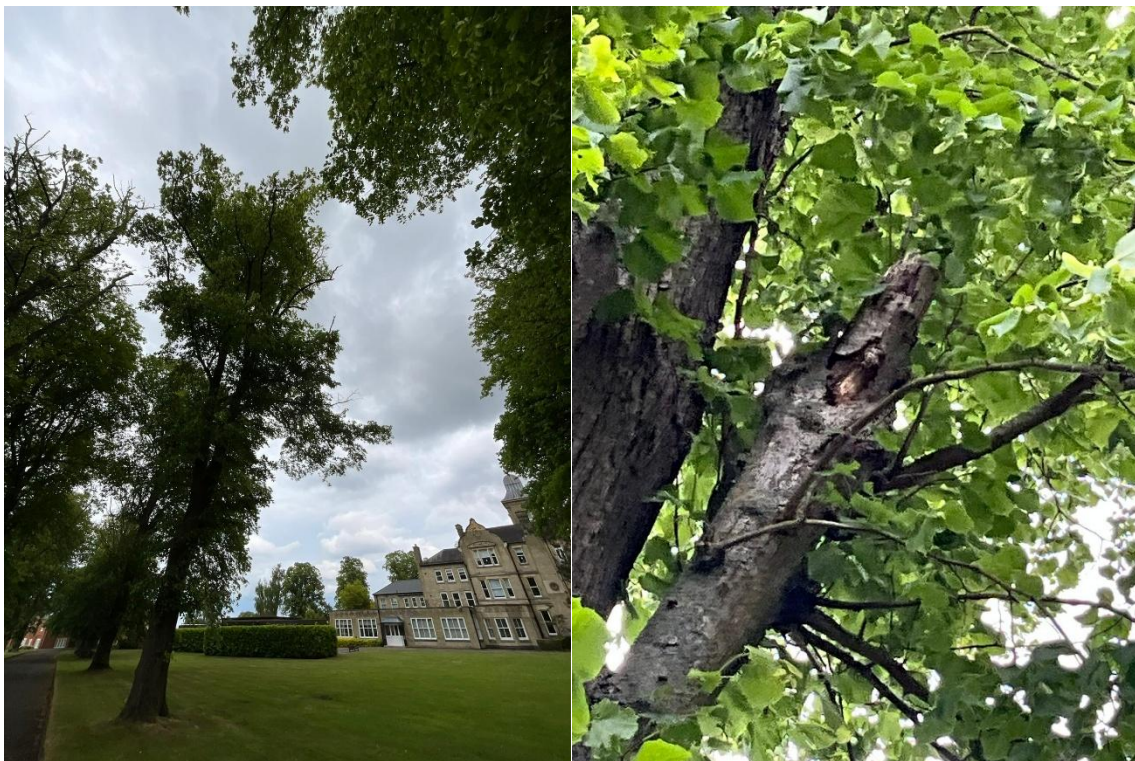
Tree T9

| Tree or Group No. | Common Tree Name | Recommendation | Priority Status |
|---|---|---|---|
| T9 | Common Lime | Deadwood & Remove Epicormic Growth Base and Stem | Emergency |

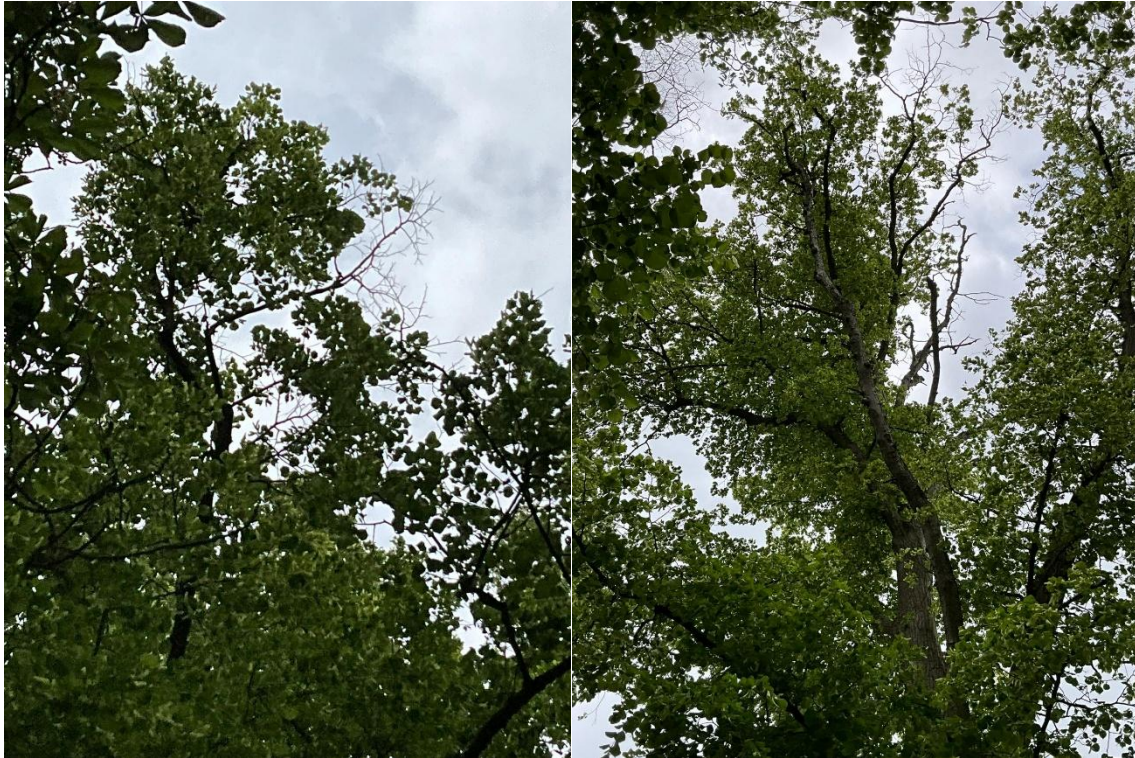
Tree T12

| Tree or Group No. | Common Tree Name | Recommendation | Priority Status |
|---|---|---|---|
| T12 | Common Lime | Take off Previous Poor Pruning Stubs | Emergency |

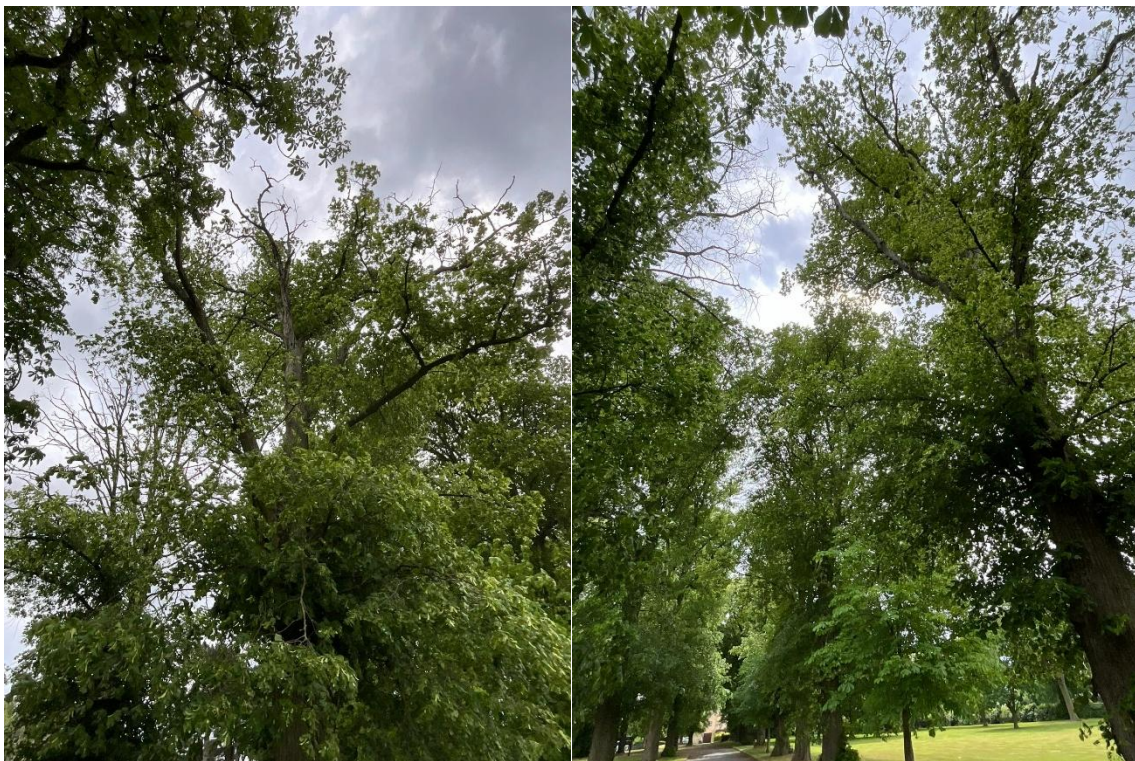
Tree T13

| Tree or Group No. | Common Tree Name | Recommendation | Priority Status |
|---|---|---|---|
| T13 | Common Lime | Deadwood & Remove Epicormic Growth Base and Stem | Emergency |

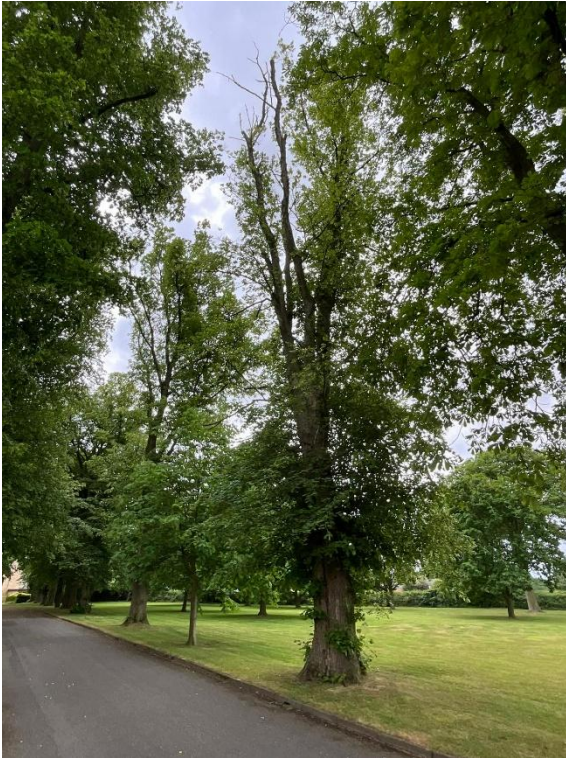
Tree T15

| Tree or Group No. | Common Tree Name | Recommendation | Priority Status |
|---|---|---|---|
| T15 | Common Lime | Remove dead branches over road within 3 months of Deadwood | Emergency |

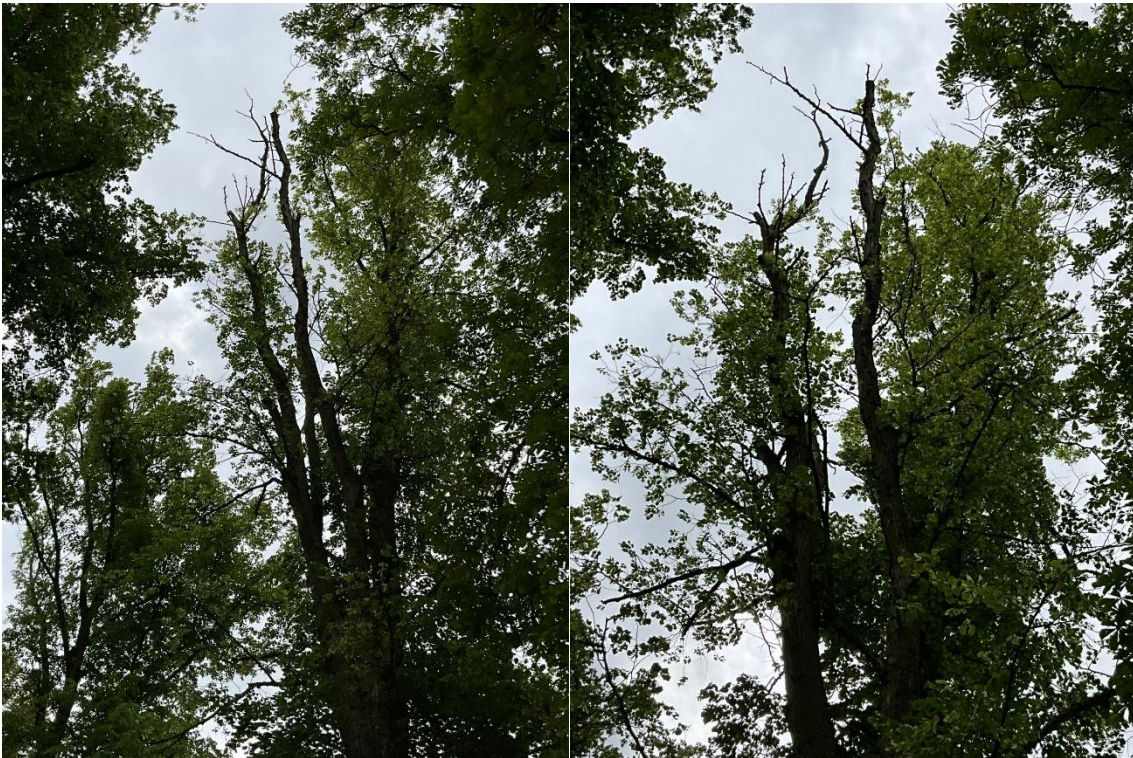
Tree T19

| Tree or Group No. | Common Tree Name | Recommendation | Priority Status |
|---|---|---|---|
| T19 | Common Lime | Pollard to 8 Meters | Emergency |

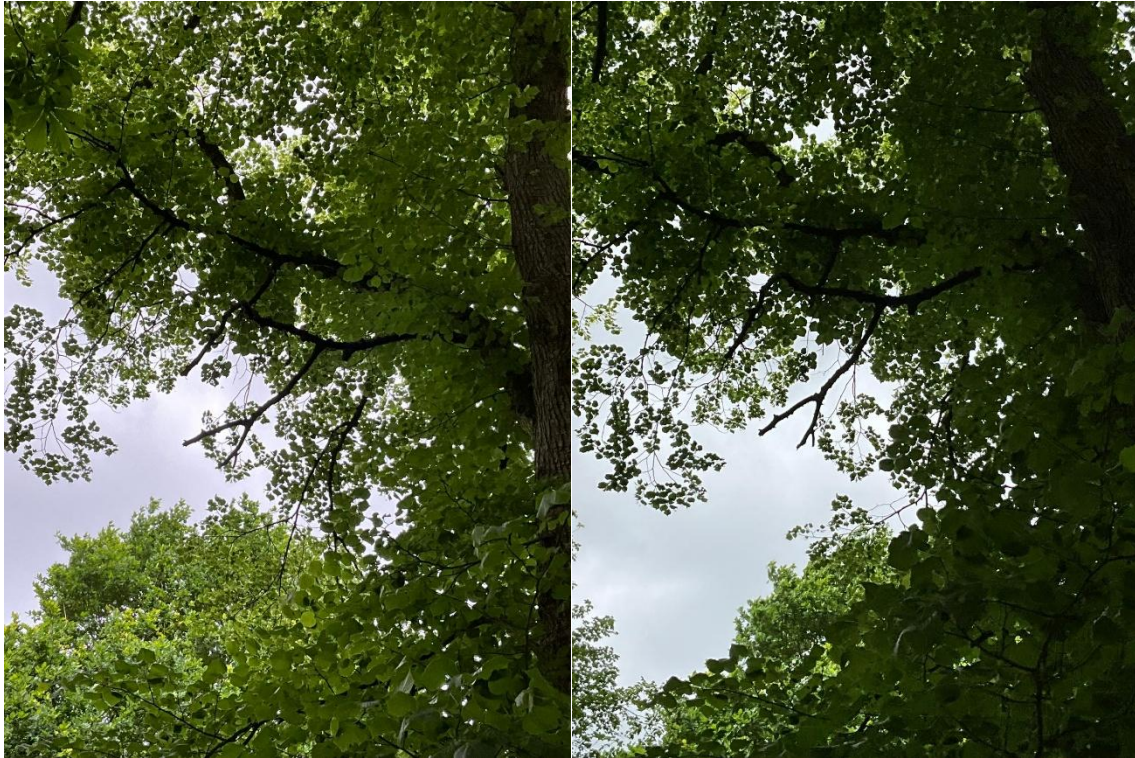
Tree T21

| Tree or Group No. | Common Tree Name | Recommendation | Priority Status |
|---|---|---|---|
| T21 | Common Lime | Deadwood | Emergency |

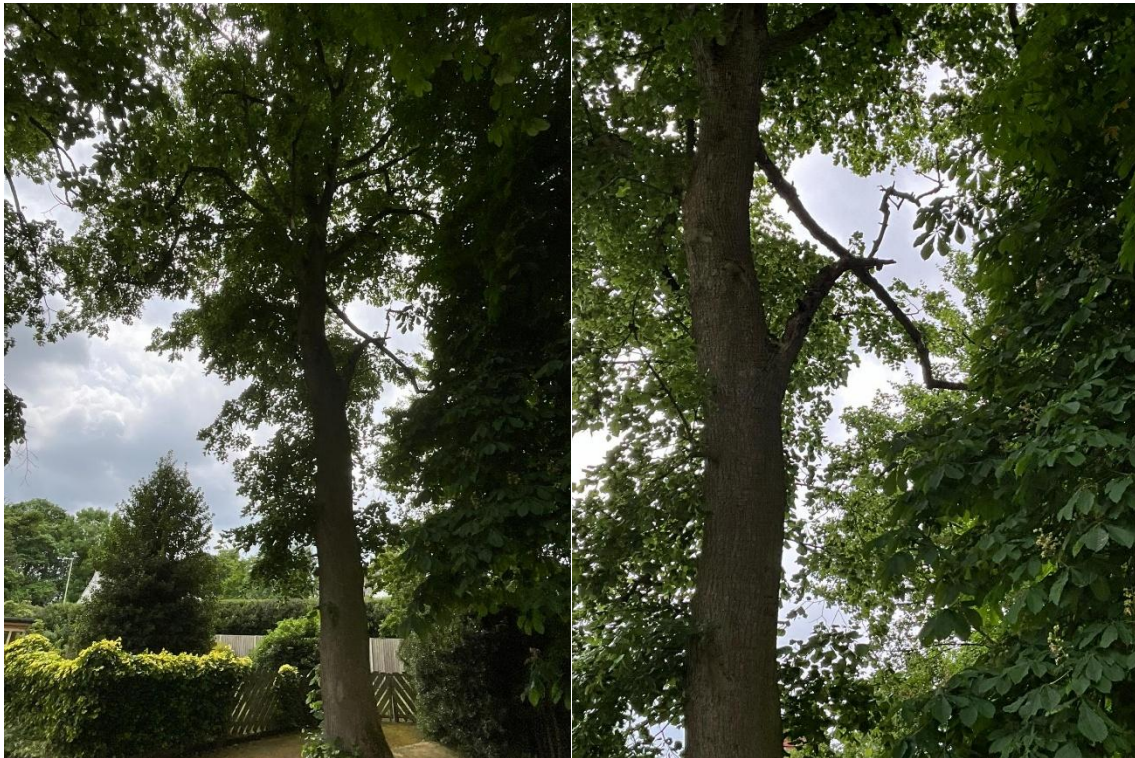
Tree T28

| Tree or Group No. | Common Tree Name | Recommendation | Priority Status |
|---|---|---|---|
| T28 | Common Lime | Deadwood (Dieback) | Emergency |

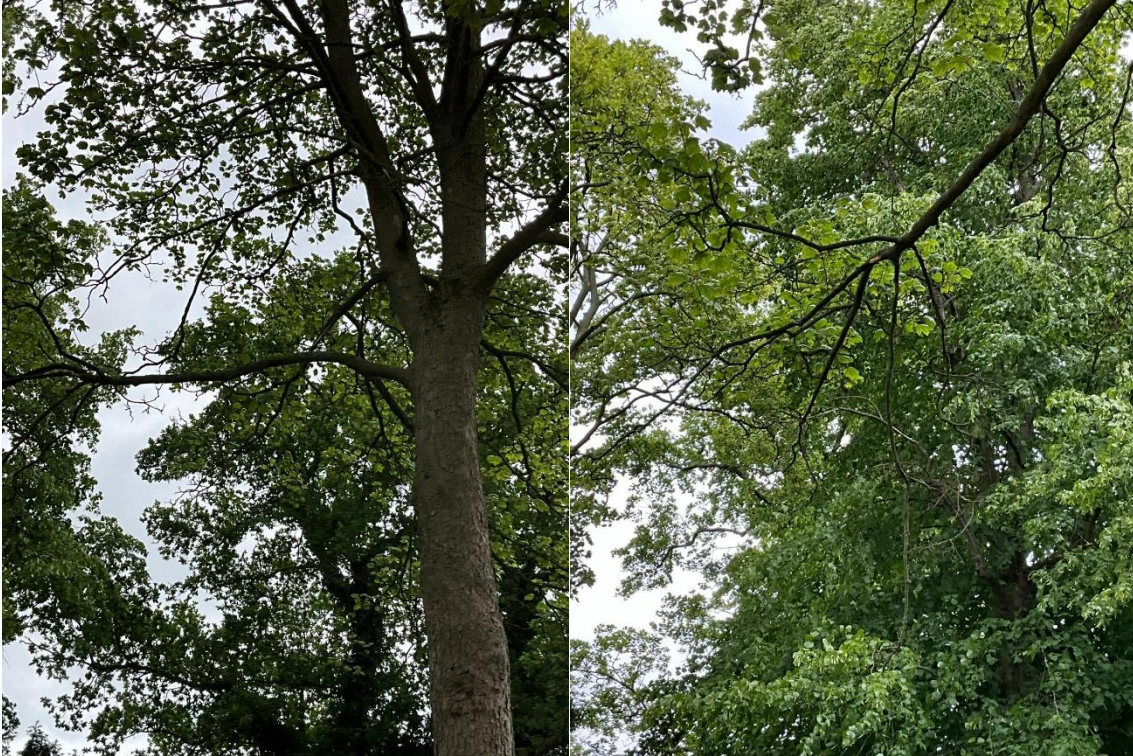
Tree T31

| Tree or Group No. | Common Tree Name | Recommendation | Priority Status |
|---|---|---|---|
| T31 | Sycamore | Deadwood | Emergency |

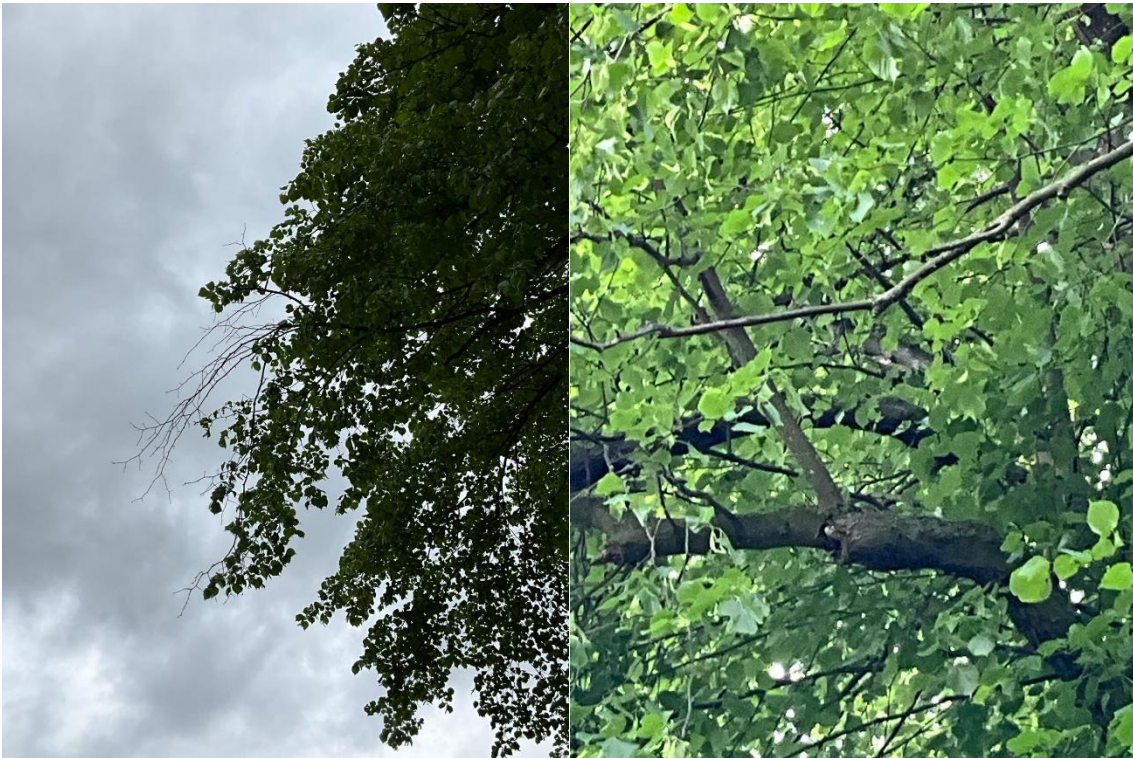
Tree T55

| Tree or Group No. | Common Tree Name | Recommendation | Priority Status |
|---|---|---|---|
| T55 | Common Lime | Deadwood | Emergency |

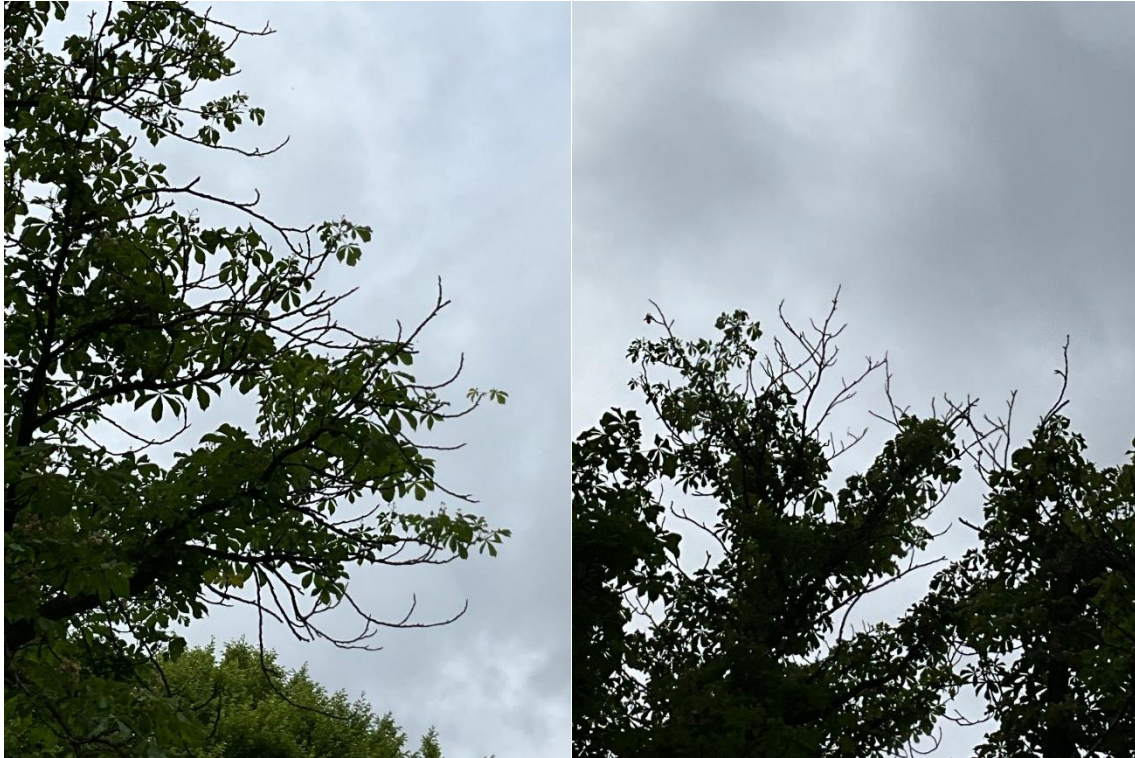
Tree T61

| Tree or Group No. | Common Tree Name | Recommendation | Priority Status |
|---|---|---|---|
| T61 | Horse Chestnut | Veteren Tree, Disease present, tree in natural decline. Due to location and ecological value, tree should be allowed to decay. Consider reduction/veterenisation | Emergency |

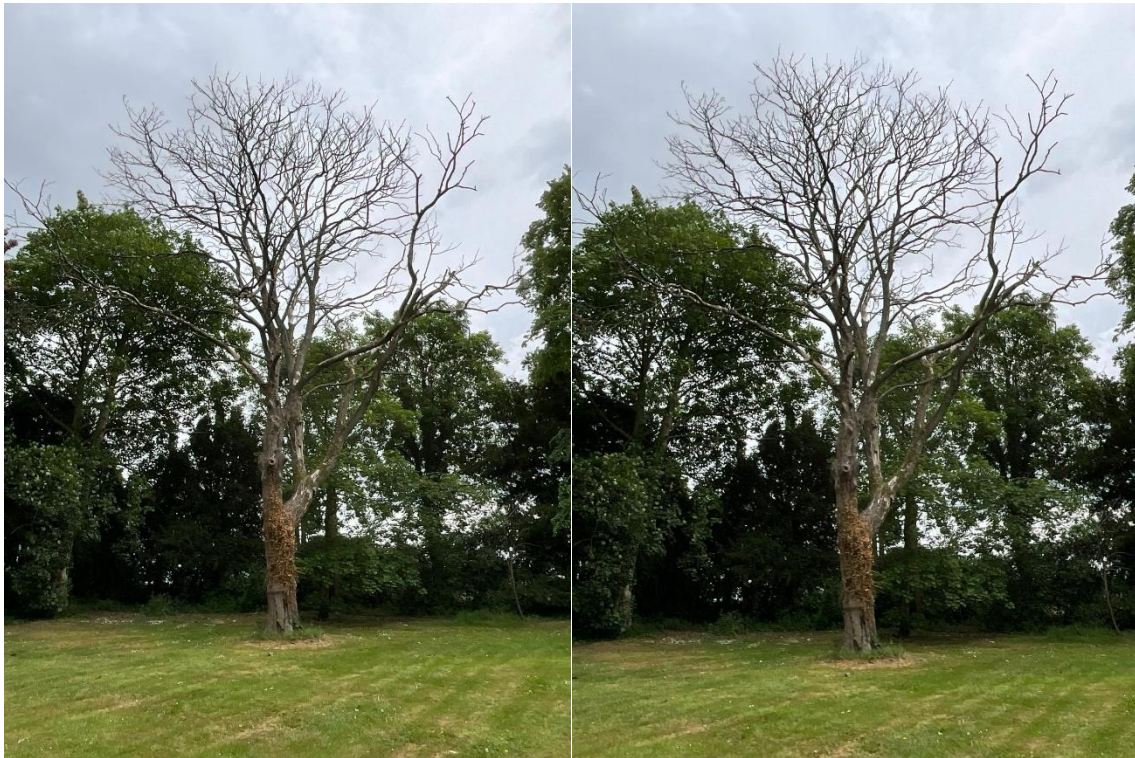
Tree T65

| Tree or Group No. | Common Tree Name | Recommendation | Priority Status |
|---|---|---|---|
| T65 | Horse Chestnut | Tree in decline and is now unsafe - to be removed | Emergency |

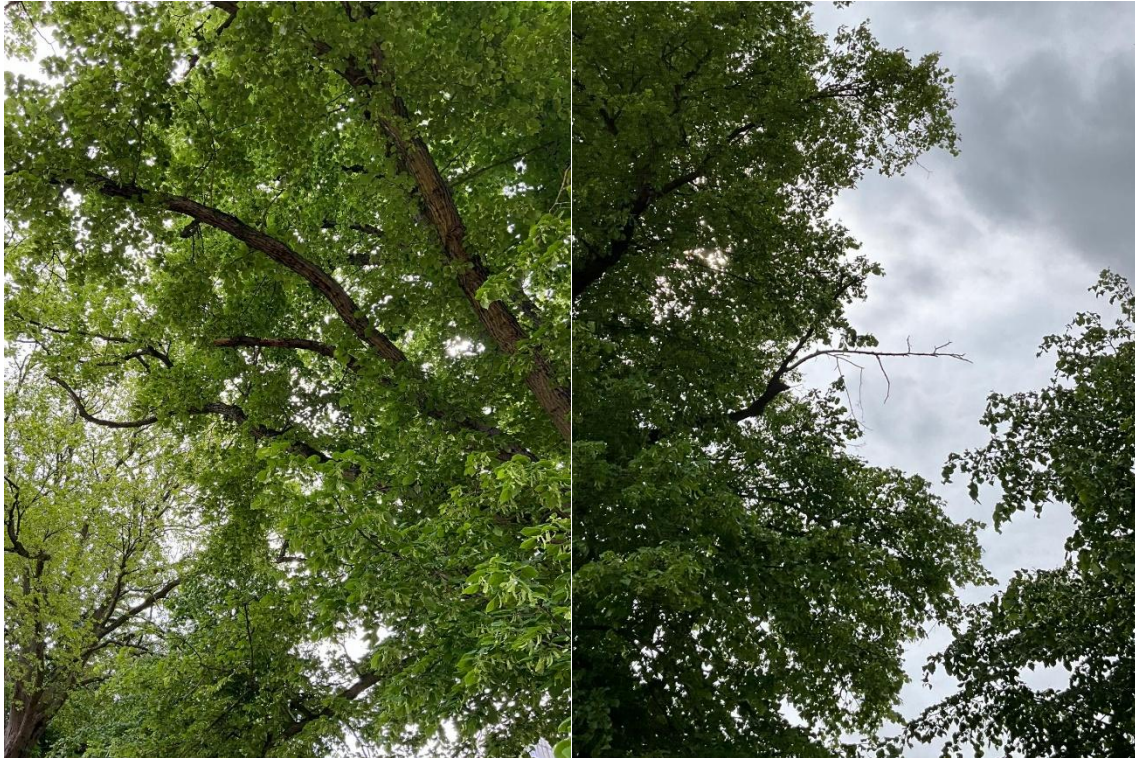
Tree T77

| Tree or Group No. | Common Tree Name | Recommendation | Priority Status |
|---|---|---|---|
| T77 | Common Lime | Crown Lift and Deadwood | Emergency |

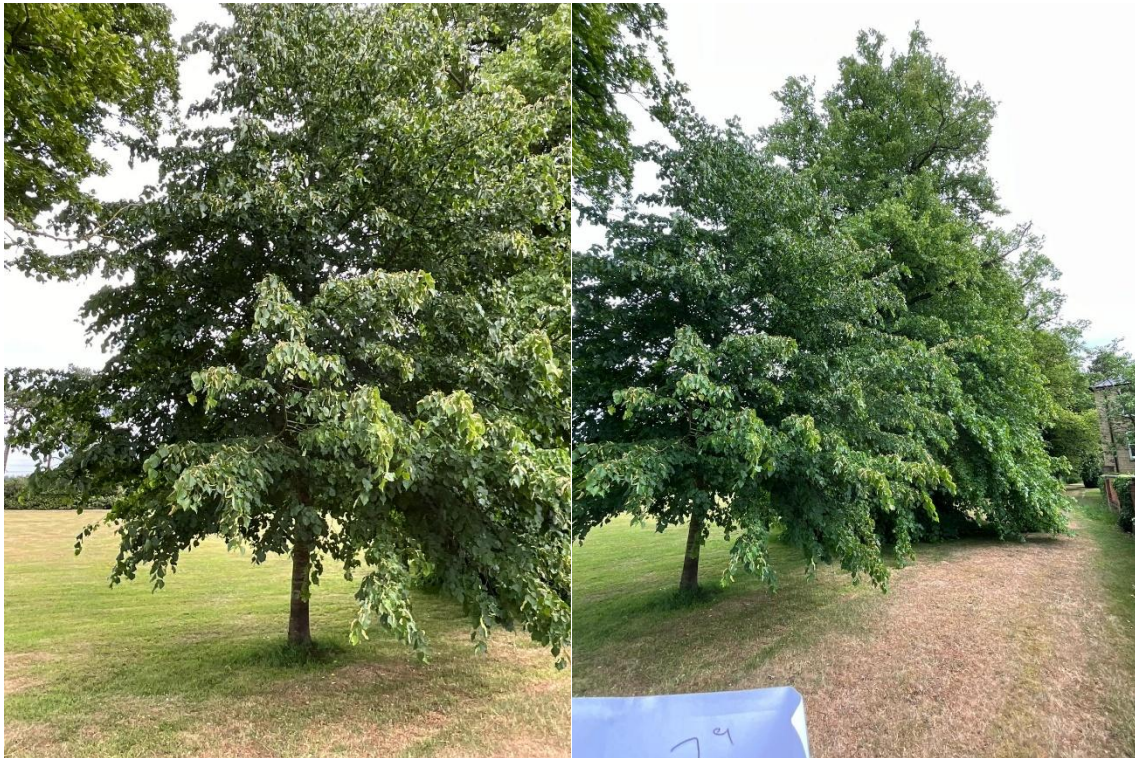
Tree T78

| Tree or Group No. | Common Tree Name | Recommendation | Priority Status |
|---|---|---|---|
| T78 | Common Lime | Crown Lift and Deadwood | Emergency |

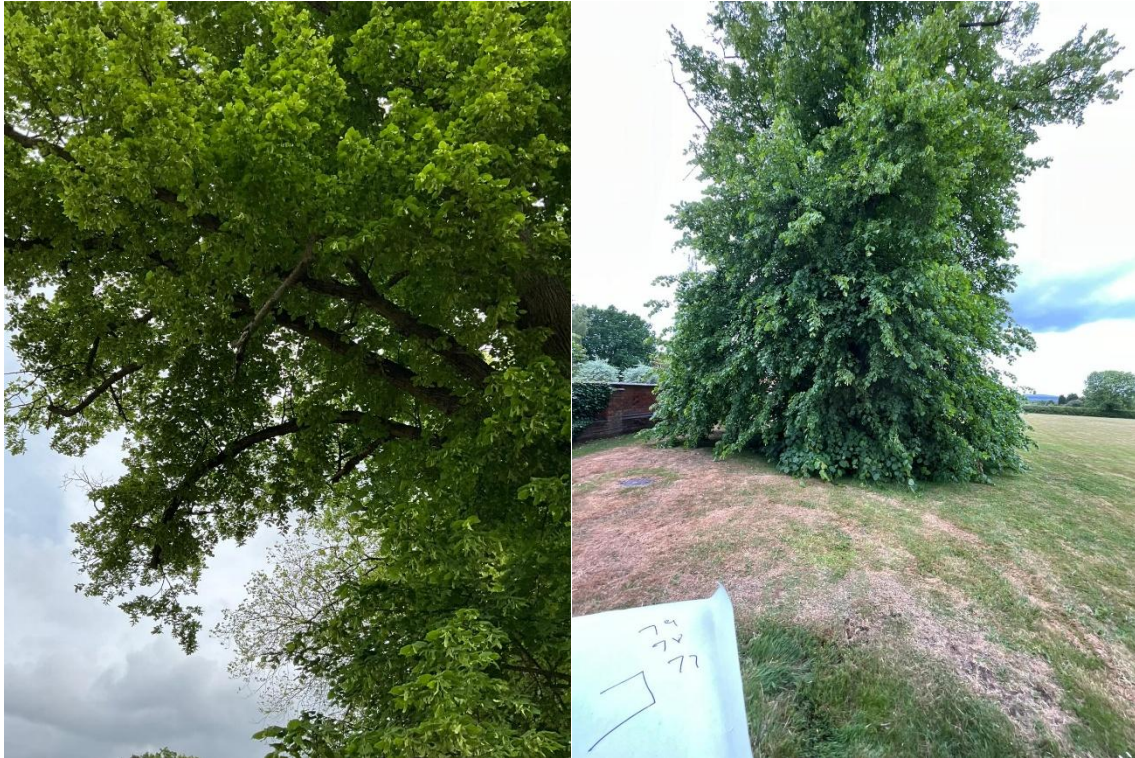
Tree T79

| Tree or Group No. | Common Tree Name | Recommendation | Priority Status |
|---|---|---|---|
| T79 | Common Lime | Crown Lift and Deadwood | Emergency |
