**BUILDING CONDITION SURVEY**  
**ON FARM BUILDINGS**  
**AT**  
**SHEEPY PARVA FARM,**  
**WELLSBOROUGH ROAD, SHEEPY PARVA**

**CMC LTD**

**MARCH 2026**

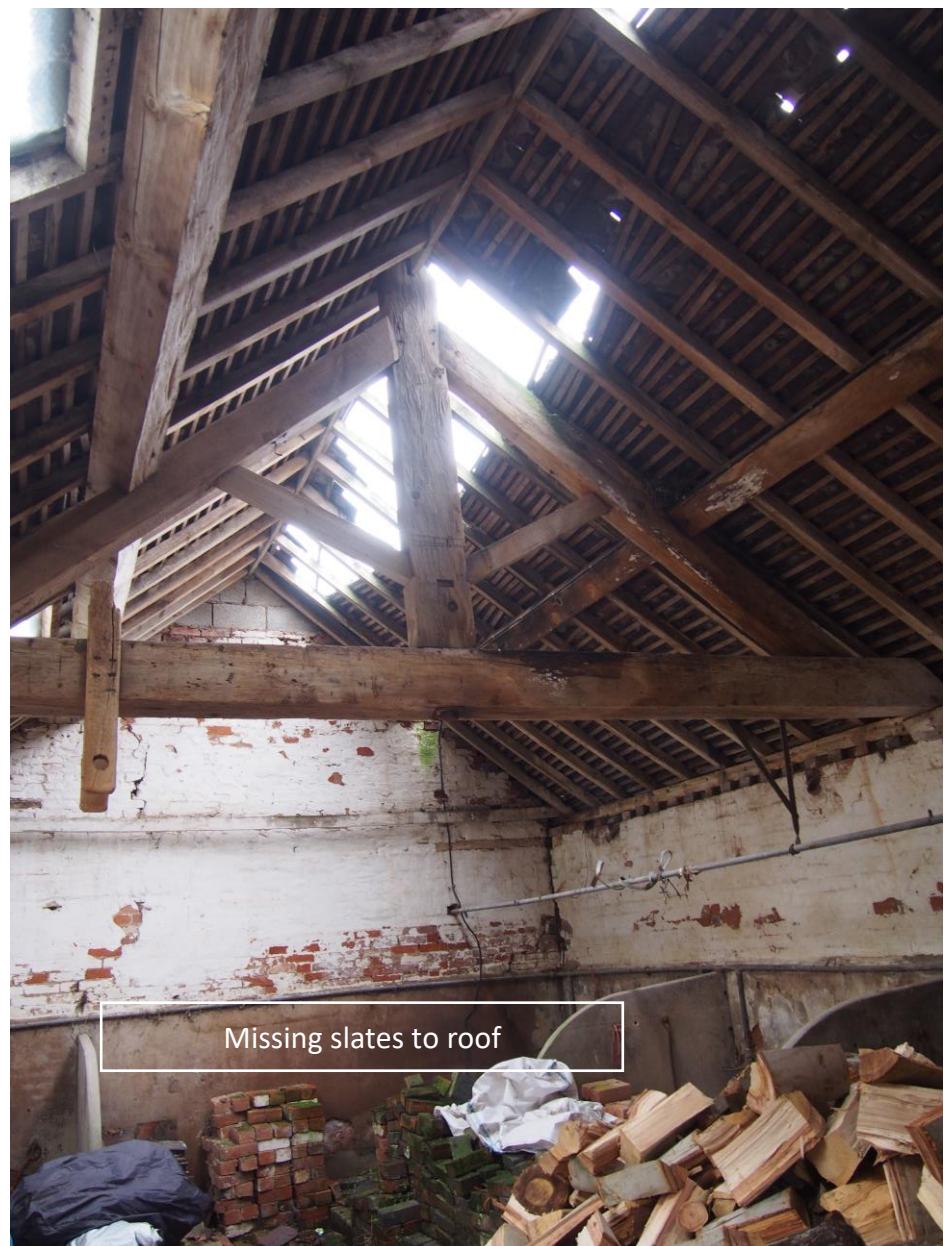
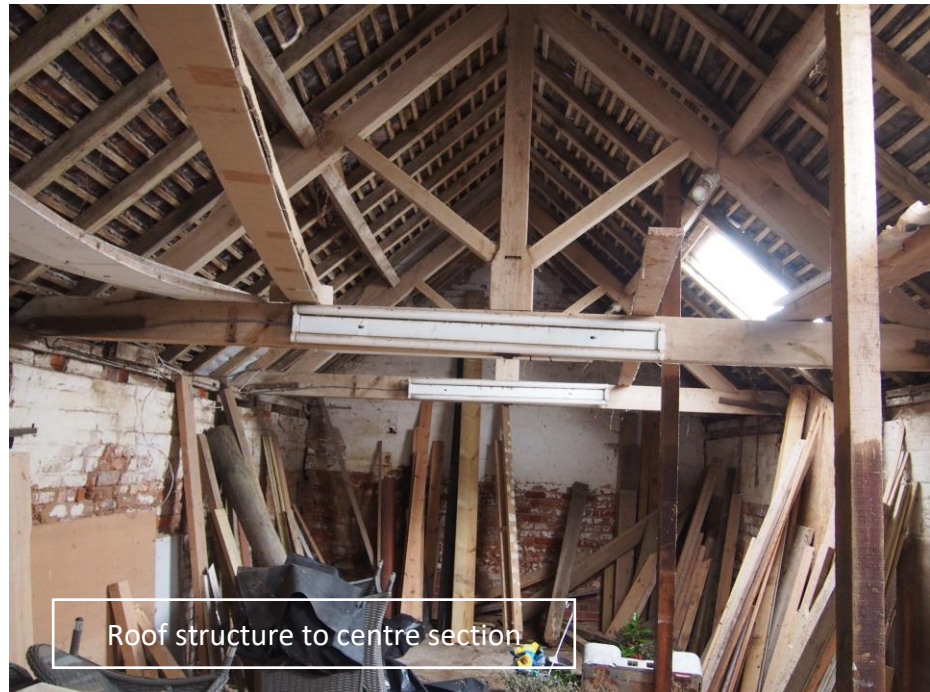
There are areas to the western section where the roof tiles have fallen away, and water is ingressing the property. The roof timbers are predominantly in sound condition, and all of the roof tiles are capable of being reused during any re-covering of the roof. The roof to the eastern section is predominately in good condition with the exception of the far eastern section to which the tiles have slipped.

It would be beneficial during the conversion works to install stepped lead flashings to replace the cement flashing to section where it abuts the wall of the adjacent buildings. The condition of the roof was only slightly worse than in 2019.

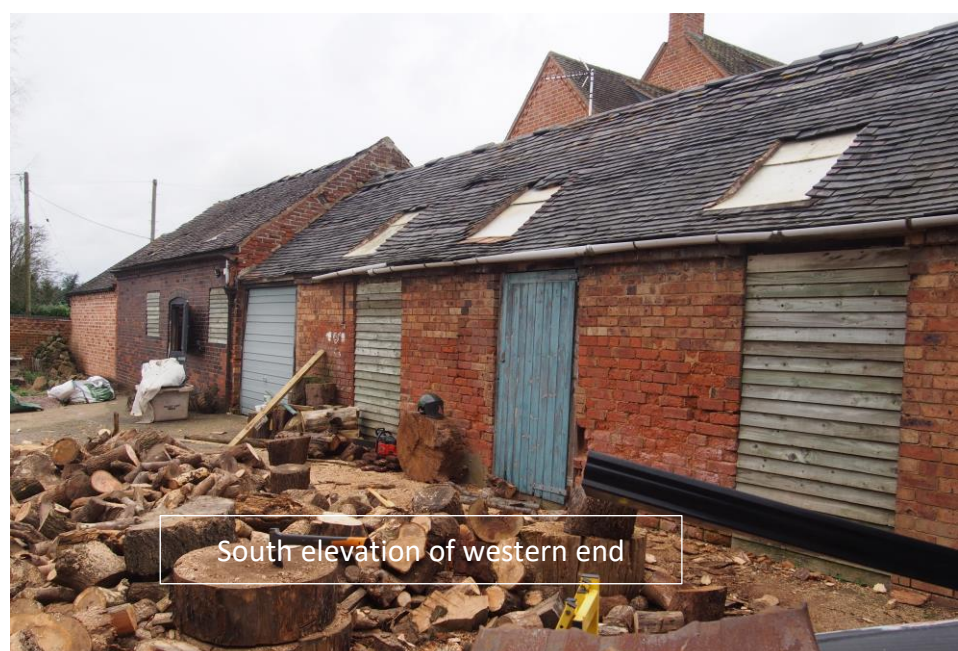
The walls to the building are principally in stable condition throughout with isolated areas requiring the replacement of spalled bricks and areas of repointing. The dentil brickwork to the eaves is intact however there has been instances of roof spread as is common in buildings of this type and consideration should be given to additional lateral support during the conversion process.

To the eastern gable there is a vertical crack along the centre of the gable. This requires stitching and it is likely that the foundations will require underpinning in this area. Some cracking of the brickwork below the purlins was also noted and the installation of a pad stone or engineering bricks will address this.

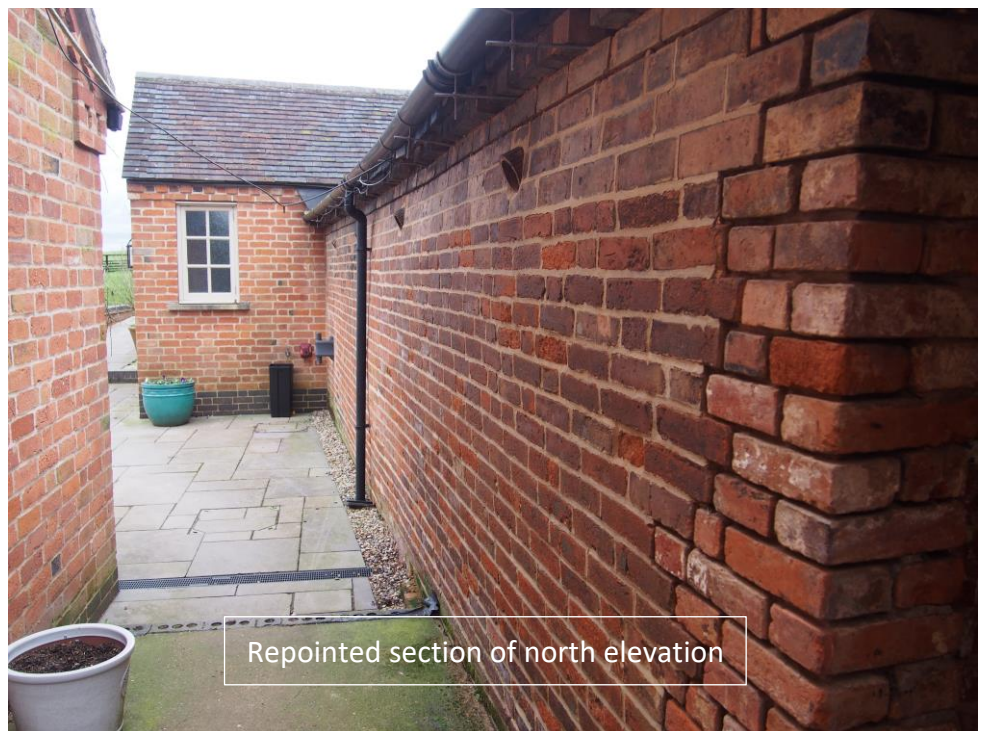
Repointed section of north elevation

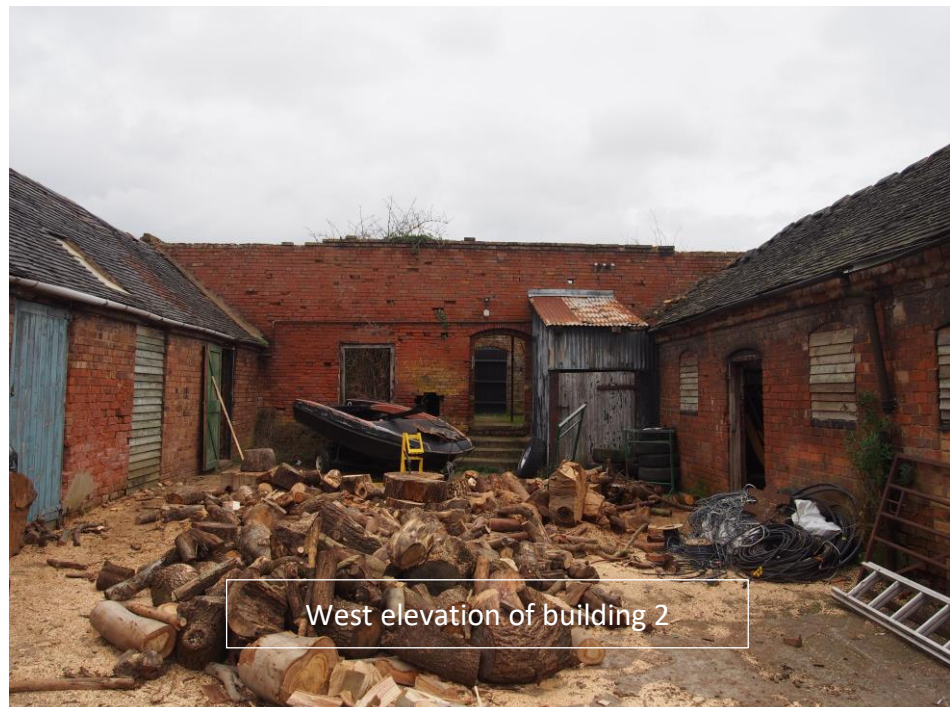
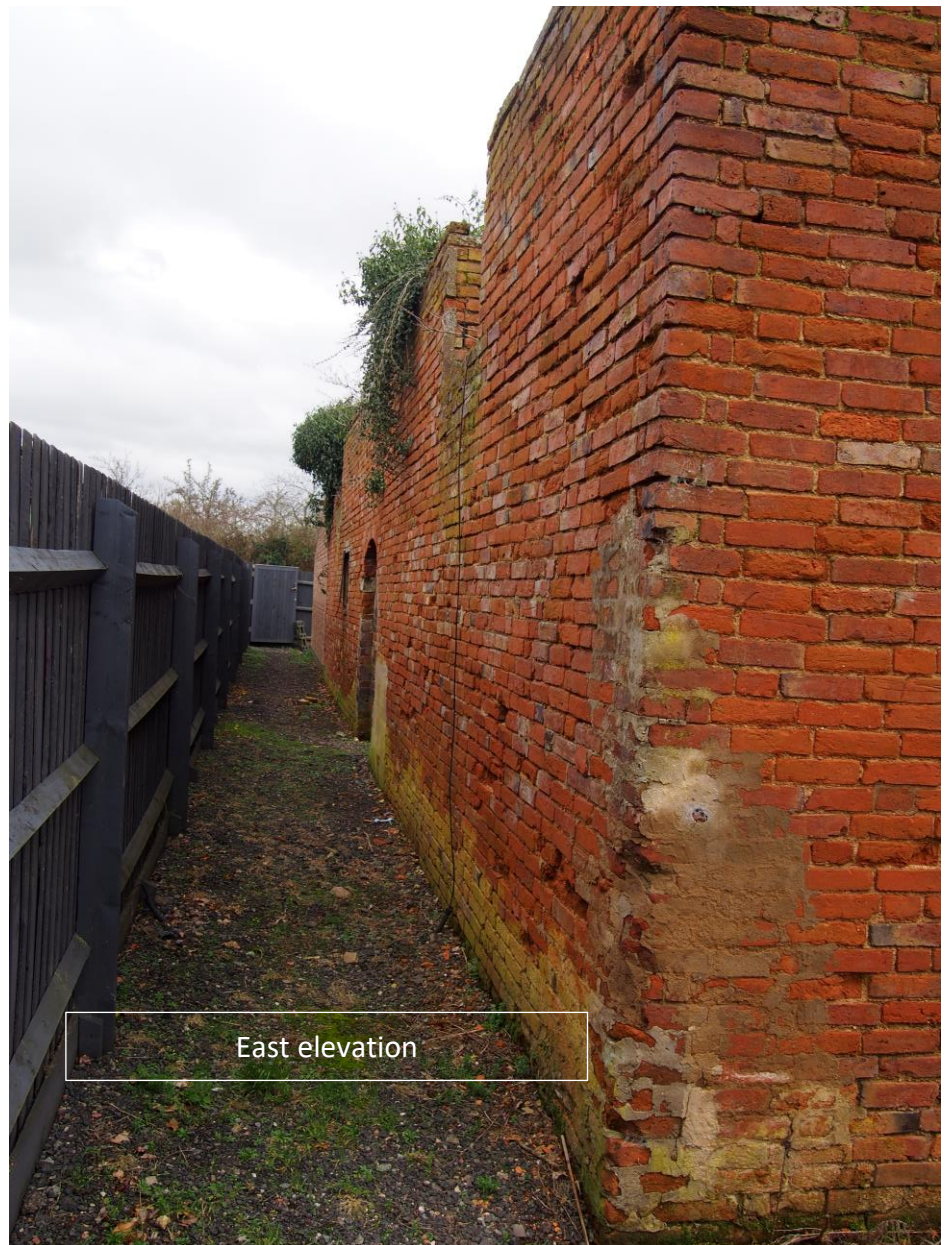
East elevation

The brickwork to the main structure is generally level and intact with no signs of any significant movement however there are areas where at eaves level where the brickwork has fallen away, and replacement brickwork will be required in these areas. To the gables the brickwork has been removed completely, and the brickwork will require complete replacement as part of the completion of the roof structure.

There are isolated areas of spalled brickwork which require chopping out and repair with a matching brick. The internal walls have been supported with more recent block walling.

As part of the refurbishment programme and replacement of the roof lateral support should be installed at eaves level. The addition of a first floor will also assist in providing lateral support. Again, there has only been a slight deterioration of the top few courses of brickwork since 2019.

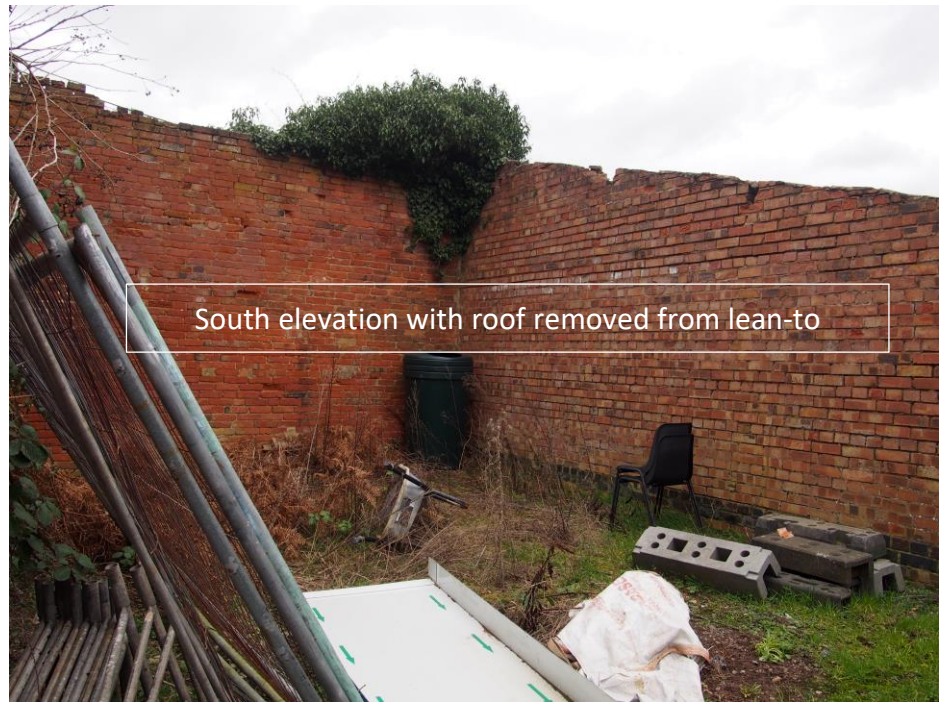
South elevation with roof removed from lean-to

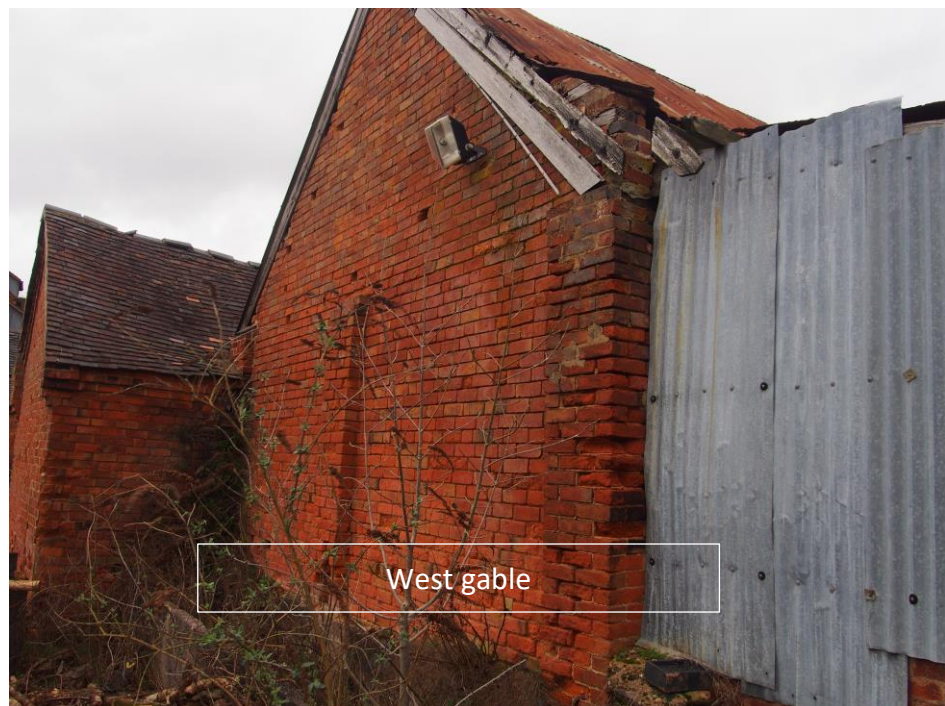
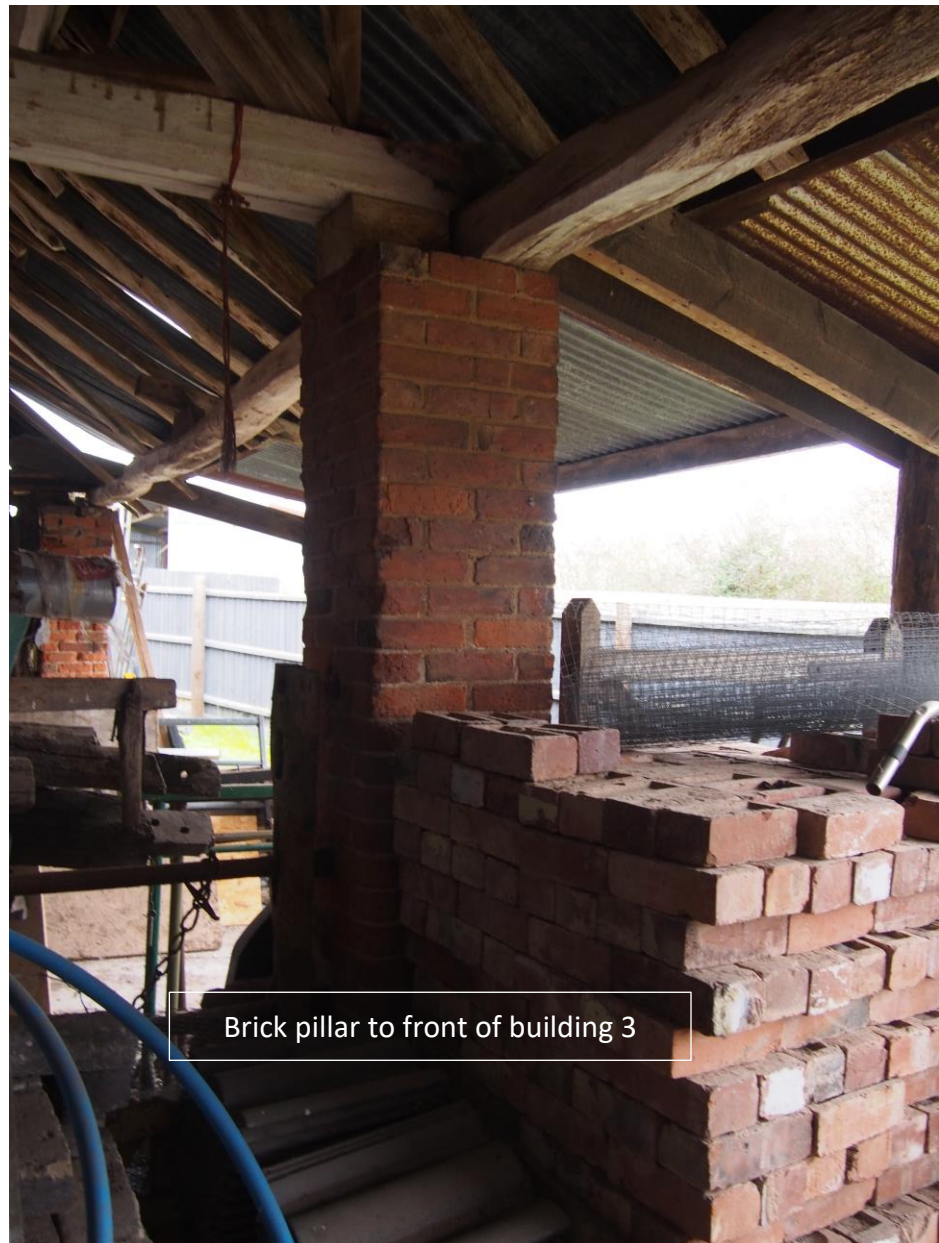
The front section of the building is supported by brick pillars of approximately 490mm x 490mm which support the timber trusses above. There was no sign of any significant movement, and it is assumed that the timber lean-to to the front will be removed as part of the conversion process.

Brick pillar to front of building 3

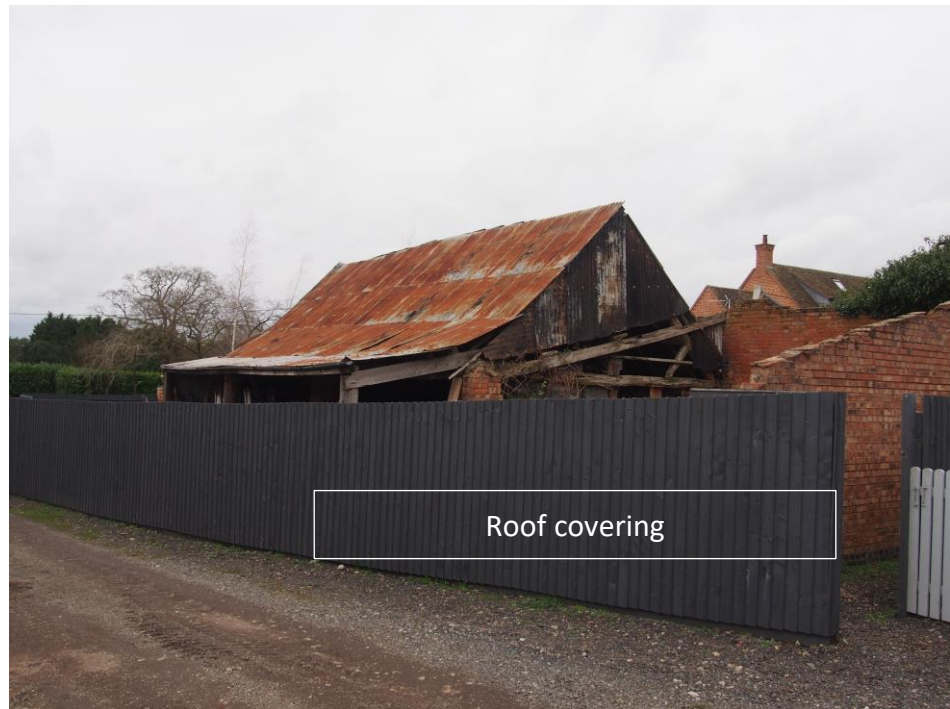
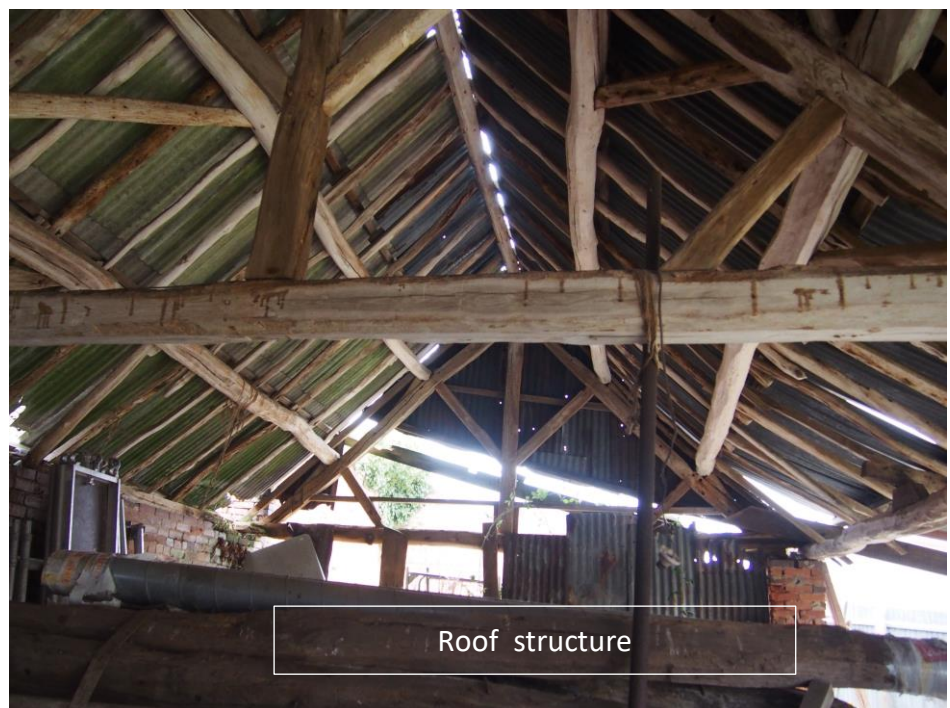
The roof to this building is constructed of random sized timbers forming trusses which support timber purlins and rafters. The roof has a covering of corrugated sheet, and some water ingress occurs.

It is considered that the roof timbers will require some additional strengthening as part of the refurbishment process, and it is assumed that the sheet roof will be replaced with traditional tiles.

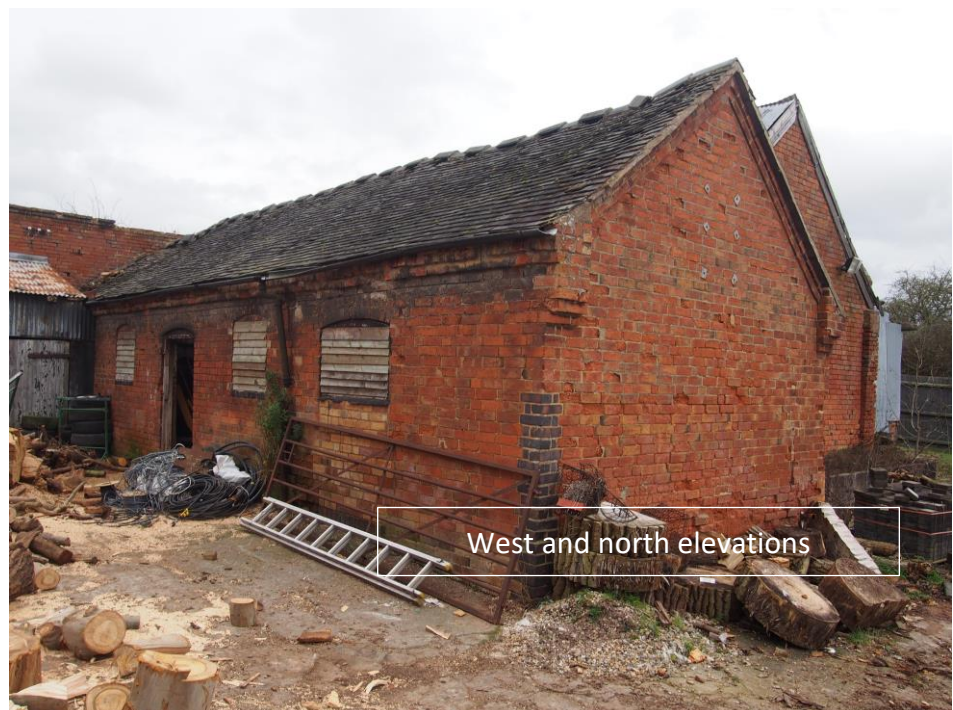
The walls are of a traditional brick with some infilling of openings in a more modern brick and with some past repairs carried out in engineering brick. Other than some minor roof spread at eaves level the walls were in stable condition with only isolated areas of replacement brick due to spalling and repointing required. To the south elevation water has been eroding the mortar to the walls and repointing will be required.

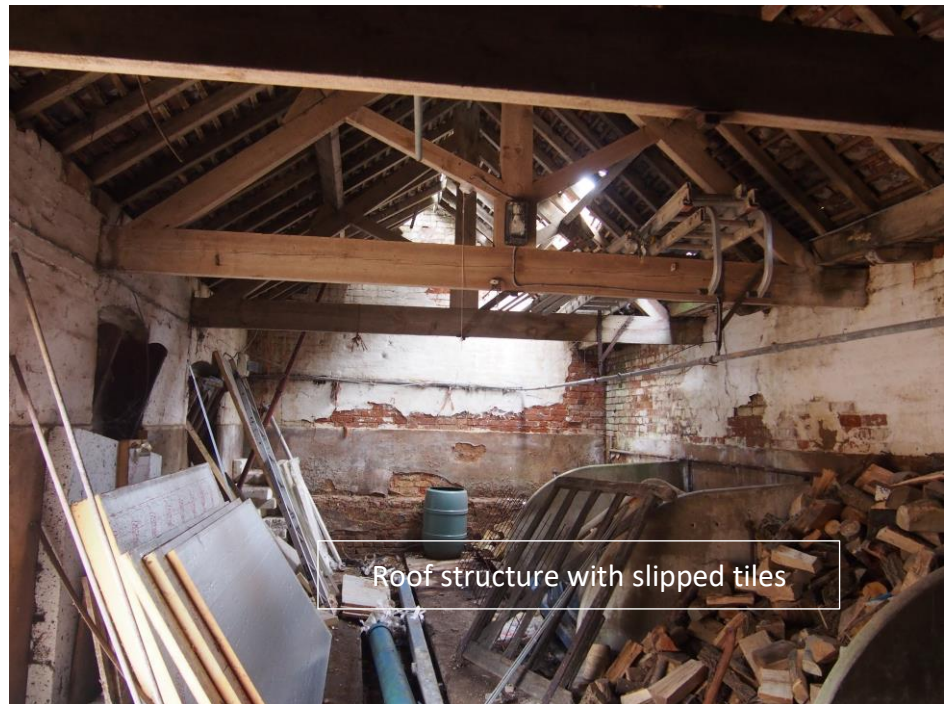
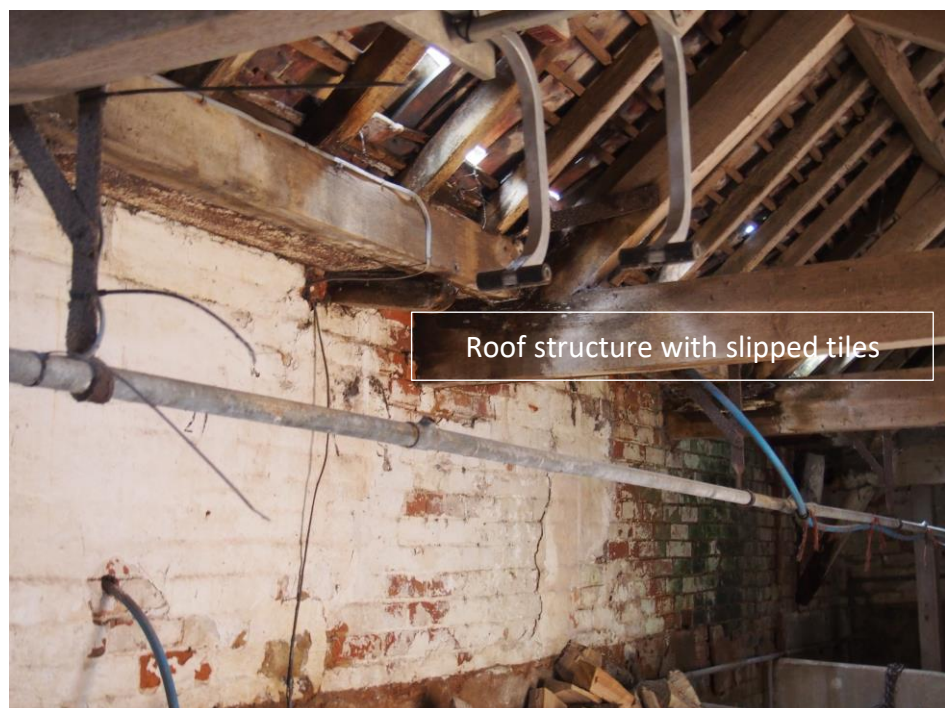
The roof is constructed of timber purlins and rafters supported by timber trusses off the external walls. The timbers were predominately in good condition however, there is some rot starting to form where the roof tiles have slipped, and these areas will require repair. The majority of the roof tiles are in place and capable of re-use.
