## STRUCTURAL ENGINEER'S REPORT

**Site Address:** Shaw Farm, Orton Lane, Orton On The Hill, Atherstone, CV9 3NW

**Project No:** 251006 Rev1

**Date of Inspection:** 4<sup>th</sup> December 2025.

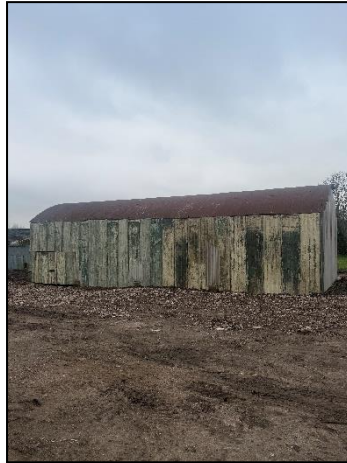
29. Fig 1 is a general view of the front of the building.
30. The building is an enclosed steel framed agricultural building. There are no internal partition walls.

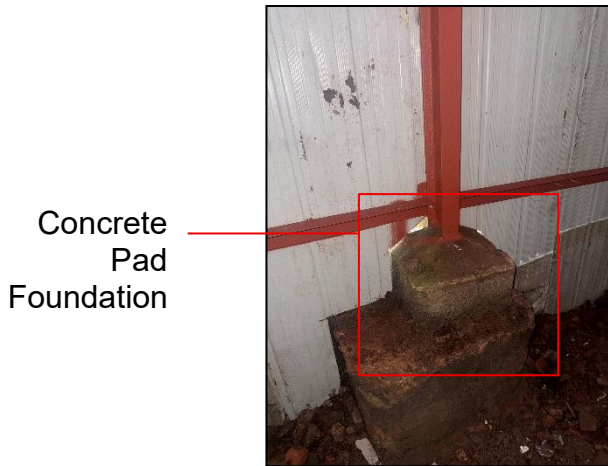
38. Fig FO1 shows the encased concrete columns on concrete pad foundations. The concrete pad foundations are approximately 0.7 x 0.7 x 1.0m length x breadth x depth (l x b x d)

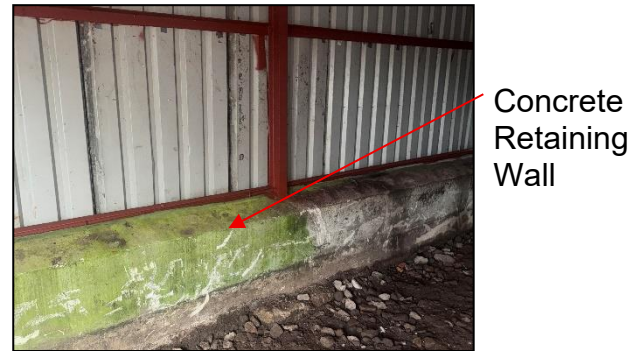
39. Fig FO2 shows structural steelwork columns encased in a 450mm thick concrete retaining wall.

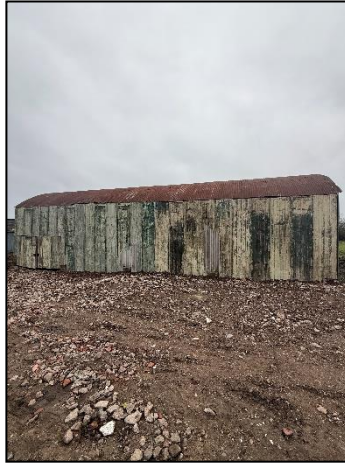
47. Fig FE1 is a general view of the front elevation.

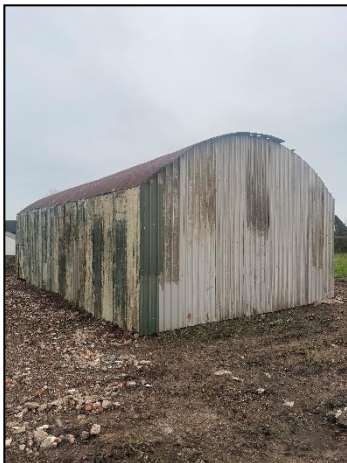
49. Fig SE1.1 is a general view of side elevation 1 (SE1).
50. Fig SE1.2 shows a typical truss/column joint (See Appendix A GP1E: Steel column Drg No. 642/225/01).

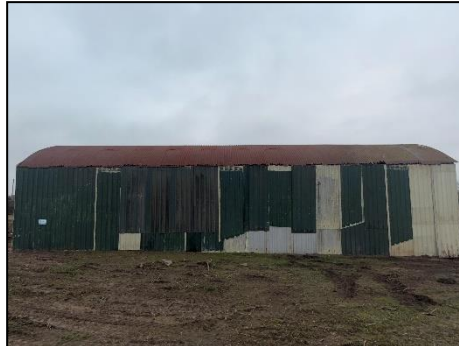
52. Fig RE1.1 is a general view of the rear elevation.

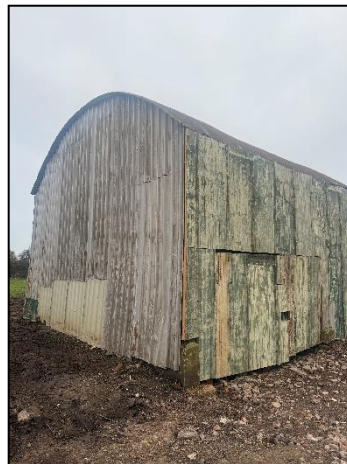
54. Fig SE2.1 is a general view of side elevation 2 (SE2).

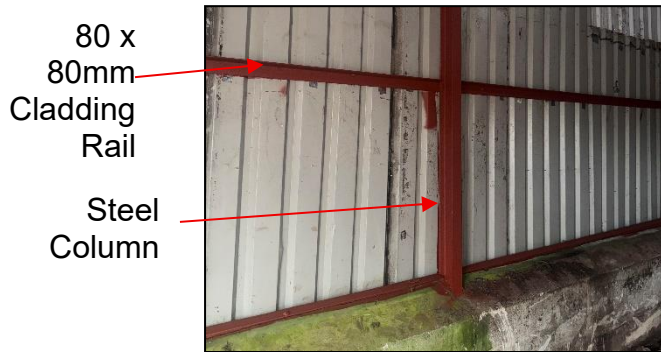
56. Fig GF1 is a view towards the rear corner (See Appendix A GP1A Drg No. 642/225/01) and shows the 80 x 80mm structural steelwork angle cladding rails.

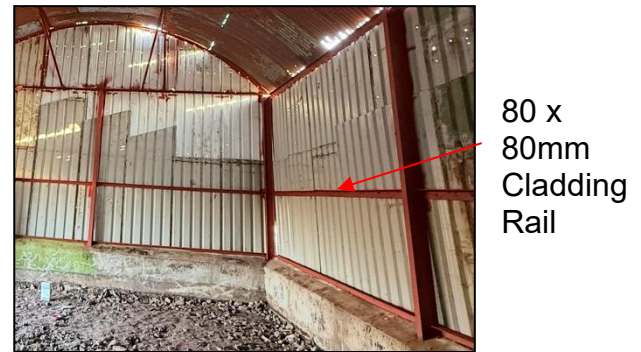
57. Fig GF2 is a view towards the rear corner (See Appendix A GP1A Drg No. 642/225/01).

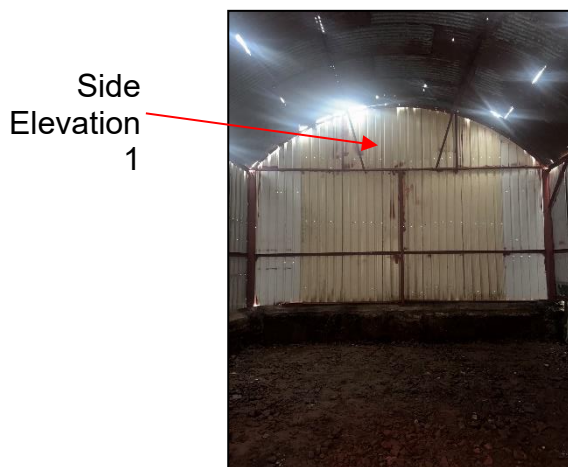
58. Fig GF3 shows the side wall on the north west (Side elevation 1).

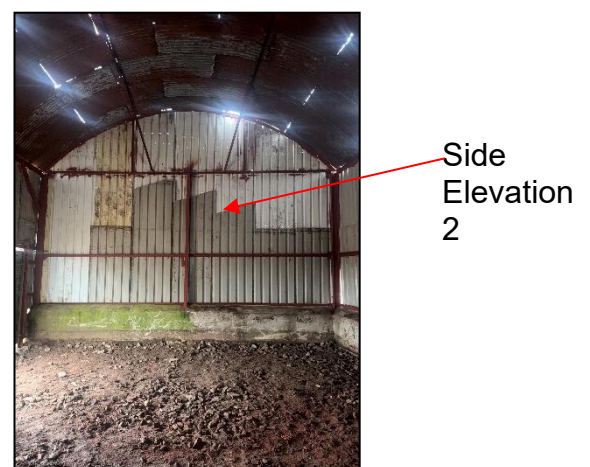
59. Fig GF4 shows the side wall on the south east (Side elevation 2).

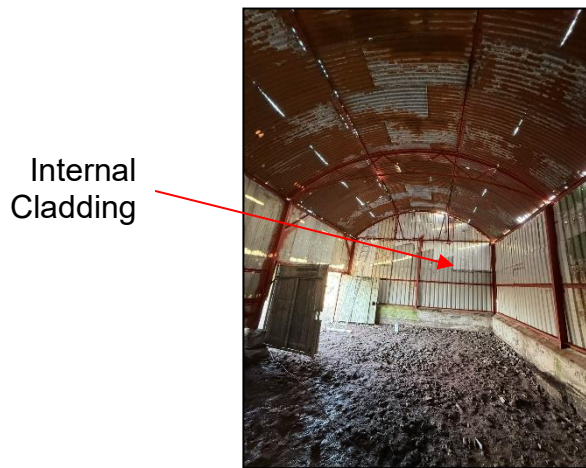
60. Fig GF5 shows the typical inclined angle support for the top internal cladding rail on the side wall (SE2).

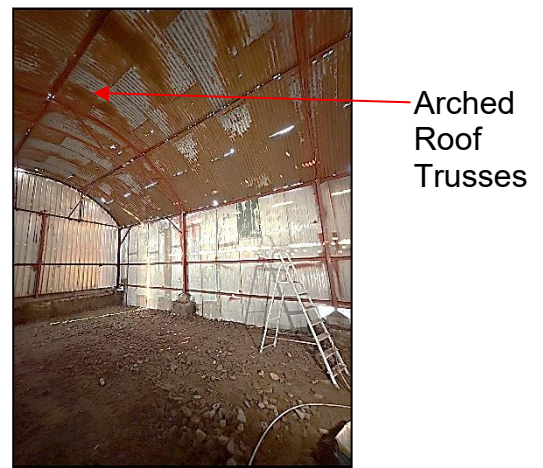
61. Fig GF6 shows the arched roof trusses that support the roof.

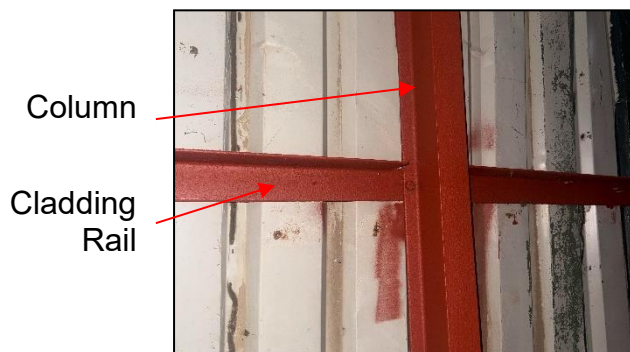
62. Fig GF7 shows a typical column to cladding rail joint.

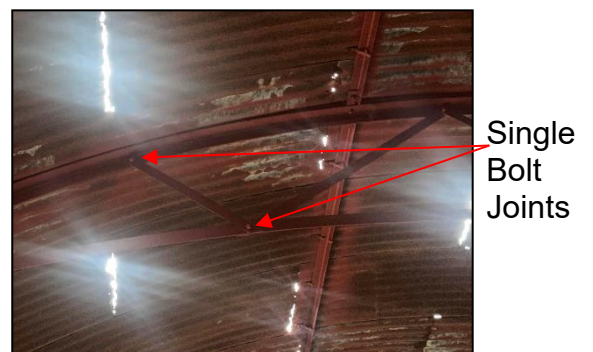
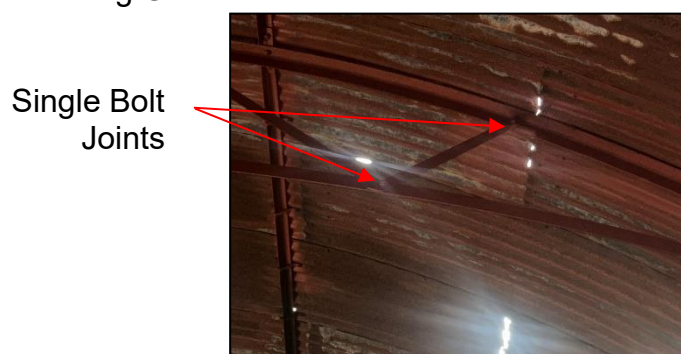
63. Fig GF8 and Fig GF9 show the single bolt truss joints.

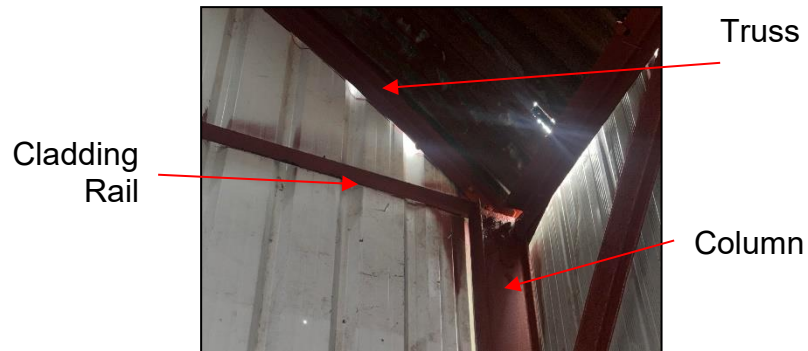
64. Fig GF10 shows a typical corner column/ roof truss/ cladding rail joint.
