# ARBORICULTURAL ASSESSMENT REPORT

Holly Cottage, Wharf Lane, Sutton Cheney, Nuneaton, CV13 0AL

**PRI Ref:** 305782

**Survey Date:** 09/09/2024

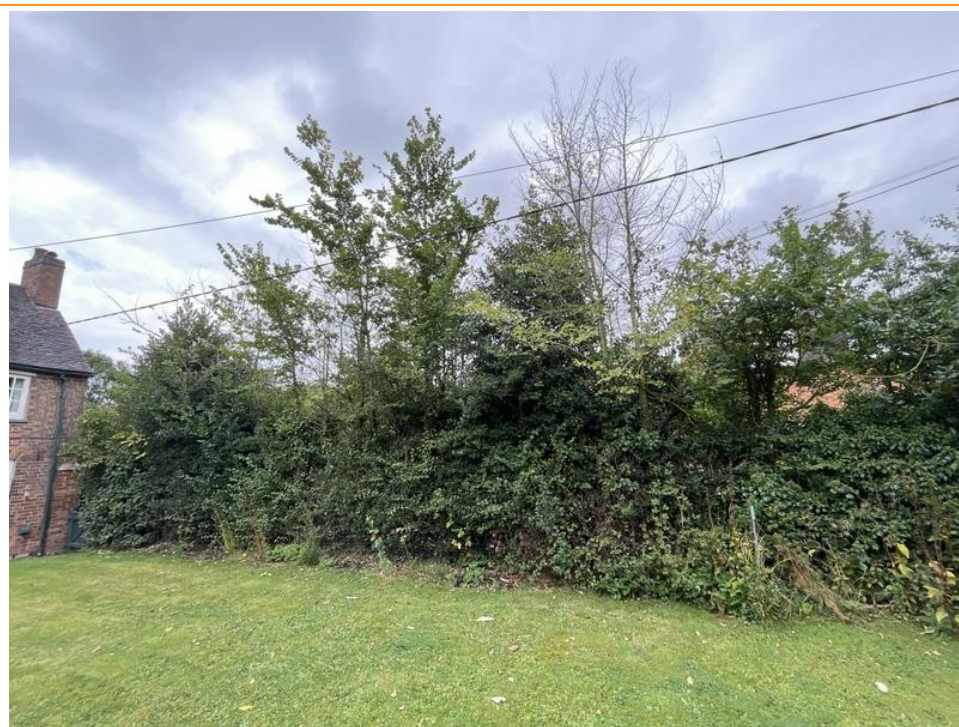
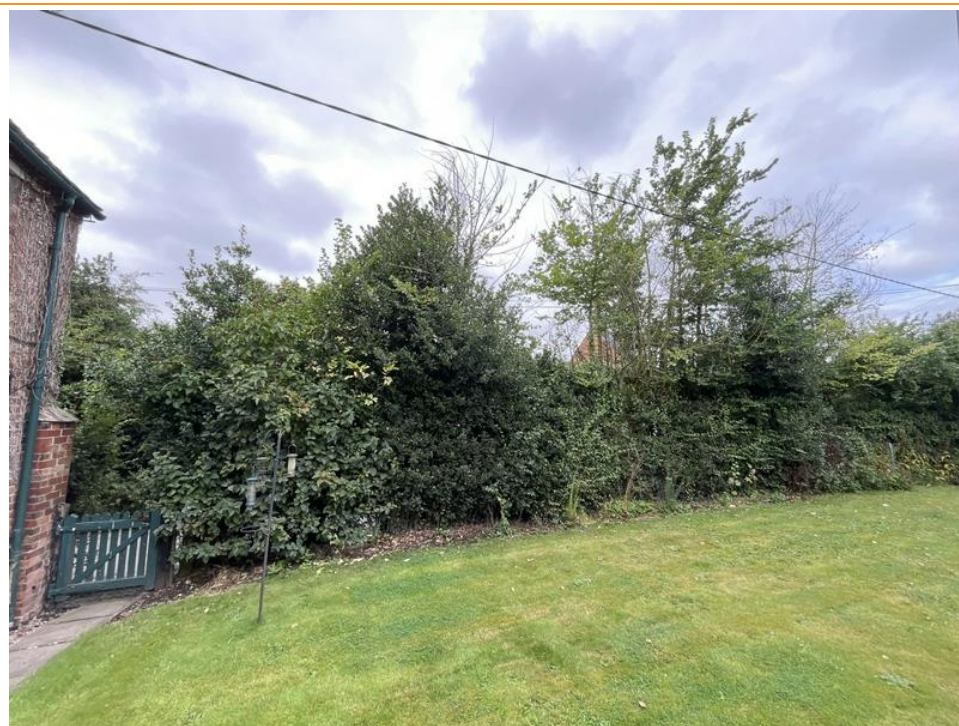
HG1 Mixed species hedge

| Tree No: | Common Name | Age Class | Condition | Height (m) | Crown Spread (m) | Stem diam. (mm) | No. of Stems | Dist to bldg. (m) | Roots Implicated | Pruning History | Recommendation | Tree Work Constraints | Notes | Owner address | Owner |
|---|---|---|---|---|---|---|---|---|---|---|---|---|---|---|---|
| HG1 | Mixed species hedge | Early Mature | Fair | 4.50 | 2.00 | 50 | 20 | 2.00 | Yes | No significant past works. | Remove all vegetation within 4m of property.<br>Remove a section of hedge group to allow a minimum clearance of 6.0m from the front of the property. (Approximately 4.5m in length to remove). | There are restrictions to the site or to the tree - contractor should quote. Adjacent to road. Phone/power lines near crowns. | Group includes Lilac, Holly, Elm and Blackthorn. Stem diameters range from 25mm-75mm. Elm trees within this group are suffering from Dutch elms disease. | Holly Cottage Wharf Lane, Sutton Cheney, Nuneaton CV13 0AL | PH |

| Tree No: | Species | Works Required | CA | TPO | Ownership |
|---|---|---|---|---|---|
| HG1 | Mixed species hedge | Remove all vegetation within 4m of property.<br>Remove section of hedge group to allow a minimum clearance of 6.0m from the front of the property. (Approximately 4.5m in length to remove). | Yes | No | PH |

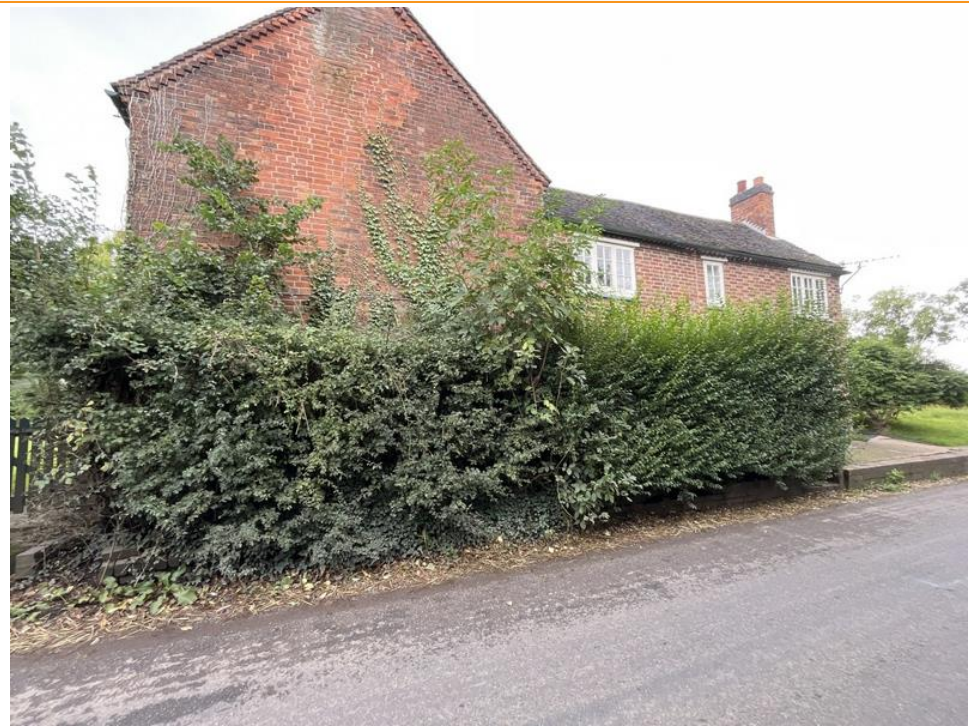
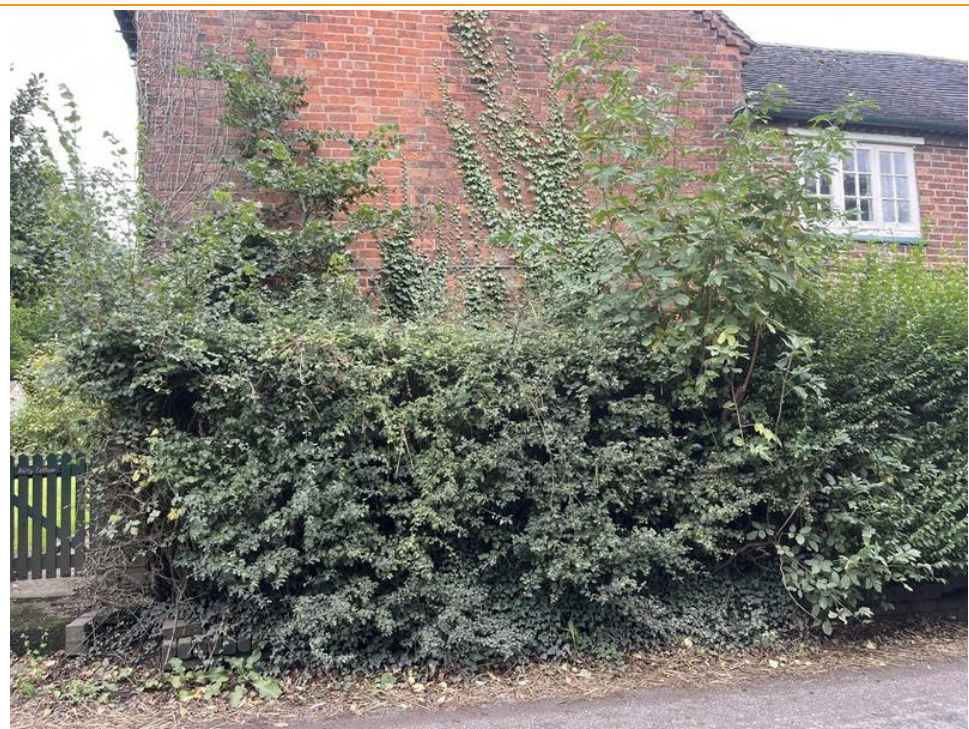
HG2 Mixed species hedge

| Tree No: | Common Name | Age Class | Condition | Height (m) | Crown Spread (m) | Stem diam. (mm) | No. of Stems | Dist to bldg. (m) | Roots Implicated | Pruning History | Recommendation | Tree Work Constraints | Notes | Owner address | Owner |
|---|---|---|---|---|---|---|---|---|---|---|---|---|---|---|---|
| HG2 | Mixed species hedge | Early Mature | Fair | 2.50 | 1.00 | 50 | 20 | 0.50 | Yes | No significant past works. | Remove all vegetation within 2m of property.<br>Remove a section of hedge group to allow a minimum clearance of 2.0m from the property (Approximately 5.0m in length to remove).<br>RETAIN PRIVET. | There are no restrictions to the site or to the tree - scheduled rates may apply. Adjacent to road. | Group includes hawthorn, Elm, Elder and Privet. Estimated stem count and diameter. | District Land Registry search required | UKN |

| Tree No: | Species | Works Required | CA | TPO | Ownership |
|---|---|---|---|---|---|
| HG2 | Mixed species hedge | Remove all vegetation within 2m of property.<br>Remove section of hedge group to allow a minimum clearance of 2.0m from the property (Approximately 5.0m in length to remove). RETAIN PRIVET. | No | No | UKN |

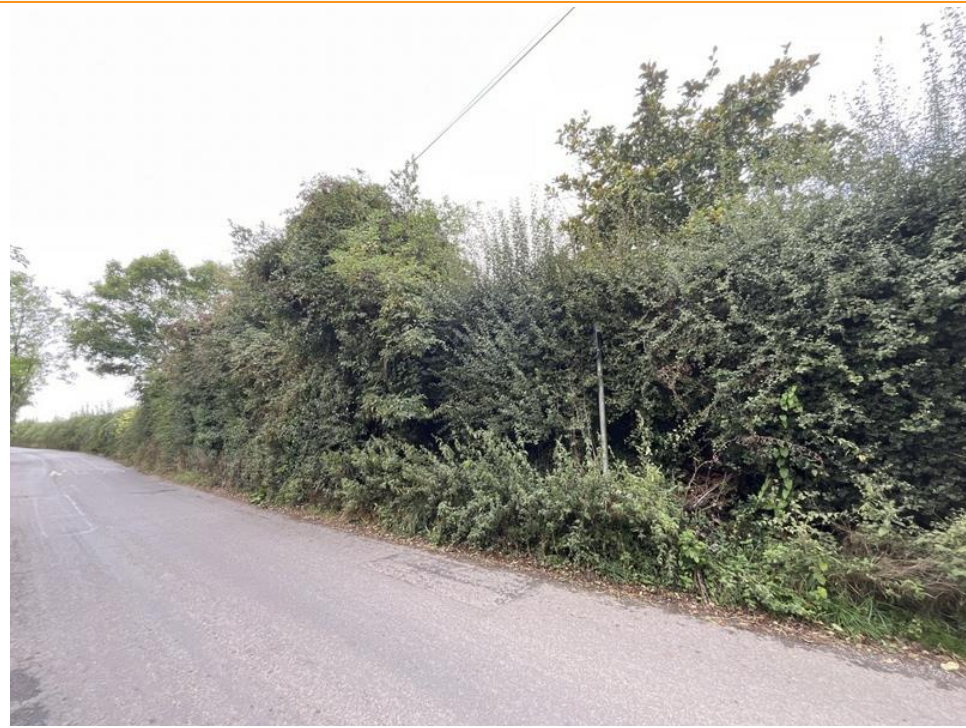
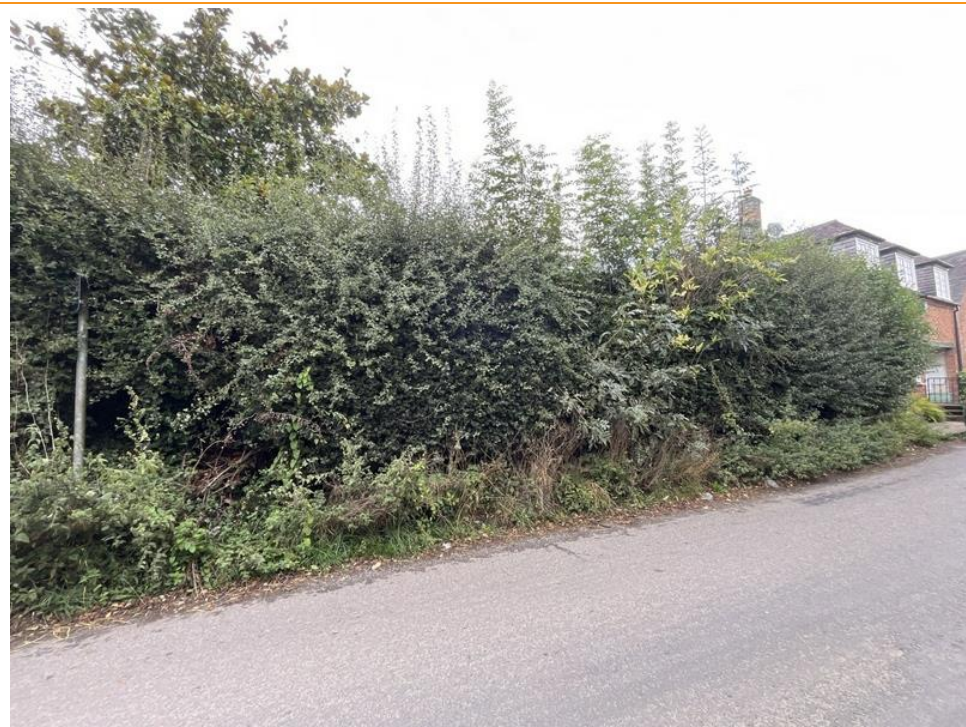
HG3 Mixed species hedge

| Tree No: | Common Name | Age Class | Condition | Height (m) | Crown Spread (m) | Stem diam. (mm) | No. of Stems | Dist to bldg. (m) | Roots Implicated | Pruning History | Recommendation | Tree Work Constraints | Notes | Owner address | Owner |
|---|---|---|---|---|---|---|---|---|---|---|---|---|---|---|---|
| HG3 | Mixed species hedge | Mature | Fair | 5.00 | 3.00 | 50 | 20 | 9.50 | Yes | No significant past works. | No work required. | There are no restrictions to the site or to the tree - scheduled rates may apply. | Group includes Hawthorn, Elder, Ash and Ivy. Estimated stem count and diameter. | District Land Registry search required | UKN |

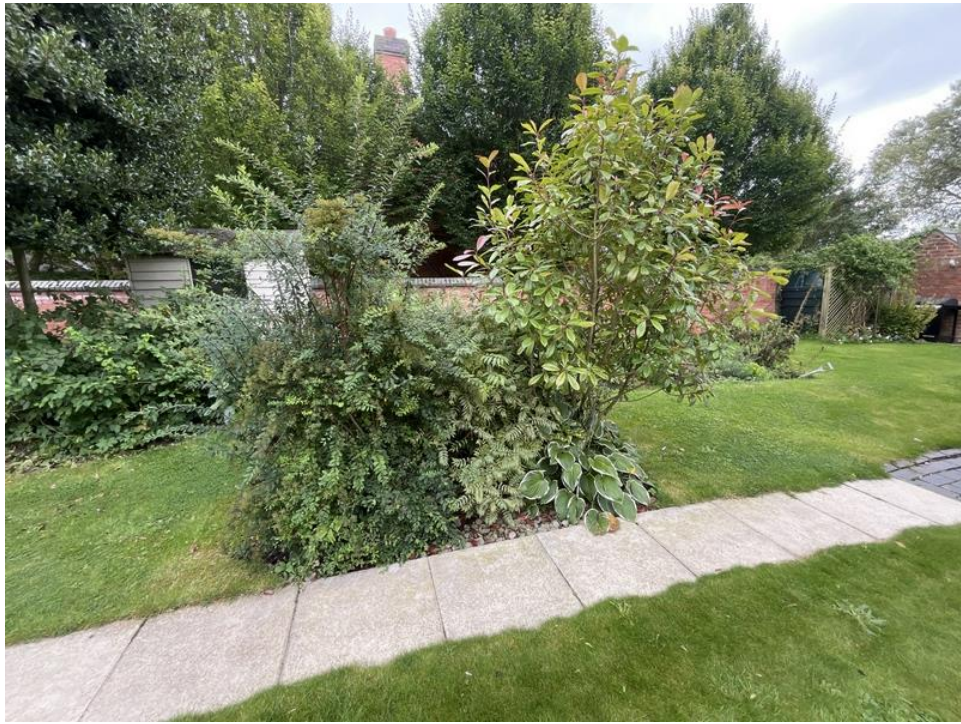
SG1 Mixed species shrubs

| Tree No: | Common Name | Age Class | Condition | Height (m) | Crown Spread (m) | Stem diam. (mm) | No. of Stems | Dist to bldg. (m) | Roots Implicated | Pruning History | Recommendation | Tree Work Constraints | Notes | Owner address | Owner |
|---|---|---|---|---|---|---|---|---|---|---|---|---|---|---|---|
| SG1 | Mixed species shrubs | Semi-Mature | Fair | 1.50 | 1.25 | 25 | 5 | 3.80 | No | No significant past works. | No work required. | There are no restrictions to the site or to the tree - scheduled rates may apply. | Group includes Photinia, Spirea, Bergenia and Spotted Laurel. Estimated stem count and diameter. | Holly Cottage Wharf Lane, Sutton Cheney, Nuneaton CV13 0AL | PH |

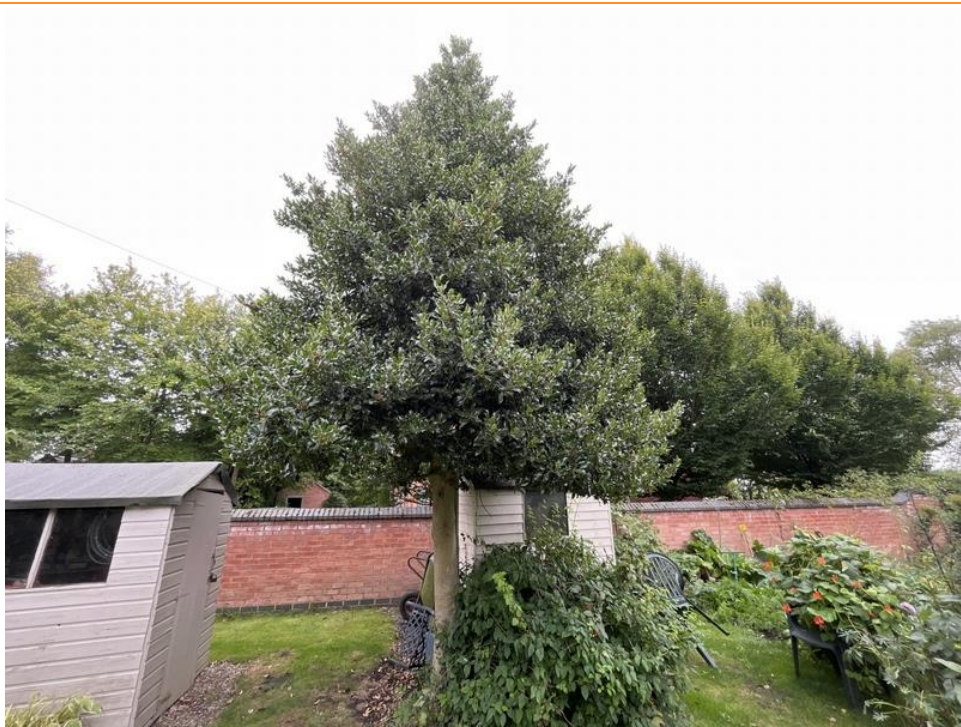
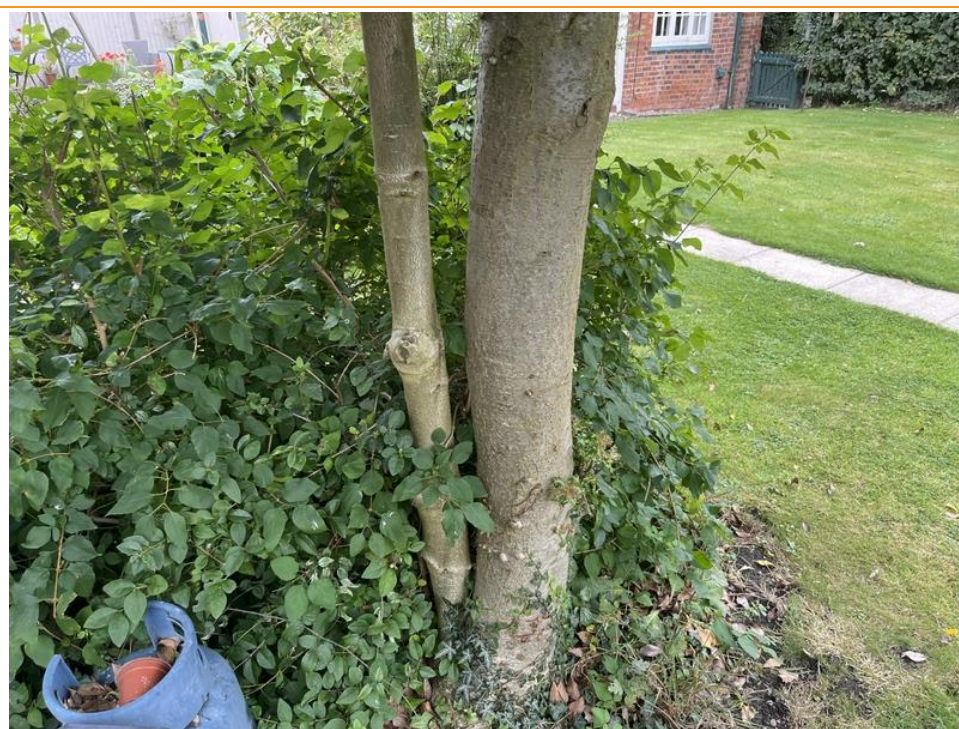
T1 Holly

| Tree No: | Common Name | Age Class | Condition | Height (m) | Crown Spread (m) | Stem diam. (mm) | No. of Stems | Dist to bldg. (m) | Roots Implicated | Pruning History | Recommendation | Tree Work Constraints | Notes | Owner address | Owner |
|---|---|---|---|---|---|---|---|---|---|---|---|---|---|---|---|
| T1 | Holly | Mature | Fair | 7.50 | 3.50 | 150 | 2 | 8.80 | Yes | No significant past works. | No work required. | There are no restrictions to the site or to the tree - scheduled rates may apply. | Although roots were found, it is unlikely they are from this tree. Stem diameters range from 75mm-175mm. | Holly Cottage Wharf Lane, Sutton Cheney, Nuneaton CV13 0AL | PH |

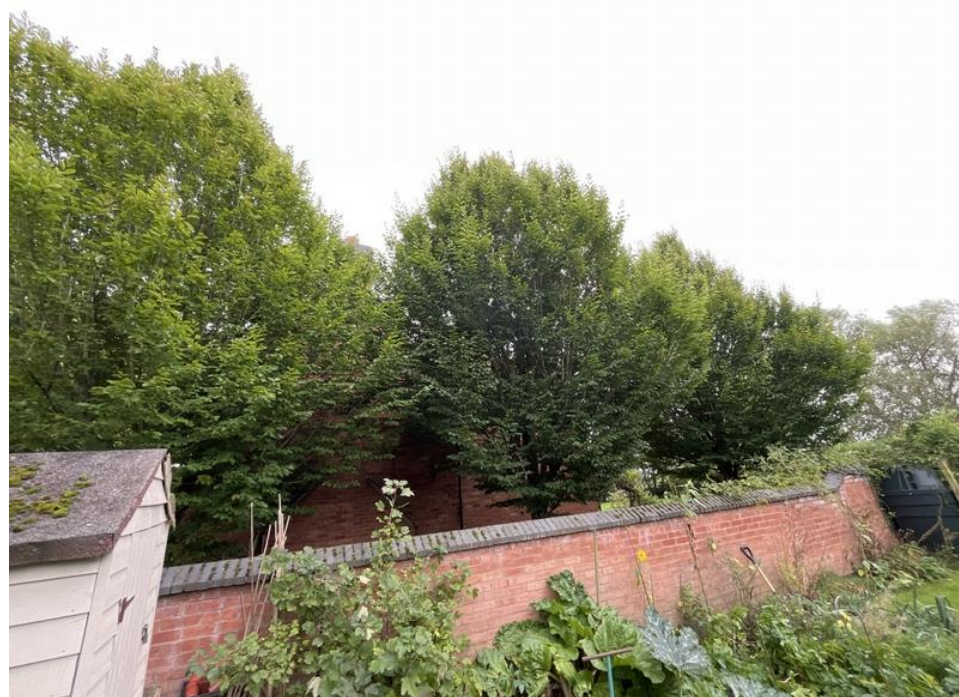
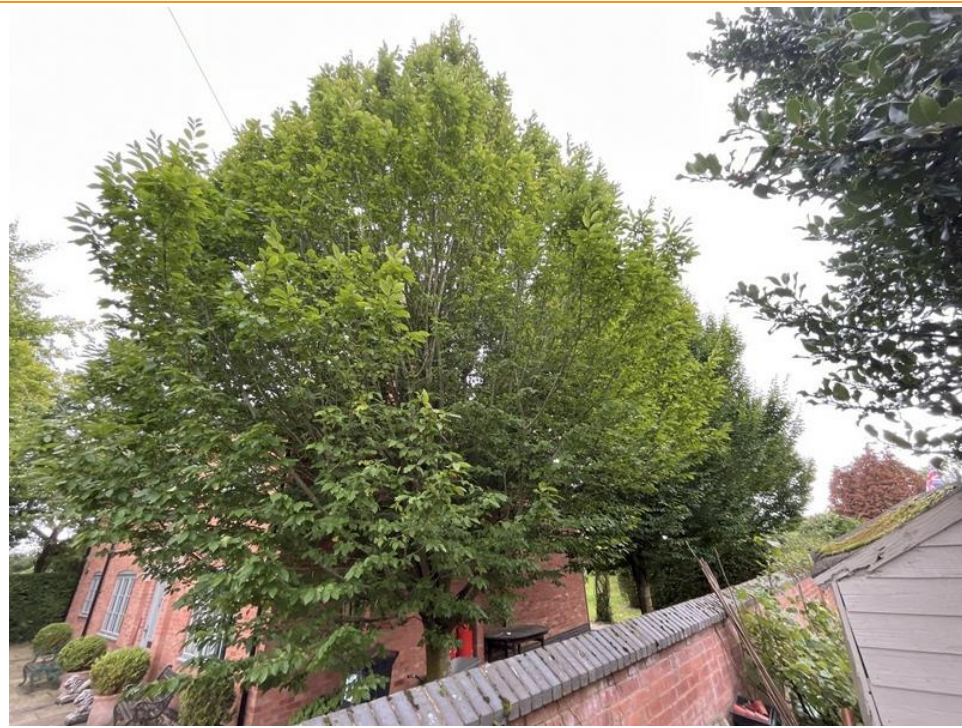
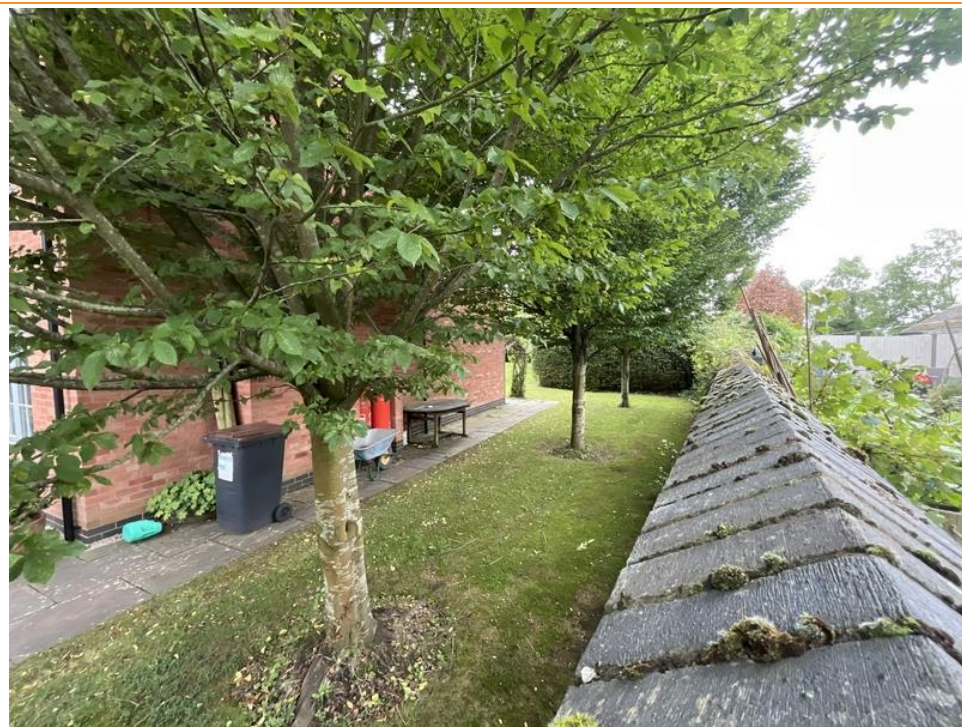
TG1 Hornbeam

| Tree No: | Common Name | Age Class | Condition | Height (m) | Crown Spread (m) | Stem diam. (mm) | No. of Stems | Dist to bldg. (m) | Roots Implicated | Pruning History | Recommendation | Tree Work Constraints | Notes | Owner address | Owner |
|---|---|---|---|---|---|---|---|---|---|---|---|---|---|---|---|
| TG1 | Hornbeam | Semi-Mature | Fair | 10.00 | 8.00 | 200 | 3 | 8.50 | No | No significant past works. | No work required. | There are no restrictions to the site or to the tree - scheduled rates may apply. | Although not currently involved, going forward management is advised. Estimated stem count and diameter. | District Land Registry search required | UKN |

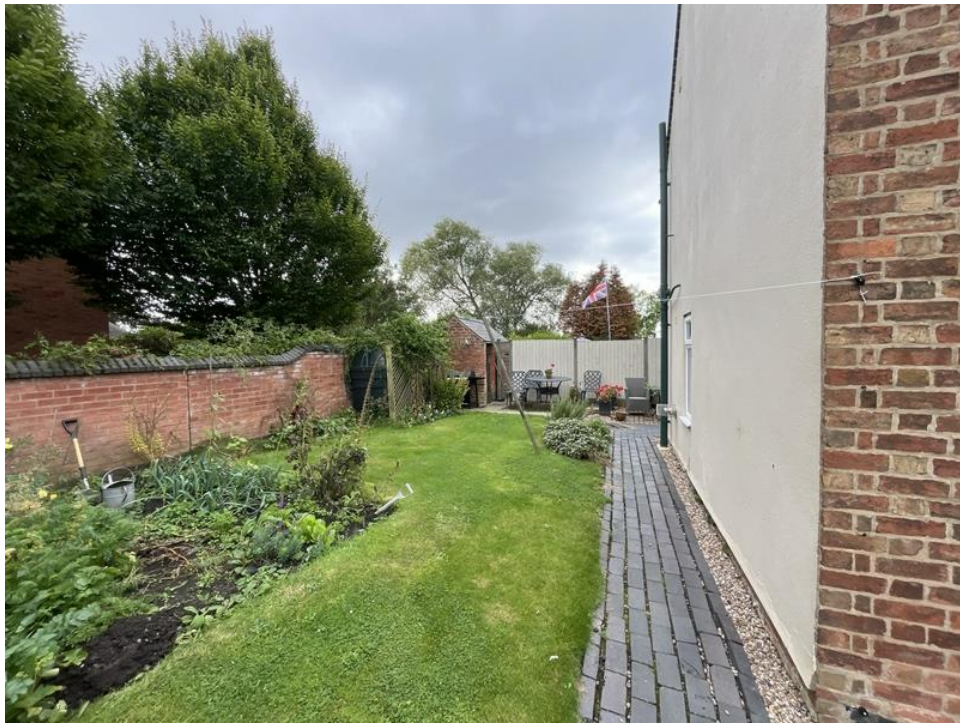
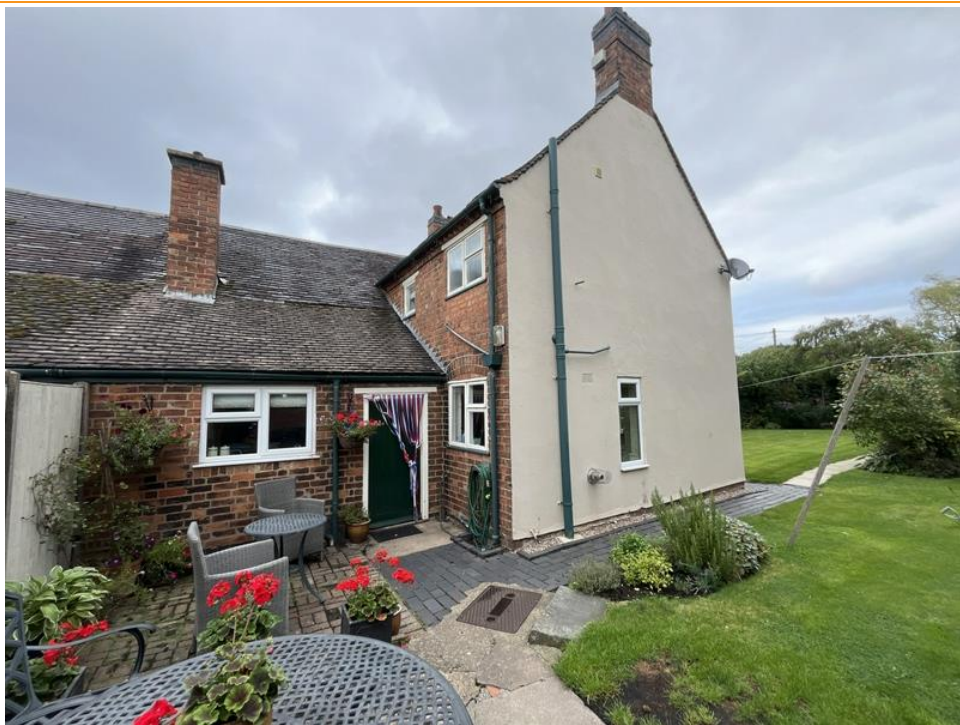
Limited vegetation to rear/right hand side
