## SITE INVESTIGATION FACTUAL REPORT

Report No: SI-872710  
Client: Sedgwick International UK - Maidstone  
Site: Holly Cottage, Wharf Lane, Sutton Cheney  
Leicestershire  
Client Ref: 10257599  
Date of Visit: 16/07/2024

**Home Emergency Response - Subsidence Investigation - Drainage Services – Crack & Level Monitoring – Property Video Surveys**

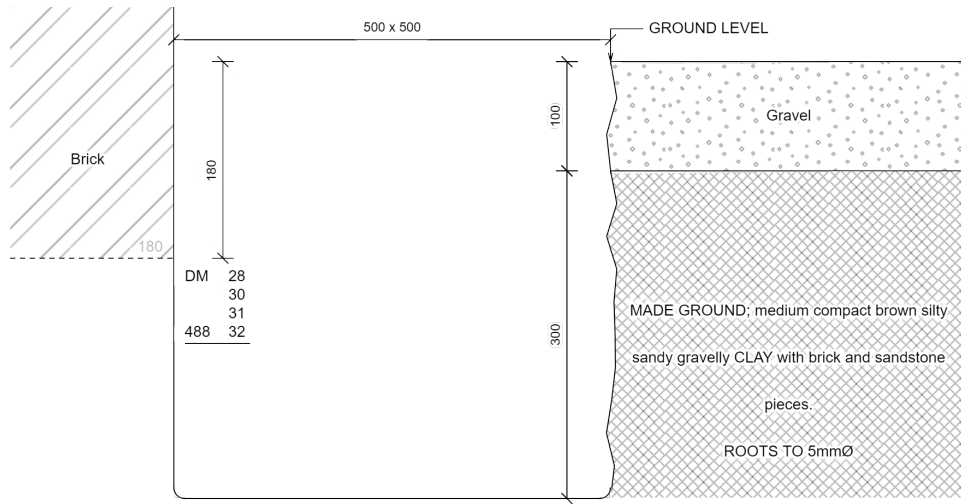
REPORT NUMBER: C1088270 / 303293.1.1.1  
 TRIAL PIT REF: TP1  
 CLIENT: Sedgwick International UK  
 JOB NO: 872710  
 EXCAVATION METHOD: Hand tools

For Strata below 400mm see Bore Hole log

Curved steel pin driven 200mm under foundation at 180mm below ground level.
