# Structural Report

## Wharf Farm Barn

CO23/0071/02

## 1. Structural Inspection Report

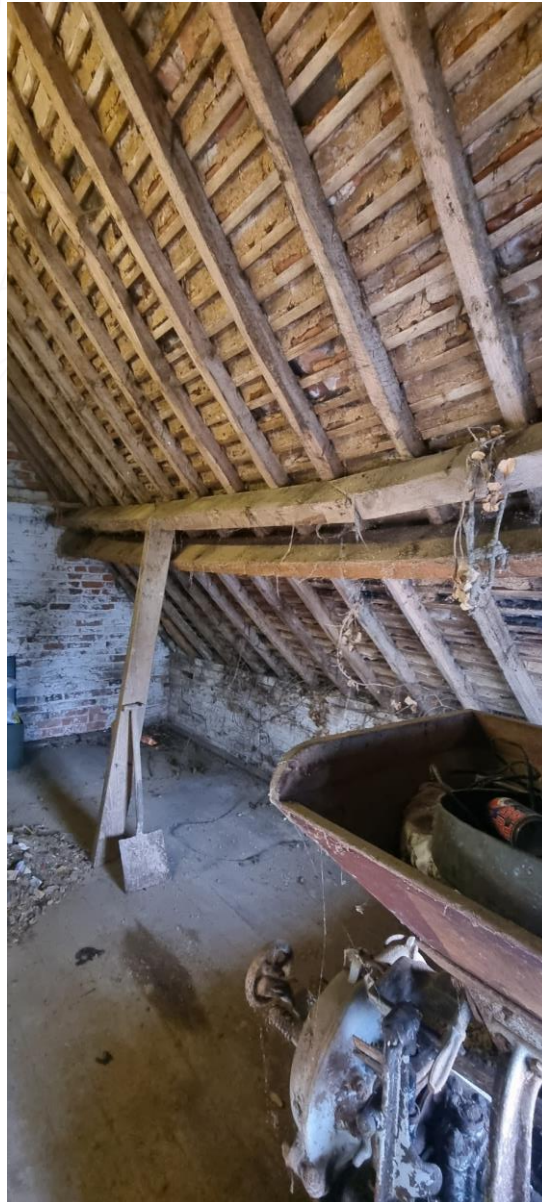
- 3.1 The existing building a 2 storey traditionally built brick barn with a timber first floor support on joists spanning front to back.
  - 3.1.1 The roof is a traditional purlin and trussed roof construction supporting clay tiles over.
- 3.2 The roof has significant undulation visible externally combined with the bowing to the purlins that will have contributed to the visible eaves spread. The purlins have failed and been propped and strengthened at various different times during the life of the building. It is likely that a new roof structure will be required.
  - 3.2.1 The rear wall can be seen to be bulging at the eaves by up to 150mm from its original position and the likely cause will be the spread from the roof.

PURLINS WITH BOWING AND REPAIRS VISIBLE

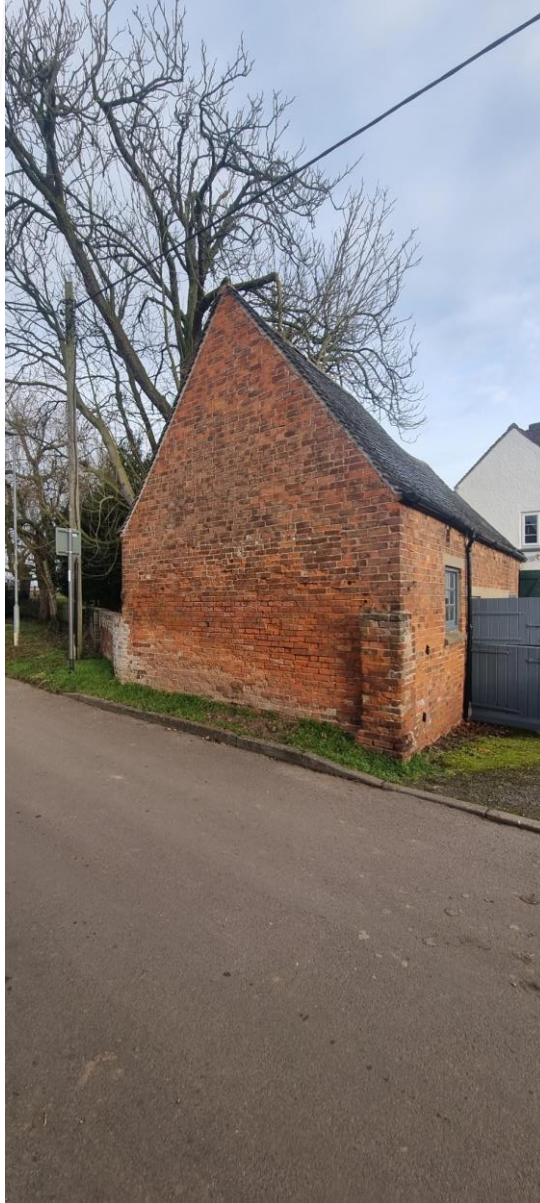
- 3.3 The masonry to the gable wall has suffered with significant numbers of spalled bricks. It is anticipated that these will need to be chopped out and replaced. As these consist of around 40% of the gable, rebuilding of this gable is considered likely.

**GABLE WITH SPALLED BRICKWORK**

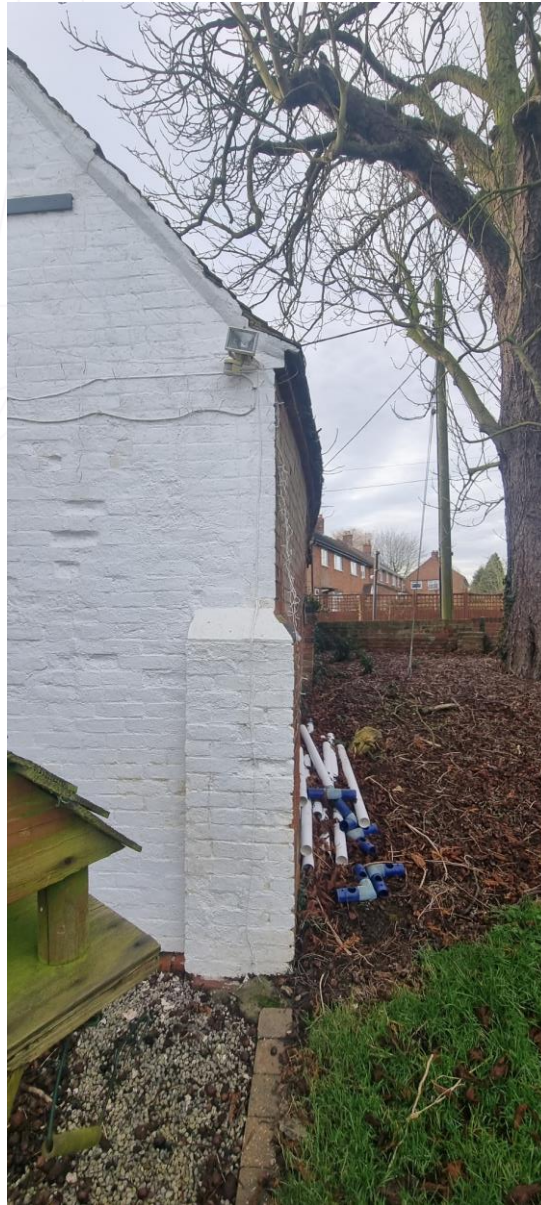
- 3.4 The rear wall retains around 1m of soil in addition to a mature sycamore tree. The foundations to this wall are loose spread brick foundations less than 75mm below the internal ground level. It is likely that the heave caused by the nearby tree will be contributing to the cracking visible in the rear wall. There are horizontal cracks internally near the first floor as the wall is rotating and the joists are trying to stabilise the wall.

REAR WALL BULGING

- 3.4.1 This wall will need to be underpinned as part of a conversion, with significant areas of rebuilding required. As such, it is likely that this rear wall will need to be demolished and re-built of a suitable foundation.

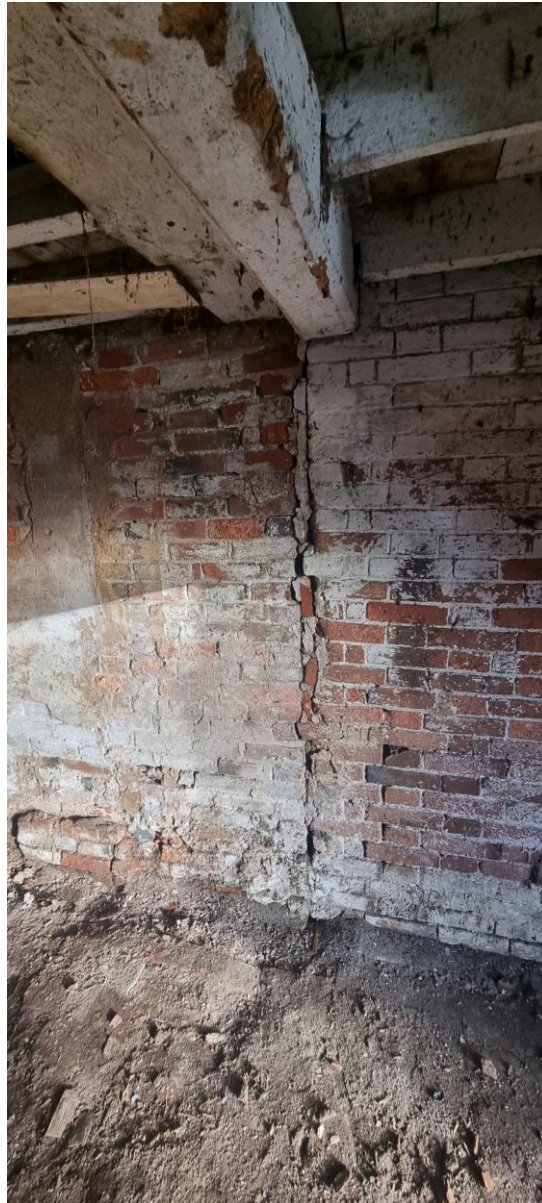
INTERNAL CRACKING TO MASONRY

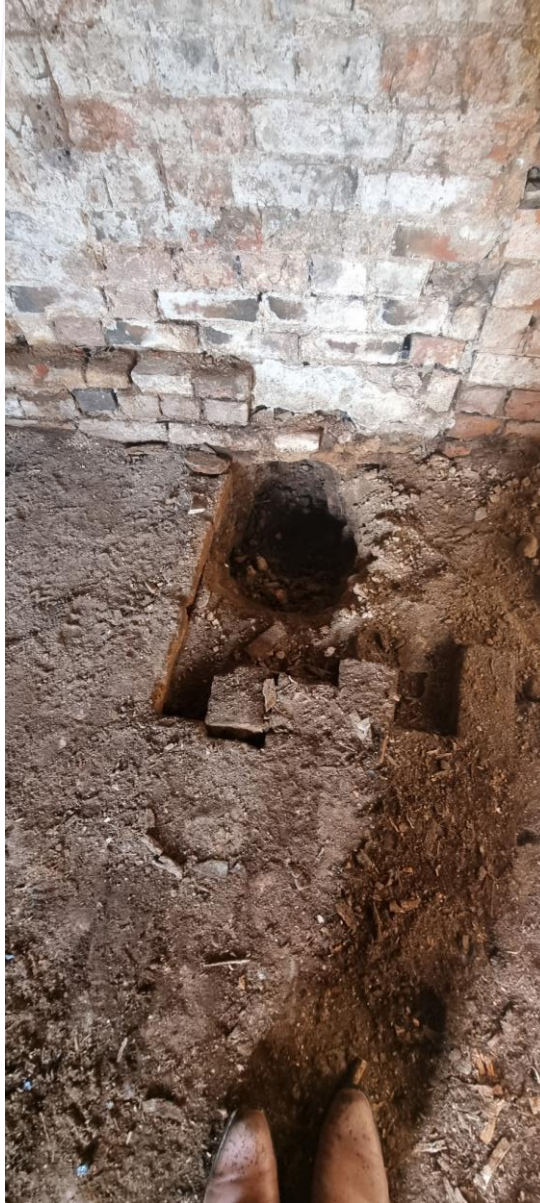
FOUNDATION TO REAR WALL

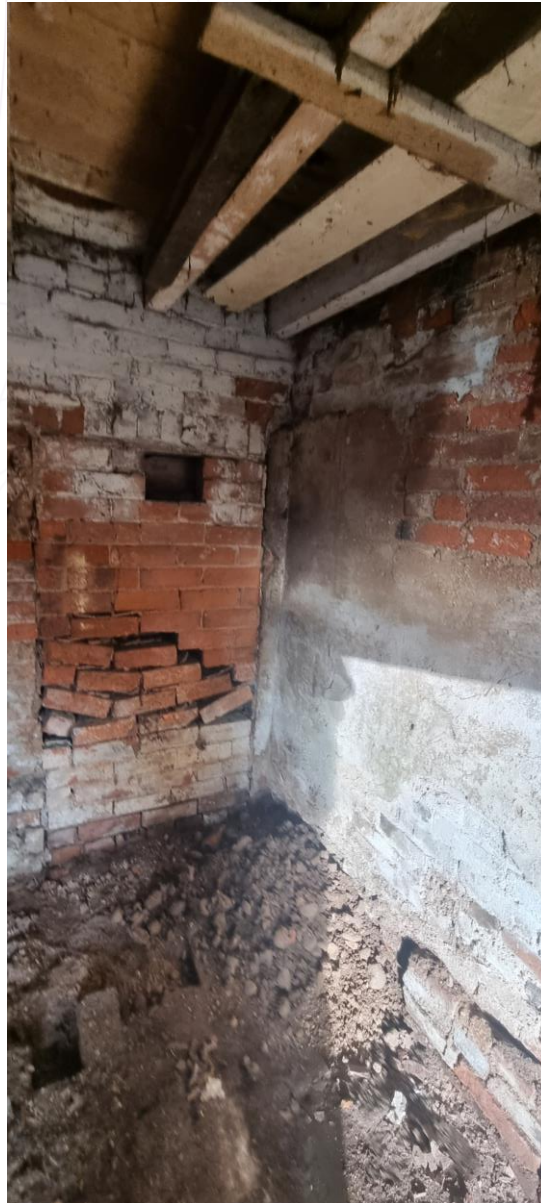
- 3.5 The ground floor is a loose brick floor that is not considered suitable for re-use.

**LOOSE BRICKS INTERNALLY AND CRACKING**
