# **ARBORICULTURAL SURVEY**

**CROWN HILL CLOSE  
STOKE GOLDING  
NUNEATON  
CV13 6EW**

**Prepared by  
M J Boddy *F Arbor A, FICFor, CEnv***

**18<sup>th</sup> August 2025**

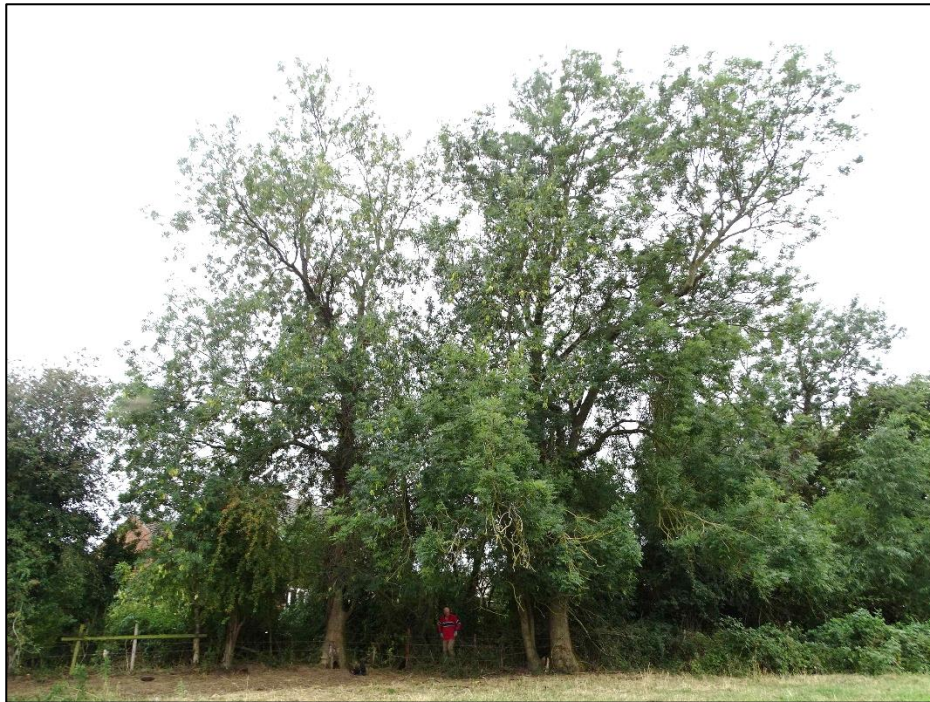
**Photograph 1: Area viewed from the north showing the two ash trees on the boundary**

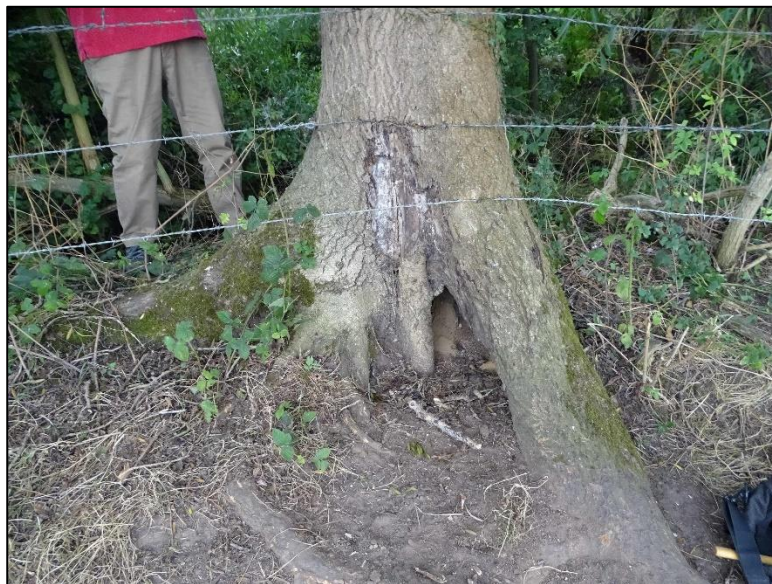
- 2.5** There are two mature ash trees growing on the boundary fenceline on the northern side of the pond, one single stemmed and one twin-stemmed, the ownership of which is unclear. The single stemmed tree has a cavity in the base of the northern side but is well buttressed and the cavity and associated decay did not appear sufficiently extensive to currently be compromising the tree's stability.

**Photograph 2: Cavity in the base of the single-stemmed boundary ash**

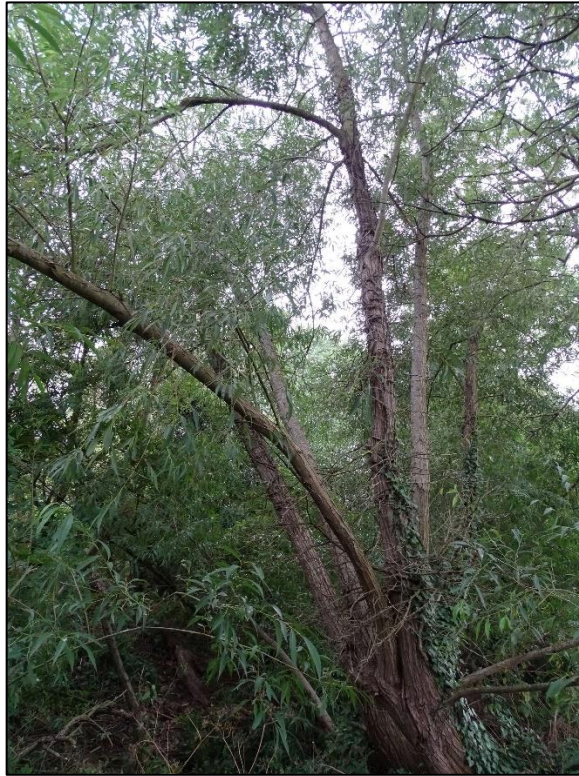
- 2.4** On the northern side of the pond is a multi-stemmed crack willow which has regenerated from the trunk of a historically collapsed tree (tag 93). The stems are tall and slender with two arching to the south, towards number 28 and impeding the development of two immature ash on the southern side of the pond. I have recommended that all of the willow stems be reduced by approximately 5 metres to maintain their stability and provide more space for the ash tree to develop.

**Photograph 3: Multi-stemmed crack willow tag no. 93 viewed from the east**

| TREE TAG NO | SPECIES | STEM DIA (mm) | AGE CLASS | OBSERVATIONS | RECOMMENDATIONS | PRIORITY |
|---|---|---|---|---|---|---|
| 93 | Crack willow<br><i>Salix fragilis</i> | Multi-stemmed:<br>Up to 320 | Mature | Multiple slender stems regenerated from the trunk of historically collapsed tree. Two stems lean acutely to the south-east and are growing around a pair of immature ash trees | Reduce all stems by approx. 5m to retain their stability and increase the clearance around the adjacent ash trees. Remove the lower laterals branches extending close to or over the boundary fence | Moderate |

- 6.2 However, as the balancing pond is situated within the Stoke Golding Conservation Area, a Section 211 notification giving the Council six weeks' written notice will be required prior to the recommended pruning of the willow being implemented. The removal of the dead trees are exempt from this requirement but a minimum of five day's written notice needs to be given that these works are to be carried out.

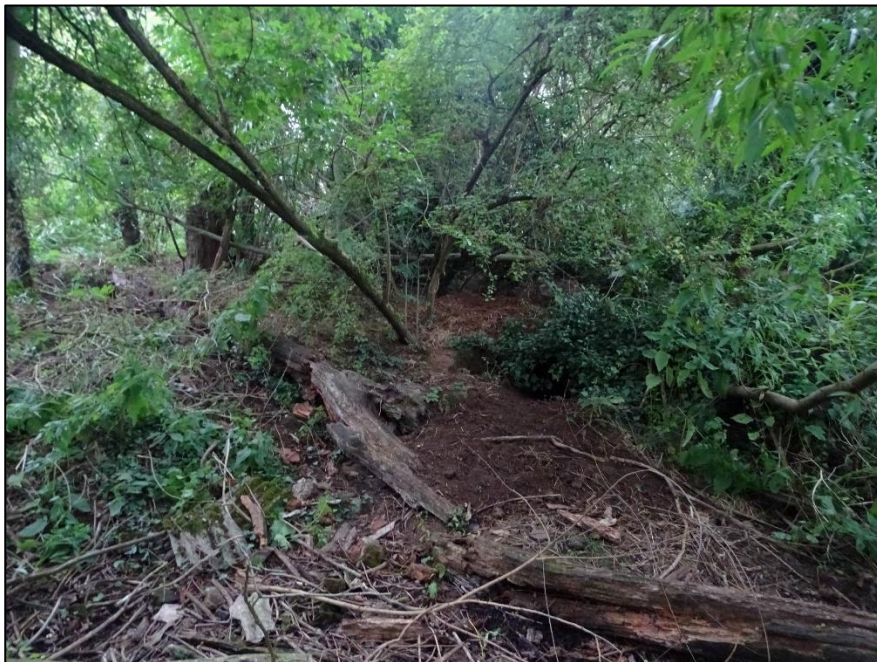
- 2.2** The balancing pond was dry at the time of my visit. The surrounding enclosed area is densely overgrown and contains several collapsed or partially collapsed trees and bushes. There is an extensive active badger sett, with multiple entrances, to the west of the pond. Accordingly, there should be minimal disturbance to this area.

**Photograph 4: Badger sett viewed from the east**
