Our Ref: BSL-2025-058

**Re: 28 Spinney Drive, Kirby Grange, Leicestershire LE9 9FG**

Thank you for your instructions to carry out a Specific Defect Survey of the above property. We can confirm that the property was inspected by Andrew Gamble on Friday 6 December 2024.

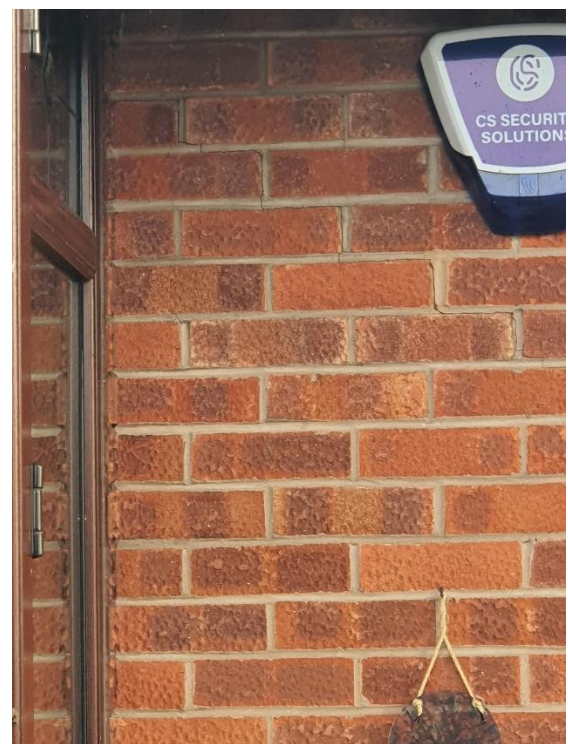
- 2.2.1. Externally, to the rear elevation wall of the property, we noted a raking/diagonal crack leading down from soffit level for approximately 8-10 brick courses. This cracking was not visible internally.
- 2.2.2. To the adjacent road we noted extensive cracking to the surface, most likely due to the tree roots.

- 3.1.1. Importantly we can conclude the damage to the rear extension is the result of subsidence, caused by root induced clay shrinkage from the water uptake of the nearby pine tree. This has caused a downward and rotational movement to the conservatory relative to the original bungalow.

Minor cracking to rear elevation from the pull of the conservatory as a result of the rotational movements.

- 3.1.4. To the rear elevation of the property, the minor cracking can be raked out and repointed in a mortar colour match as closely as possible.

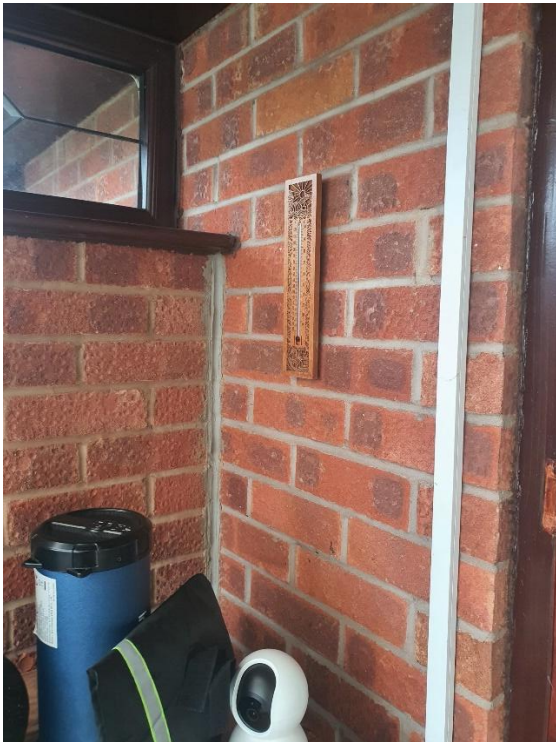
- 2.1.1. Viewed internally, to the right-hand side wall of the conservatory at the abutment of the bungalow, arising up from ground level to soffit height is a vertical crack of up to 10mm in width (Now been repointed). Distortion to the frame can also be seen in this area, indicating rotation and a drop in level to the rear corner of the structure.
- 2.1.2. We observed the frame of the double-glazed unit to the right junction had been pulled away from the brickwork. To the left junction a gap in the region of 10mm had also formed indicating rotation and a drop in level to the rear right corner.

General view of right junction of conservatory to main bungalow – Gap has been repointed

- 3.1.3. Repairing of the cracks at the junctions of the conservatory will be required, with the glazed framed being loosened, packed and refitted. This can be repointed in a cement-based mortar. Or alternatively, a Polysulphide sealant could be applied along the crack, this allows more flexibility within the mortar joint should any unsightly minor movement shrinkage/thermal occur in the future.

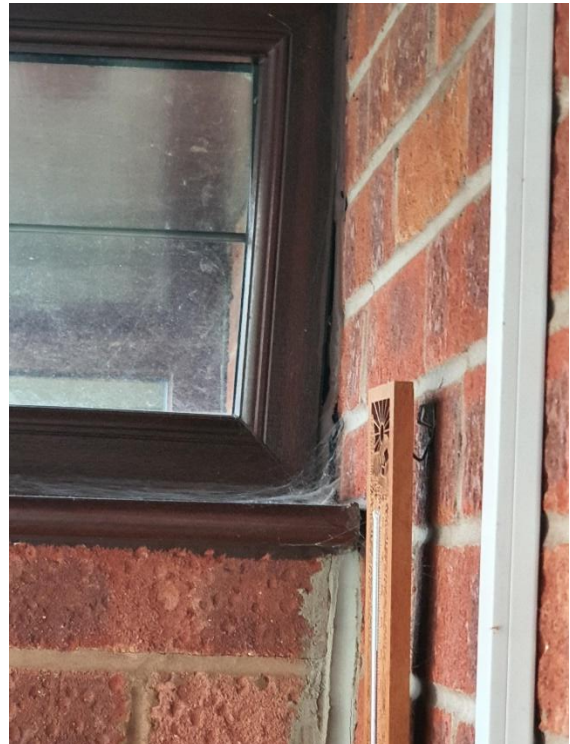
Close view of pulling of the double-glazed frame

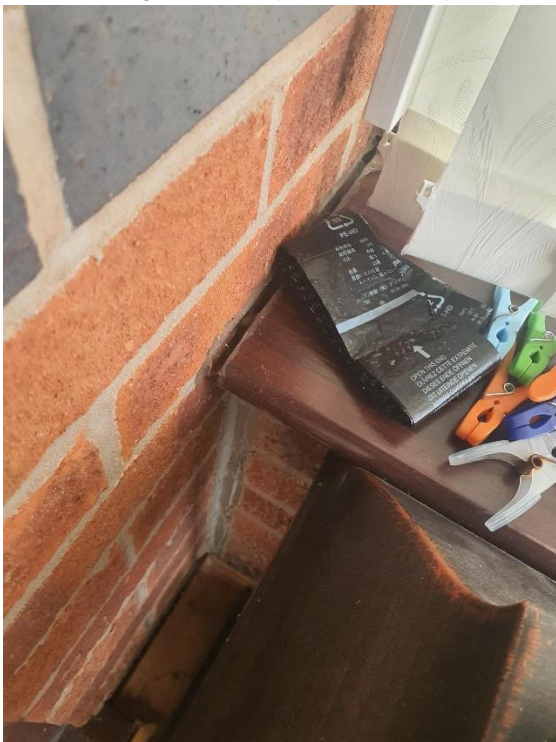
Gap which has formed at left junction of conservatory, floor slab has also pulled away

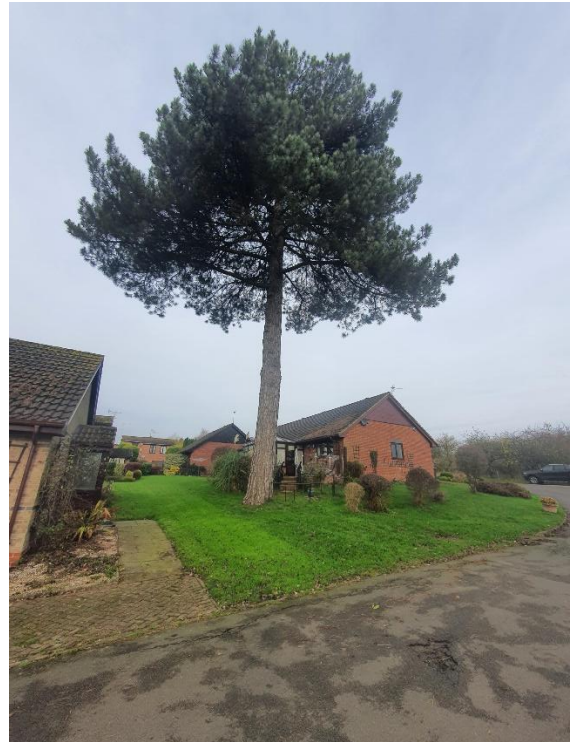
Pine tree to the rear left of the building

- 3.1.2. We recommend removal of the Pine tree, namely the tree at the left of the garden, this should be followed by a period of up to 6 months through a winter, to allow the ground to rehydrate and stabilise. During this time, the cracking may reduce in width and begin to close up as rehydration and beneficial heave naturally occurs to the clay soil.

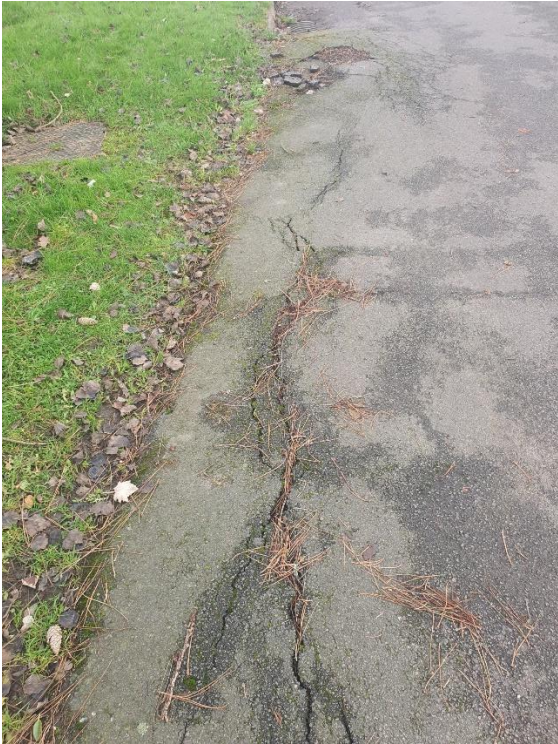
Damage to the adjacent road from tree roots.
