BS5837:2012 Tree Survey  
Land off Barton Lane  
Congerstone  
Leicestershire  
NGR SK36996 05611

Survey by  
Christopher Barker CEnv dipHort ACIEEM

# **BS5837 Tree Survey, Land off Barton Lane, Congerstone**

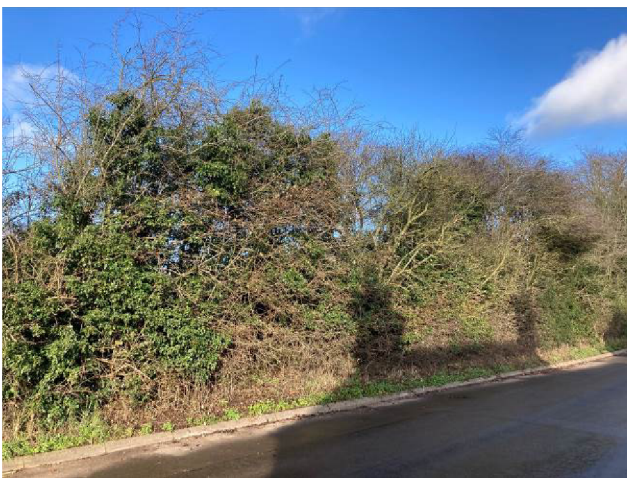
Hedgerow H1

**Hedgerow H1 – T10** form a linear canopy along Barton Road with the larger Oak dominating the eastern end. A number of the Oak are large mature specimens in good condition but are choked by dense ivy.

| Tree No | Species | Ht (m) | Stem Diam mm@ 1.5m | Canopy Spread (m) | Height of Crown Clearance | Age Class | Est yrs | Overall Condition | Structural condition | Recommendations | BS 5837 Category | RPA Radius (m) |
|---|---|---|---|---|---|---|---|---|---|---|---|---|
| H1 | Hedgerow | 3-5 | <200 | N-2<br>S-2<br>E-2<br>W-2 | 0 | M | 10+ | G | Side trimmed but not topped. Hawthorn, Holly, Elm, Oak, Blackthorn. | Top and trim. | C2 | 2.4 |

| Ref | Tree | Category | Potential Impact of development |
|---|---|---|---|
| H1 | Hedgerow | C2 | Likely to be trimmed to 1.8m to provide a dense tidy boundary screen. |

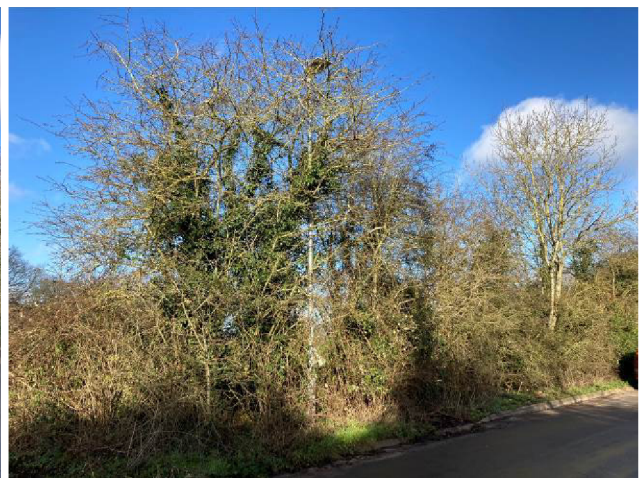
Ash T2 and T3 in H1

| Tree No | Species | Ht (m) | Stem Diam mm@ 1.5m | Canopy Spread (m) | Height of Crown Clearance | Age Class | Est yrs | Overall Condition | Structural condition | Recommendations | BS 5837 Category | RPA Radius (m) |
|---|---|---|---|---|---|---|---|---|---|---|---|---|
| T2 | Ash<br><i>Fraxinus excelsior</i> | 8 | 190<br>160 | N-3<br>S-2<br>E-2<br>W-2 | 1 | SM | 10 | F | Irregular open crown. No structural faults visible from ground level | | C2 | 2.9 |
| T3 | Ash<br><i>Fraxinus excelsior</i> | 8 | 165 | N-2<br>S-2<br>E-2<br>W-2 | 2 | Y | 10+ | G | Upright ascending crown. No structural faults visible from ground level | | C2 | 1.9 |

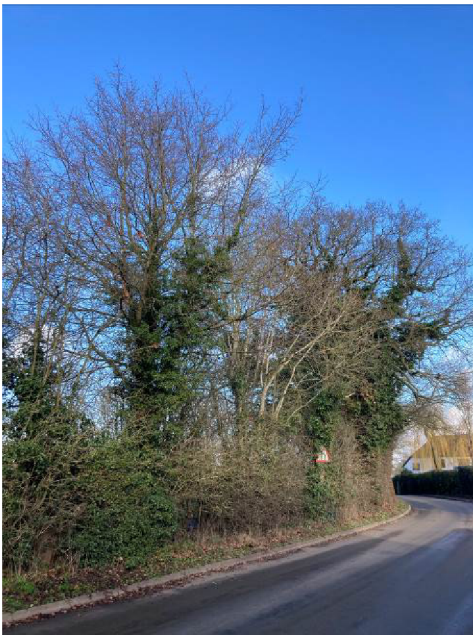
T4 and T5 in H1

| Tree No | Species | Ht (m) | Stem Diam mm@ 1.5m | Canopy Spread (m) | Height of Crown Clearance | Age Class | Est yrs | Overall Condition | Structural condition | Recommendations | BS 5837 Category | RPA Radius (m) |
|---|---|---|---|---|---|---|---|---|---|---|---|---|
| T4 | Oak<br><i>Quercus petraea</i> | 8 | 230<br>150 | N-3<br>S-4<br>E-4<br>W-4 | 4 | Y | 20+ | G | Broadly ascending with dense ivy. No structural faults visible from ground level | Remove dense ivy growth. | B2 | 3.3 |
| T5 | Ash<br><i>Fraxinus excelsior</i> | 8 | 150<br>140<br>130 | N-3<br>S-1<br>E-3<br>W-2 | 3 | Y | 10 | F | Irregular and lacking space. No structural faults visible from ground level | | C2 | 2.9 |

| Ref | Tree | Category | Potential Impact of development |
|---|---|---|---|
| T4 | Oak<br><i>Quercus petraea</i> | B2 | Crown and RPA extending across the field boundary will require protection measures. |
| T5 | Ash<br><i>Fraxinus excelsior</i> | C2 | Crown and RPA extending across the field boundary will require protection measures. |

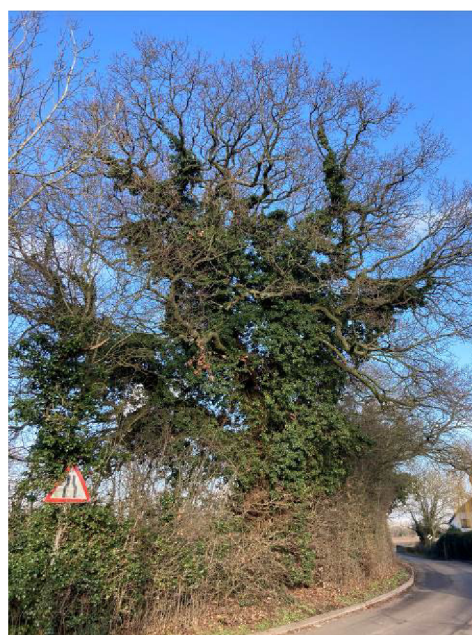
Oak T6

| Tree No | Species | Ht (m) | Stem Diam mm@ 1.5m | Canopy Spread (m) | Height of Crown Clearance | Age Class | Est yrs | Overall Condition | Structural condition | Recommendations | BS 5837 Category | RPA Radius (m) |
|---|---|---|---|---|---|---|---|---|---|---|---|---|
| T6 | Oak<br><i>Quercus petraea</i> | 12 | 760 | N-6<br>S-7<br>E-5<br>W-6 | 3 | M | 20+ | G | Broad crown choked by dense ivy. No structural faults visible from ground level | Remove dense ivy growth. | B1 | 9.1 |

| Ref | Tree | Category | Potential Impact of development |
|---|---|---|---|
| T6 | Oak<br><i>Quercus petraea</i> | B1 | Large crown and RPA extending across the field boundary will require protection measures. |

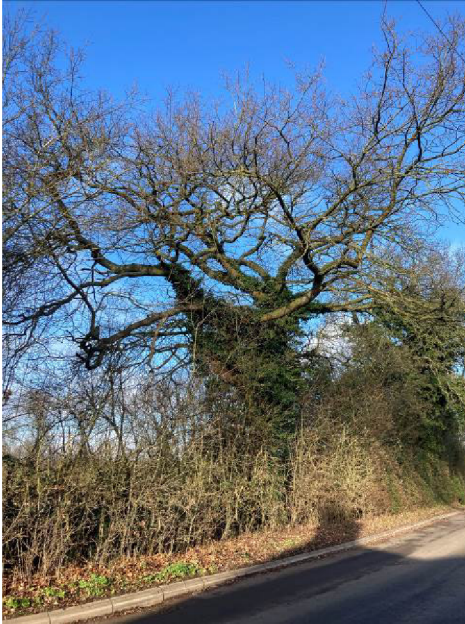
Oak T7

| Tree No | Species | Ht (m) | Stem Diam mm@ 1.5m | Canopy Spread (m) | Height of Crown Clearance | Age Class | Est yrs | Overall Condition | Structural condition | Recommendations | BS 5837 Category | RPA Radius (m) |
|---|---|---|---|---|---|---|---|---|---|---|---|---|
| T7 | Oak<br><i>Quercus petraea</i> | 11 | 685 | N-7<br>S-7<br>E-6<br>W-6 | 4 | M | 20+ | G | Broad balanced crown. Minor dead wood throughout. No structural faults visible from ground level | | B2 | 8.2 |

| Ref | Tree | Category | Potential Impact of development |
|---|---|---|---|
| T7 | Oak<br><i>Quercus petraea</i> | B2 | Large crown and RPA extending across the field boundary will require protection measures. |

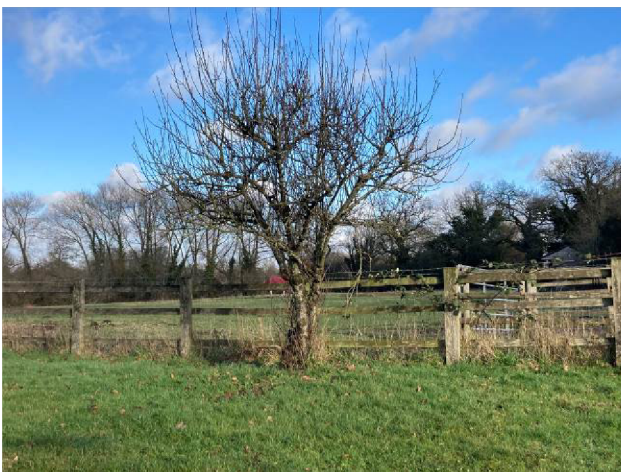
Apple T11

**Apple T11 and Cherry T12** are small specimen trees in the road verge along Chapel Lane adjacent to the western boundary of the survey area.

| Ref | Tree | Category | Potential Impact of development |
|---|---|---|---|
| T11 | Apple<br><i>Malus domestica</i> | C2 | Can presumably be retained in this boundary position. Crown poses no constraint. |

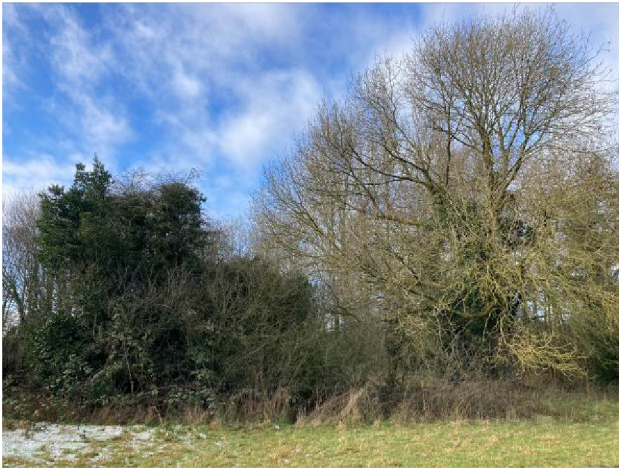
Hedgerow H13 and Ash T14

**Hedge H13 and Ash T14** are positioned in the interior of the survey area at the north end of Chapel Lane extending toward the small stream on the northern boundary. H13 comprises untrimmed Holly and Hawthorn forming a dense thicket. Ash T14 is a very large tree with a broad crown. This tree has a very deep stress fracture running through the centre of the trunk to the main crown junction which is a cause for concern as it is a point of weakness which may result in structural failure of this tree.

| Ref | Tree | Category | Potential Impact of development |
|---|---|---|---|
| H13 | Hedgerow | C2 | Likely to be trimmed back or entirely removed if access is required through this part of the field |
| T14 | Ash<br><i>Fraxinus excelsior</i> | C2 | Likely to be removed as the structural concerns make this tree unsuitable for retention close to buildings or structures |

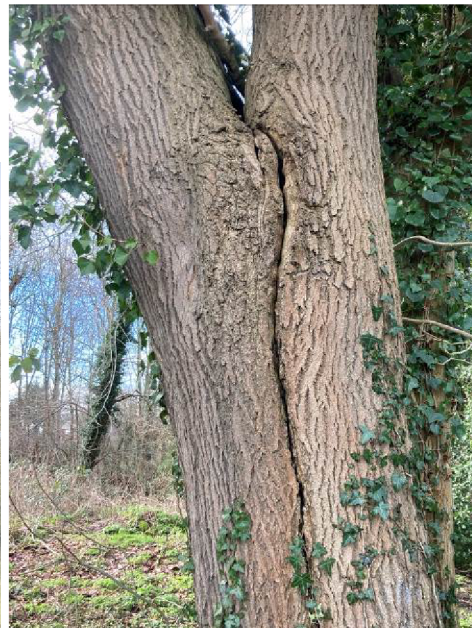
Stress fracture on Ash T14

| Tree No | Species | Ht (m) | Stem Diam mm@ 1.5m | Canopy Spread (m) | Height of Crown Clearance | Age Class | Est yrs | Overall Condition | Structural condition | Recommendations | BS 5837 Category | RPA Radius (m) |
|---|---|---|---|---|---|---|---|---|---|---|---|---|
| T14 | Ash<br><i>Fraxinus excelsior</i> | 18 | 700<br>240 | N-7<br>S-6<br>E-9<br>W-7 | 3 | M | 10 | F | Broad crown extending east. Large stress fracture through centre of trunk. <b>Tree may be structurally compromised in the main trunk.</b> | Consider removal if close to new development. | C2 | 8.8 |

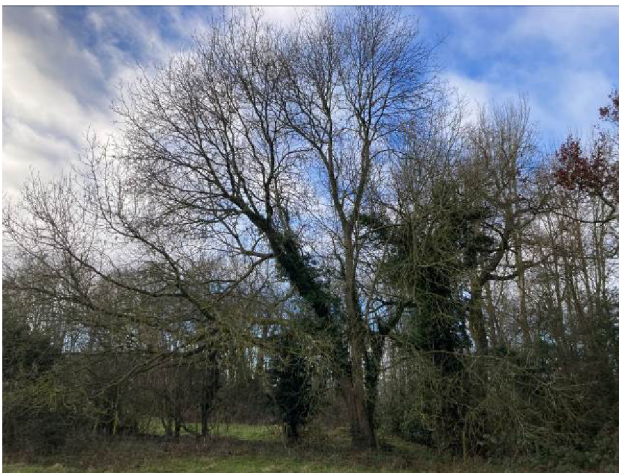
T15 and T16

**Trees T15 – T20** run along the northern and western edge of the field to the north of Chapel Lane. There is significant badger activity in this location and the trees run along the top edge of the flood zone of the stream forming a merging linear canopy. Oak and Sycamore dominate.

| Ref | Tree | Category | Potential Impact of development |
|---|---|---|---|
| T15 | Oak<br><i>Quercus petraea</i> | C2 | Large crown and RPA extending across the field boundary will require protection measures. |
| T16 | Oak<br><i>Quercus petraea</i> | B2 | Large crown and RPA extending across the field boundary will require protection measures. |

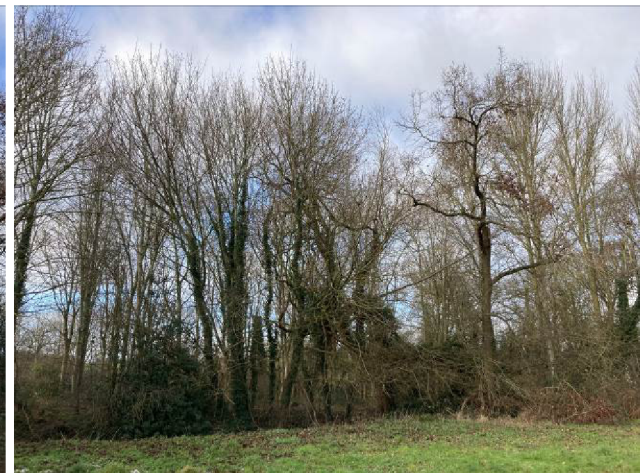
T20 (right) T17-T19 (left)

| Tree No | Species | Ht (m) | Stem Diam mm@ 1.5m | Canopy Spread (m) | Height of Crown Clearance | Age Class | Est yrs | Overall Condition | Structural condition | Recommendations | BS 5837 Category | RPA Radius (m) |
|---|---|---|---|---|---|---|---|---|---|---|---|---|
| T17 | Oak<br><i>Quercus petraea</i> | 12 | 325 | N-6<br>S-<br>E-<br>W- | 5 | SM | 10 | P | Leader lost at 7m. Irregular remaining crown extending east. <b>Lost leader may allow decay into the trunk interior.</b> | Consider removal if close to new development. | C2 | 3.9 |

| Ref | Tree | Category | Potential Impact of development |
|---|---|---|---|
| T17 | Oak<br><i>Quercus petraea</i> | C2 | Crown and RPA extending across the field boundary will require protection measures. |

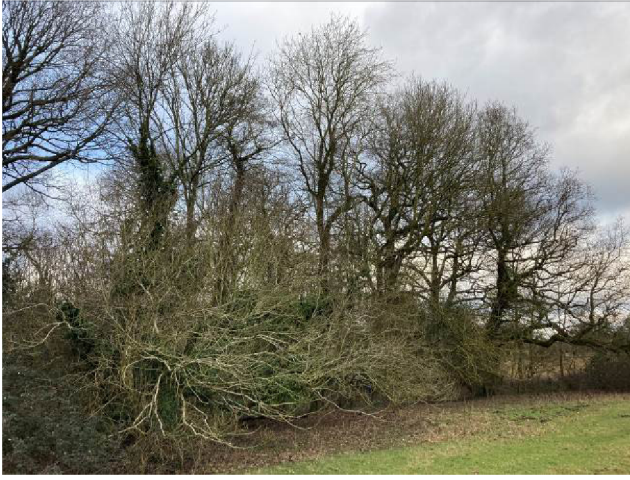
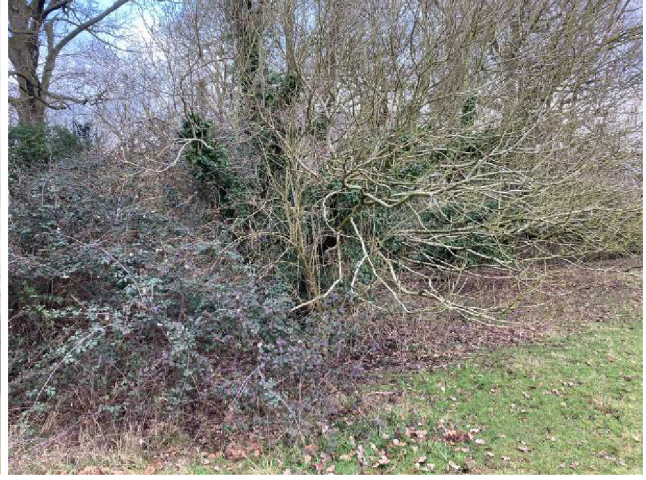
T22 – T25

**Trees T201 – T27** run along the northern edge of the field where the ground starts to fall towards the river. These trees form a linear canopy line, quite dense in places, with Oak dominating and occasional Ash present. There is dense Holly, Hawthorn and Blackthorn under canopy along the field edge.

| T22 | Ash<br><i>Fraxinus excelsior</i> | C2 | Large crown and RPA extending across the field boundary will require protection measures. |
| T23 | Oak<br><i>Quercus petraea</i> | B2 | Large crown and RPA extending across the field boundary will require protection measures. |
| T24 | Oak<br><i>Quercus petraea</i> | B2 | Large crown and RPA extending across the field boundary will require protection measures. |
| T25 | Ash<br><i>Fraxinus excelsior</i> | B2 | Large crown and RPA extending across the field boundary will require protection measures. |

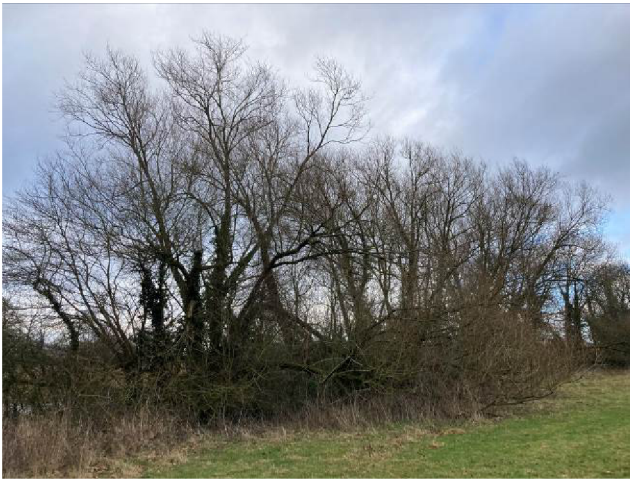
Crack Willow G28

Along the north eastern edge of the field is a line of dense **Crack Willow G28**. These trees have significant fallen timber and the crown along the south side has dropped to ground level and extend some distance into the field interior.

| Tree No | Species | Ht (m) | Stem Diam mm@ 1.5m | Canopy Spread (m) | Height of Crown Clearance | Age Class | Est yrs | Overall Condition | Structural condition | Recommendations | BS 5837 Category | RPA Radius (m) |
|---|---|---|---|---|---|---|---|---|---|---|---|---|
| G28 | 5 x Crack Willow<br><i>Salix fragilis</i> | 20+ | <750 | Varies up to 9m south | 0 | OM | 20 | F | Liner of dense Willow merging along stream edge. Significant fallen wood on the south side with branches lying on the ground along the field edge. Large, cracked branches of structural concern. | Remove dead wood and trim back crown. | B2 | 9.0 |

| G28 | 5 x Crack Willow<br><i>Salix fragilis</i> | B2 | Likely to require dead wood and low branches to be removed. RPA and canopies will require sufficient space to protect any new structures. |
