## *Structural Inspection Building 1*

Project: ***Red House Farm  
39 Main Road  
Ratcliffe Culey  
Atherstone  
CV9 3NY***

Project No: ***24-21204***

Document No: ***0-030***

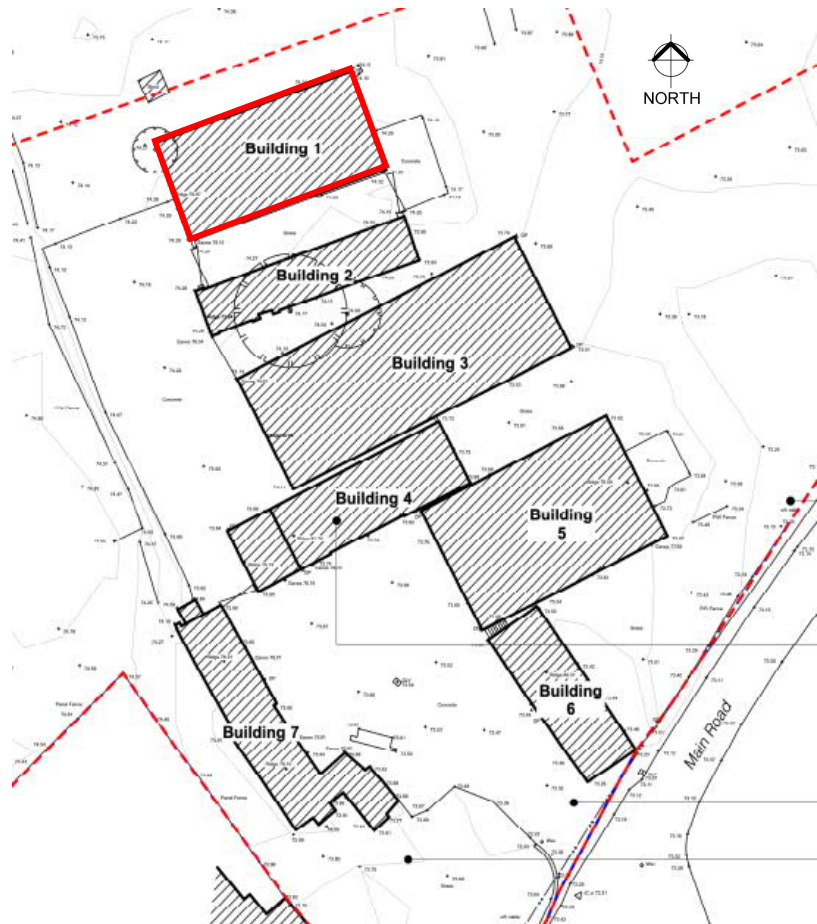
Figure 1

2.1 Building 1 is located to the rear of the farm complex. [Figure 1]
