## *Structural Inspection Building 5*

Project: ***Red House Farm  
39 Main Road  
Ratcliffe Culey  
Atherstone  
CV9 3NY***

Document No: ***0-033***

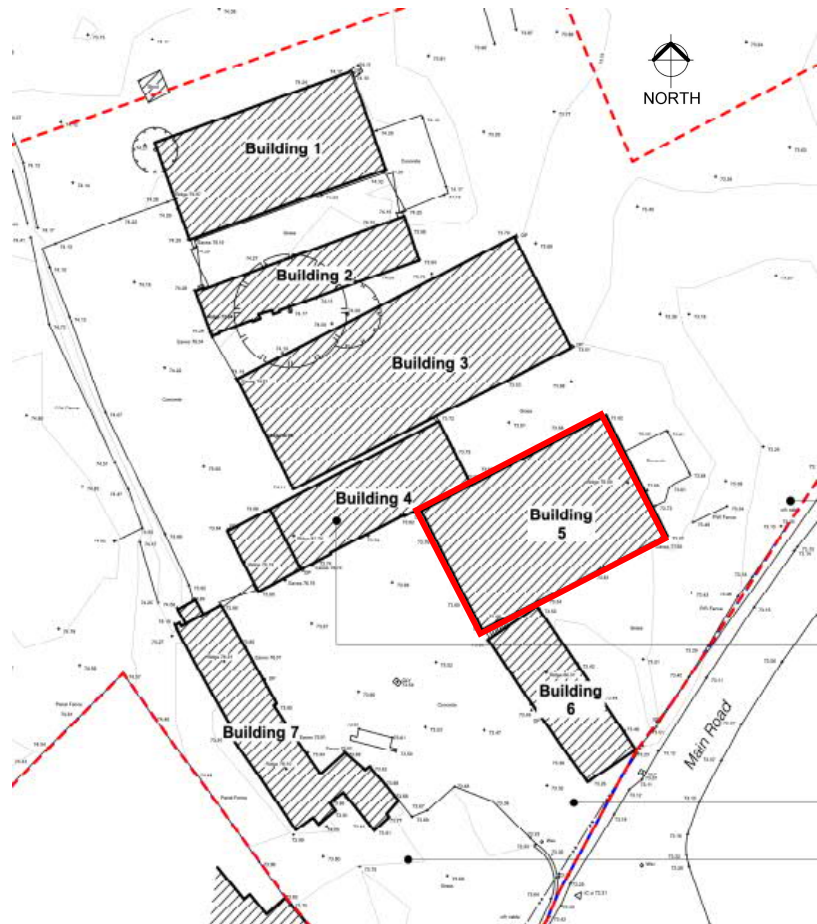
Figure 1

2.1 Building 5 is located to the rear of the farm complex. [Figure 1]
