# **PRELIMINARY ROOST ASSESSMENT REPORT**

Moor Barns Farm,  
Pipe Lane,  
Orton-on-the-Hill,  
Atherstone  
CV9 3NF

1631-PRA-V1-A

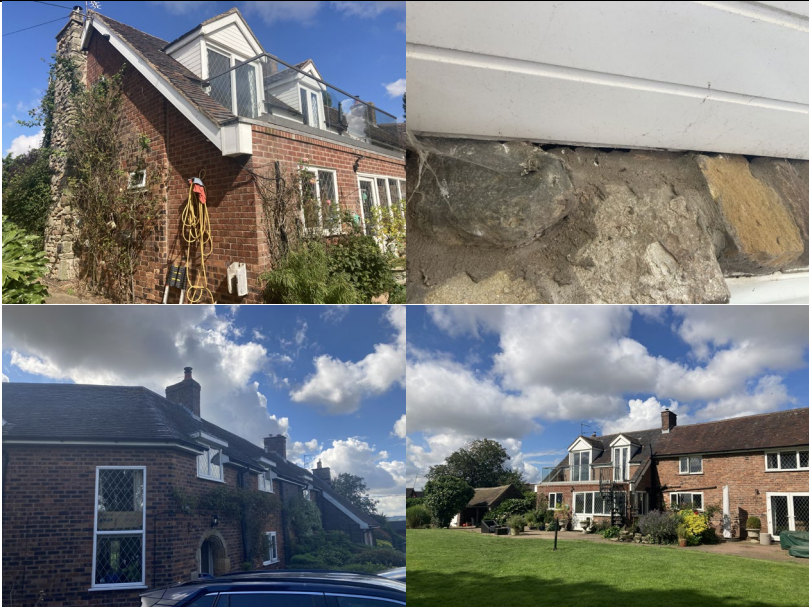
| Feature | Photograph |
|---|---|
| Building 1 external | |

- 3.1.3. B1 comprises a two-storey residential dwelling which is currently in use. An extension was located on the southern aspect, which including two dormer windows and a balcony. Windows and doorways were present across much of the building, which were flush to the brick work. The dormer windows were sealed with plastic finishes, with no PRFs or access points. The brick work was also in good condition, with no PRFs, and no missing mortar on the northern and southern gable ends.

- 3.1.4. The roof was pitched with which had multiple lifted tiles across its extent which may provide a PRF or internal access to the loft (where felt was ripped internally). Mortar was missing at multiple ridge tiles which may provide a PRF. Gaps were observed between the brick and overhanging eaves on many aspects (minus the eastern aspect) which may provide a PRF or potential access points.

- 3.1.8. **Due to the number of PRFs and potential access points observed, the building was assessed as having moderate bat roosting potential.**

- 4.1.1. B1 and B3 were assessed as having moderate bat roosting potential. Therefore, in accordance with Best Practice guidance (Collins, 2016) further nocturnal emergence/ re- entry surveys should be undertaken between May-September (inclusive) to determine usage by roosting bats (depending on the extent of development works). A minimum of one survey should be undertaken between May – August to capture the maternity season.

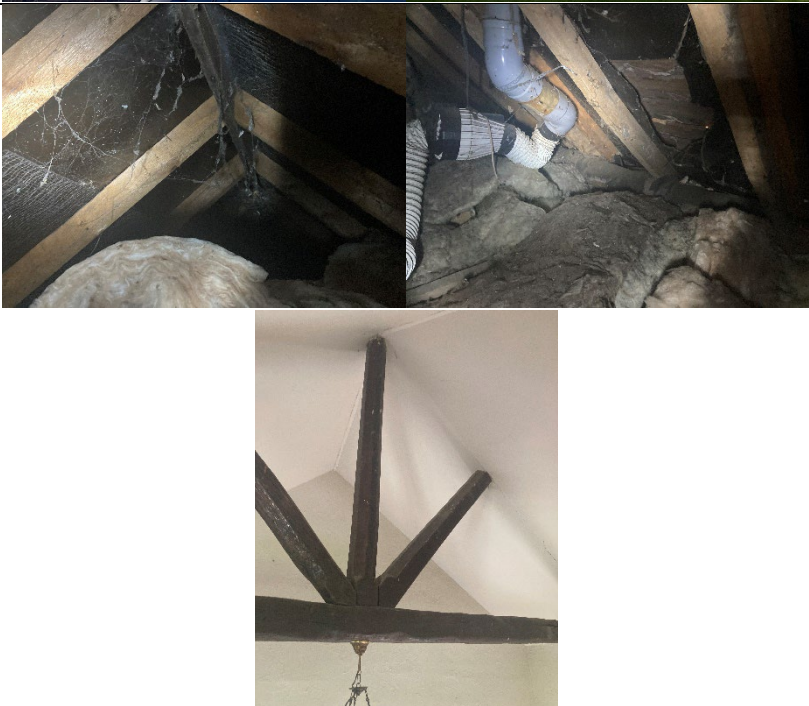
| Feature | Photograph |
|---|---|
| Building 1 internal | |

- 3.1.5. Internally, the rooms were used for residential purposes, where on the upper floor, some aspects of the ceiling were vaulted and covered in plaster board and painted. Three lofts were present, two of which were inspected. The loft height was approximately 1-1.5m tall and lined with roofing felt, with exposed supporting wooden beams.

- 3.1.6. The northern loft area was generally in good condition, with no obvious ripped areas of felt and no light gaps to indicate potential access points observed. Extensive piles of mouse and rat droppings were observed, making it difficult to identify if bat droppings were present, but none were found.

- 3.1.7. The central loft area was of similar size and specification as the northern loft area. A section of ripped roofing was identified on the western aspect of the roof which may provide a potential access point for bats into the loft area. No bat droppings were observed, however due to the number of mouse and rat, it couldn't be ruled out.

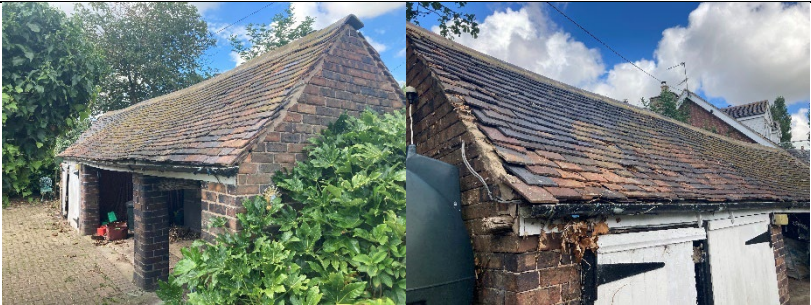
| Building 2 external | |

- 3.1.9. B2 comprised a single storey garage/ storage shed. It was approximately 2.5-3m tall and constructed of red brick with a pitched, clay tile roof. It was open on the eastern aspect which will provide open access to the internal aspect. No crevices were identified within the external brick work and no PRFs were noted. The roof was in poor condition, with multiple lifted and slipped tiles which would provide internal access.

- 3.1.11. **Due to no PRFs observed internally or externally, and no field signs, the building was assessed as having negligible bat roosting potential.**

- 4.1.4. B2 was assessed as having negligible bat roosting potential and will not require any further surveys or mitigation relating to bats.

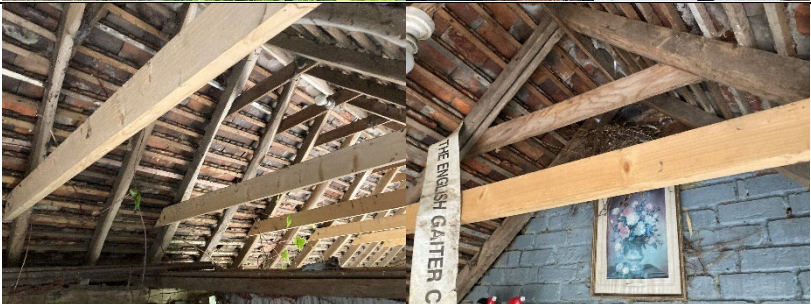
| Building 2 internal | |

- 3.1.10. Internally, the brick work and slate tiles were exposed, with the wooden supporting beams. No roofing felt was present across its extent. A single pigeon nest was noted. An inspection for PRFs internally was completed where no suitable crevices were observed and due to being open on the eastern aspect, the building likely provides limited cover.

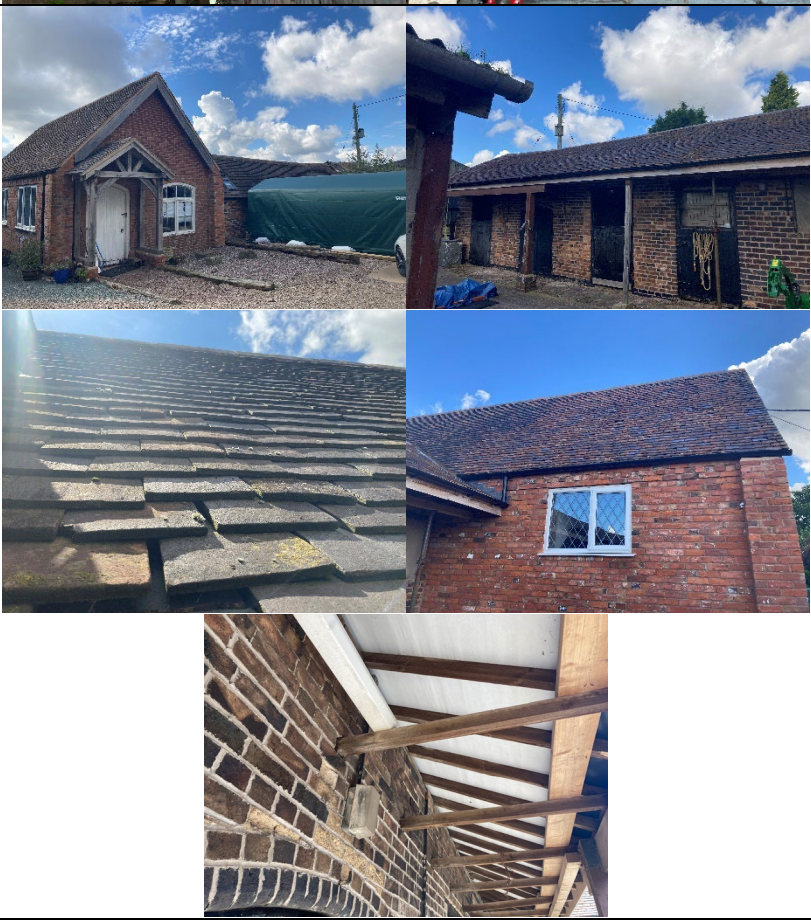
| Building 3 external | |

- 3.1.12. B3 comprised a single storage stable which had partially been renovated by the previous owner, which included re-roofing works. It had a pitched roof constructed of clay tiles in which multiple were lifted which may provide a PRF or potential access point across the roof structure. Generally, the mortar at the ridge tiles appeared in good condition, with no missing sections observed from the ground and mortar was sealed on all gable ends.

- 3.1.13. The overhanging beams on the gable ends had a gap between the beams and brick work which may provide an access point or a PRF to between the tiles and internal roofing felt.

- 3.1.14. The external brick work was in good condition, with no crevices observed across its extent.
- 3.1.15. An entrance canopy was located to the north of the site. It was pitched with a tile roof, where tiles were lifted, which may provide a PRF between the cavity of the tiles and underside boarding. A gap between the brick work and canopy structure was observed which may provide a PRF.

- 3.1.18. **Due to the number of PRFs and potential access points observed, the building was assessed as having moderate bat roosting potential.**
- 3.1.19. Please refer to Table 2 for photographs.

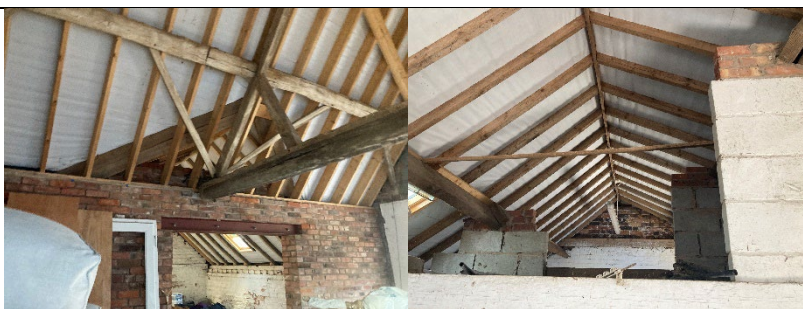
Building 3 internal

- 3.1.16. Internally, the eastern aspect was subject to the recent renovation works where an internal breeze block wall was present providing a cavity between the external wall and the internal wall and will be suitable for bats. Insulation was observed in the cavity, but it still may provide a PRF. The supporting roof beams were mainly new, and mortar was located around the beams were placed in the walls and won't provide a PRF. However, some older beams were present, where cracks in the beams may provide a PRF. The roofing felt was exposed whilst no crevices in the brick work was identified across the internal aspect. A nesting pigeon was observed on the internal beam during the survey.

- 3.1.17. The stables on the western aspect also had recent re-roofing works and of similar structure as the eastern aspect. Multiple access points to the internal via gaps above the brick wall and the roof. Limited PRFs were identified due to mortar missing in some brick work which may provide a crevice. No cavity walls identified. Possible feeding remains were identified due to a butterfly wing, but this may relate to birds foraging.
