27 July 2023  
Ref: P2802 / 260723

Further to my inspection of the tree on the property at Wharf Farm, Shakerstone, owned by Mr W Naylor, I provide details of the Horse Chestnut situated very close to the existing building which is being considered for demolition and redevelopment. The table below provides details of this tree and I have also provided a plan showing the location of this, canopy extents and the calculated root protection area.

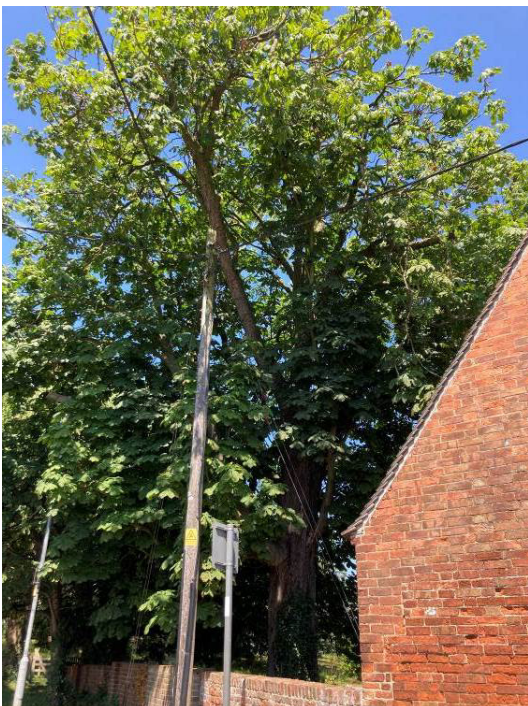
View of tree from south east

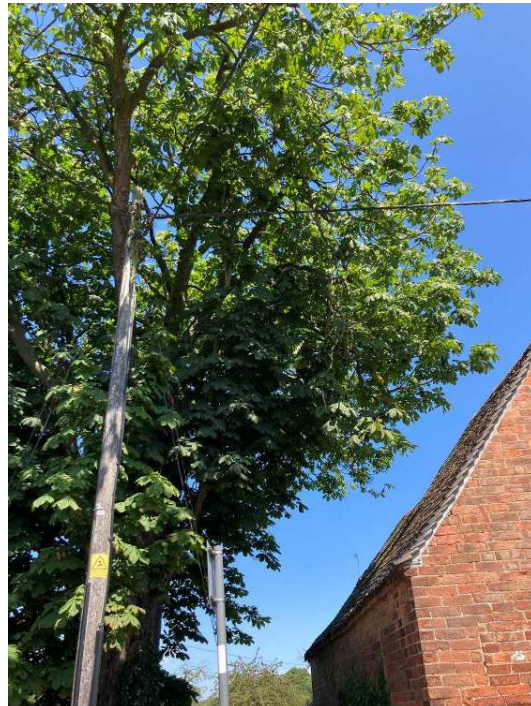
View of tree and pole from south

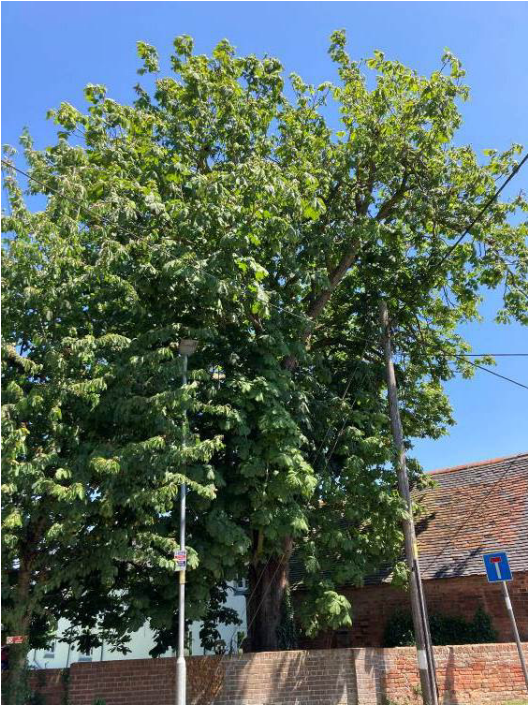
View of tree from south west

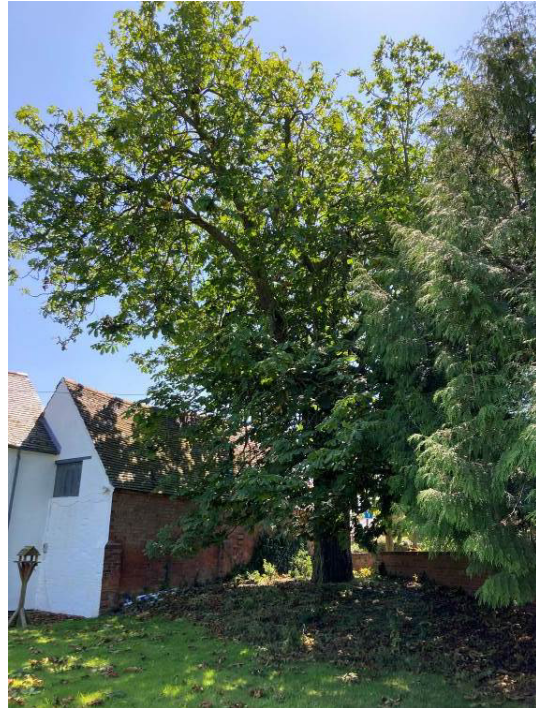
View of tree from north west

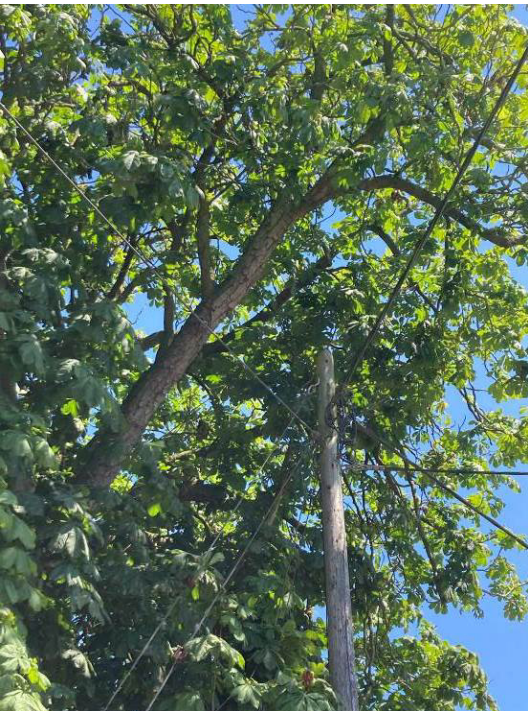
- a) There is some evidence of canker, albeit not advanced, on the main trunk as photographed below. This disease will weaken the entire tree as it progresses and is often the cause of death for many Horse Chestnut.
- b) The tree is showing significant signs of stress in the form of die back in fresh growth around the canopy extremities. This may be from the canker but is just as likely to be a combination of the rust / leaf minor infection, and the combined seasonal trimming that has taken place to remove limbs and branches from the telephone pole very close by.
- c) As a result of the above, I am not convinced this tree has a minimum of 20 years of useful life remaining. If retained, it would continue to require trimming to protect the telephone pole and avoid the crown coming into contact with the roof of the building which it overhangs.

Severe trimming around telephone pole

If the tree is retained, there will be pressure to reduce the crown as a result of risk from overhanging branches. This crown is already unbalanced and irregular due to the removal of large areas around the telephone pole. It would be reasonable to consider a more balanced reduction of the crown by around 2m on the eastern and northern sides which will remove the canopy overhanging the roof of the building and improve the balance and shape of this tree. Such work would have to be completed by a suitably qualified and professional arboricultural contractor and cannot be undertaken without the permission of the Planning Authority.

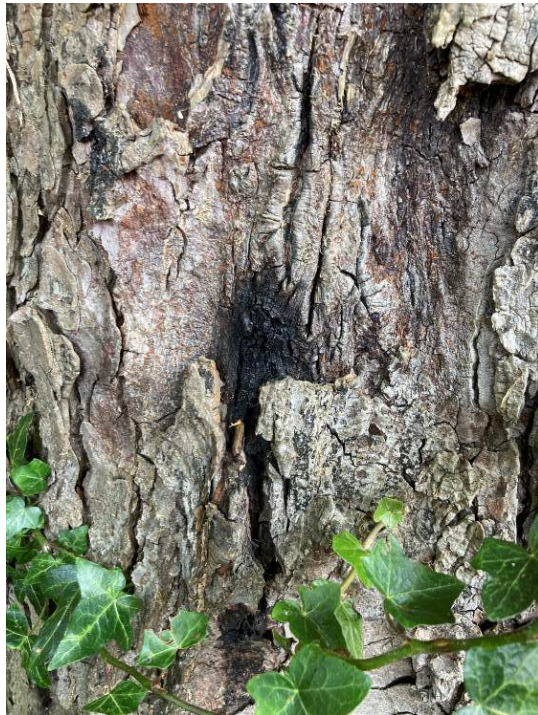
Canker present on trunk

Alternatively, taking into consideration the condition and location of this tree and the likelihood that pruning will continue to take place in the future to ensure the telephone pole and wires attached to this are not impacted or compromised, there is an argument in favour of removing this tree completely and replacing it with a new tree. This could be conditioned as part of any planning approval granted for the demolition / construction being proposed. It would address concerns about impact on the telephone pole and falling branches and provide a longer-term solution to maintaining canopy cover in this location. If the tree is starting to decline due to disease, stress and past cutting back, as appears to be the case, then this decline may only accelerate.
