Structural Inspection Building 4

*Red House Farm
39 Main Road
Ratcliffe Culey
Atherstone
CV9 3NY*

24-21204

0-032

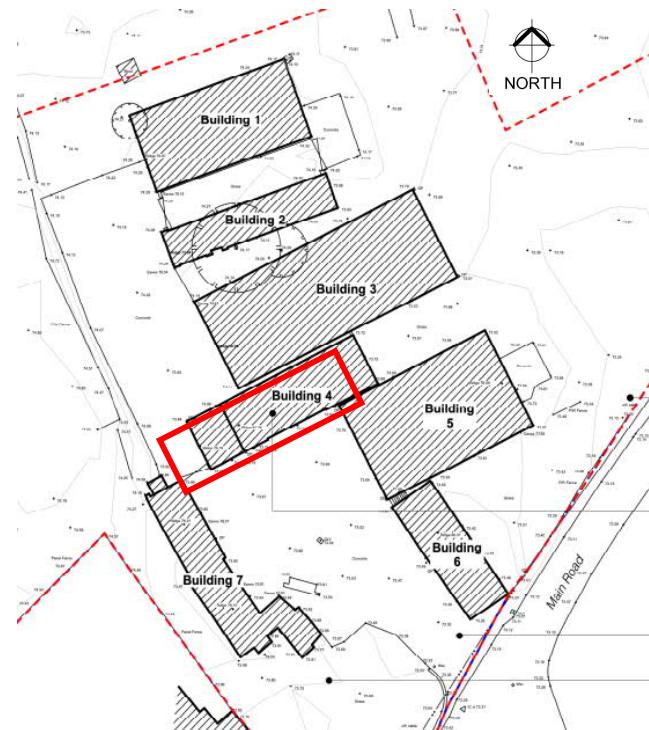
Figure 1

2.1 Building 4 is located towards the centre of the farm complex between two further, newer buildings and a temporary accommodation unit. [Figure 1]
