**Re: Swedish Cottage, Earl Shilton – Percolation Testing To Assist With Soakaway Design**

The following report presents the findings of site works undertaken on 16th April 2026 and details the results of the percolation testing. Site location and exploratory hole location plans are provided in **Appendix A**.

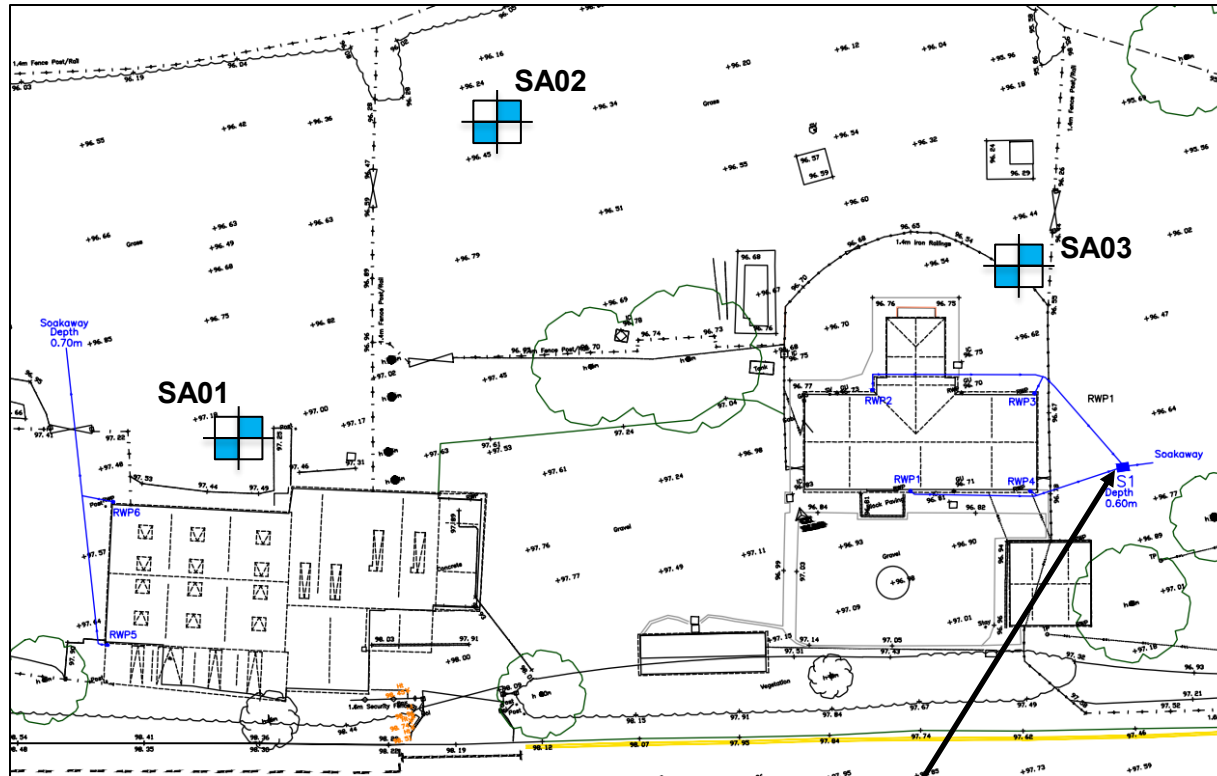
Figure 3

request, the chamber was filled and tested. Based on the observed results, an indicative drainage rate of  **$9.50 \times 10^{-5} \text{m/s}$**  has been calculated for the existing drainage system. This value reflects the performance of the existing system only and is not representative of the surrounding ground conditions. The size, extent, and construction of the existing drainage system are unknown.

Existing drainage  
chamber that was  
tested.

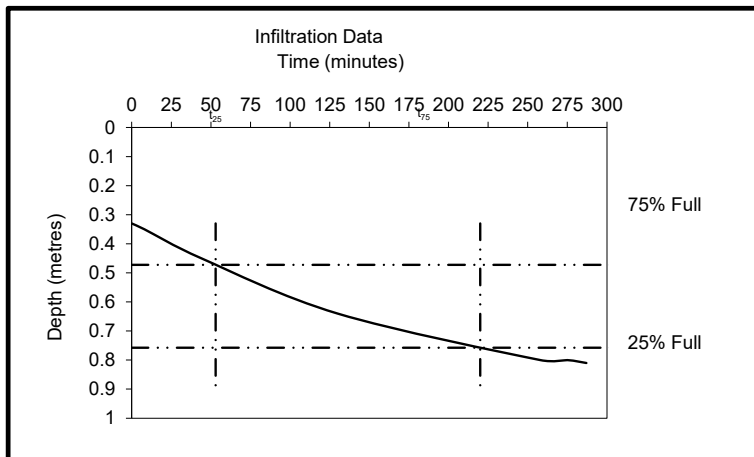
Trial Pit No.: SA02

In summary, insufficient infiltration was recorded within the natural cohesive deposits, and these are therefore not considered suitable for soakaway drainage. While infiltration was recorded within the made ground (SA02), the rate is low, and soakaway construction within made ground is generally not recommended due to potential variability and the risk of mobilising contaminants.

$$\text{Soil Infiltration Rate: } i = \frac{V_{p75-25} \times N}{a_{p50} \times t_{p75-25}} = 8.90\text{E-}06 \quad f_{\text{run1}} = \frac{8.90 \times 10^{-6}}{\text{m/s}}$$
$$\text{or } = 3.21\text{E-}02 \quad \text{or } \frac{3.21 \times 10^{-2}}{\text{m/hr}}$$

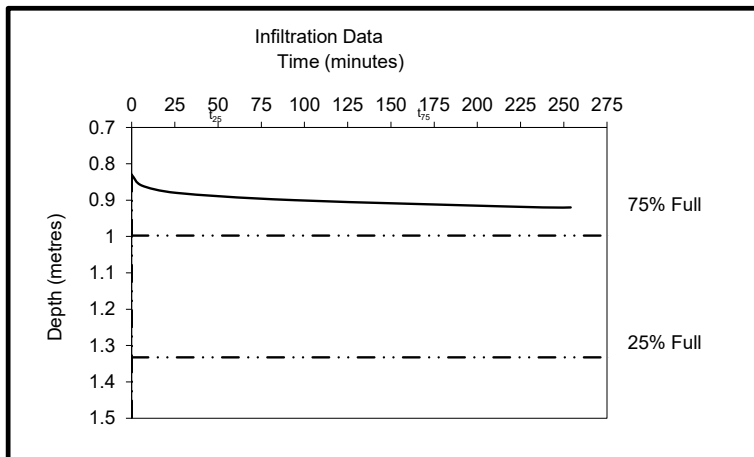
**Trial Pit No.: SA03**

Water did not sufficiently dissipate during test period. Therefore the soils at this locality are not considered to be suitable for soakaway drainage.
