K C & D A Hughes  
Clare's Barn Farm  
Twycross  
Warwickshire  
CV9 3PG

## **Report on visual structural survey of barn**

**Survey date: 09 May 2022**

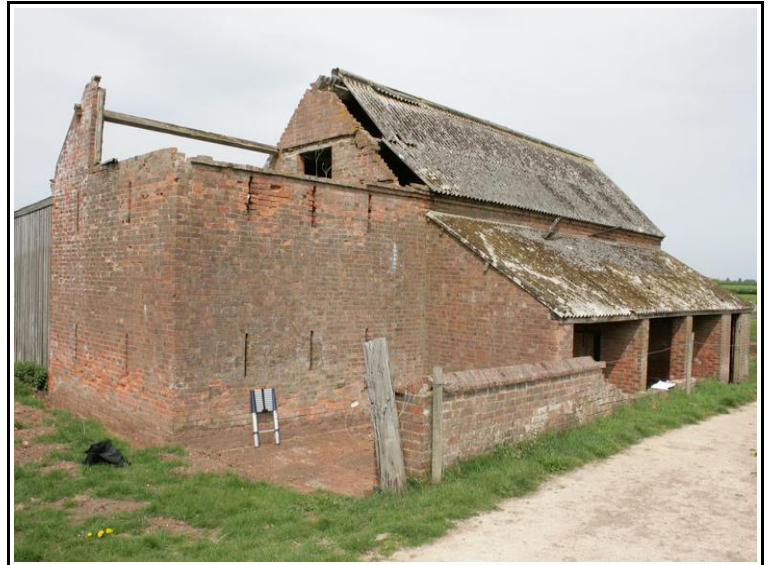
3.1 With the exception of a small area within the main barn, all of the walls have been formed with 9" solid brickwork in predominantly stretcher bond, with some headers seen. The piers forming the front elevation are generally 2.0 x 1.5 bricks in section, as seen on the right of the general view in photograph 3.1.

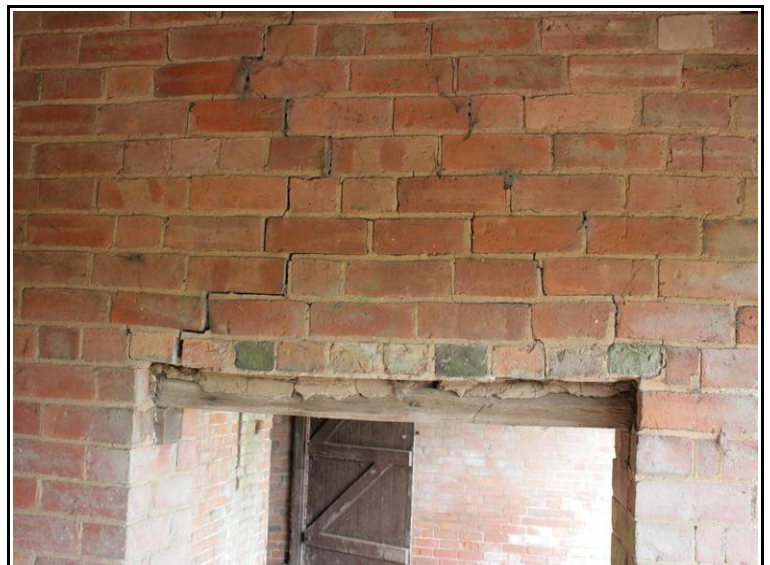
3.3.1 Timber lintels have been used for some of the openings, and are either missing or are in a poor condition. The timber lintel over the dividing wall in the front lean-to section is an example where the lintel is sagging, and the brickwork over has cracked as a result of this sag. See adjacent photograph (3.2).

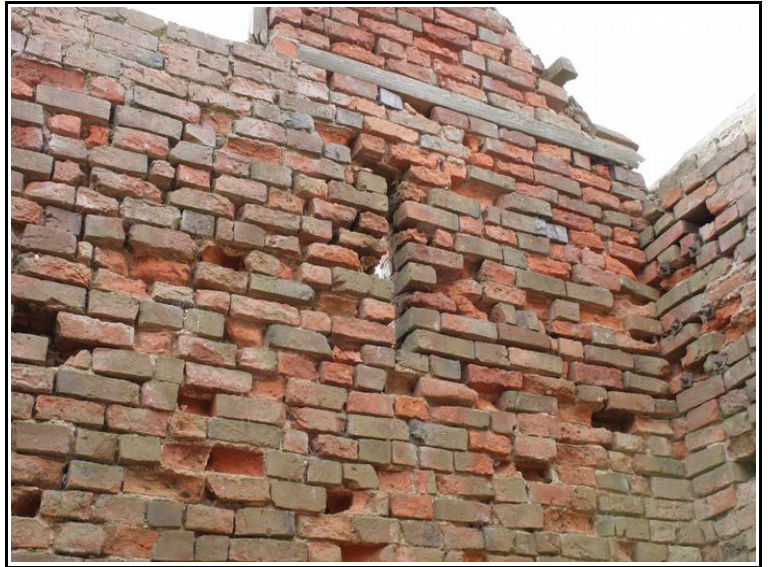
3.3.2 There is evidence of frost damage to the brickwork in some areas, and this is most pronounced in the room next to the south-facing side elevation. Photograph 3.3 is an internal view, and photograph 3.4 is an external view of the same wall.

Frost damage normally occurs at the base and head of walls exposed to wetting and frost action, and it is possible that the bricks used on this part of the barn were reclaimed from another building, and re-used here, with the least affected facings used externally.

Although there are other areas of frost damage, these are much more localised, as the bricks generally are in good condition. Some re-building will be required to replace this section of the barn to achieve structural integrity.

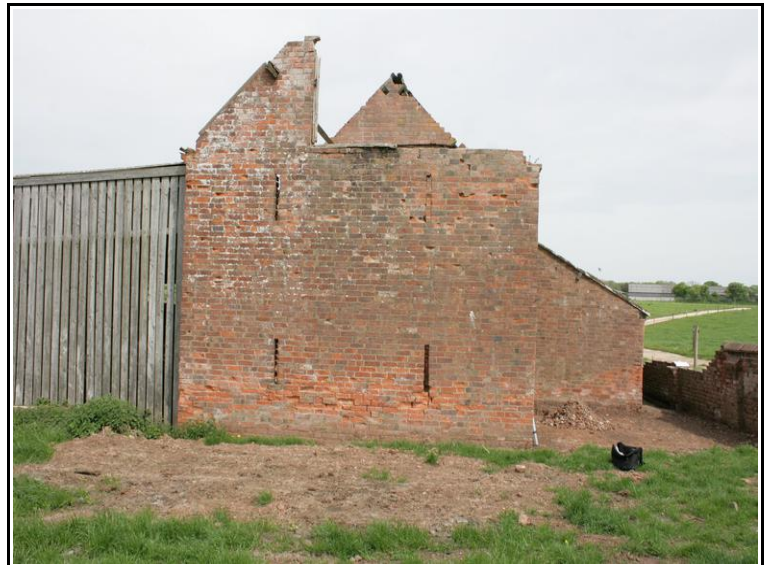
3.4

3.3.3 The mono-pitched section at the south-east corner (at the right of the above image) has moved relative to the main barn, with a crack seen at the junction, together with dipping of the brick coursing and further associated cracking. This may be due to settlement, and some local re-building may be needed here. The opposite (north-east) junction of this lean-to section with the main barn has been formed with toothed bricks, and there is very little evidence of movement in this location.

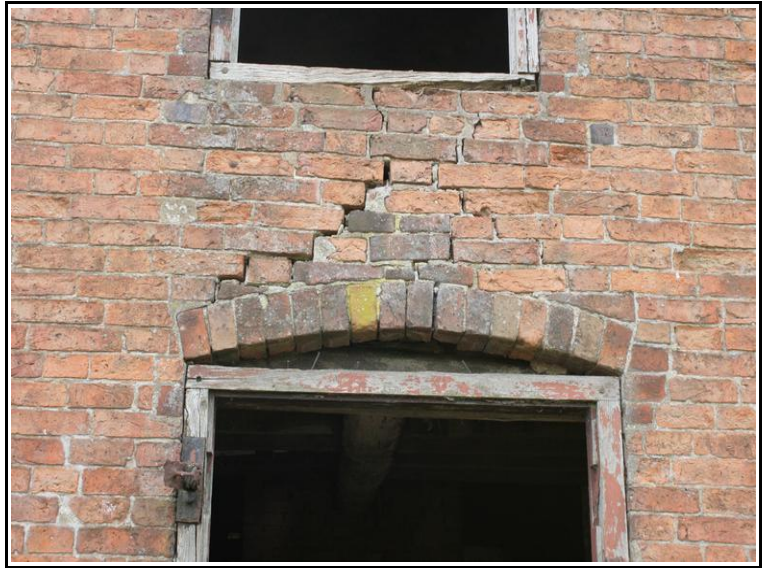
3.5

3.3.4 Arched lintels have been used for some of the openings, and a few of these are in a poor condition with sagging brickwork and cracking over. See adjacent photograph (3.5) for a typical example.

Localised rebuilding or repair will be required to these elements.

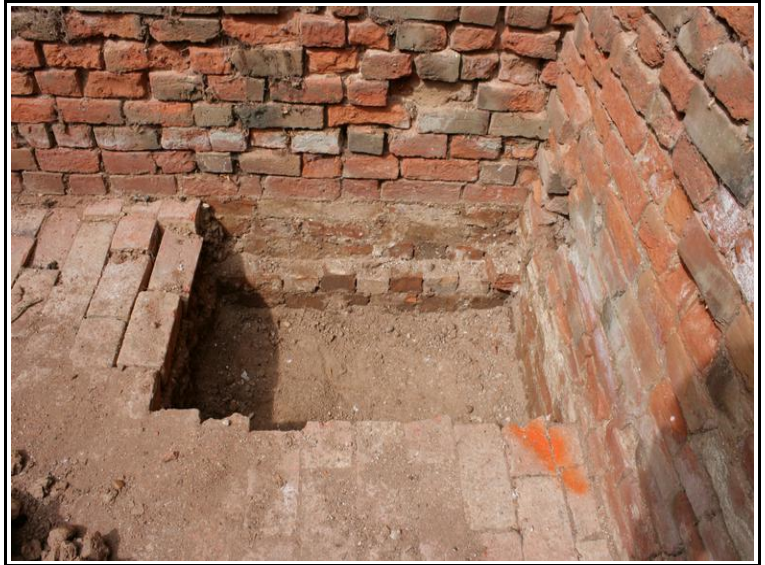
3.6

3.5.3 Trial pit 04 was dug at the junction of an internal and external wall, and can be seen in photograph 3.6. The external wall foundation (rear of image) can be seen, but there does not appear to be an internal wall foundation (right of image). Note also the brick flooring.

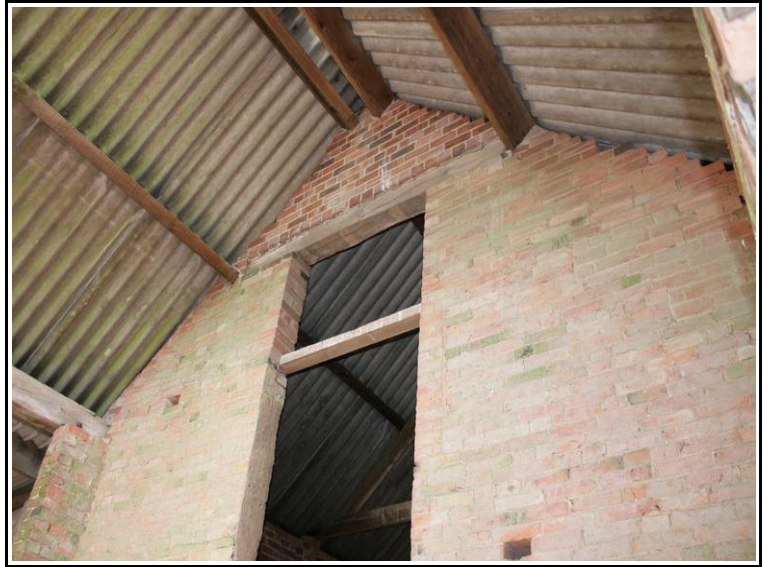
3.8 Some localised strengthening may be required to support the likely increase in permanent load, necessary to achieve thermal performance for use as a dwelling. The adjacent photograph 3.7 shows the general roof structure of the main barn, with a typical example of the sound construction of the internal walls.

Note the re-built triangular brick section, presumably added when the roof was renewed.

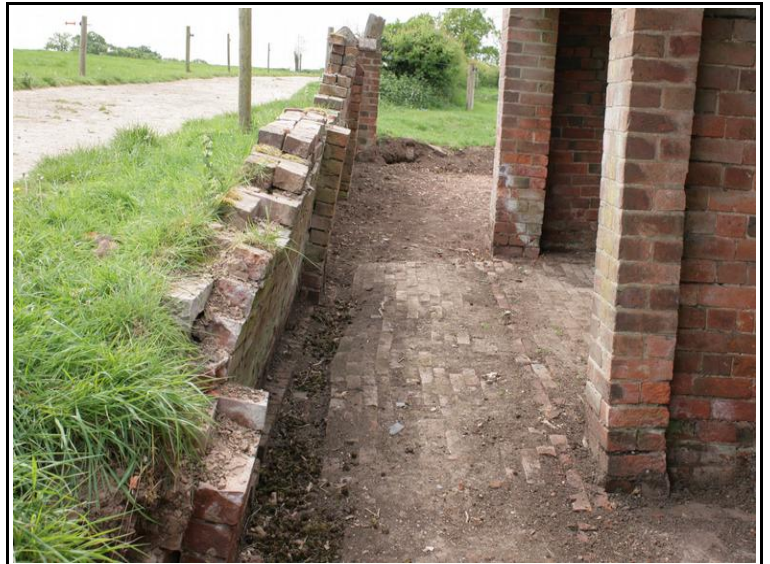
3.8

3.9 A retaining wall is present on the east side of the property. The purpose of this wall is to support the adjacent farm track, which is around 1.0m above the level of the barn. This wall is of solid brickwork construction and is in very poor condition. This wall (on the left of the image 3.8) will require re-building.

Note the good condition of the barn walls generally.

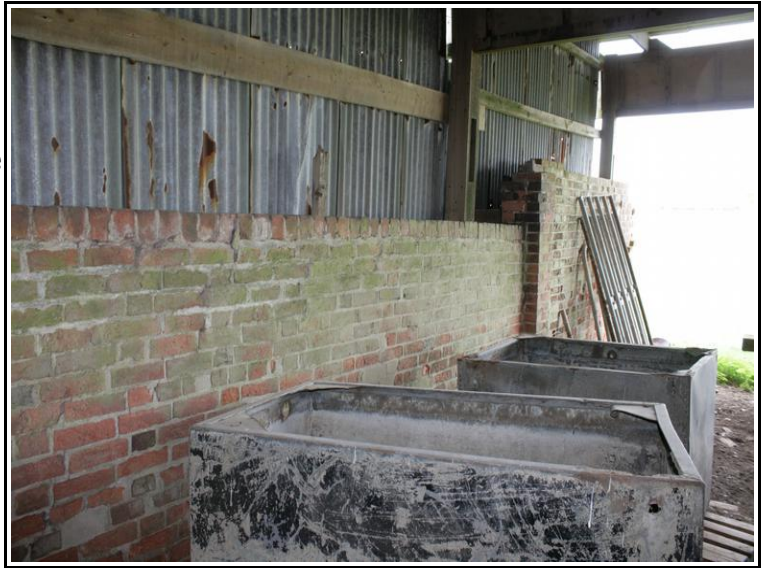
3.9

3.10 A solid brick wall is present on the west side of the building, forming part of the open barn. This wall is generally in good condition (see photograph 3.9), but the foundations were not exposed.
