# Preliminary Roost Assessment

23 Newbold Road  
Desford  
Leicestershire  
LE9 9GT

For  
Uzima Limited

# Gritstone Ecology

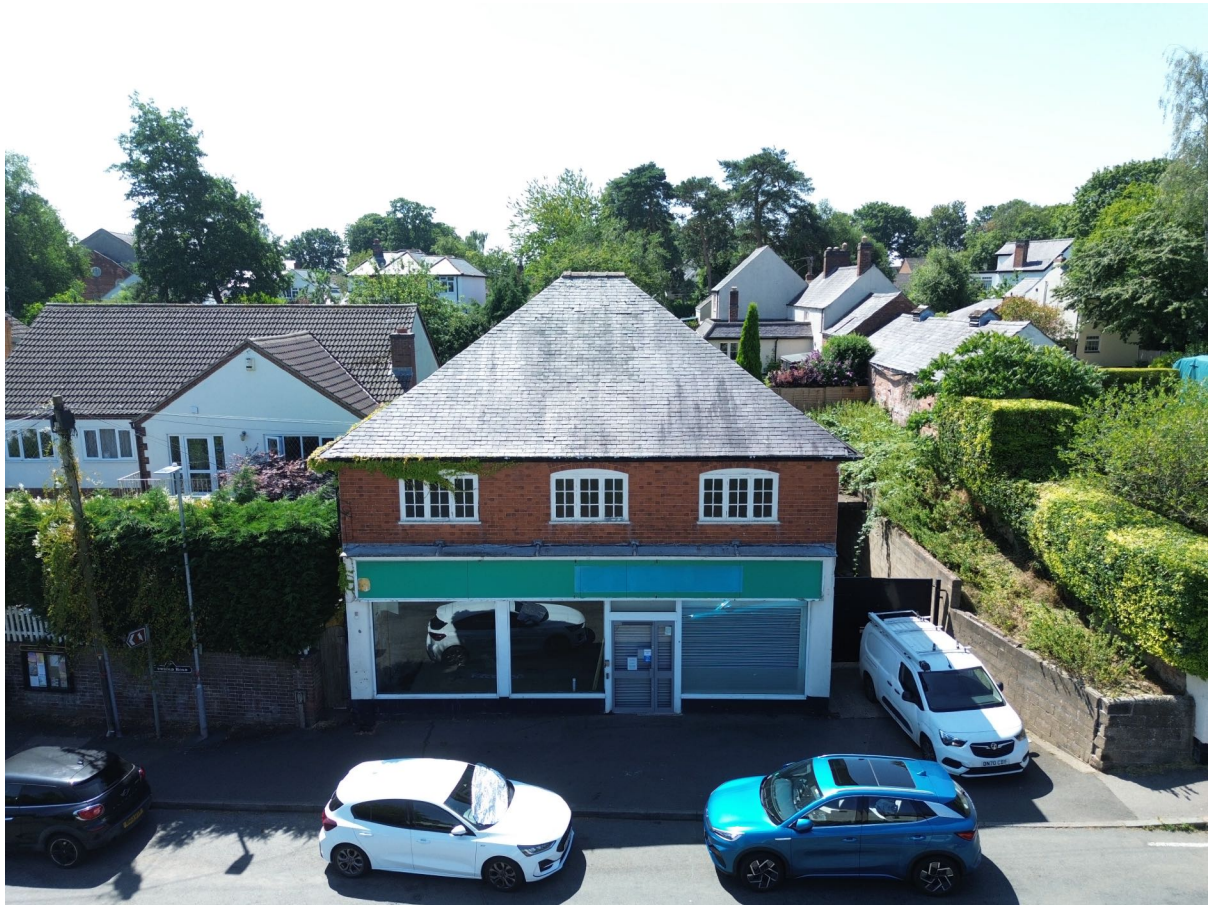
3.1a – The front of the house.

Nº23 Newbold Road, Desford, is a pre-1950's built detached former retail store, which is currently unoccupied, and has been empty for approximately six months. It has a pitched, hipped, roof, covered with slate roof tiles, and ceramic ridge tiles. A ground floor extension to the rear has a flat felt-covered roof with parapet walls. A covered area to the side side has a flat felt-covered roof.

The building is well maintained, and in good condition. Ridge tiles are fixed tightly, there are no damaged or missing ridge tiles. There are no missing roof tiles. Roof tiles are tightly fitted, with no viable gaps between tiles. Fascia boards and boxed soffits are fitted tightly against the walls with no viable gaps. Walls are in good condition, with no missing mortar or cracks.

There are no features externally which are likely be used by roosting bats, and no indications of use by bats were present during the inspection.

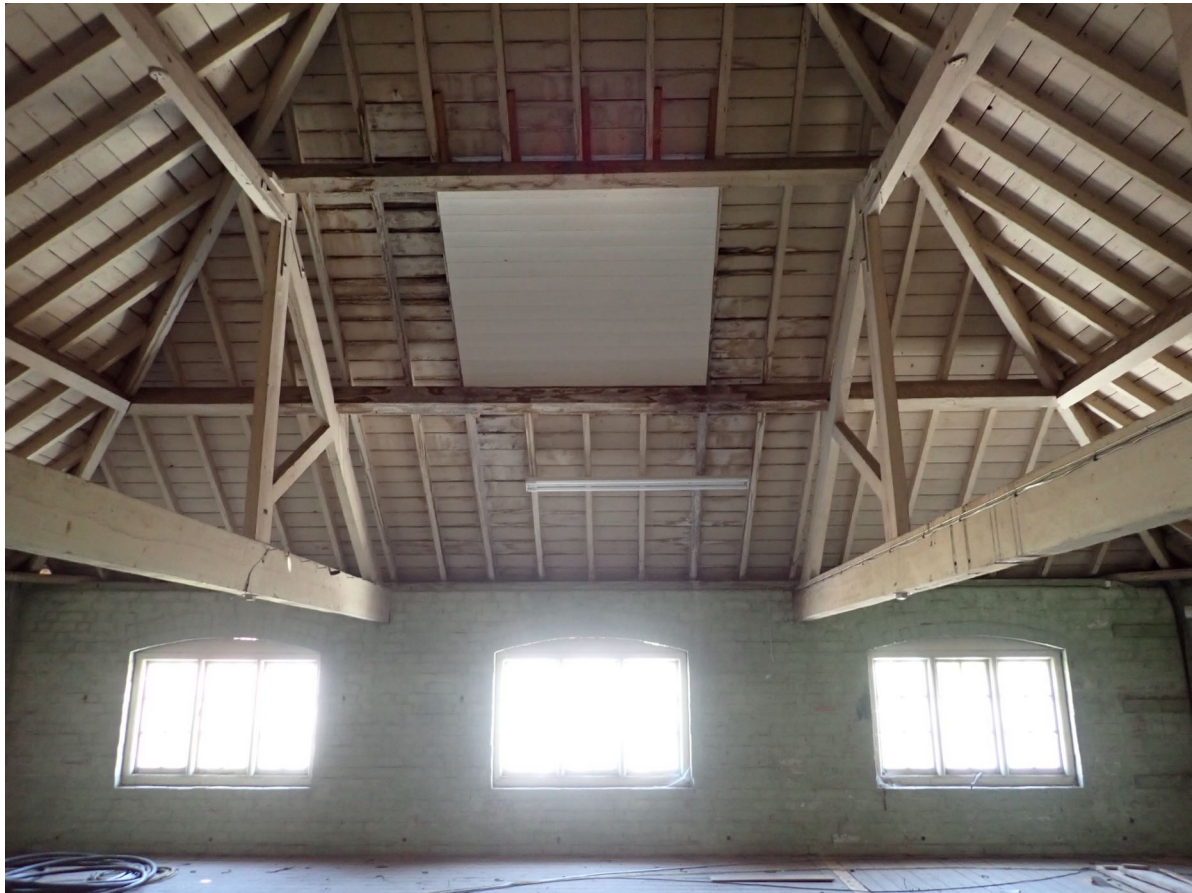
3.2a – The roof void.

The main roof of the building has no enclosed roof void, and is open from floor to apex. The roof has a timber rafter and purlin structure, with supporting timber trusses and painted sarking boards. The roof is not lined with bitumen felt or insulated. The roof is in good condition with no obvious gaps between materials. The first floor was formerly used for storage, and is well lit by natural light.

There is a small enclosed roof void to the rear of the building, which has a single pitched slate tiled roof. The roof is not lined or insulated, and the underside of roof tiles and timbers is exposed. At the time of inspection the void had been undisturbed for a number of years, and was filled with dusty cobwebs.

The wall plate and the inside of boxed soffits were inspected using a torch and endoscope. There are no viable gaps at the eaves; and there are no gaps which give direct access to the building from the outside.

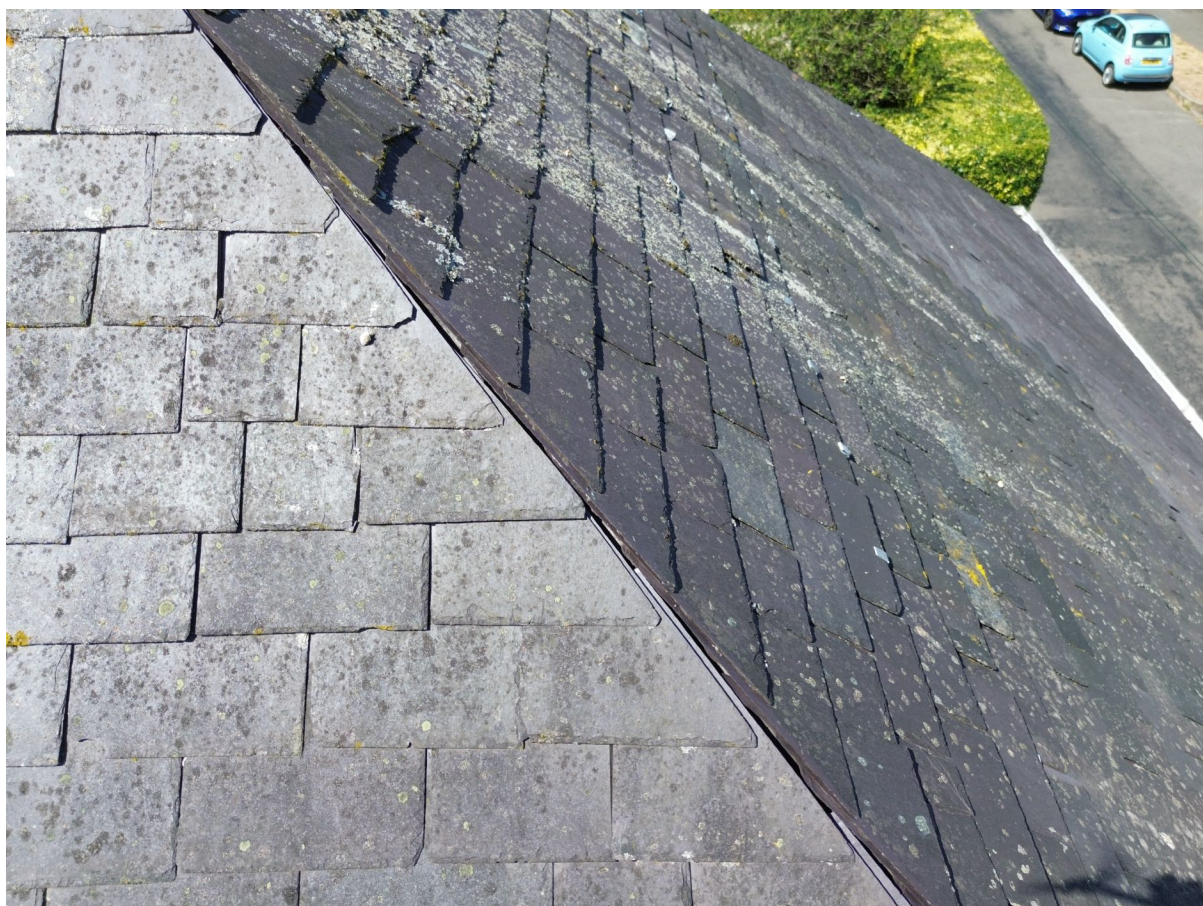
Roof and ridge tiles are in good condition; ridge tiles are sealed with cement. There are no gaps between roofing materials which are likely to be used by roosting bats.

3 – Roof and ridge tiles are in good condition with no suitable gaps.

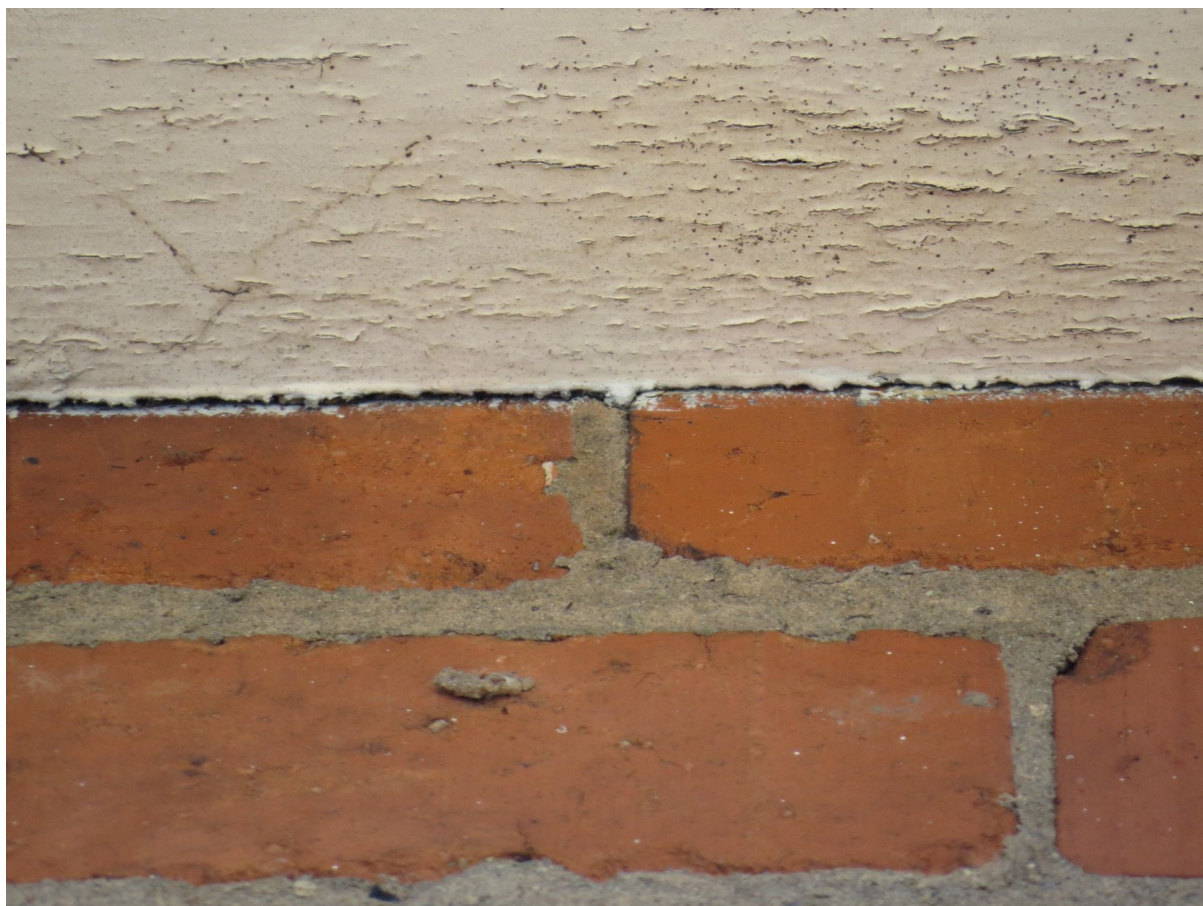
Fascia boards and boxed soffits at the eaves are fixed tightly against brickwork, with no suitable gaps; boxed soffits open into the roof void, and were inspected from above.

4 – Fascia boards and soffits at the eaves are fixed tightly against brickwork.

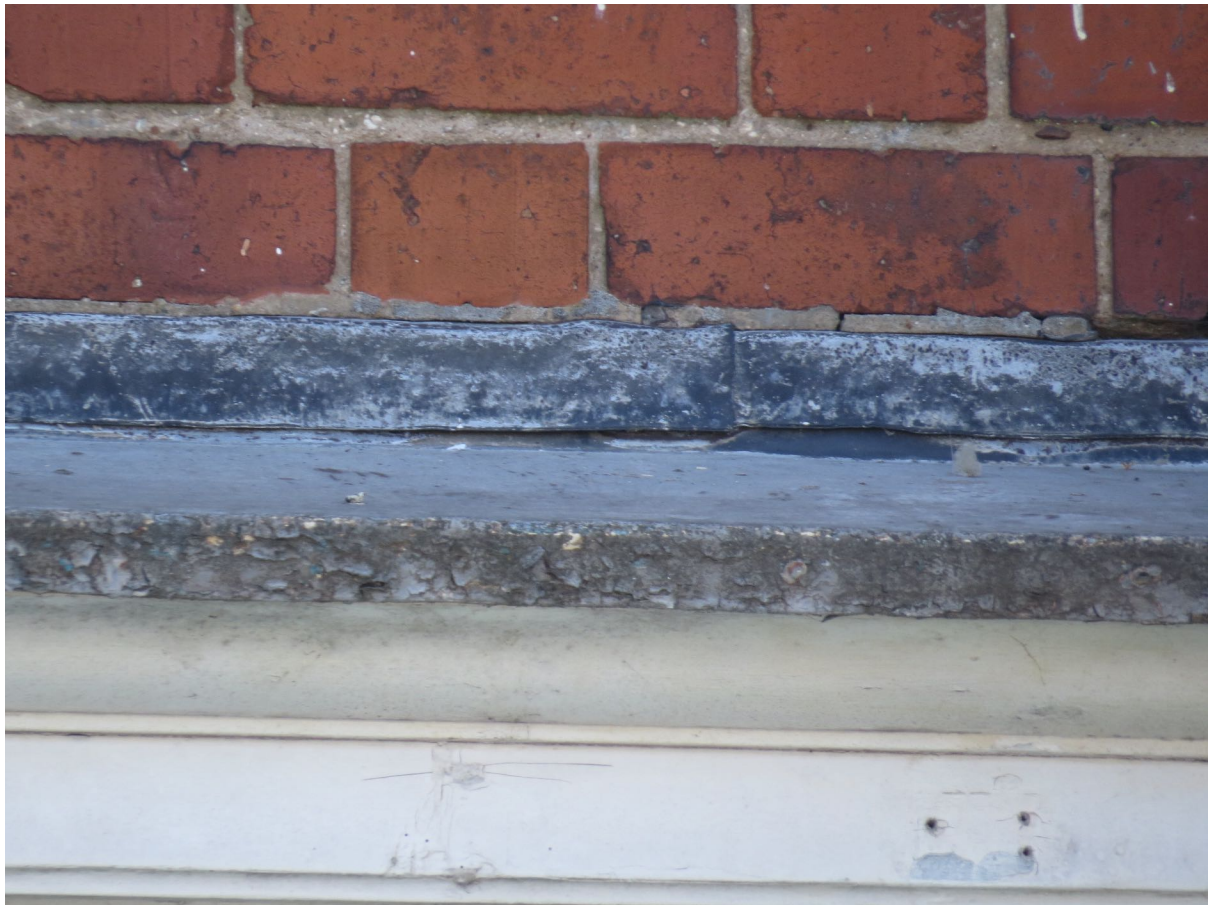
5 – Lead flashing above signage is fitted tightly with no suitable gaps.

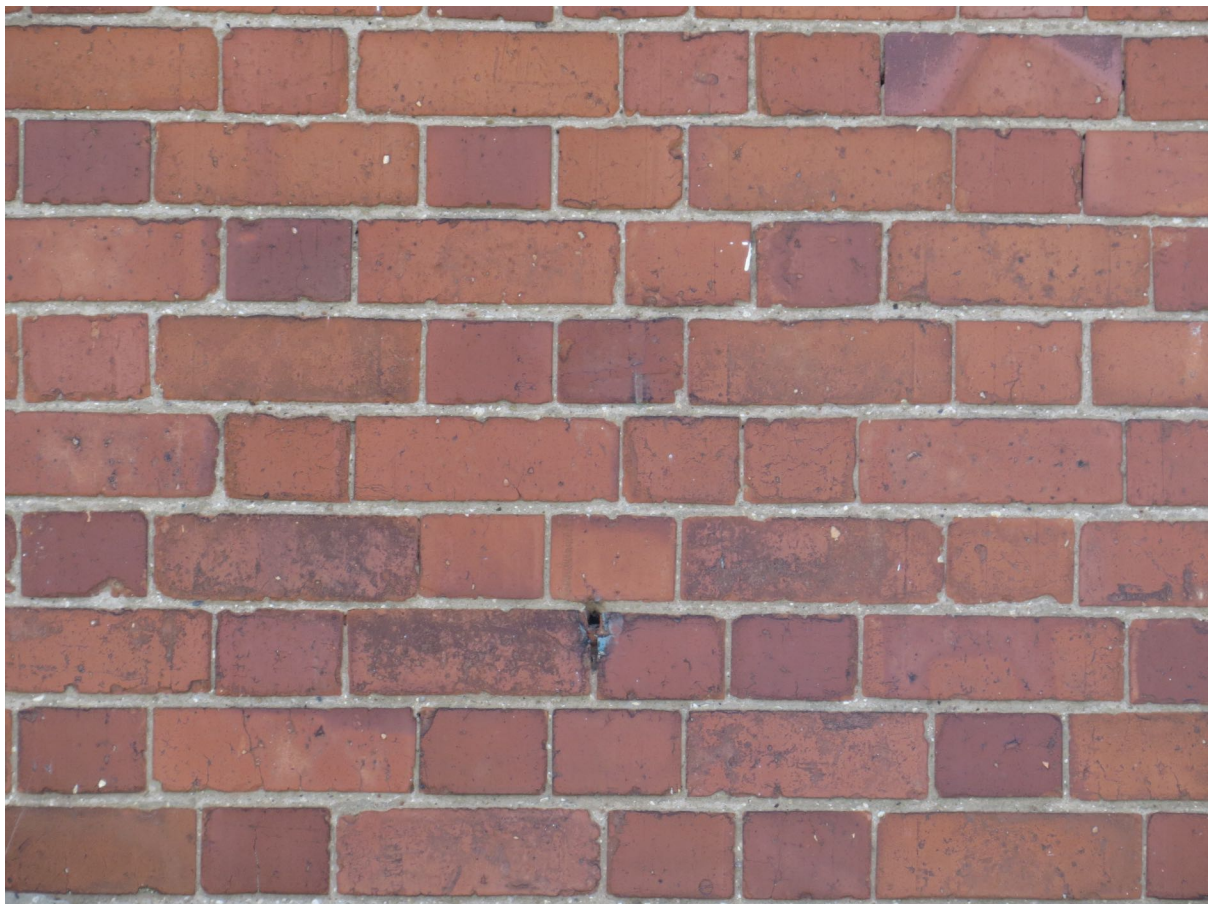
Walls are solid brick with no insulating cavity. Walls and brickwork are in good condition, with no cracks, or missing mortar which could be used by crevice dwelling bats.

6 – Brickwork and mortar are in good condition with no suitable gaps.

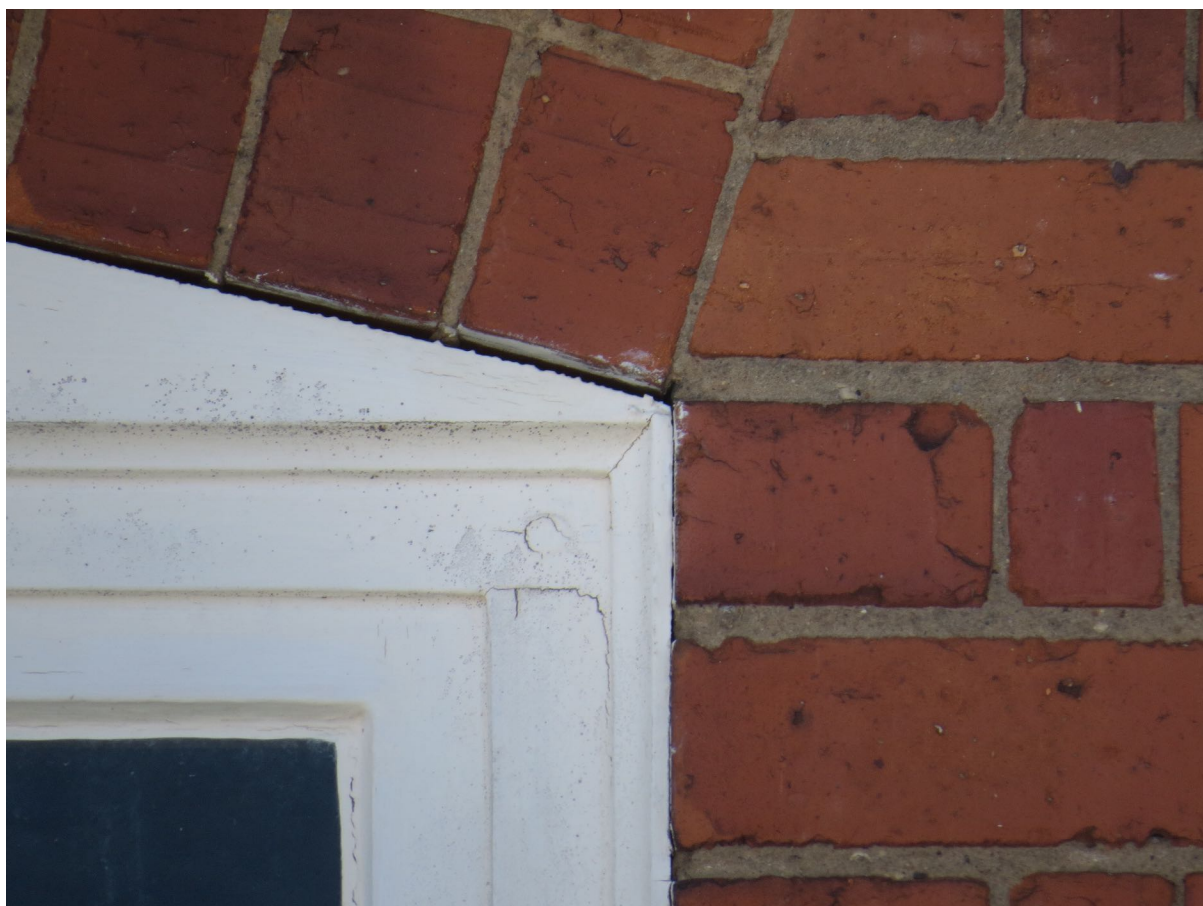
Window and door frames are fixed into the brickwork, gaps are filled with sealant, and offer no suitable roosting opportunities.

7 – Window and door frames are tightly sealed into brickwork with no suitable gaps.

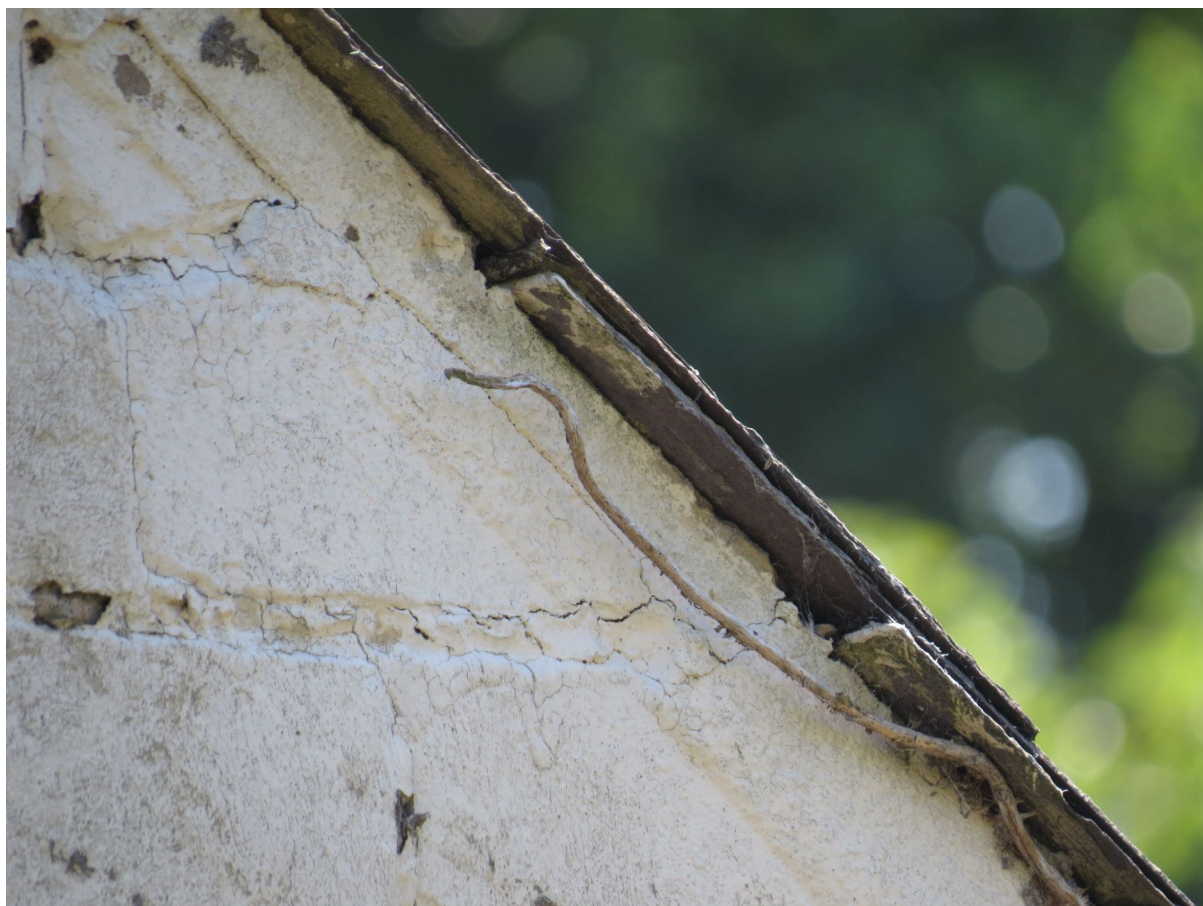
8 – End tiles at the verges are sealed with cement.

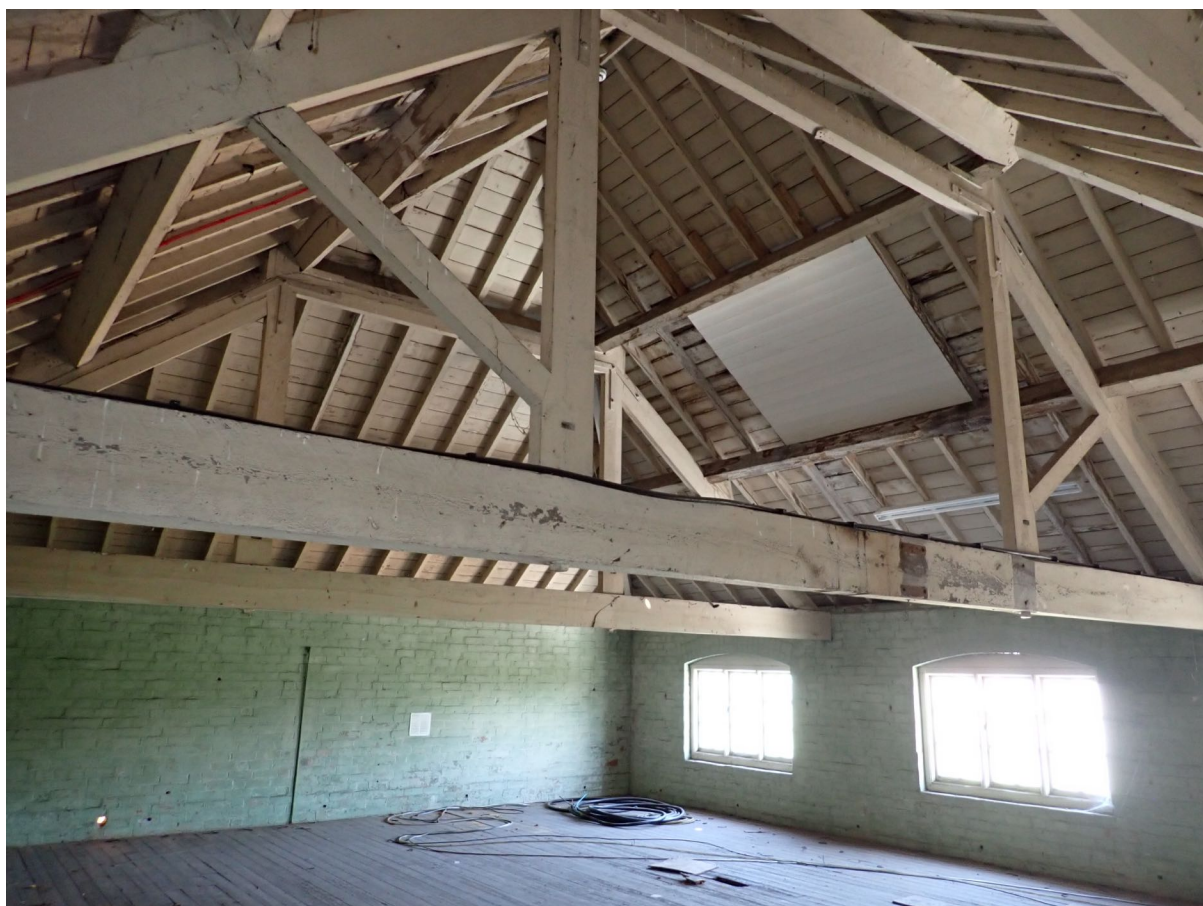
9 – The main section the roof has no enclosed roof void.

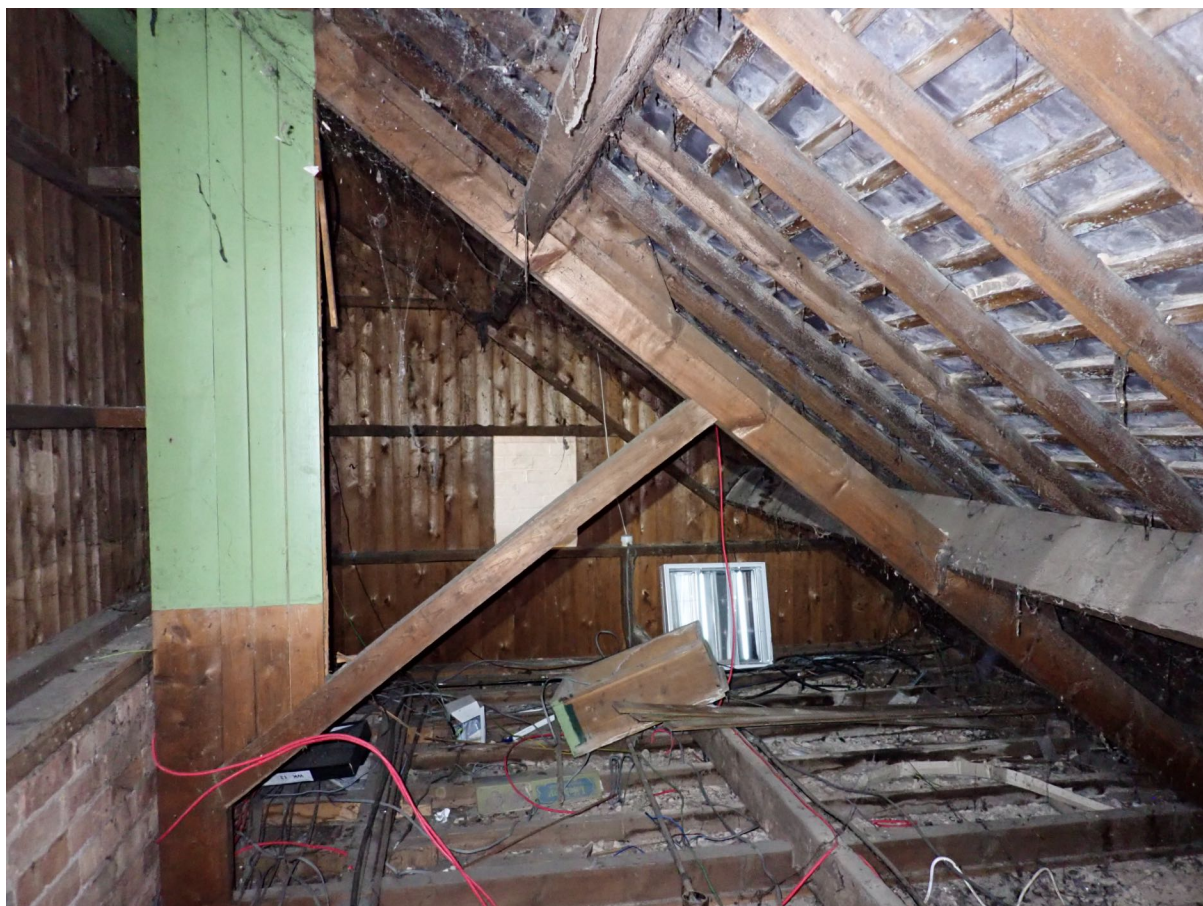
The small gaps between brickwork, roof timbers, and roofing materials, in the roof void were inspected in detail using an endoscope. No droppings were found, and no suitable gaps were present which could give access, or shelter to roosting bats.

10 – A small roof void to the rear has no lining, and is filled with dusty cobwebs.
