# GeoShield Verification Report 01

PROJECT REFERENCE: GEO104923

PROJECT: Land off Sapcote Road

SPECIFICATION: Verified in accordance with CIRIA 735.

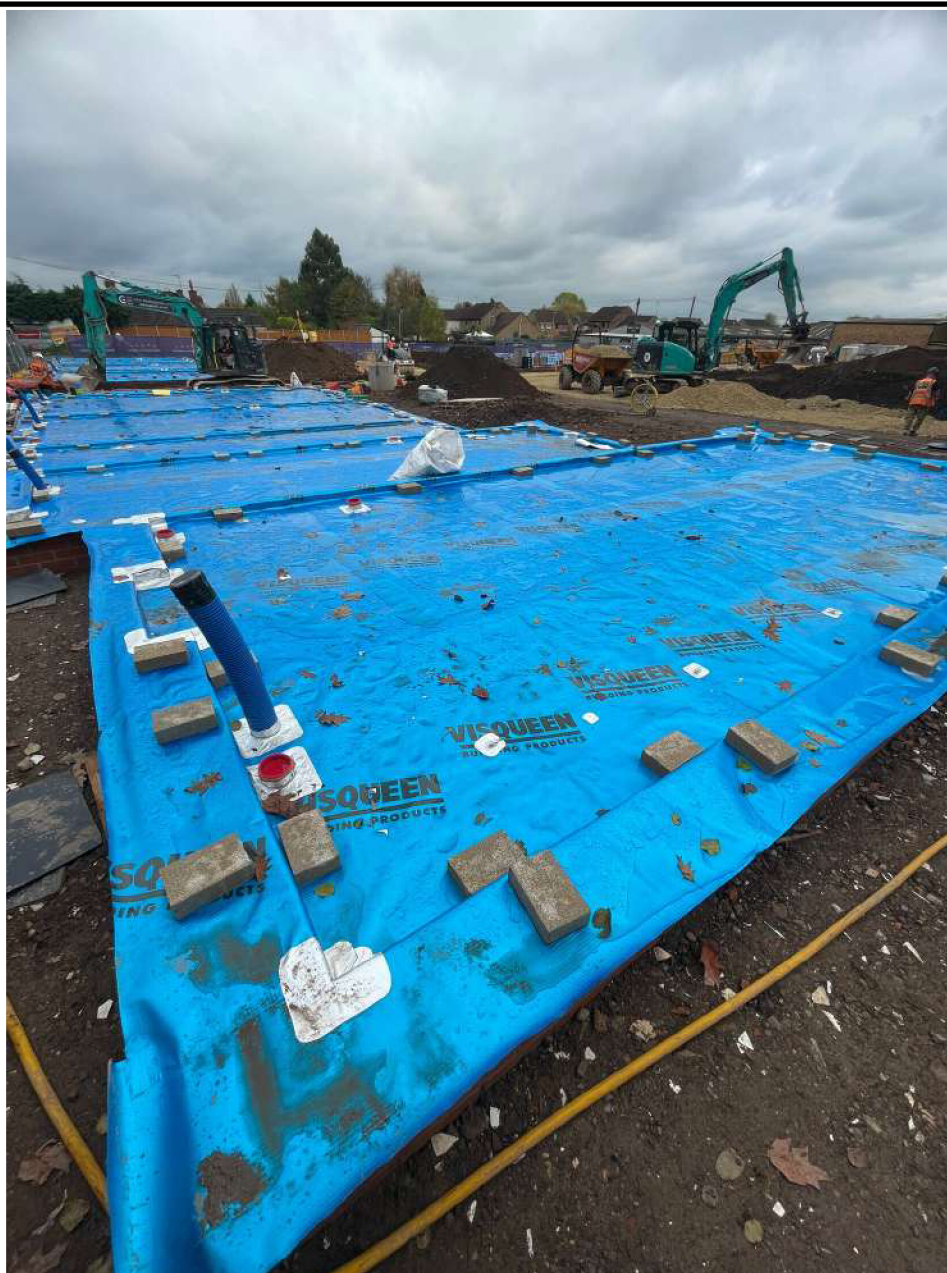
The photograph above displays an overview of plots 1, 2, 3, 4 & 5 where today's verification inspection took place on site.

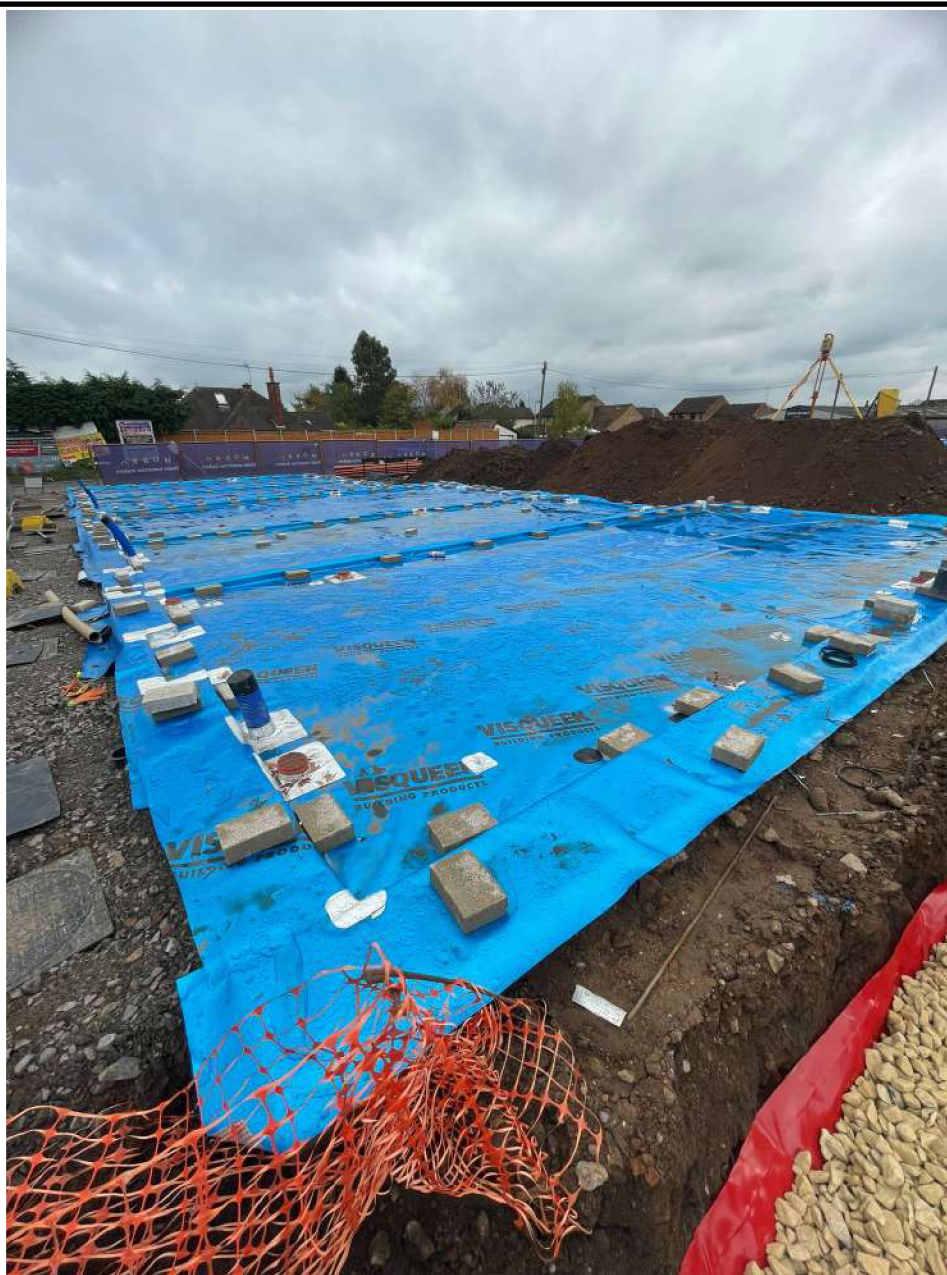
The photograph above displays an overview of plots 6, 7 and 8 where today's verification inspection took place on site.

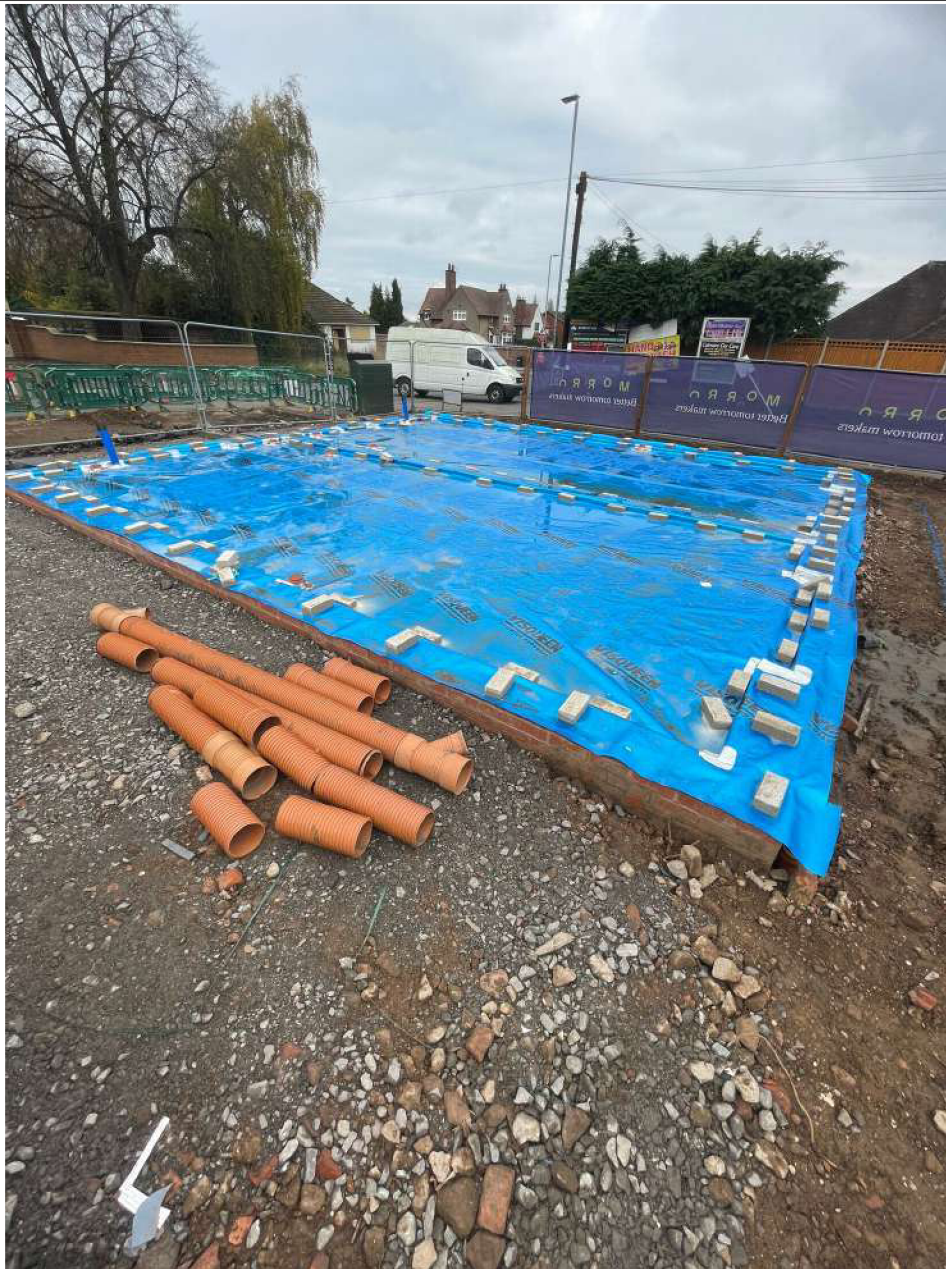
The photograph above displays an overview of plots 9 & 10 where today's verification inspection took place on site.

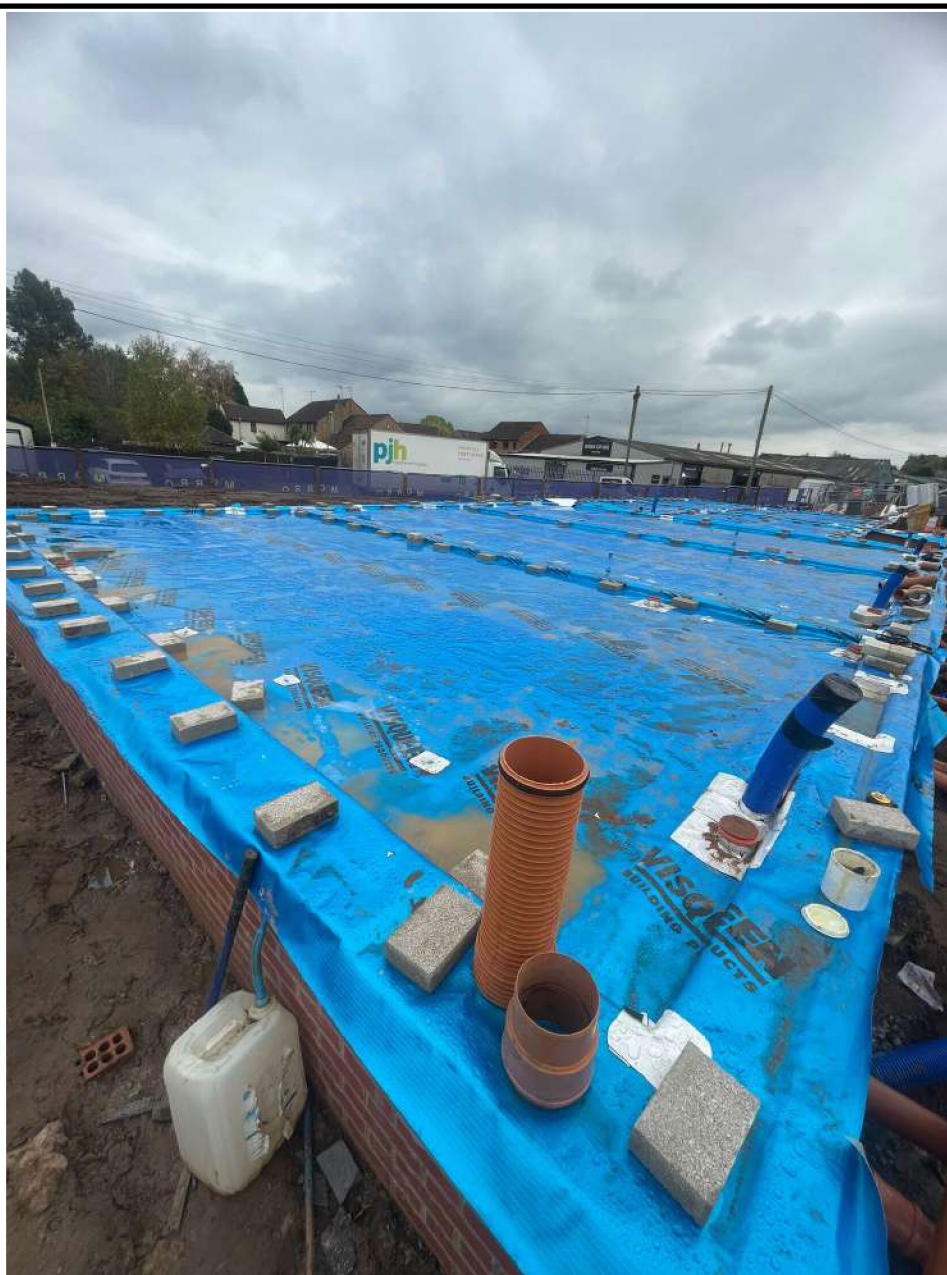
The photograph above displays an overview of plots 11, 12 & 13 where today's verification inspection took place on site.

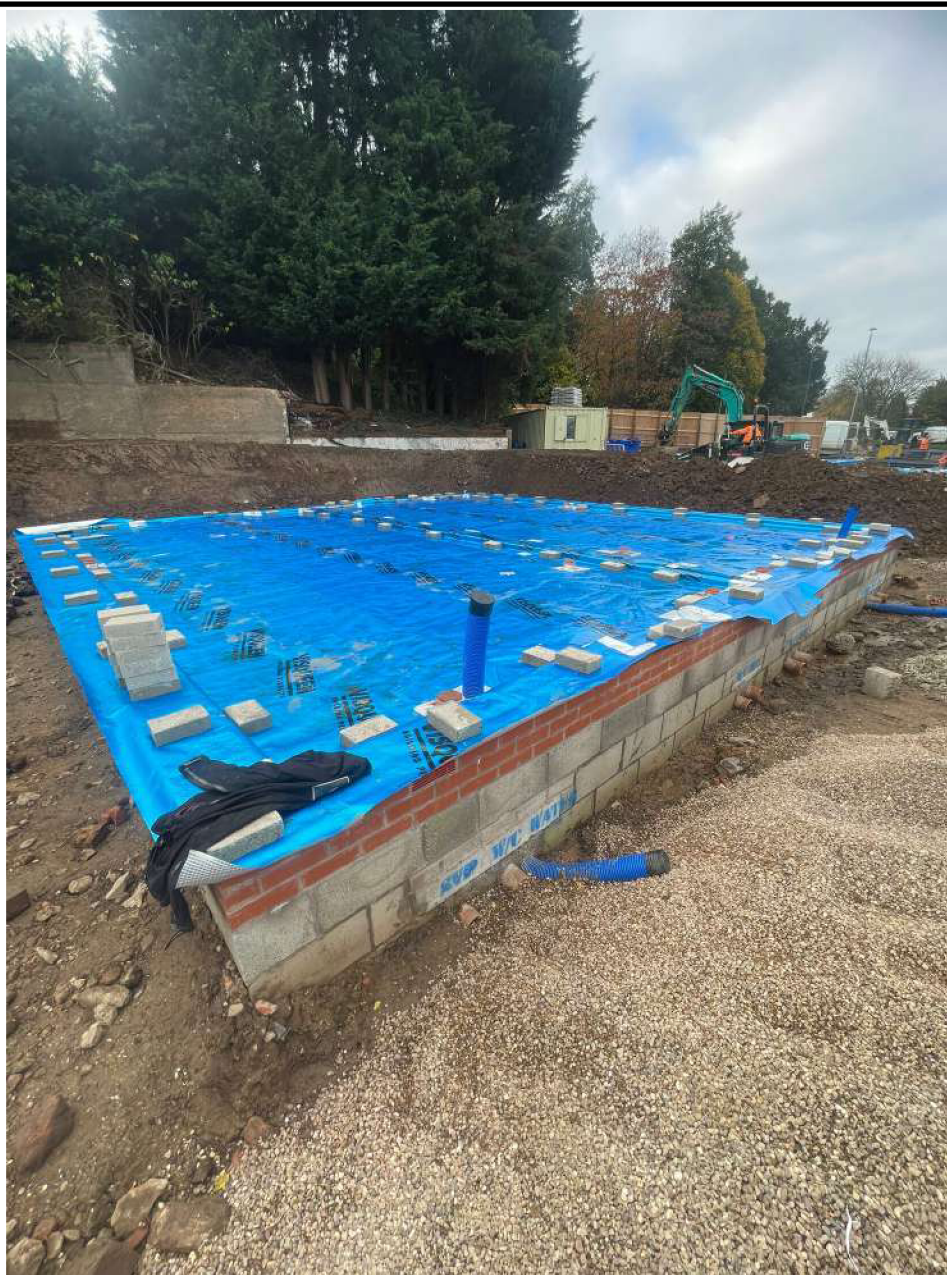
The photograph above displays an overview of plots 20 and 21 where today's verification inspection took place on site.

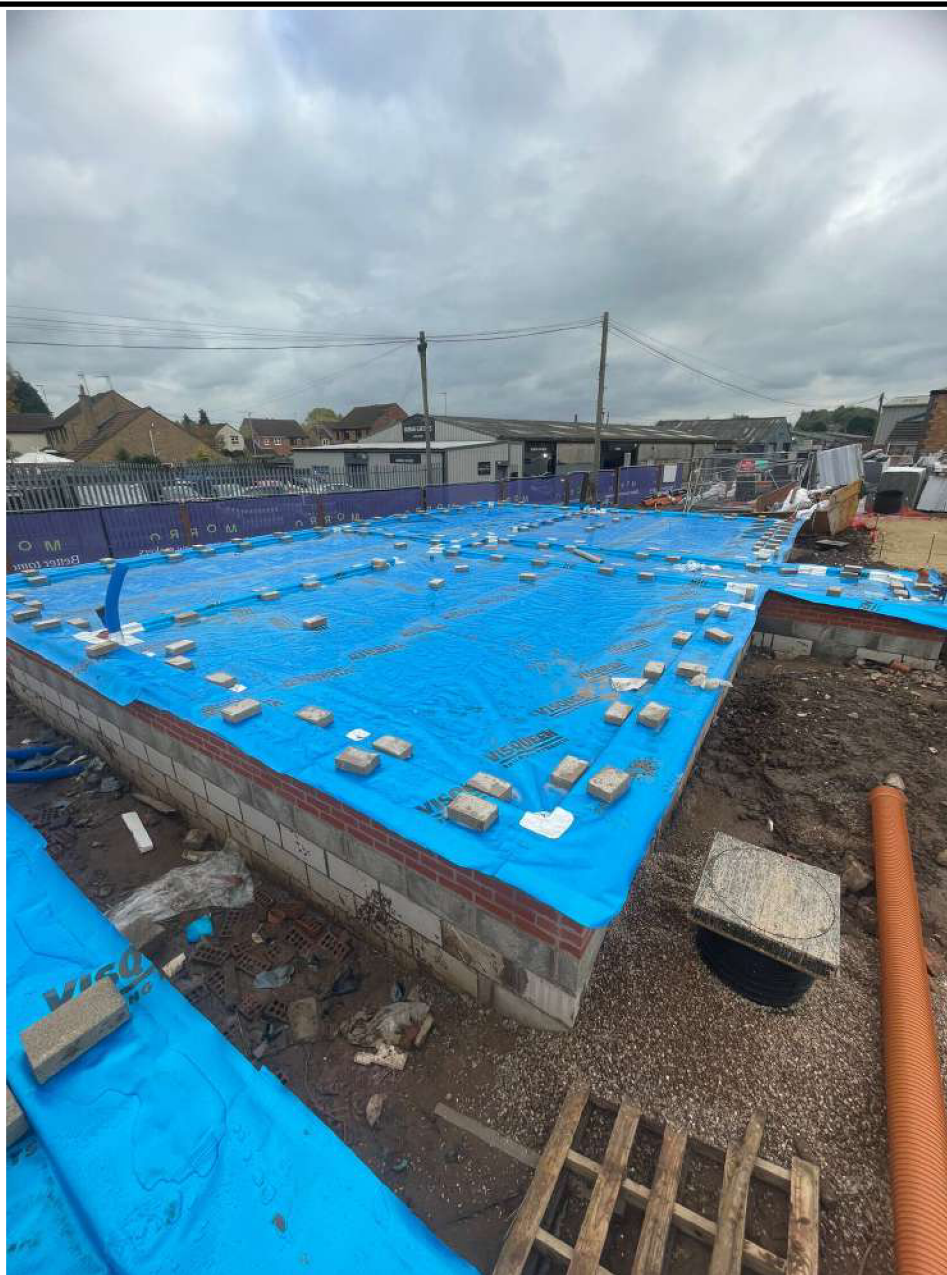
The photograph above displays an overview of flats 1, 2, 3 and 4 where today's verification inspection took place on site.

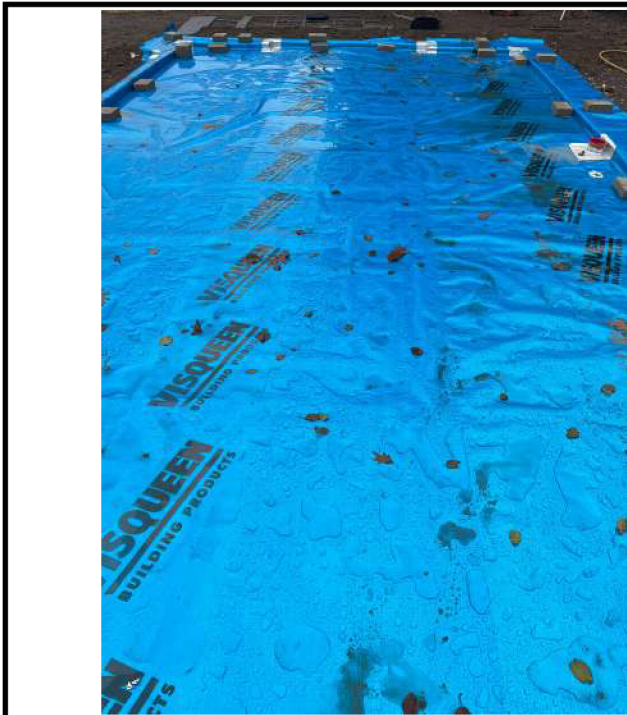
A complete line out of the Visqueen Standard Gas Barrier has been installed across the footprint of the plots referenced. The Visqueen Standard Gas Barrier has been lined across the entirety of the plots, including the internal party walls and external cavities to ensure continuity throughout.

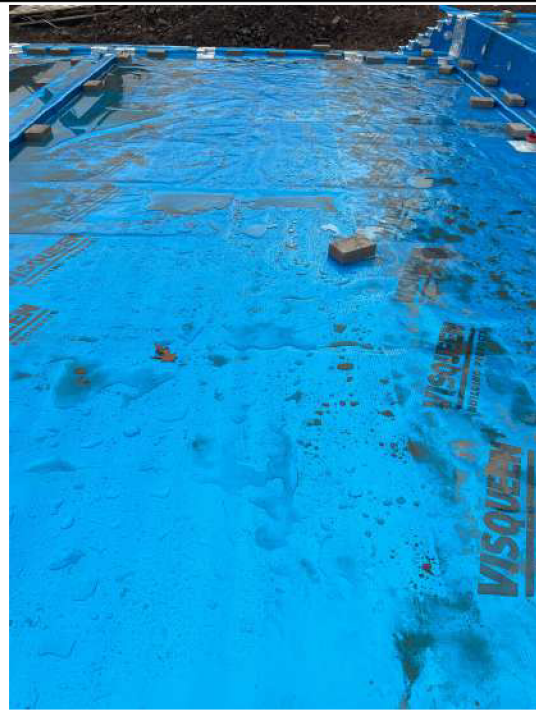
All lap joints between the adjacent sheets of Visqueen Standard Gas Barrier have been overlapped a minimum of 100mm and heat welded using a hot air leister and a silicone roller with adequate pressure applied to ensure a continuous weld is achieved. Installed in accordance with manufacturer's specifications.

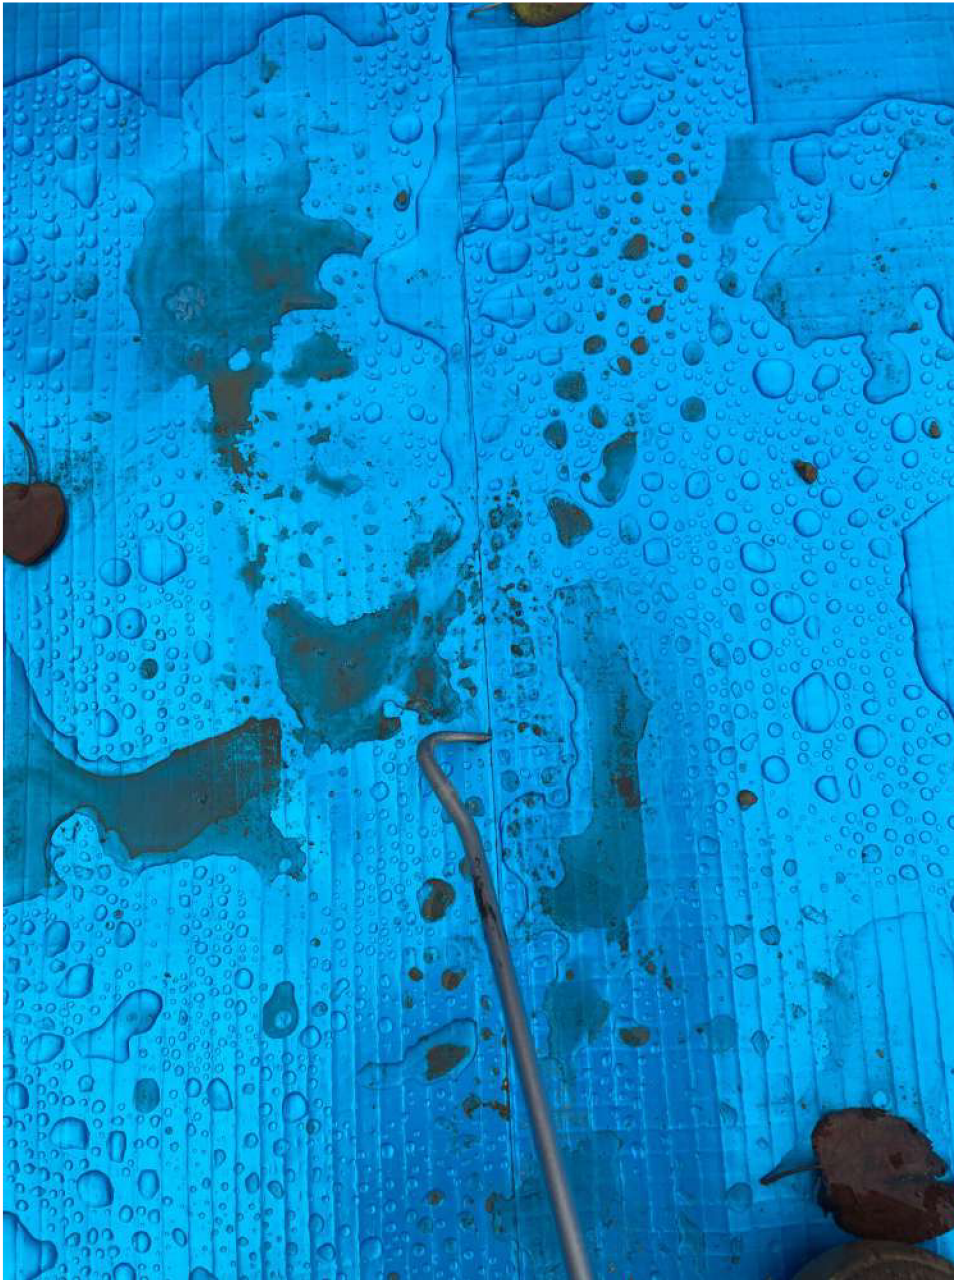
The above photograph displays a mechanical point stress test, also known as a pick and probe test, being conducted upon a welded lap joint of the Visqueen Standard Gas Barrier. All lap joints were subjected to thorough mechanical point stress testing throughout the installation. Three miswelded lap joints were identified at the time of the inspection, these were successfully remediated.

A total of three miswelded lap joints were identified, all of which were successfully remediated on site in the presence of GeoShield.

The faults were remediated by applying 150mm patches of Visqueen GR SAM over the affected areas with heat and rolled pressure applied to activate the bitumen backing. No further faults or defects were identified during the testing of the lap joints.

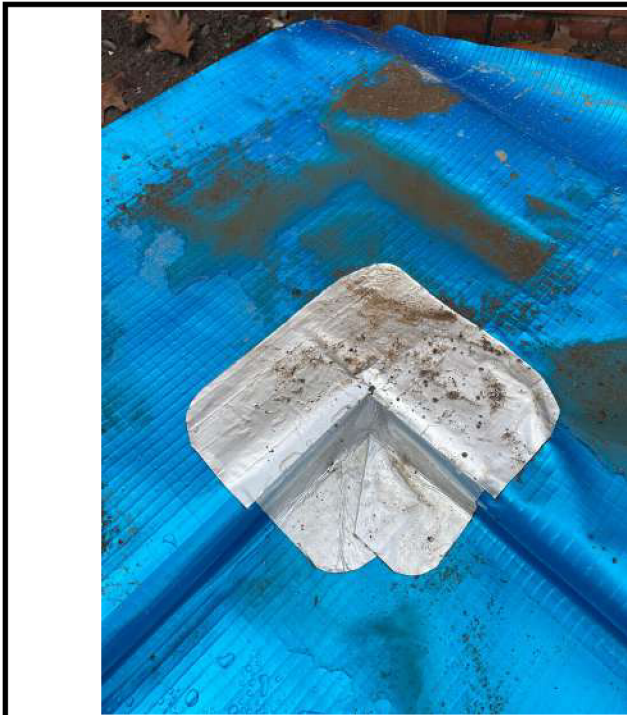
A number of corners and thresholds throughout the referenced plots have been sealed as per manufacturer's specifications and design guidelines. This has been achieved using Visqueen Standard Gas Barrier and Visqueen GR SAM. The Visqueen Standard Gas Barrier has been cut to minimise voided areas and

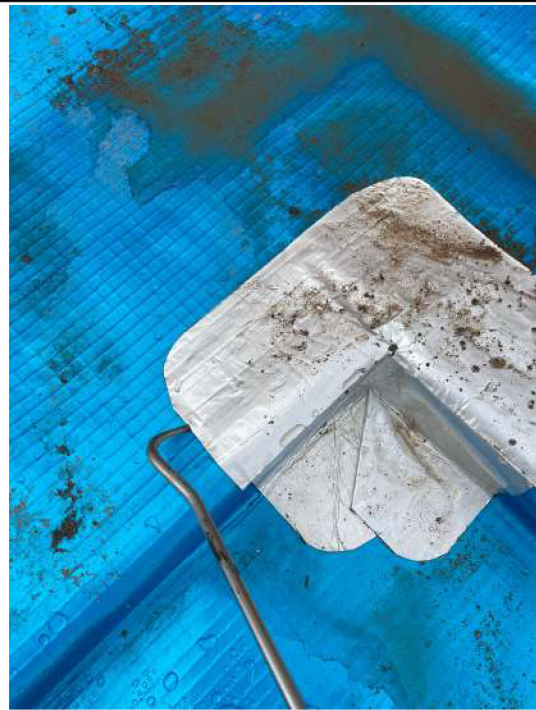
gaps across the footprint of the referenced plots. Each corner and threshold junction has been reinforced by heating strips of Visqueen GR SAM and placing them into position around each corner, onto the Visqueen Standard Gas Barrier. Firm rolled pressure is applied with a silicone roller to aid in the adhesion ensuring the

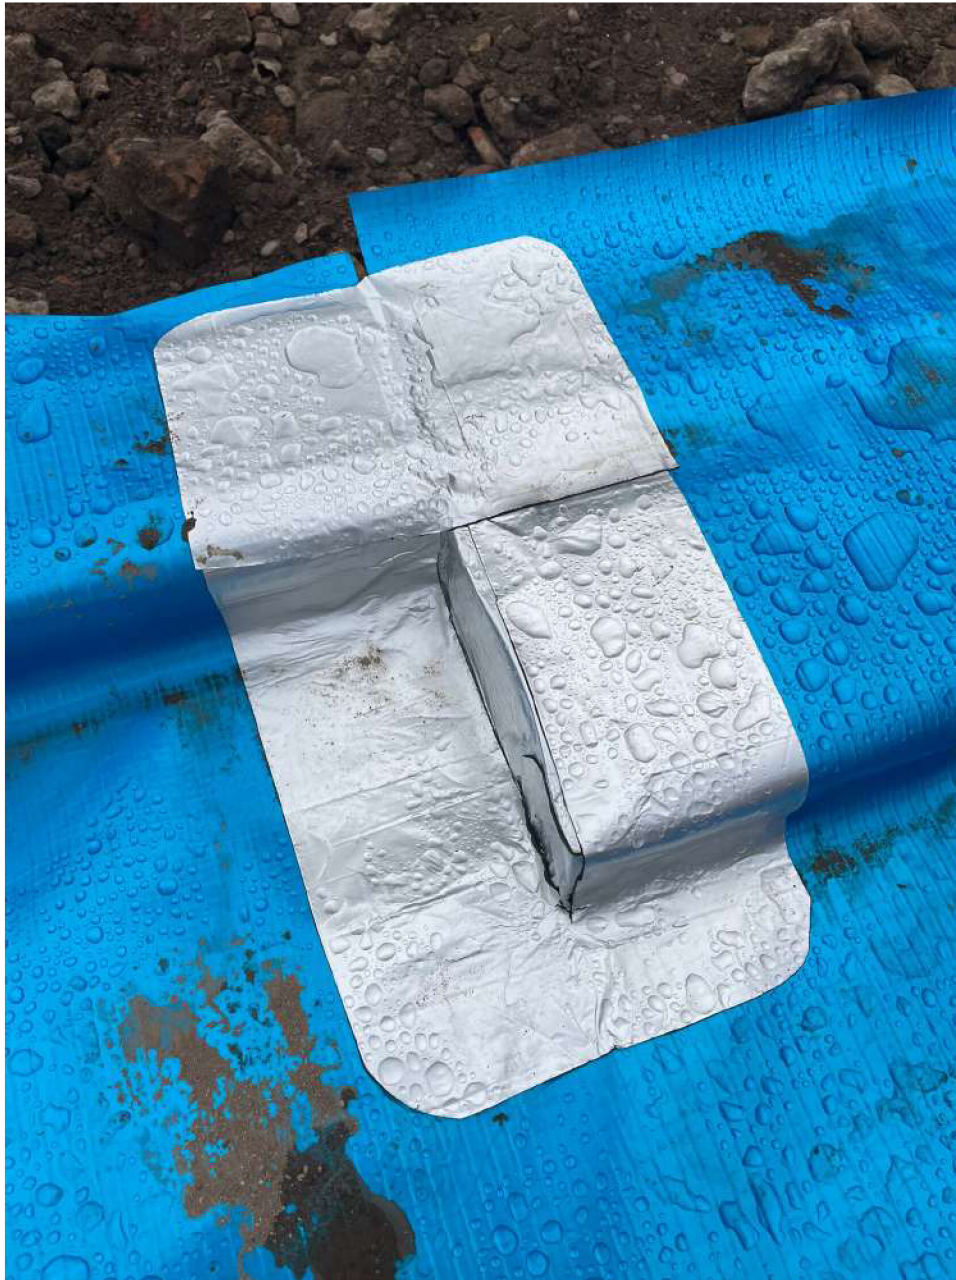
GR SAM has fully bonded. A pick and probe test was conducted upon all edges of Visqueen GR SAM to validate that a gas tight seal had been achieved between the Visqueen Standard Gas Barrier and the Visqueen GR SAM on the corner and threshold detailing.

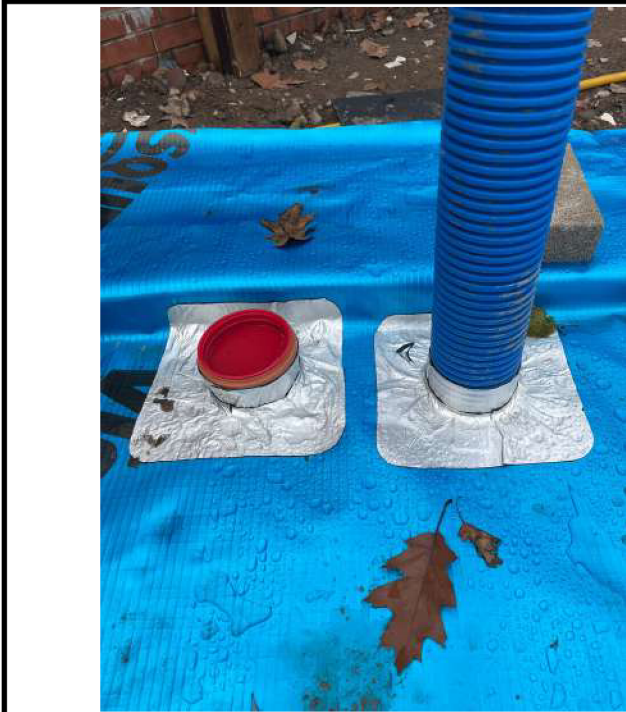
Throughout the installation of the Visqueen Standard Gas Barrier to the referenced area, there were a number of pipe penetrations that have been sealed in accordance with manufacturer's specifications and design guidelines. This has been achieved using Visqueen GR SAM which is a self adhesive membrane.

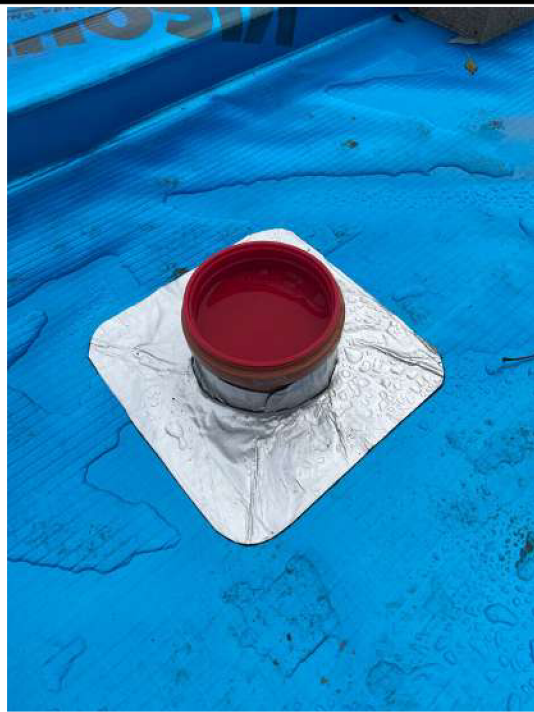
The installers have first cut the Visqueen Standard Gas Barrier tight around the base of each pipe penetration to minimise voided areas. Next, strips of Visqueen GR SAM are placed intricately in a top hat formation around the pipe penetration and onto the Visqueen Standard Gas Barrier. Heat and rolled pressure is

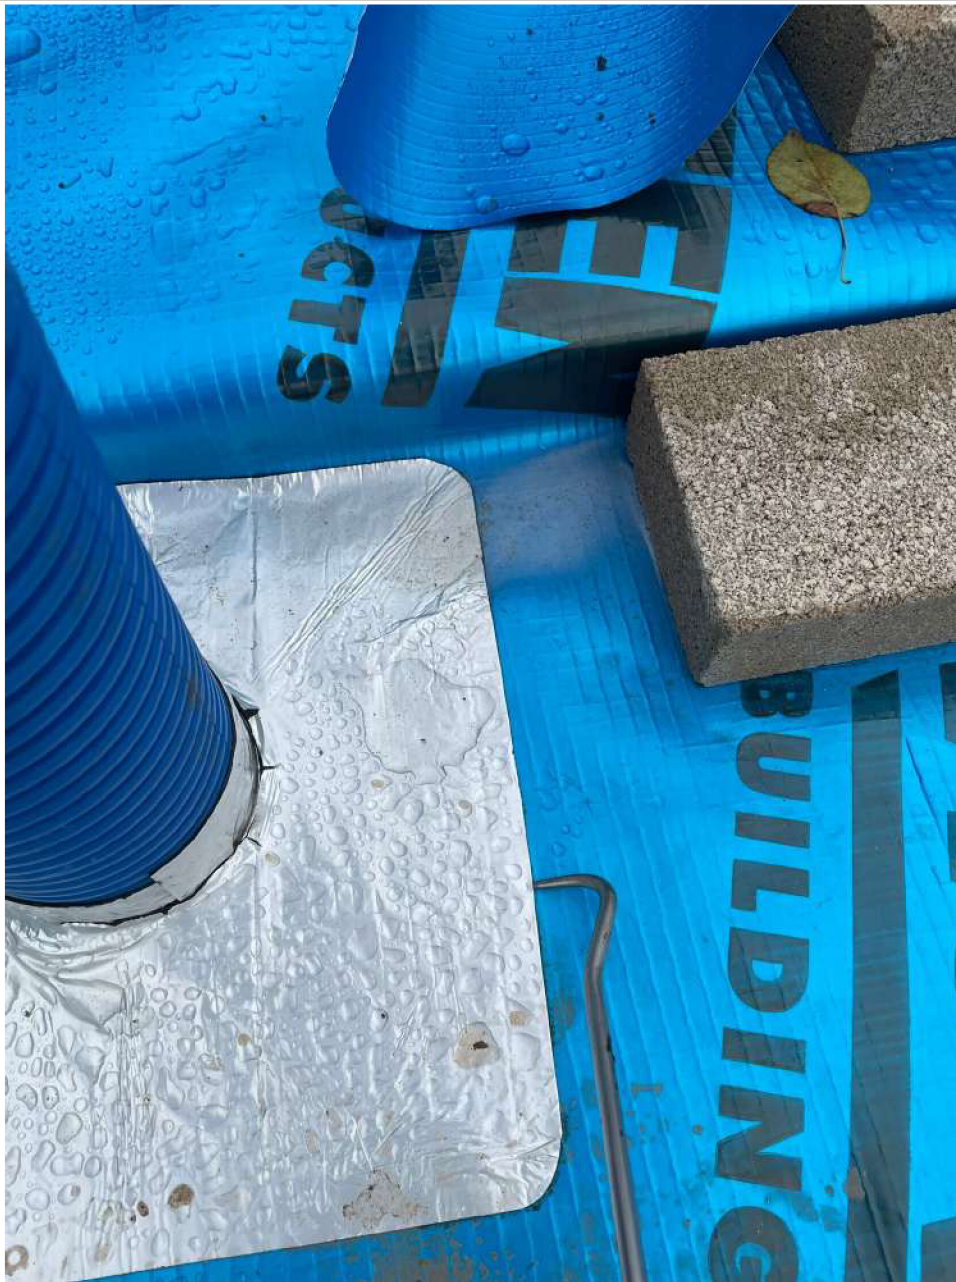
applied to activate the bitumen backing, creating a secure bond between the pipe penetration and the Visqueen Standard Gas Barrier. All pipe penetrations throughout the referenced area were subjected to thorough mechanical point stress testing where a probe was run along all edges of the Visqueen GR SAM. No faults or defects were identified with the pipe penetrations during these testing procedures.

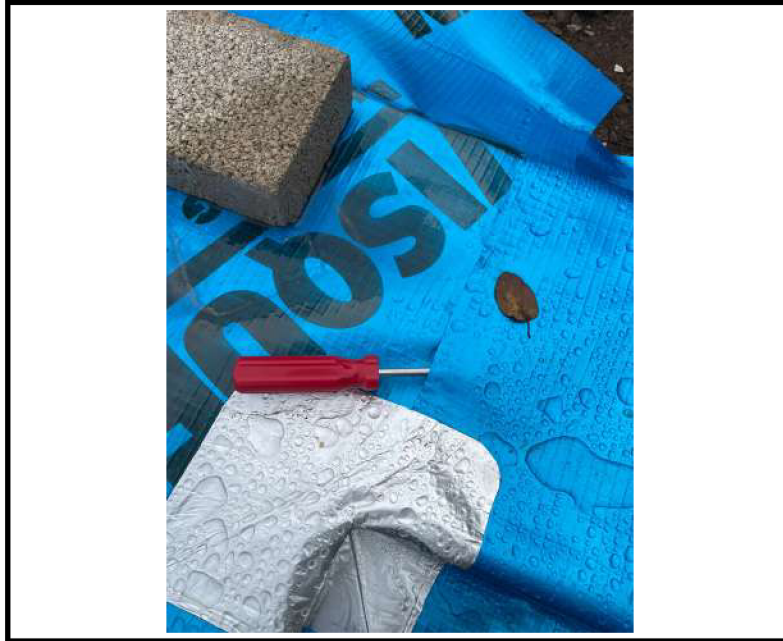
As mentioned, three miswelded lap joints were identified during the testing procedures conducted today. The faults were brought to the attention of the installers and remediated on site in the presence of GeoShield.

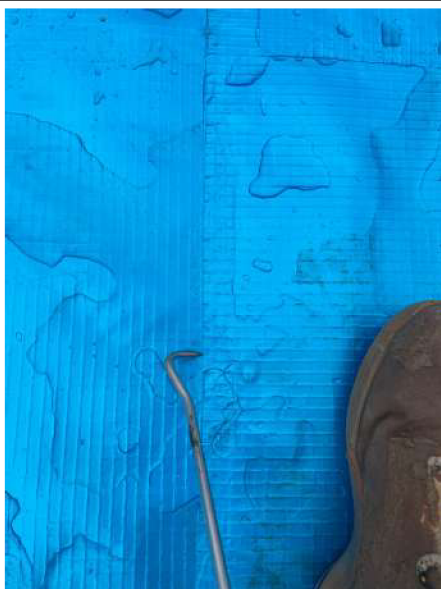
A pick and probe test being conducted upon a welded lap joint.

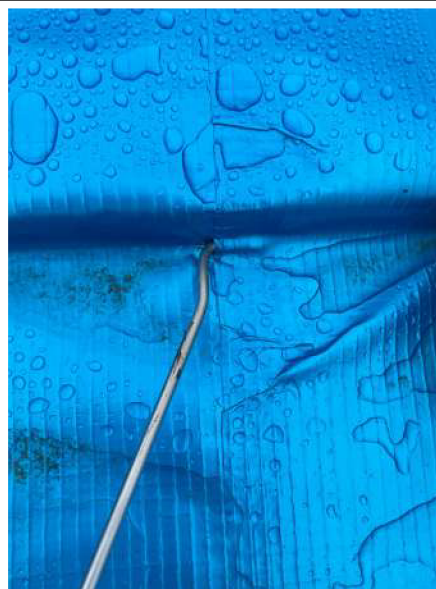
A probe demonstrating a fault identified.

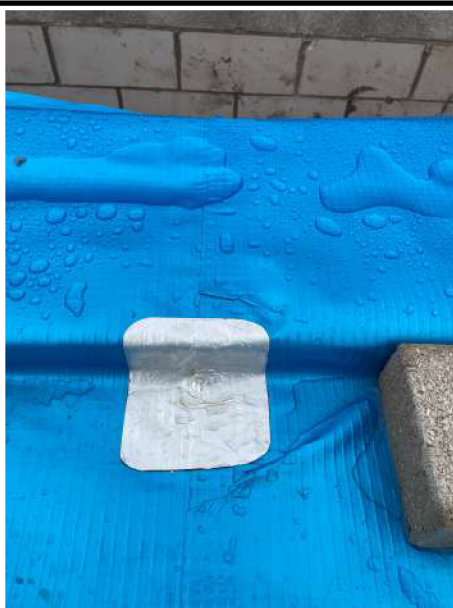
A patch of Visqueen GR SAM which has been used to seal a fault identified.

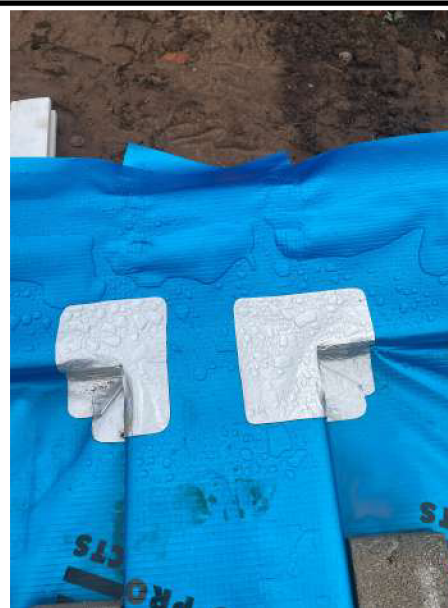
Sealed corner details.

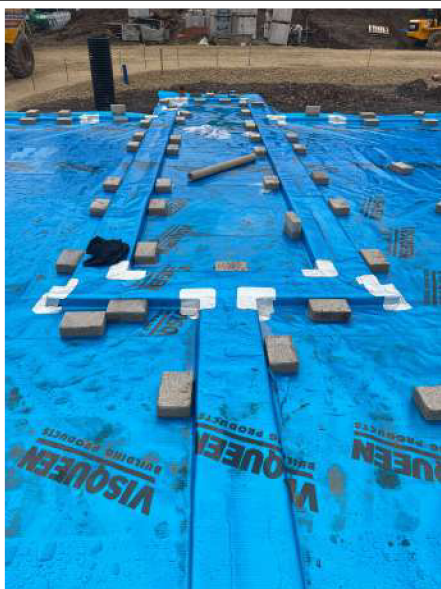
An overview of internal walls and sealed corner details.

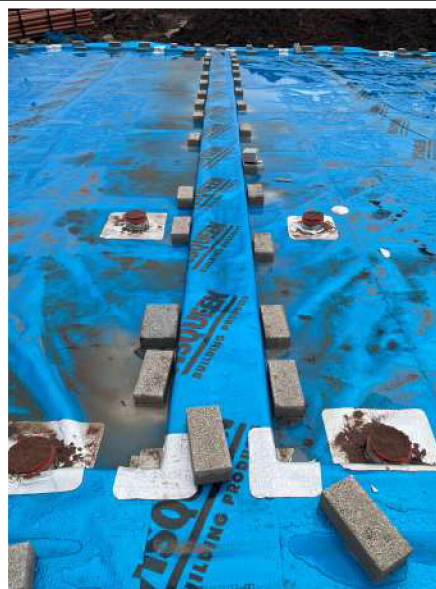
An overview of an internal wall and sealed corner and pipe penetrations.

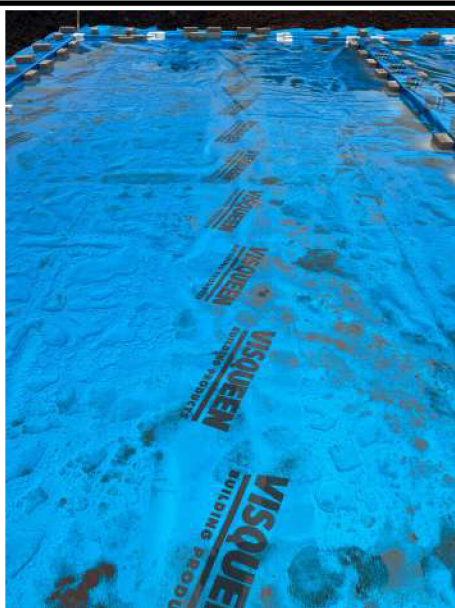
An overview of a welded lap joint.

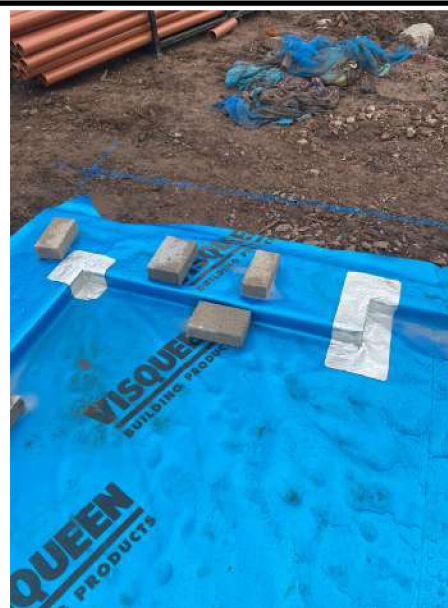
Sealed corner and perimeter details.

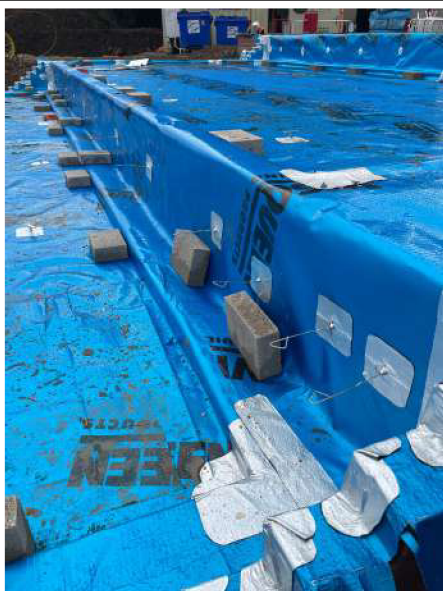
Visqueen Standard Gas Barrier has been installed tightly across two plots.

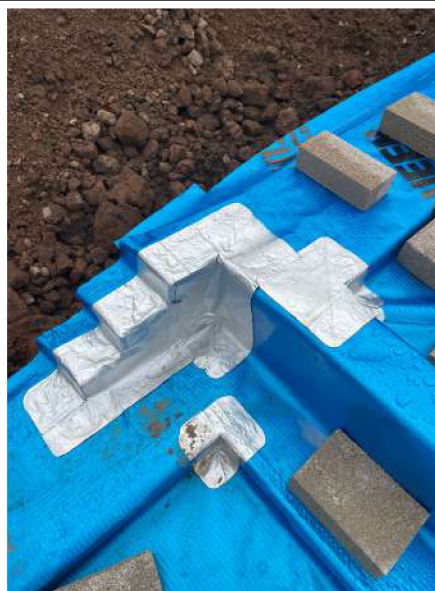
All corner details were sealed with Visqueen GR SAM.

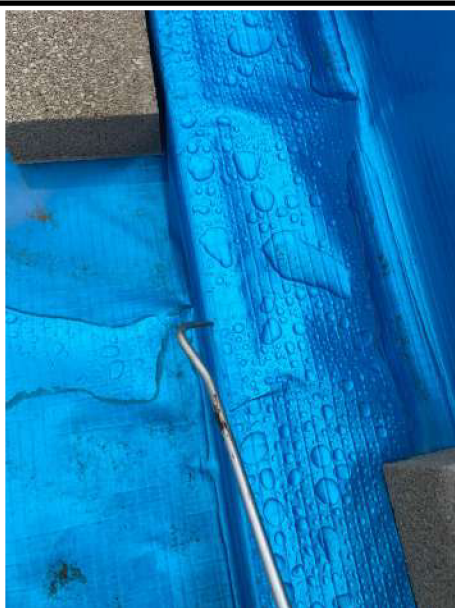
A pick and probe test being conducted upon a welded lap joint.

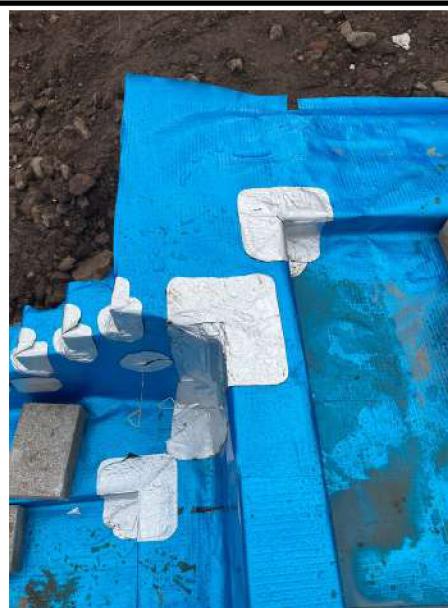
Visqueen GR SAM was used to seal corner details.
