## ENGINEERS REPORT

**Report on a visual inspection of a Barn at :**

WOODSIDE FARM

25S01/02 April 2025

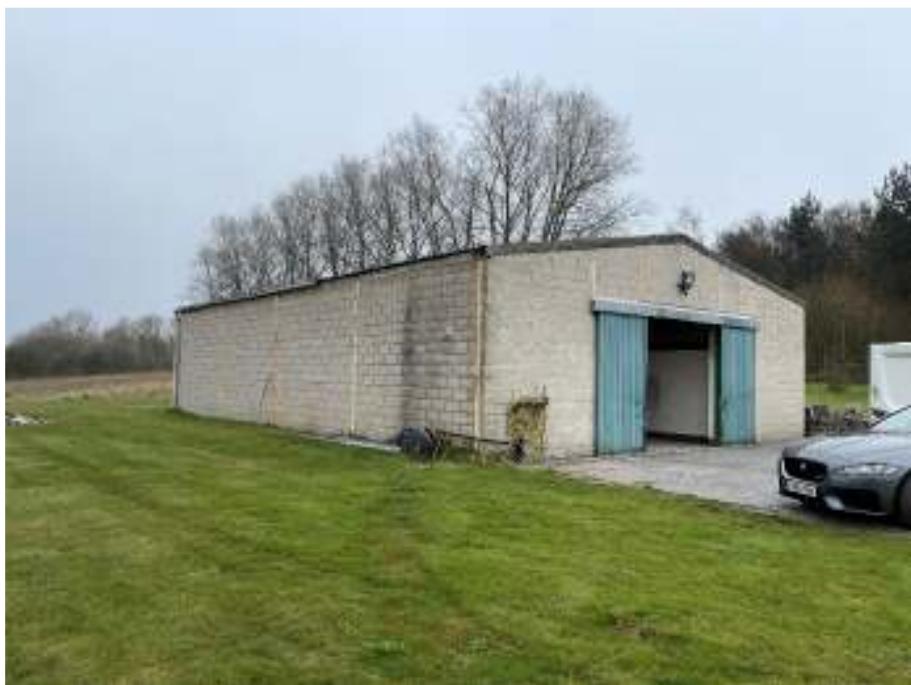
**Figure 1:** Building from the south west

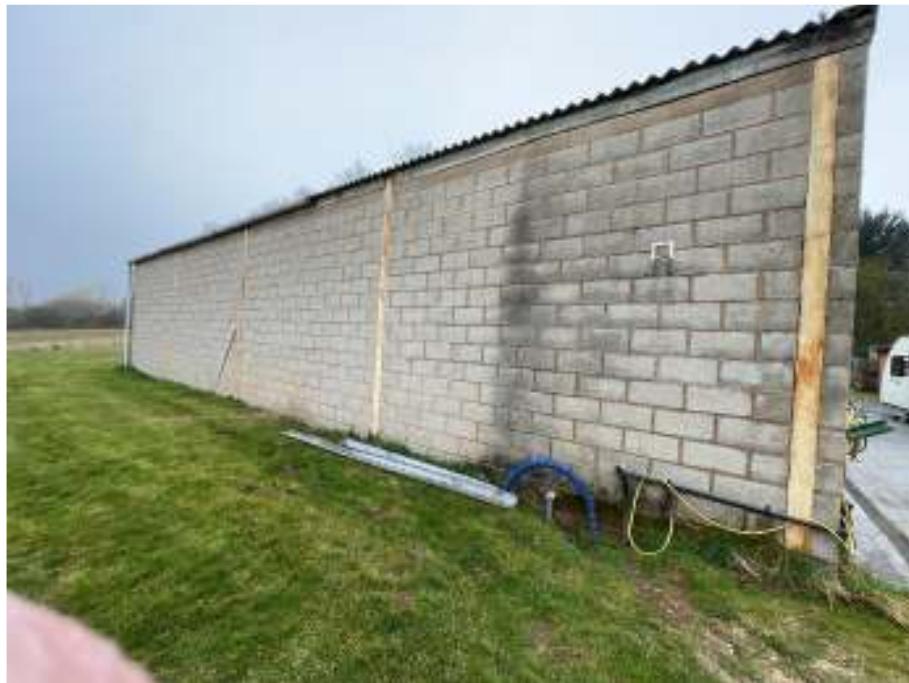
**Figure 2:** West elevation

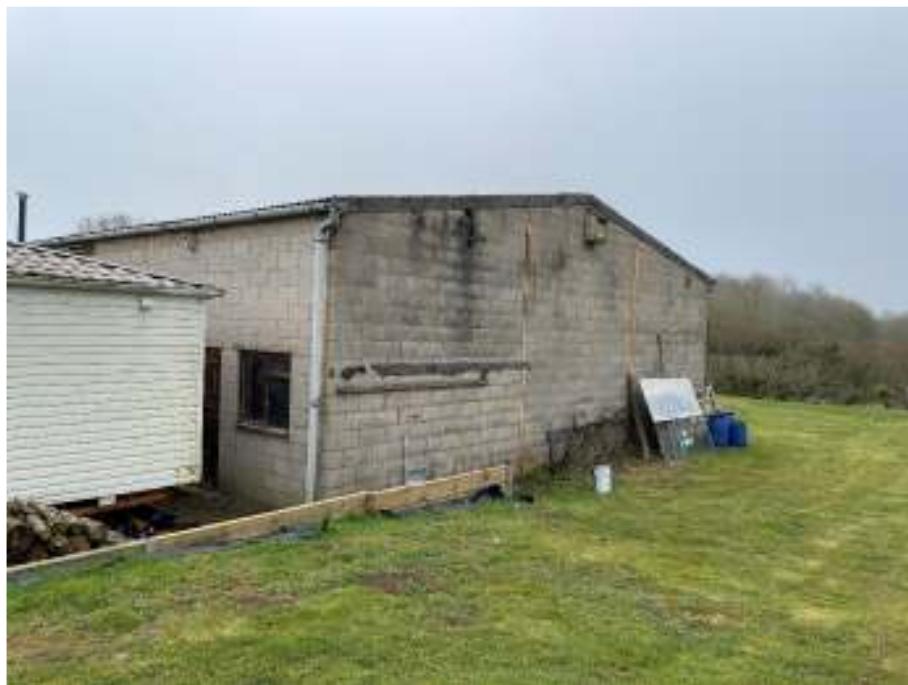
**Figure 3:** North elevation

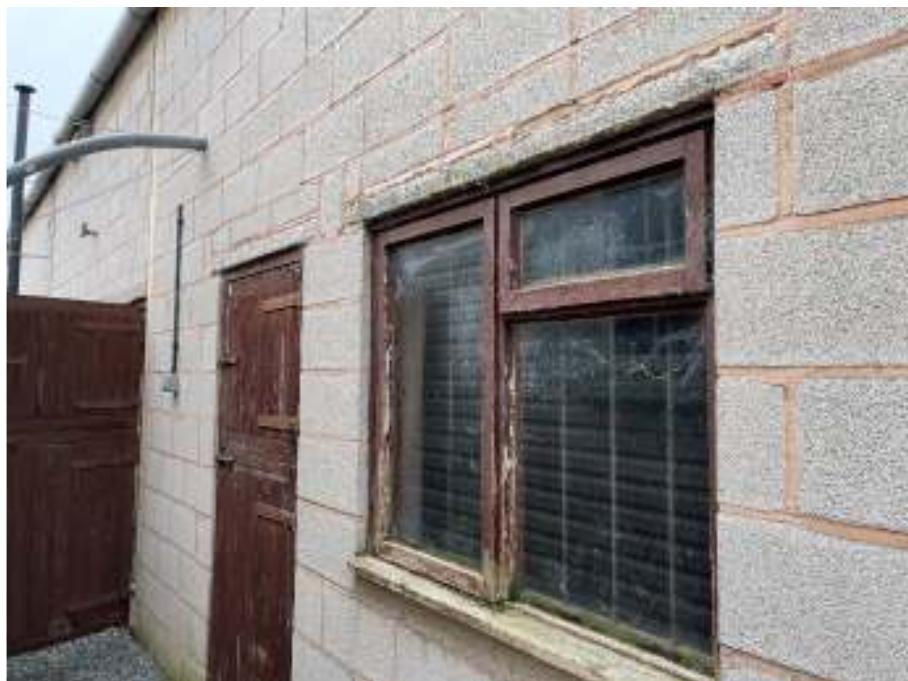
**Figure 4:** East elevation

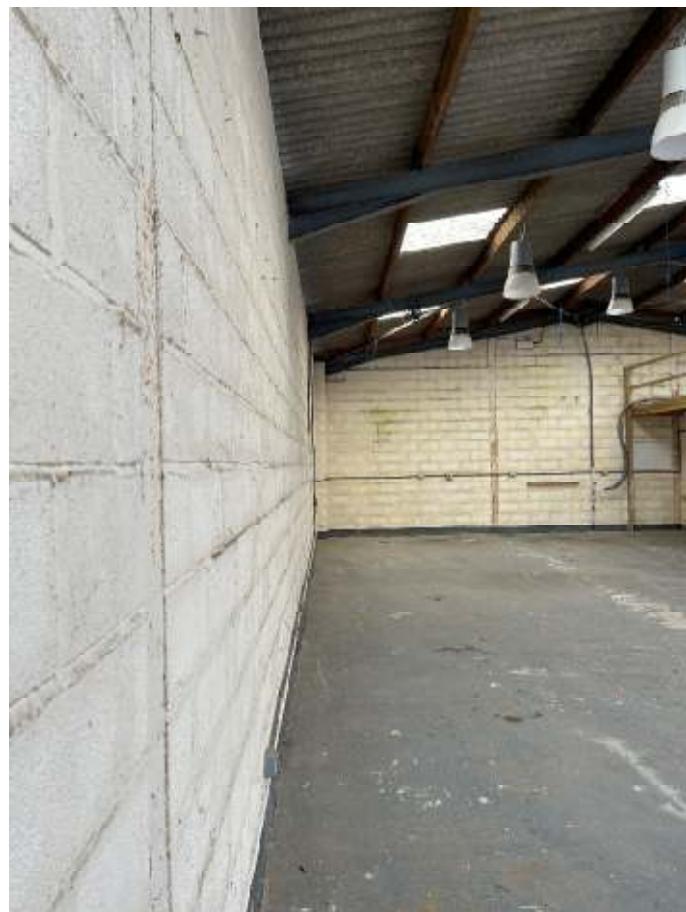
**Figure 5:** Internal

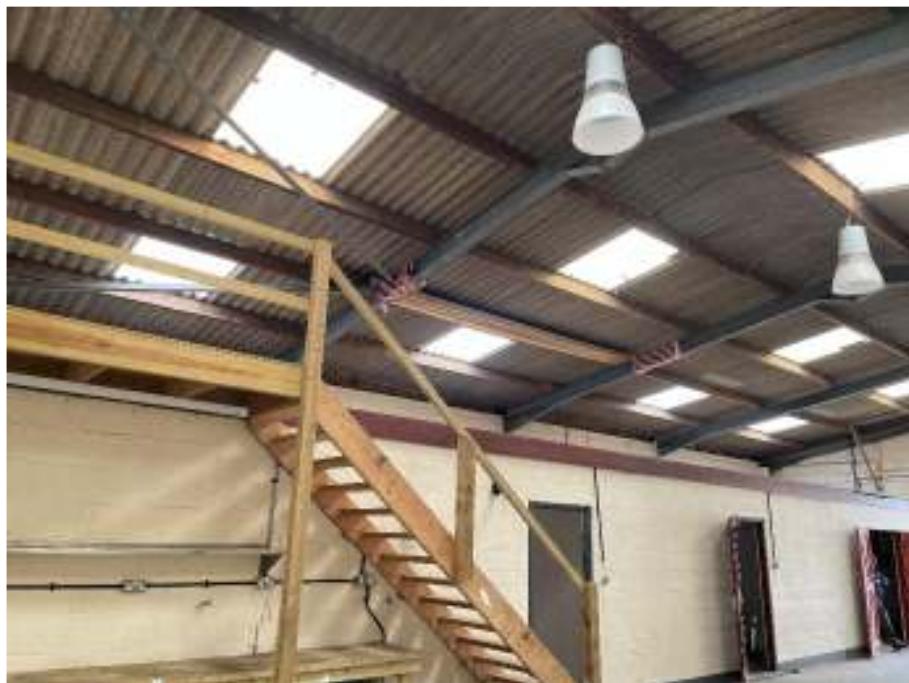
**Figure 6:** Internal rooms

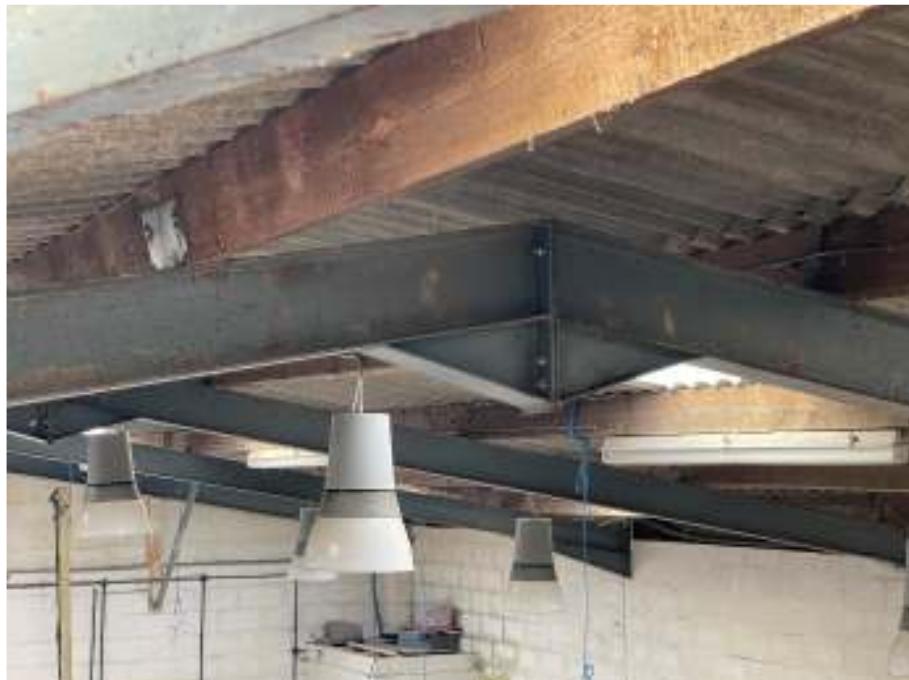
**Figure 7:** Portal frame ridge haunch

The ridge connection also contained 6No M6 bolts.

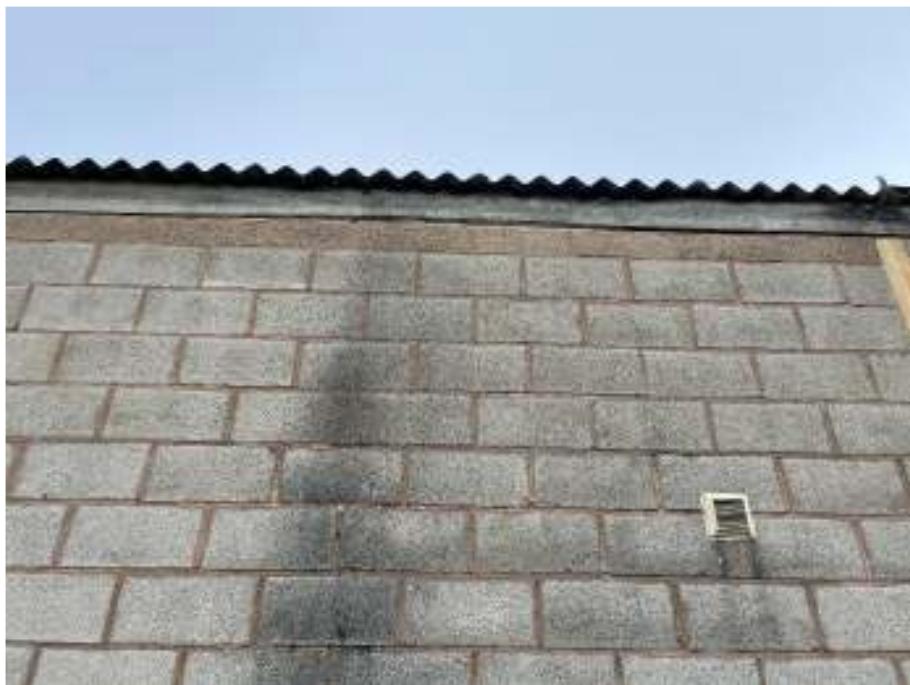
**Figure 8:** Damp staining on west wall

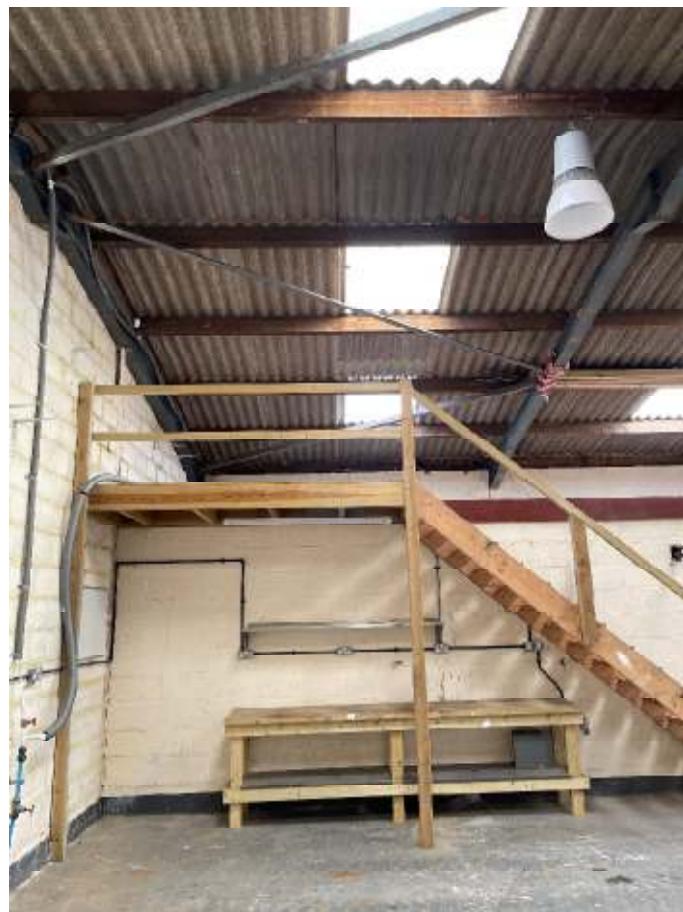
**Figure 9:** Roof bracing

The roof stability bracing comprised 70 x 70 x 5 RSA sections.

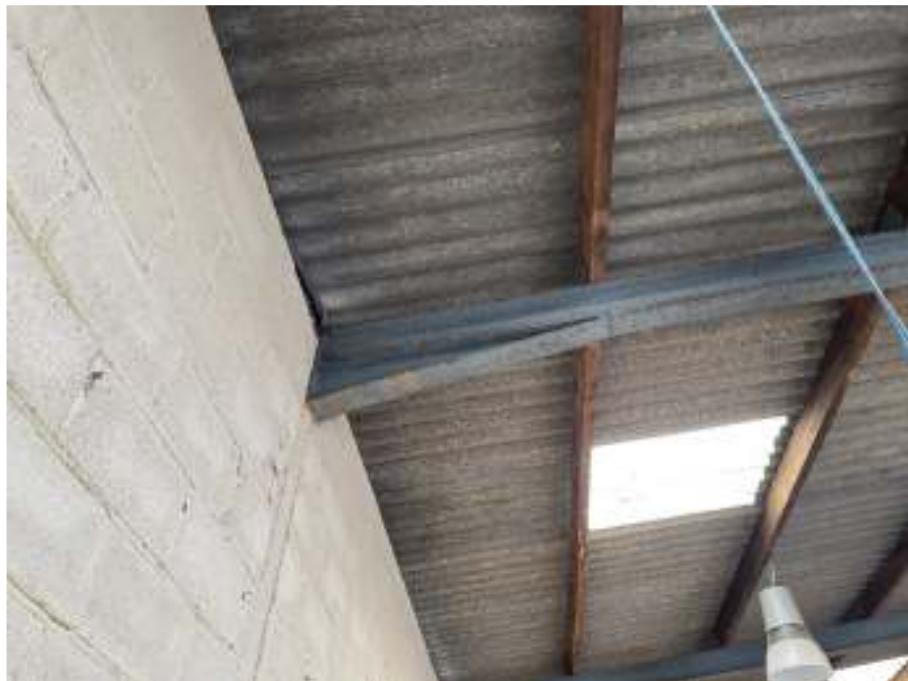
The roof purlins comprised 63mm x 180mm timber sections.

There was no evidence of any excessive deflection of the timber roof purlins.

**Figure 10:** Timber purlins

The timber purlins generally appeared to be in a satisfactory condition.

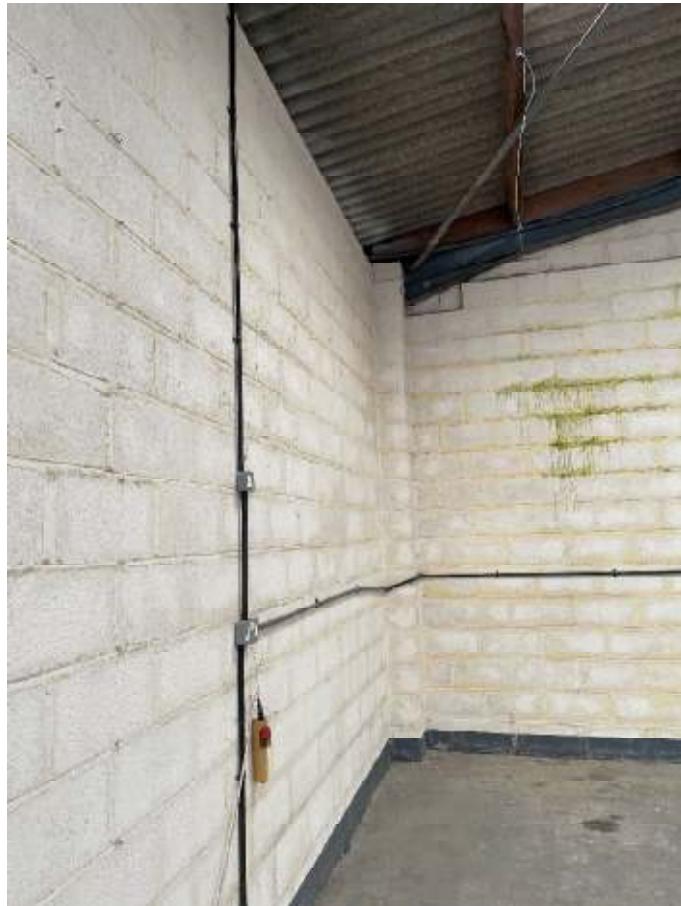
The internal dividing walls appear to have been built on the concrete floor slab, and these all appeared to be in a satisfactory condition.

**Figure 11:** Internal wall
